Form detail report

## #169: Manhole / Chamber Inspection Checklist

- 1.1 Project Name  
**Mal**
- 1.2 Date  
**Jun 13, 2022**
- 1.3 Location / Area / GL Ref  
**External drainage**
- 1.4 Specification / Drawing References  
**DR01 revC3**
- 1.5 MH / Chamber Reference  
**SW01 CATCHPIT**
- 1.6 Chamber Type: Foul Water / Storm Water / Combined  
**STORM WATER**

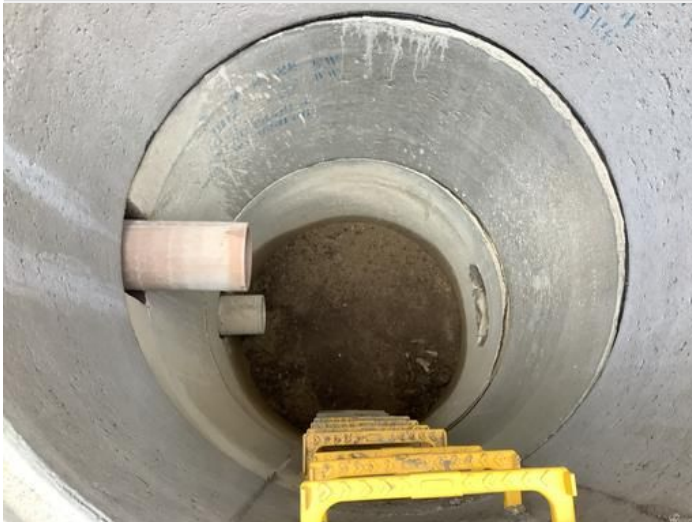
1.10 Benching / floor complete and of an acceptable standard

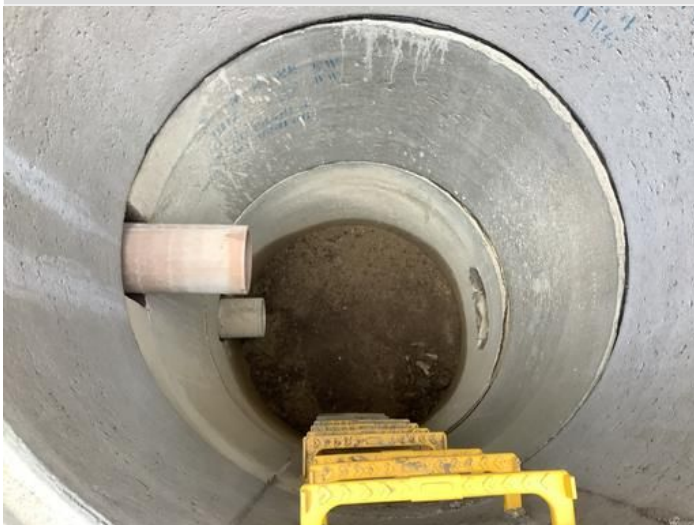
1.13 Raising Pieces / Correct courses of brickwork installed, clean & pointed to acceptable standard

1.14 All ring joints been pointed correctly

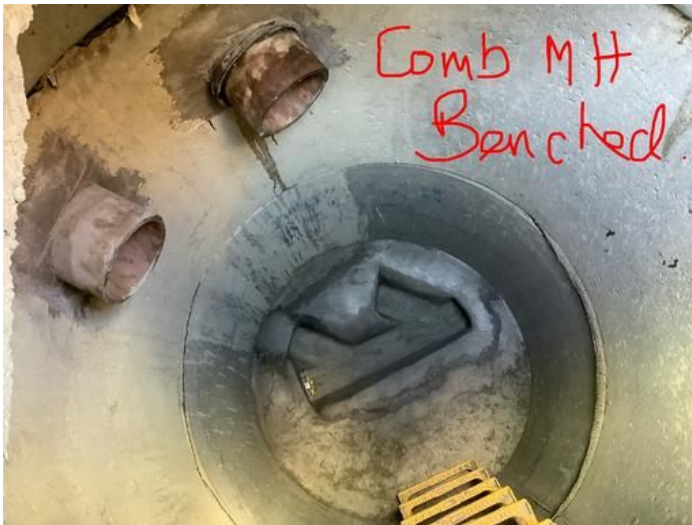
1.16 Chamber clean &amp; free of debris

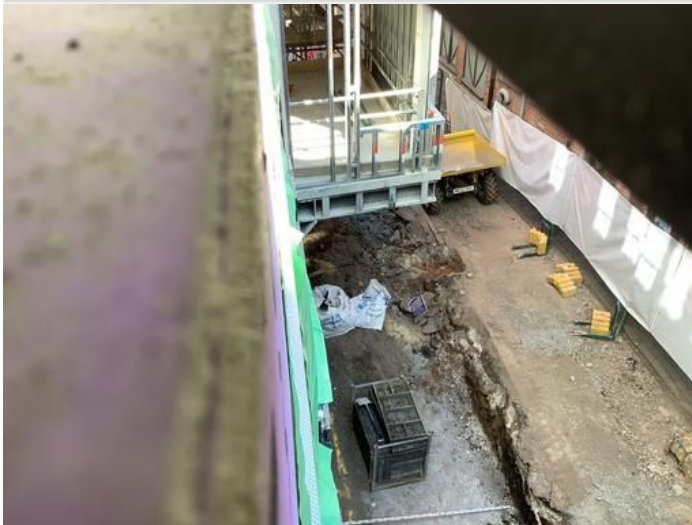
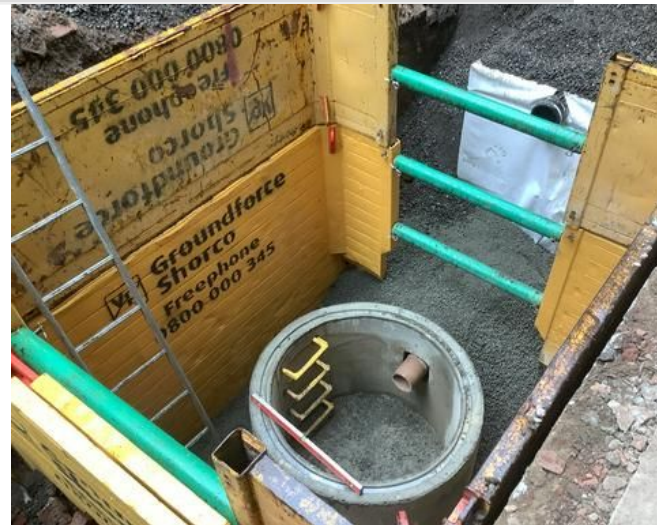
1.17 Correct cover class and depth installed correctly

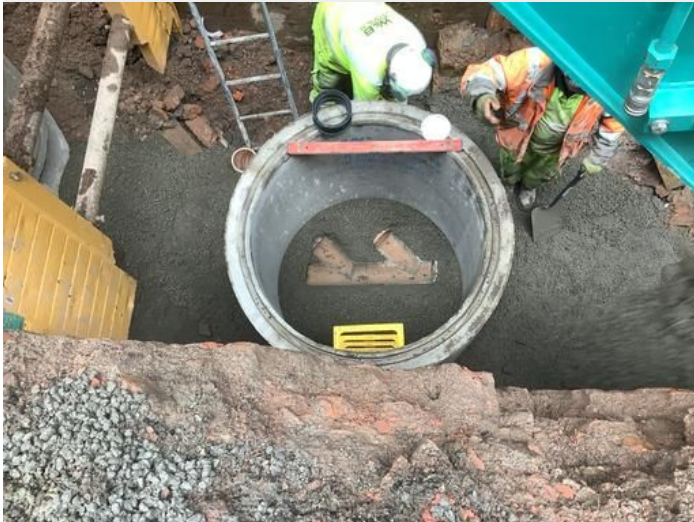
1.8 Channels installed as required

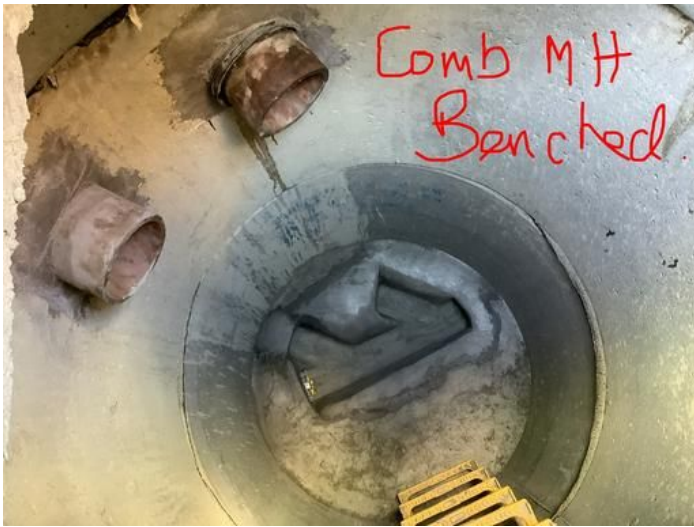
1.10 Benching / floor complete and of an acceptable standard

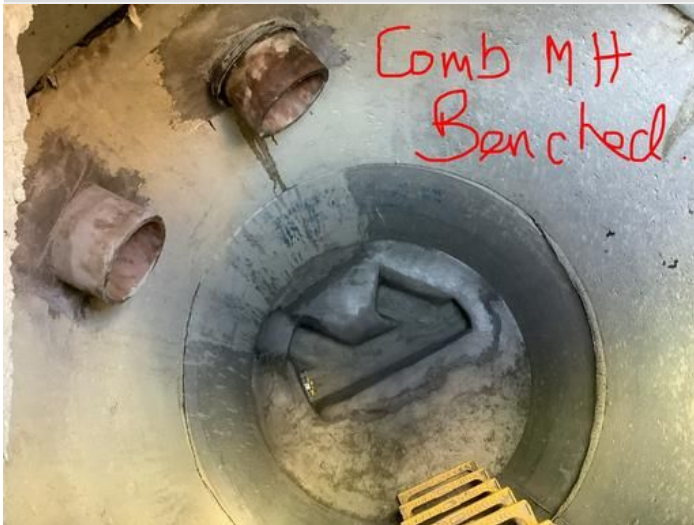
1.11 All pipe entries sealed as required

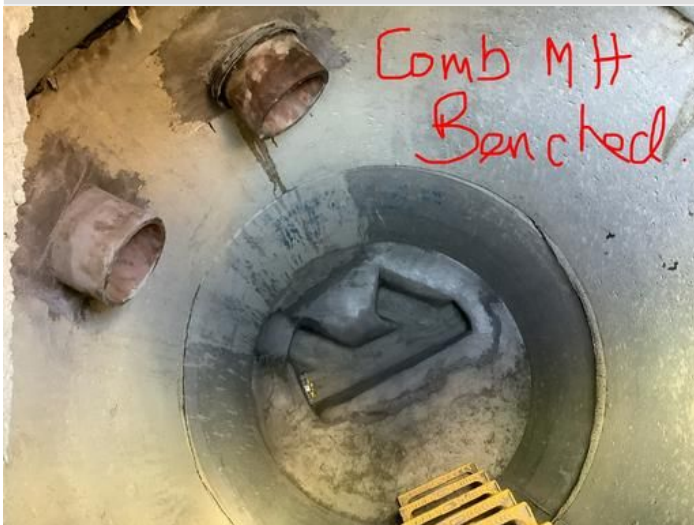
1.14 All ring joints been pointed correctly

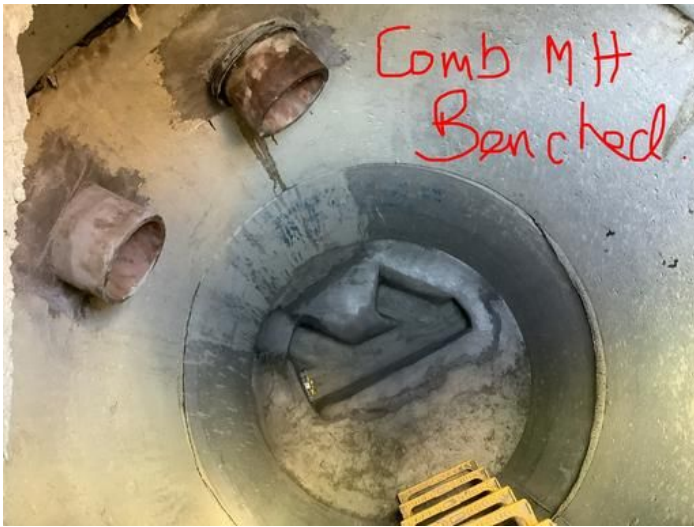
1.15 Chamber free from leaks

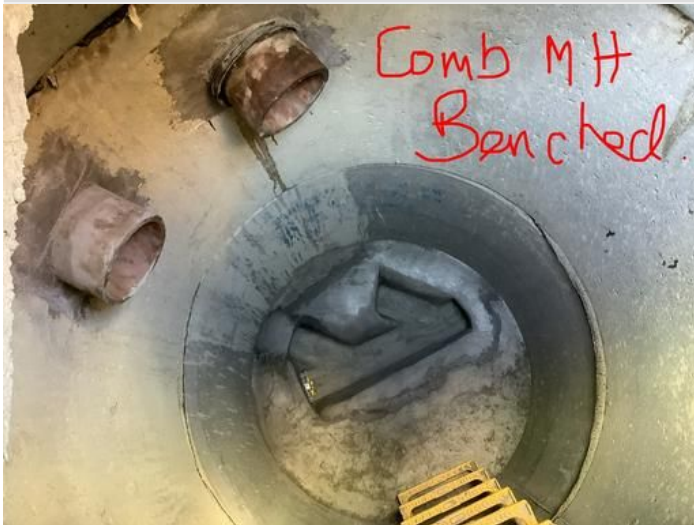
1.16 Chamber clean & free of debris

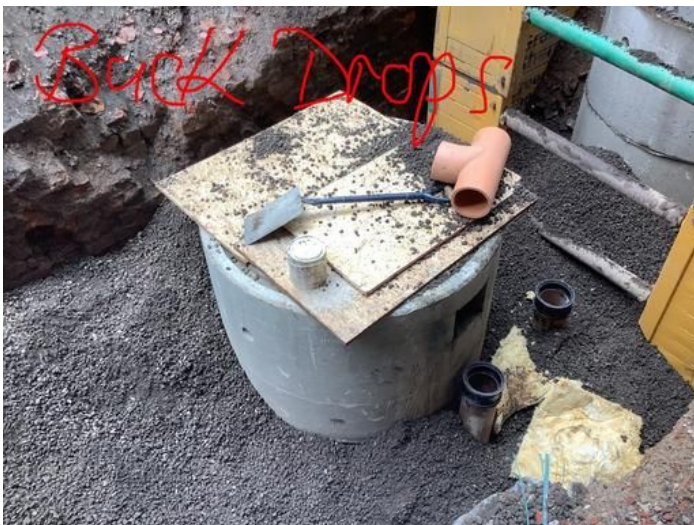
1.17 Correct cover class and depth installed correctly

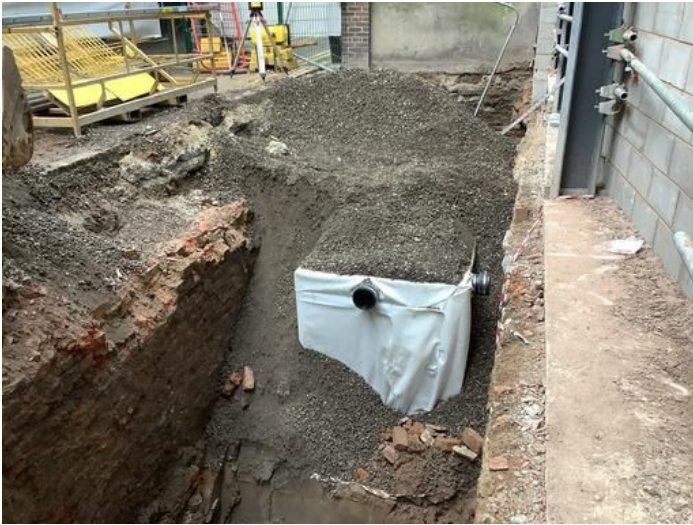
1.17 Correct cover class and depth installed correctly
