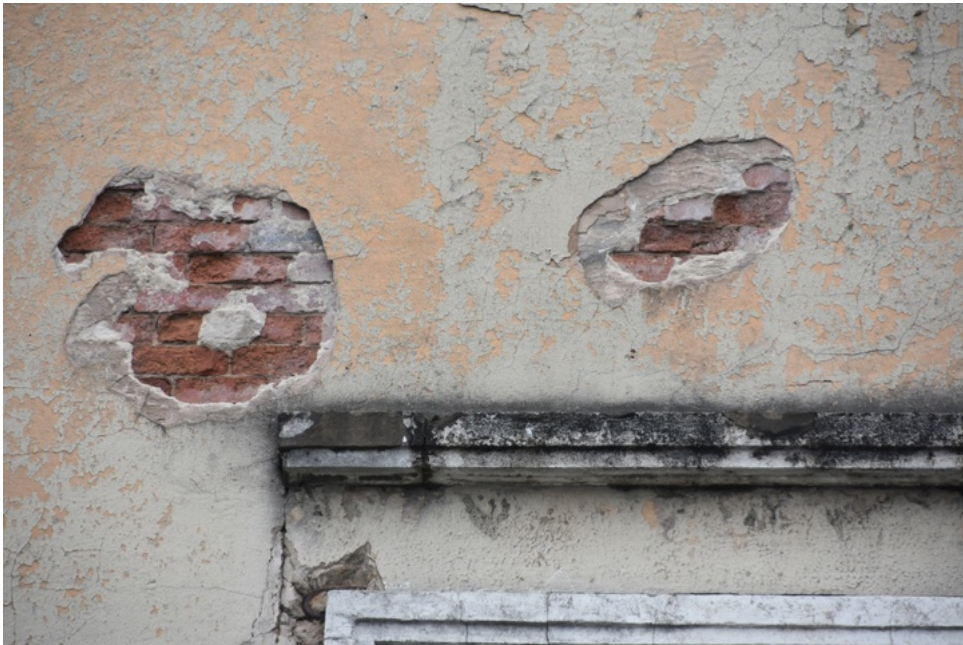
Damaged window head with exposed rebar and missing render

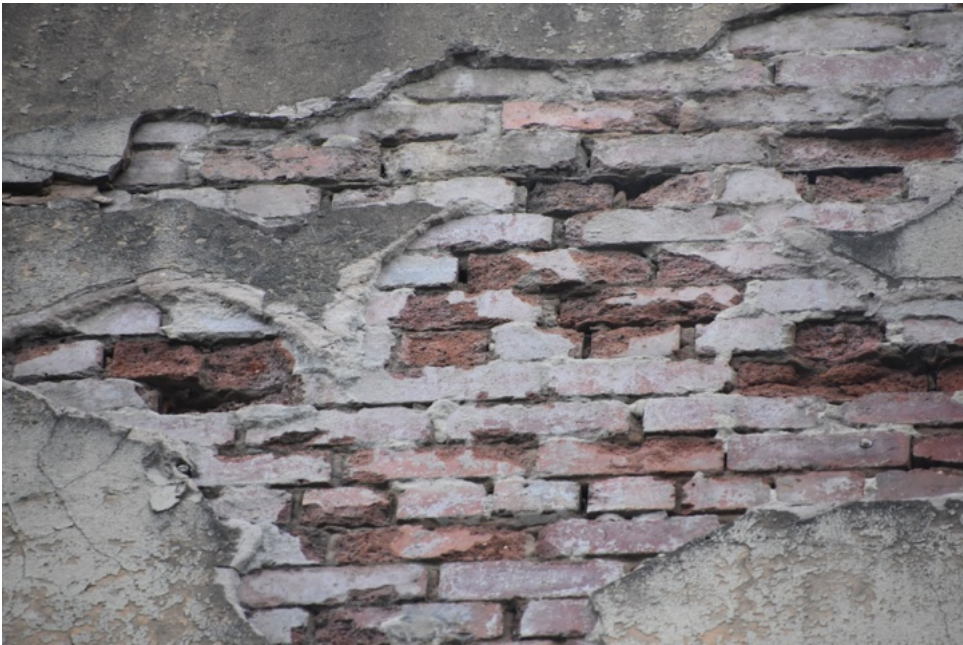
Missing render and frost damaged brickwork

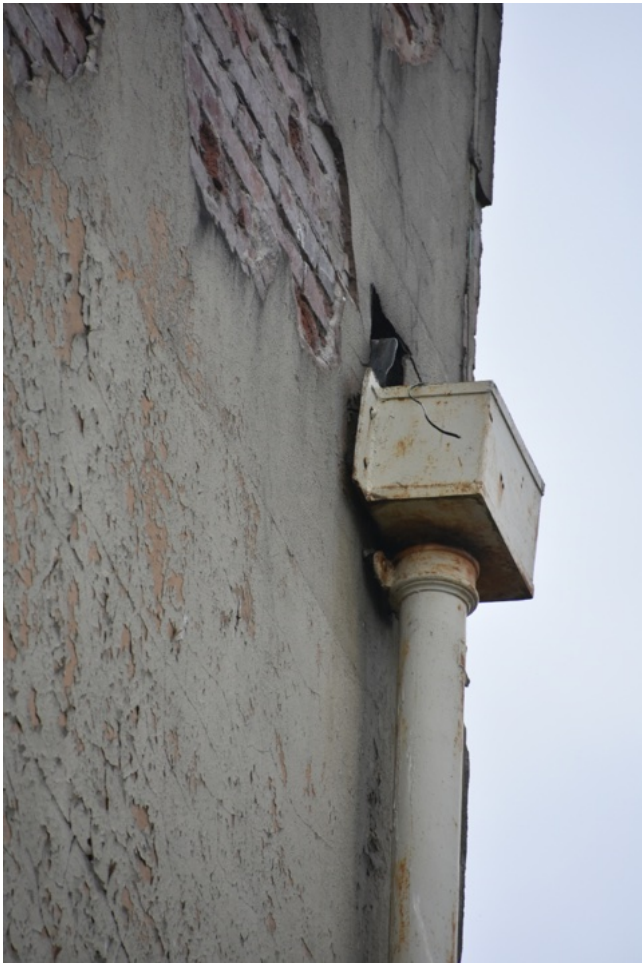
Damaged render and hopper not fixed to wall

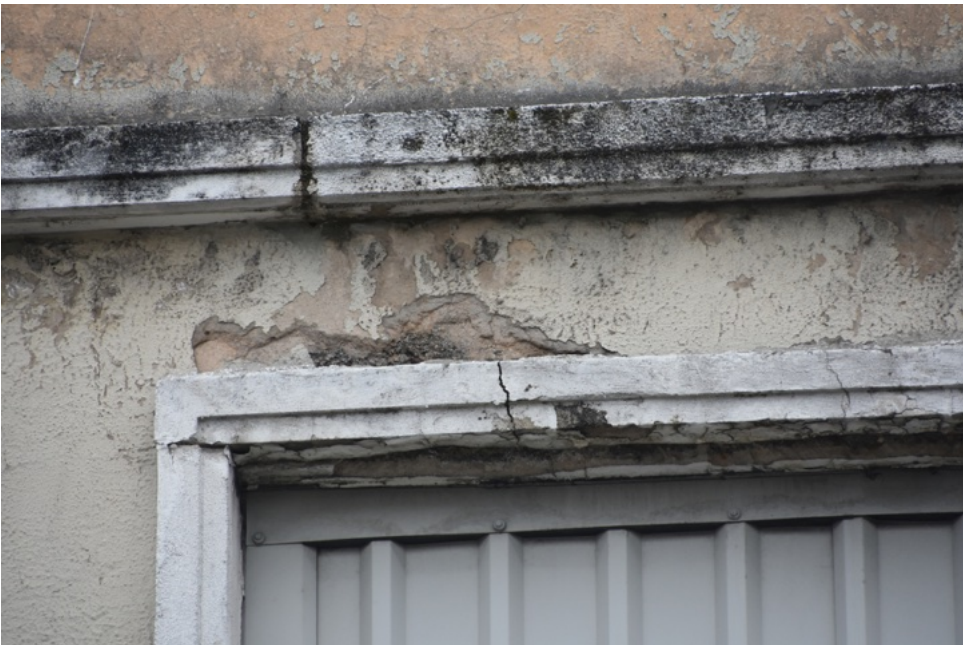
Damaged window head and render, missing grout at cornice

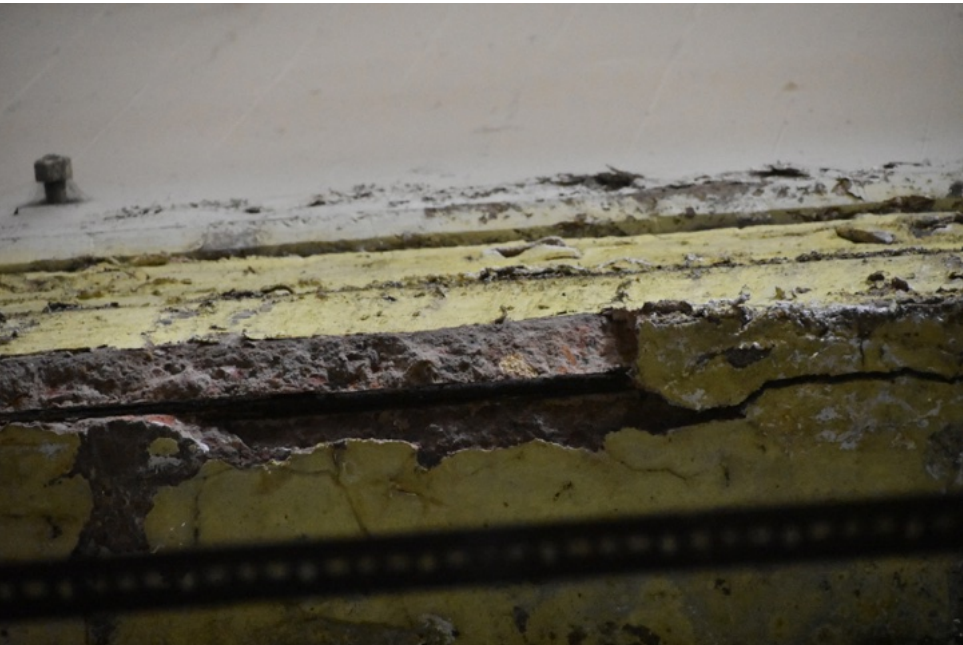
Cracked internal lintel with exposed rebar

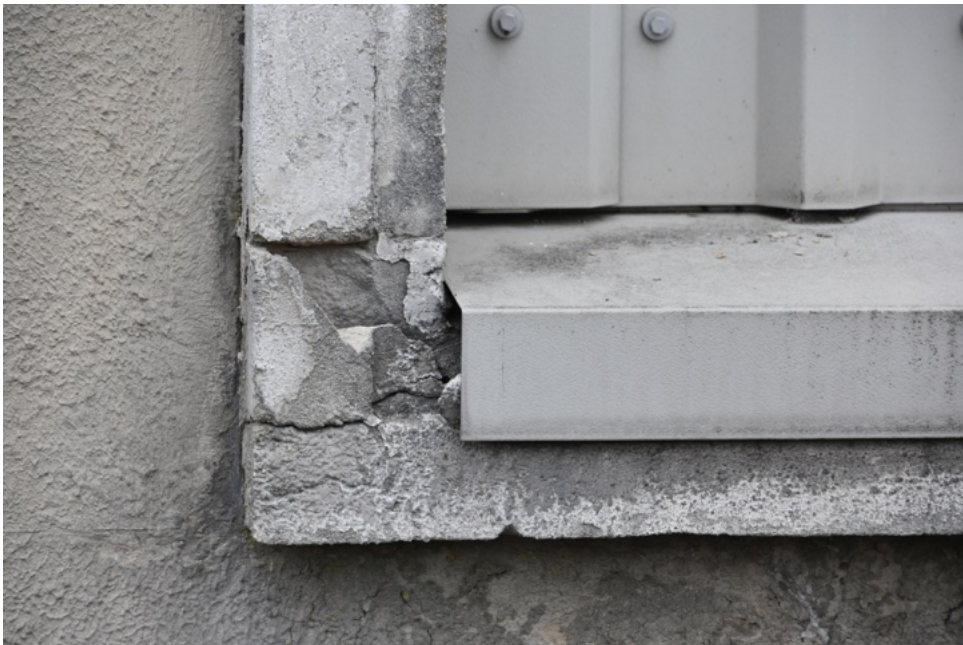
Typical frost damaged cast stone to window surround

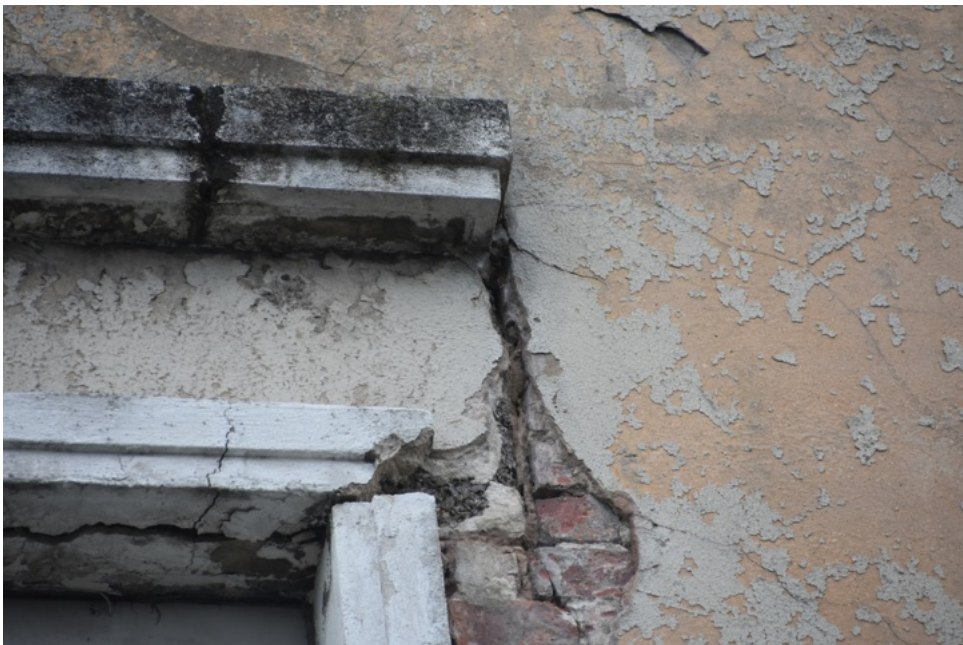
Damaged window head and outer lintel, damaged and missing render

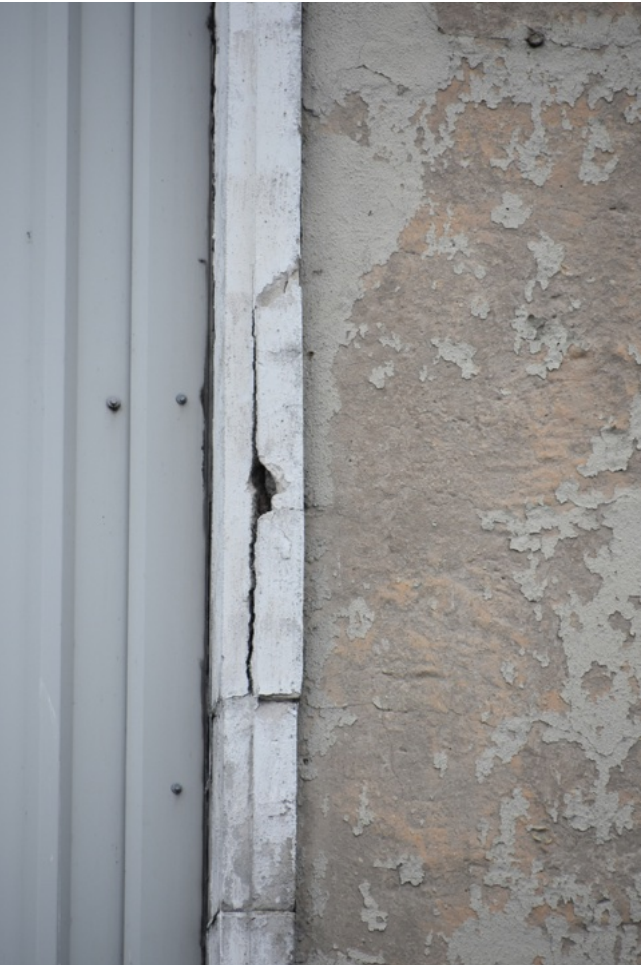
Damaged cast stone to window jamb
