Mosley Street

Proposed Elevation - Back  
George Street - Repairs

PROJECT REF. 1995  
DRWG NO. P(203)  
REVISION  
SCALE 1:100 @ A3  
DATE 1st May 24  
DRAWN HW

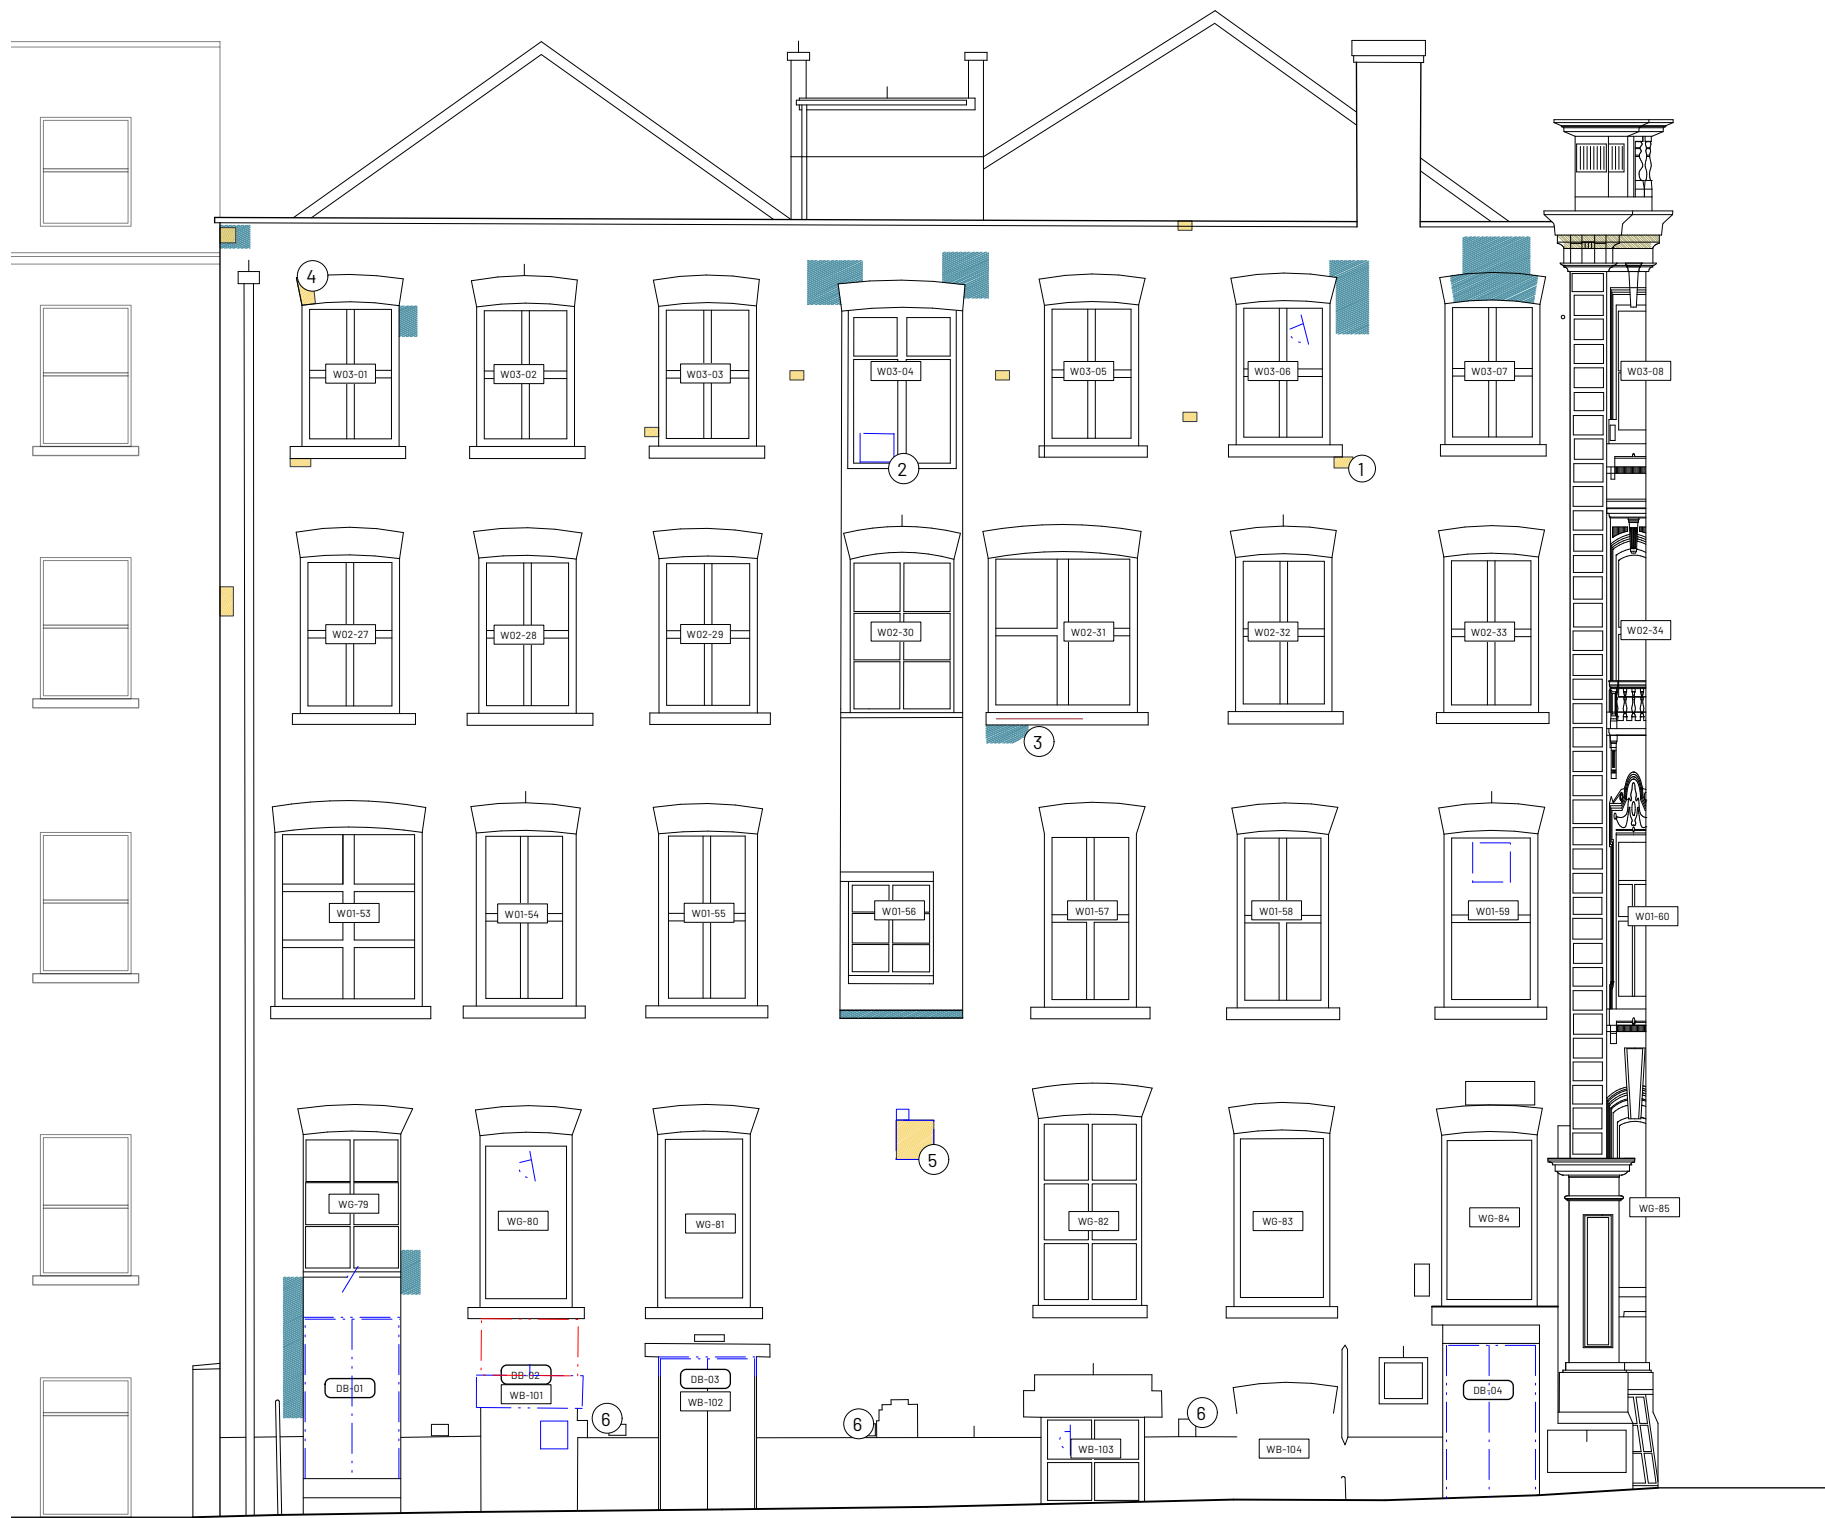
1. Replacement brick to full depth of wall.
2. Extend timber cill to incorporate drip detail.
3. Cracked stone cill - consider pinning - to S.E. details.
4. Cracked brick - consider in-situ pinning. To S.E. details.
5. Redundant plant equipment removed and brickwork reinstated to match existing.
6. Clean and repair cast iron vent.

- AtMB - Repair -Remove biological growth
- AtMB - Repair -Replace brick
- AtMB - Repair -Repointing
- AtMB - Repair -Stone indent or sacrificial mortar fill
- AtMB - Repair -Stone indent repair
- AtMB - Repair -Remove loose hard mortar with brush
- AtMB - Repair -Clean to remove guano deposits
- AtMB - Repair -Cracked brick. Mortar fill.
- AtMB - Repair -Mortar fill redundant fixing hole
- AtMB - Repairs -Clean off graffiti paint
- AtMB - Repair - Descale
- AtMB - Repair -Structural repair to S.E. details
