Client  
The National Trust

Project Title  
Castlefield Viaduct  
Phase 2

Drawing Title  
Remedials  
Lattice Girders  
Diagonal Intersections

| ID | CVI-ARUP-ZZ-ZZ-DR-S-4011 | | |

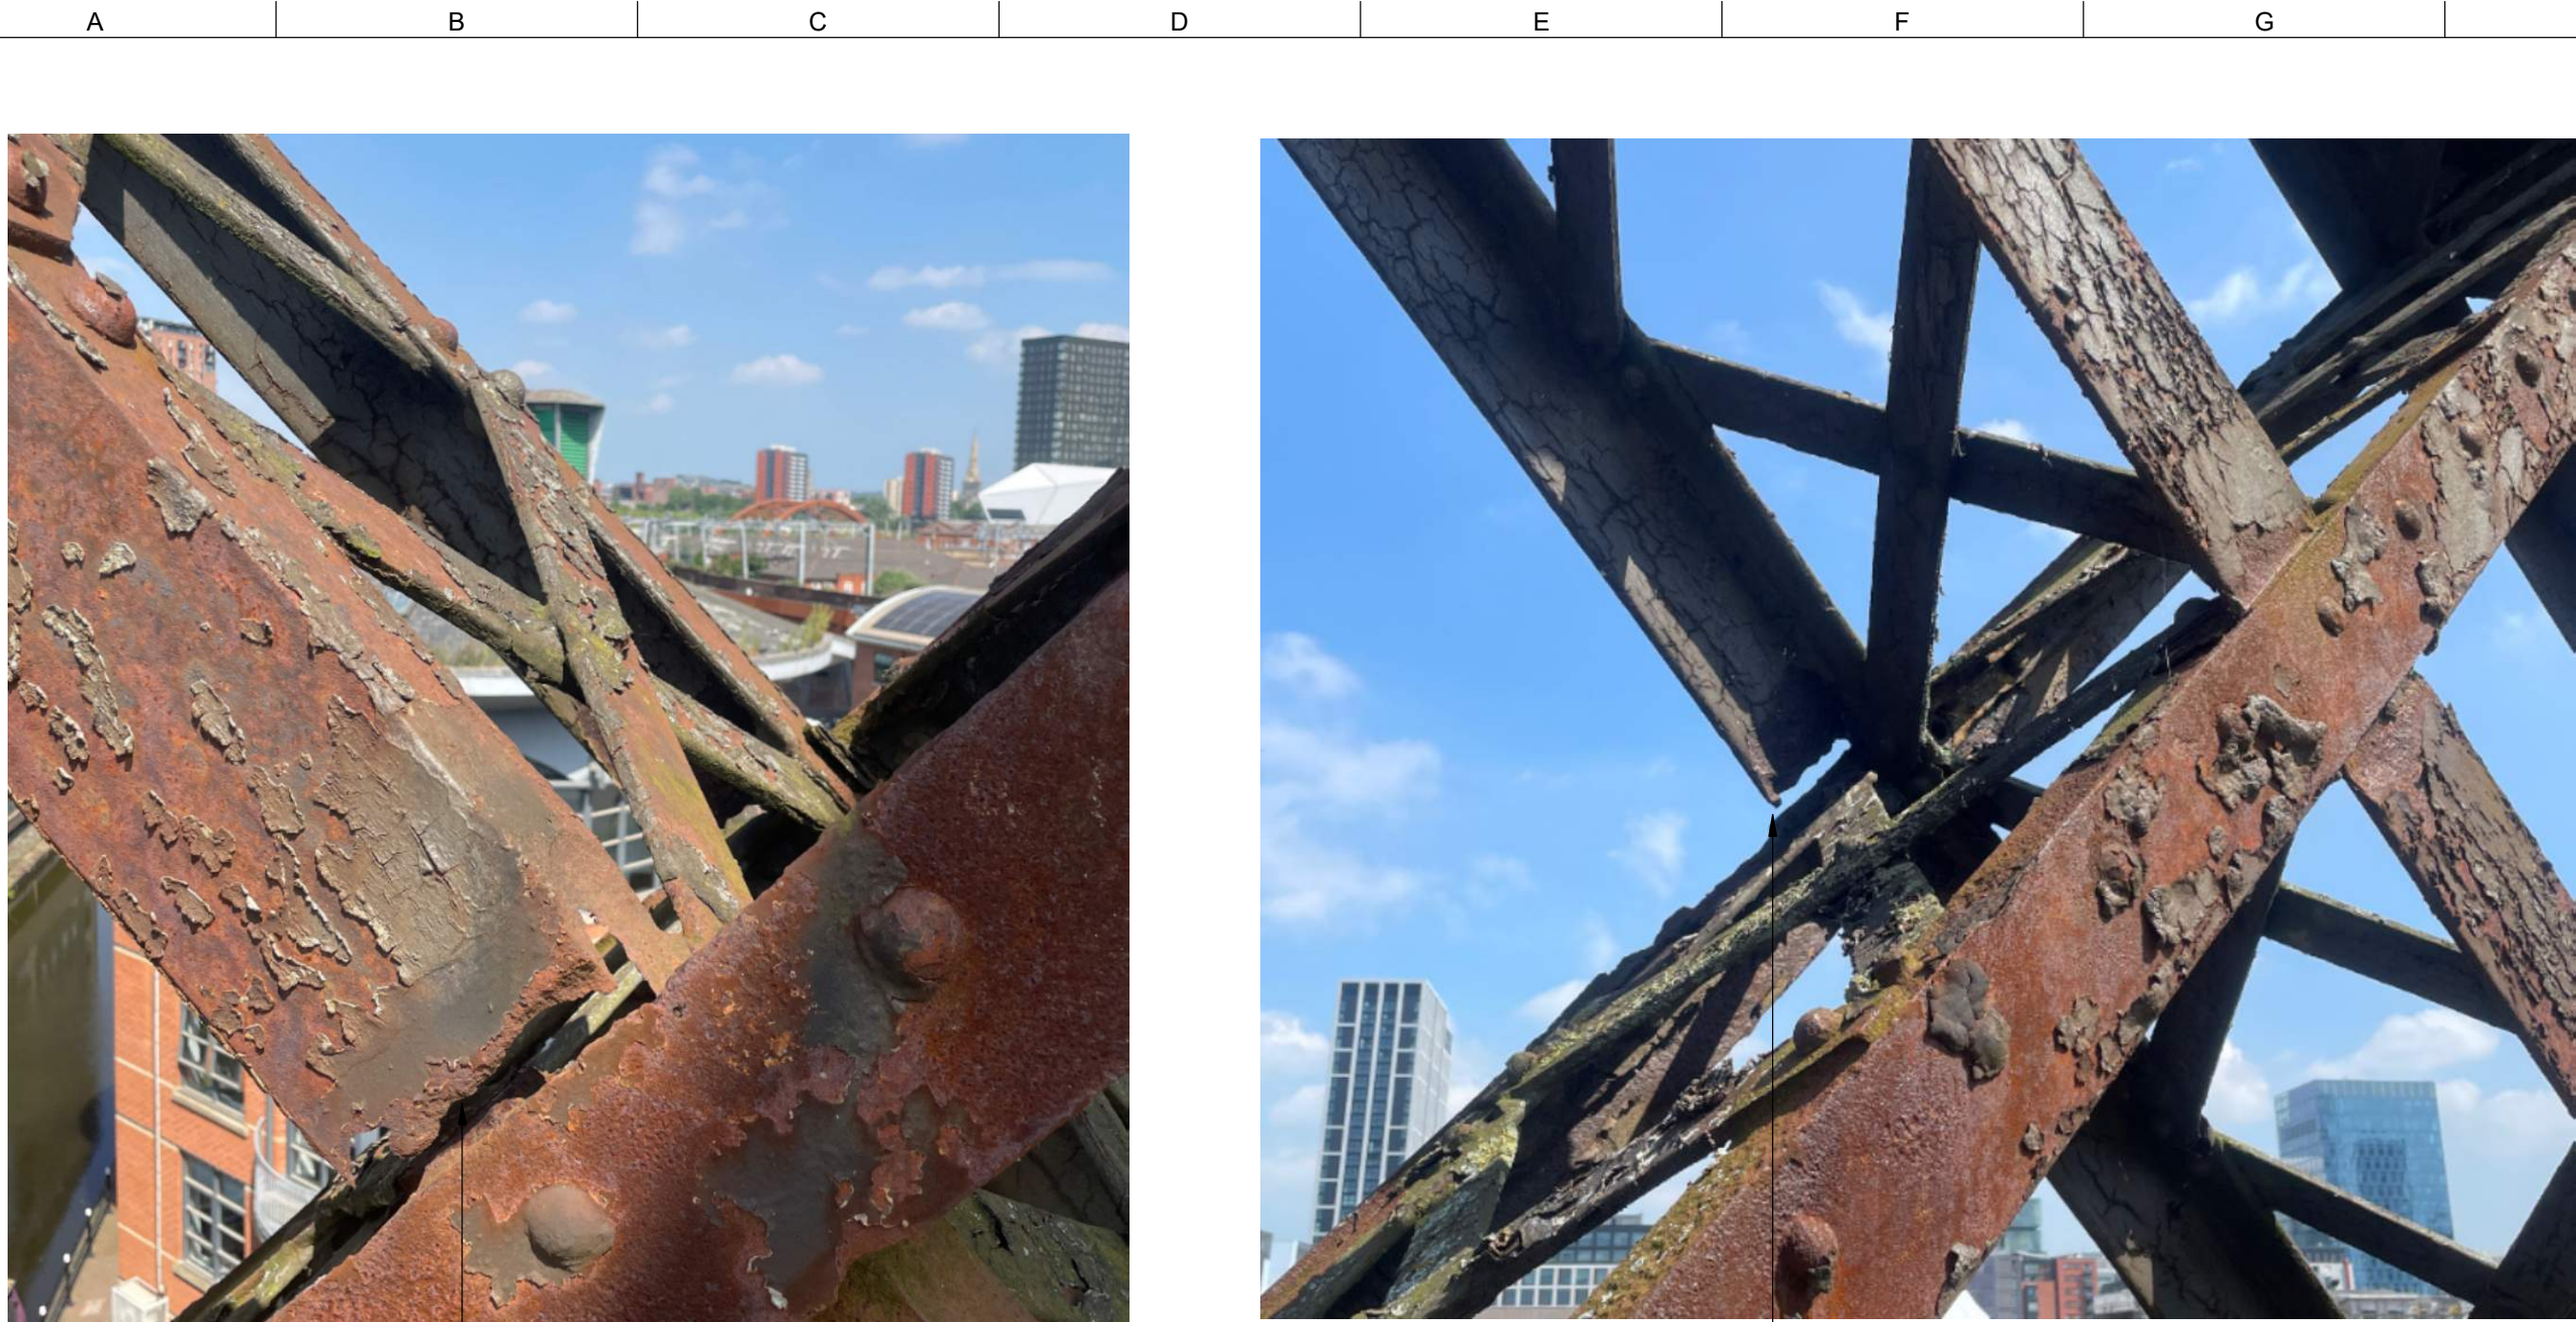
**Example 1**  
- almost complete loss of section to lattice diagonal on deck side (specifically inner plate 2 according to nomenclature on drawing CVI-ARUP-ZZ-ZZ-DR-S-1055)  
- affected diagonal is a continuous angle section running through the intersection  
- other diagonal is a rivetted built-up angle (flat to outside with smaller rivetted angle within)

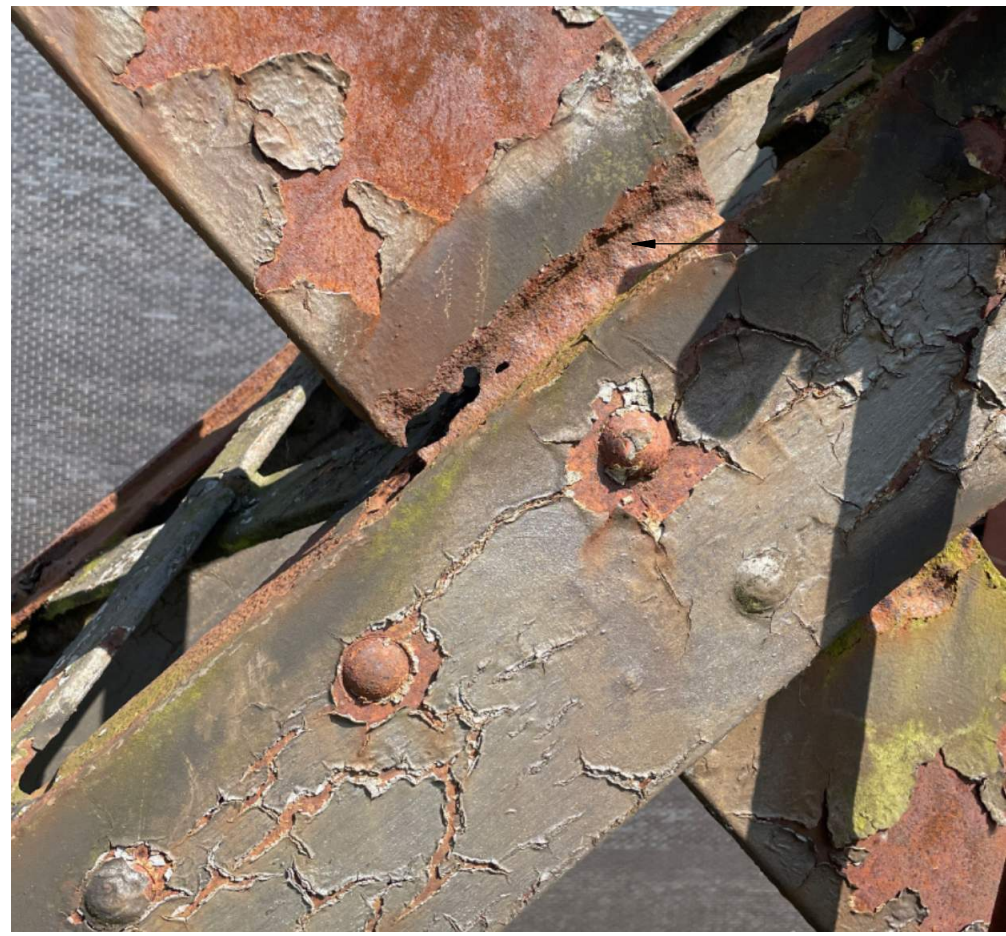
**Example 2**  
- similar to Example 1 but with diagonal on outer side (specifically outer plate 2 according to nomenclature on drawing CVI-ARUP-ZZ-ZZ-DR-S-1055)  
- affected diagonal is a continuous angle section running through the intersection

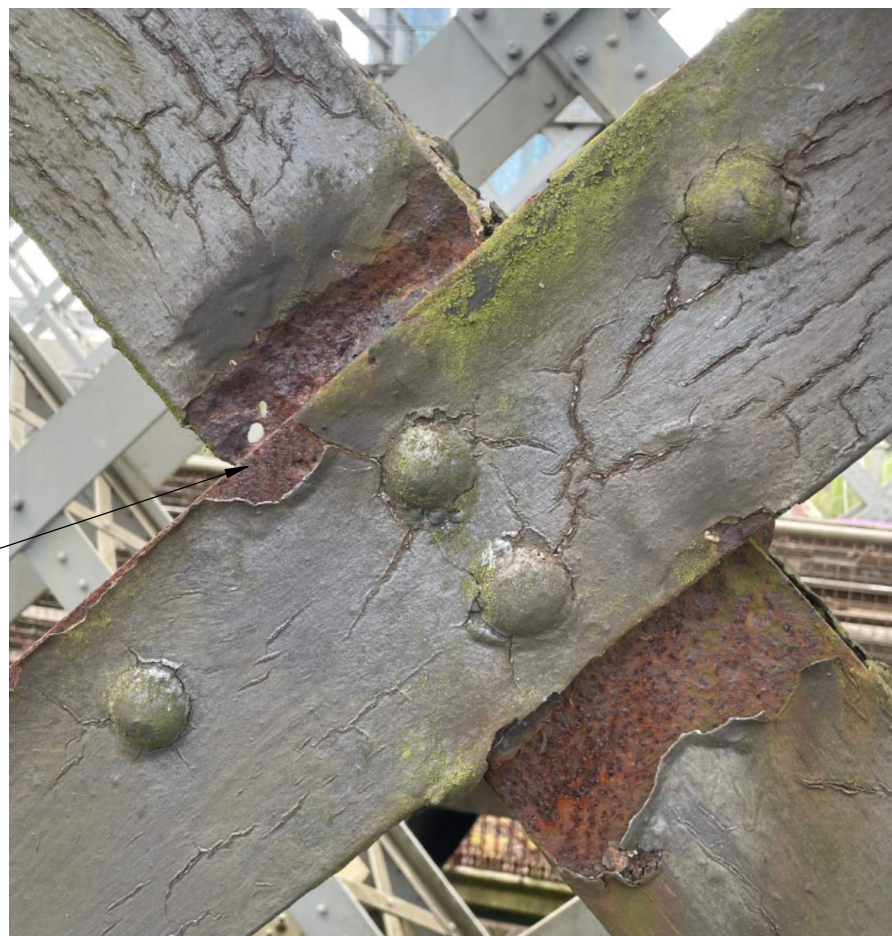
**Example 3**  
- loss of section across less than 50% length of angle web  
- pitting and loss of thickness elsewhere

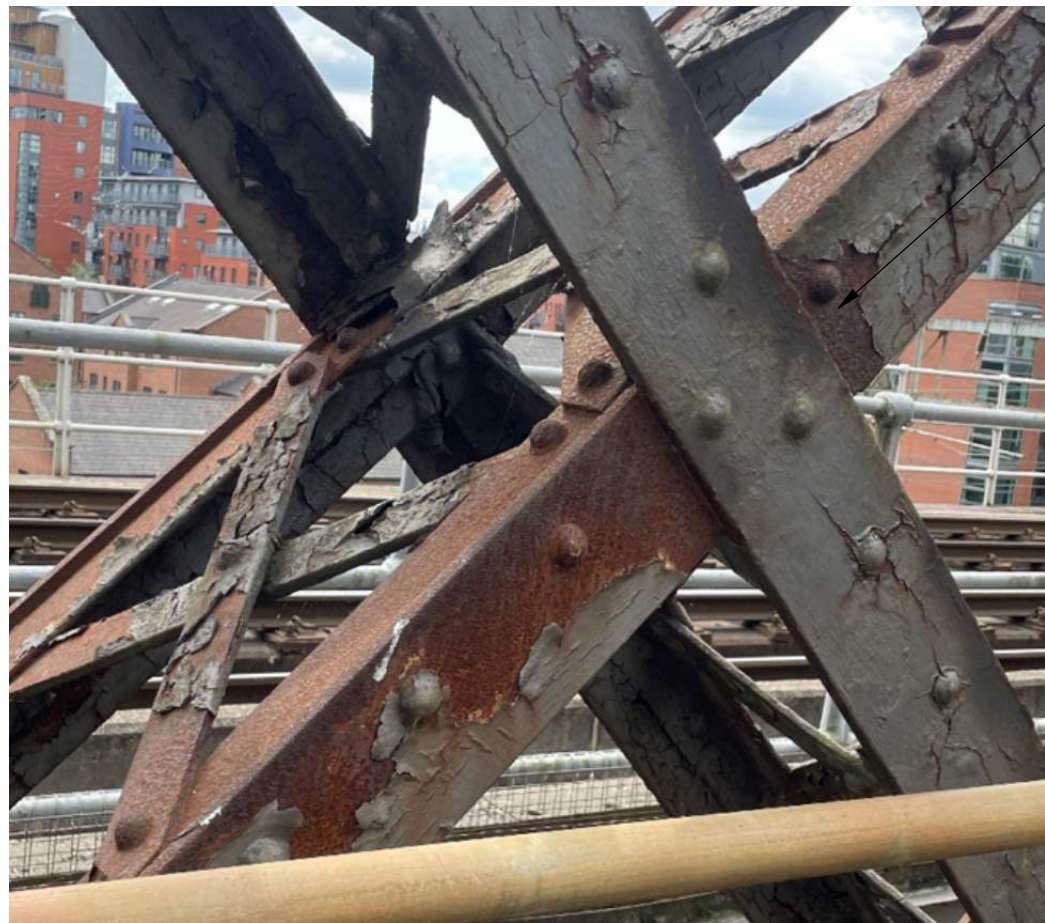
**Example 4**  
- loss of section only on short length of angle web  
- pitting and loss of thickness elsewhere

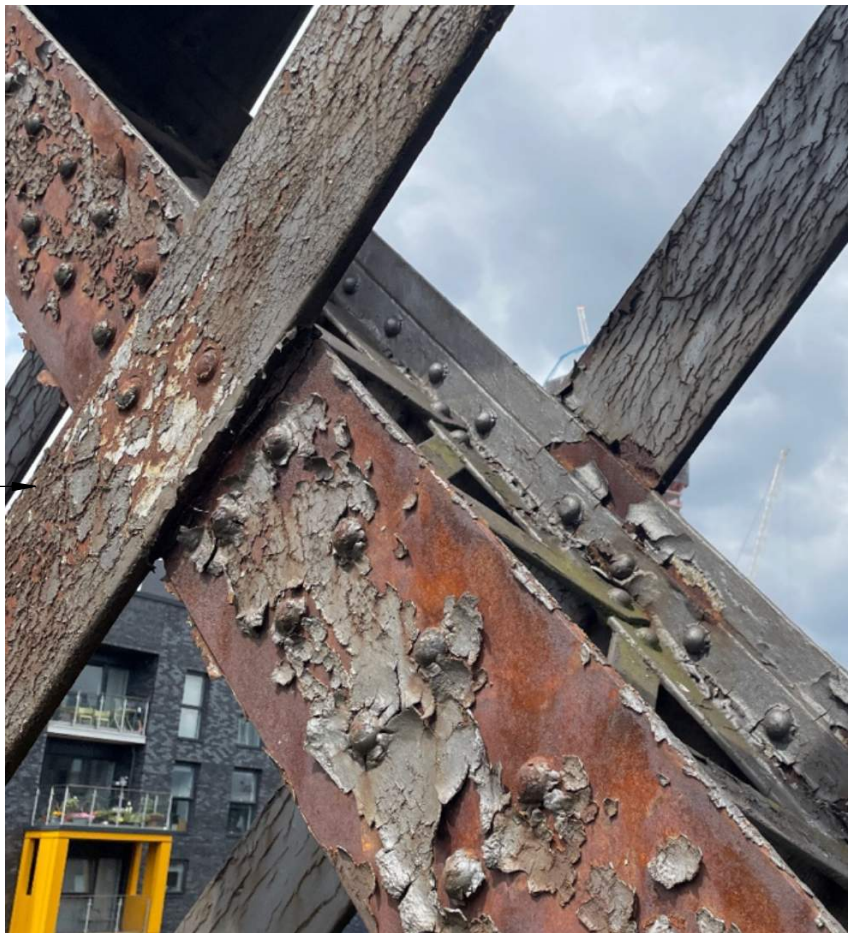
**Example 5**  
- no remedial required in this example, but shows different configuration with both diagonals being formed from rivetted built-up angles

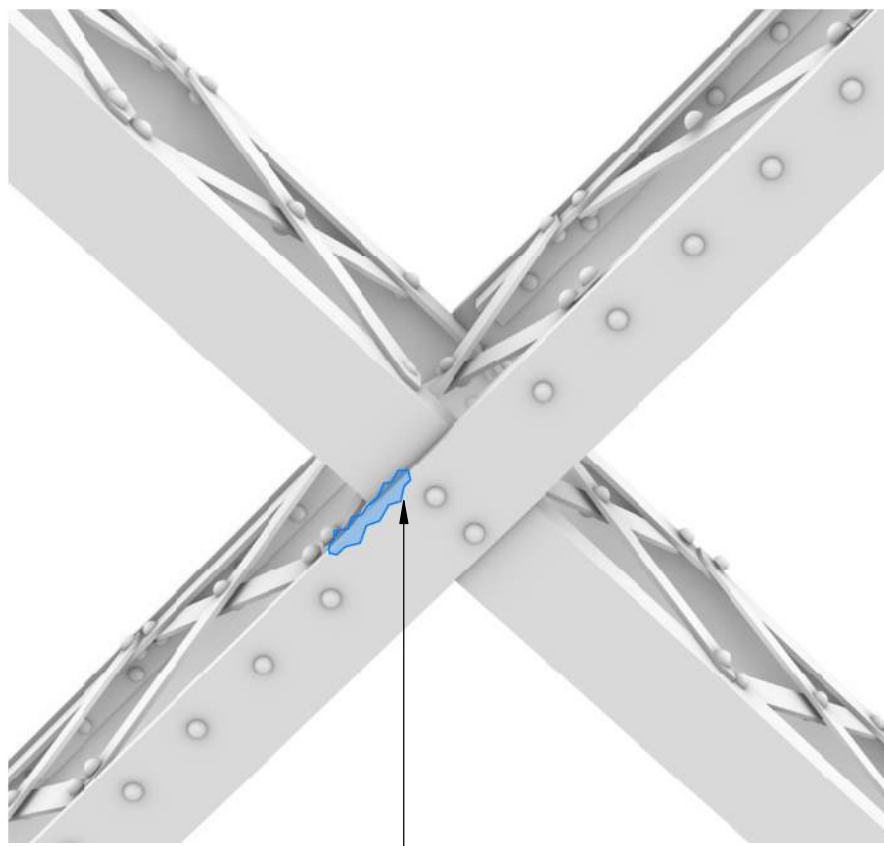
**Example 6**  
- no remedial required in this example, but shows different configuration with one diagonal as flat, other diagonal as rivetted built-up angle  
- note no cross bracing for diagonals with flats only
