# GROUND GAS RESISTANT MEMBRANE INSPECTION RECORD

| <b>Project:</b> | VICTORIA AVENUE, BLACKLEY |
| <b>Project No:</b> | 3951 |
| <b>Plot No. Inspected:</b> | 11 |

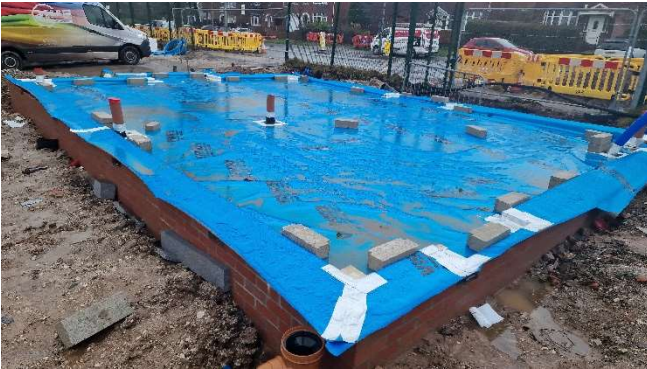
Figure 1 – General view of the plot. Sufficient coverage of cavities.

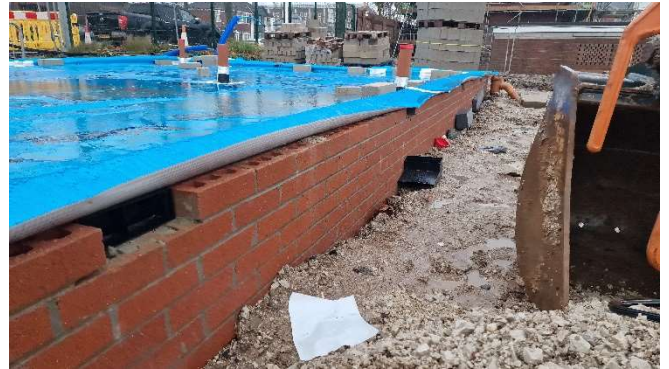
Figure 2 – Sufficient vents. Front fascia to be installed as brickwork progresses

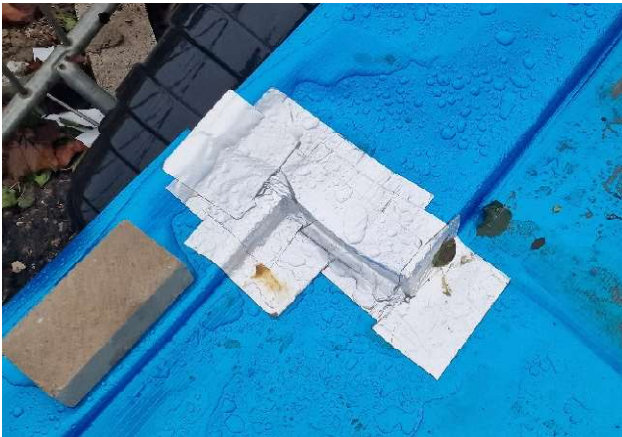
Figure 3 – Corners installed using detailing tape giving sufficient coverage of cavities

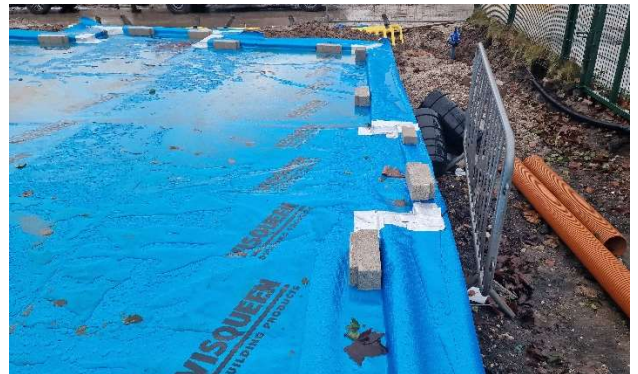
Figure 4 – Sufficient cavity cover.

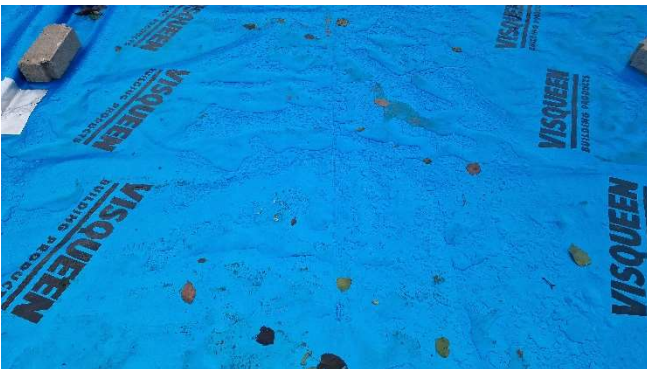
| INSPECTED ITEM | YES/NO | COMMENTS | PHOTOGRAPHED<br>YES / NO |
|---|---|---|---|
| <b>Jointing</b><br>Check that all jointing has been carried out to the manufacturer's specification. | Y | Hand welded jointing to a good standard. | Y |

Figure 5 – Hand Welded Seams

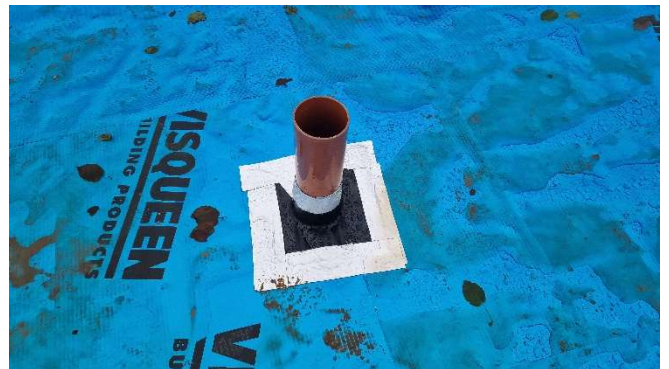
| INSPECTED ITEM | YES/NO | COMMENTS | PHOTOGRAPHED<br>YES / NO |
|---|---|---|---|
| <b>Top Hat Installation</b><br>Check that top hats have been correctly installed around service entries, including jubilee clip around pipe and correct lapping and jointing to membrane at base. | Y | Service penetrations sealed with top hats reinforced with detailing strip to enhance the stability around perimeter of "brim" and around top of pipe. | Y |

Figure 6 – Service entries sealed and secure.

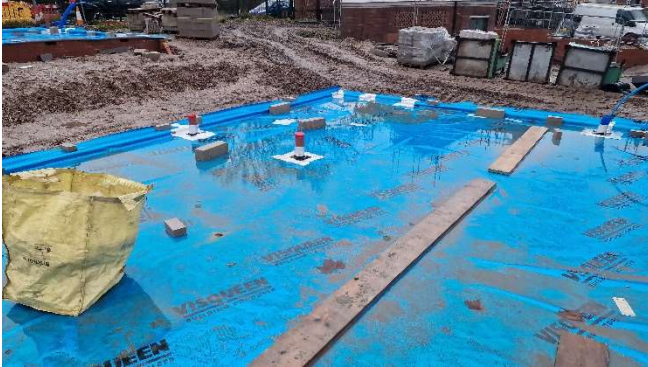
Figure 1 – General view of the plot. Sufficient coverage of cavities.

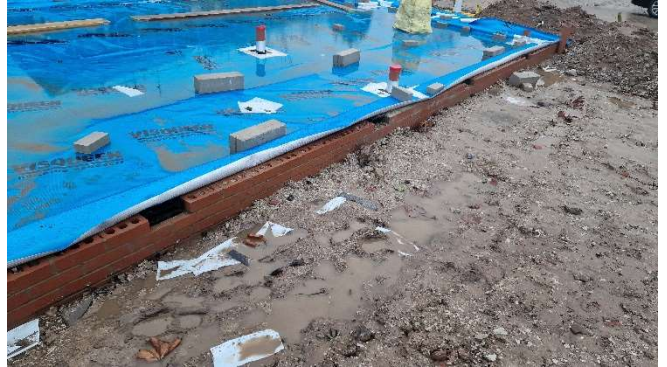
Figure 2 – Sufficient vents. Front fascia to be installed as brickwork progresses

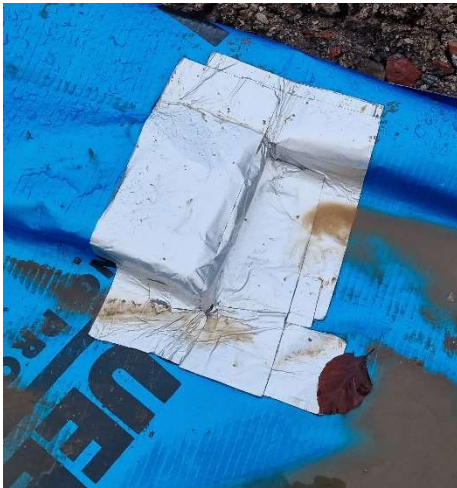
Figure 3 – Corners installed using detailing tape giving sufficient coverage of cavities

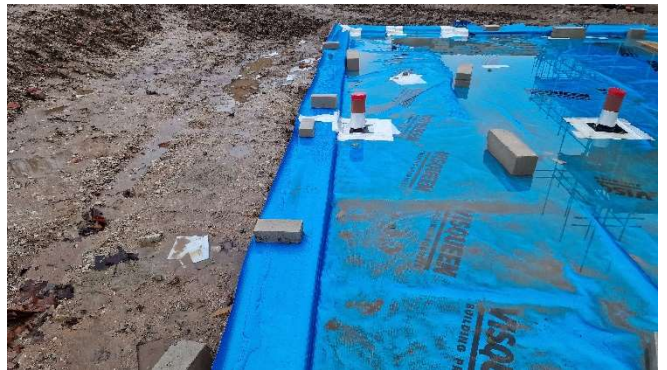
Figure 4 – Sufficient cavity cover, and partial overview

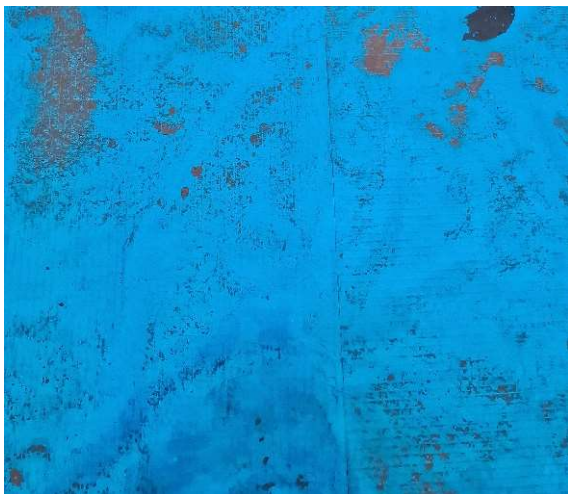
Figure 5 – Hand Welded Seams

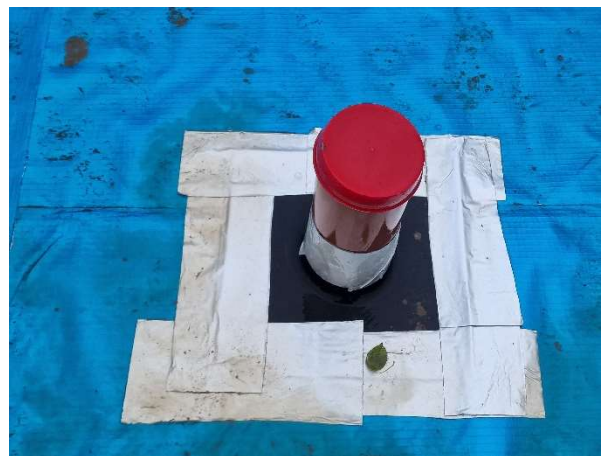
Figure 6 – Service entries sealed and secure.

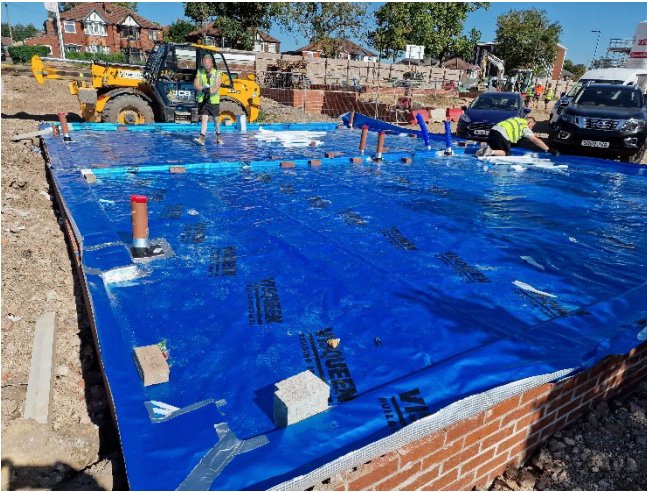
Figure 1 – General view of the plot. Sufficient coverage of cavities.

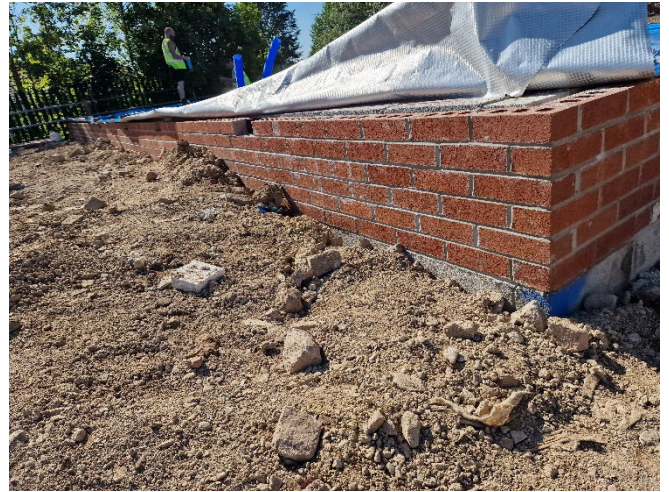
Figure 2 – Sufficient vents.

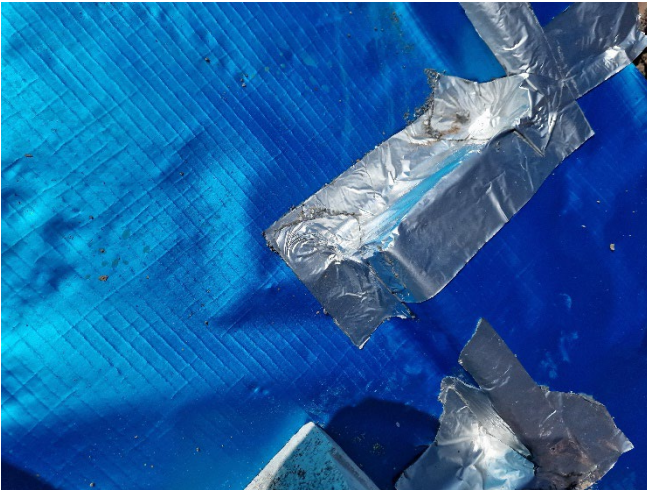
| INSPECTED ITEM | YES/NO | COMMENTS | PHOTOGRAPHED<br>YES / NO |
|---|---|---|---|
| <b>Jointing</b><br>Check that all jointing has been carried out to the manufacturer's specification. | Y | Hand welded jointing. gaps found in jointing at corners and edge of detailing strip. Correctly patched and witnessed during inspection. | Y |

Figure 3 – Corners installed using detailing tape giving sufficient coverage of cavities

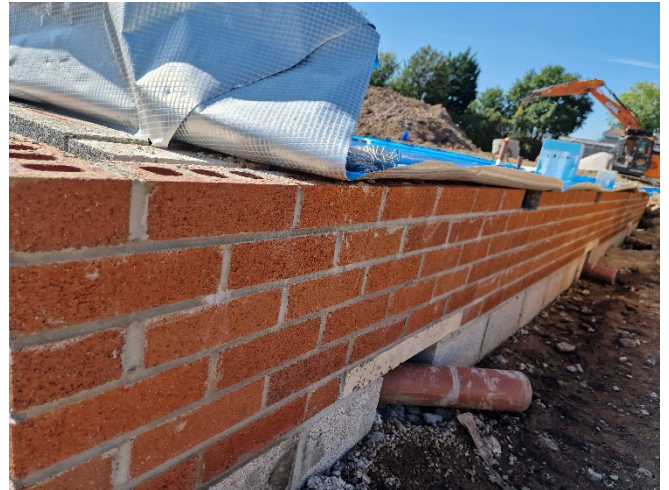
Figure 4 – Sufficient vents.

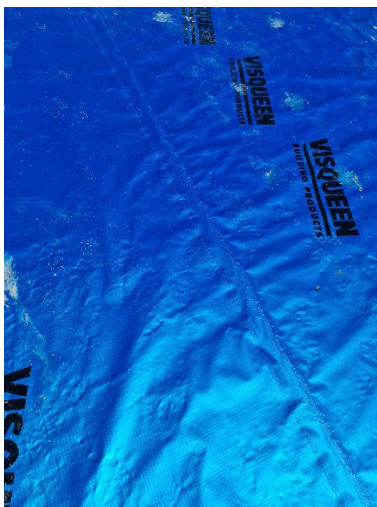
Figure 5 – Hand Welded Seams

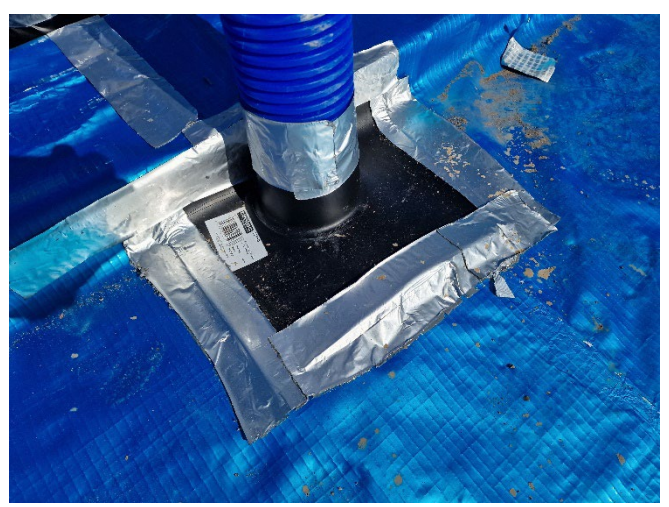
| INSPECTED ITEM | YES/NO | COMMENTS | PHOTOGRAPHED<br>YES / NO |
|---|---|---|---|
| <b>Top Hat Installation</b><br>Check that top hats have been correctly installed around service entries, including jubilee clip around pipe and correct lapping and jointing to membrane at base. | Y | Additional tape added to perimeter of top hats to reinforce the stability. Completed under supervision. | Y |

Figure 6 – Service entries sealed and secure.

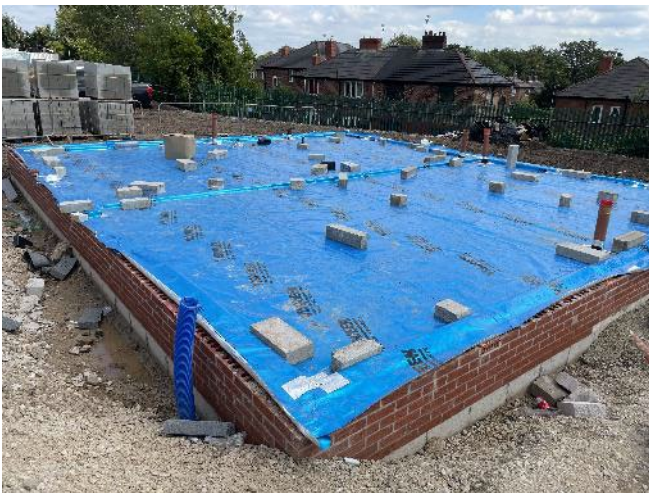
Figure 1 – General view of the plot. Sufficient coverage of cavities.

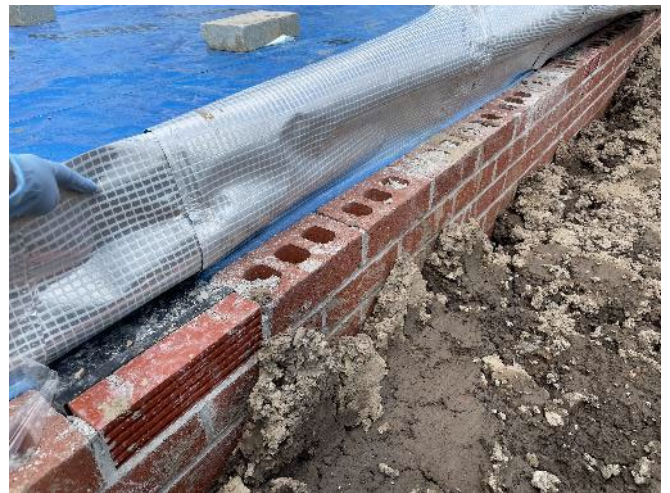
Figure 2 – Sufficient vents can be seen (every 2m).

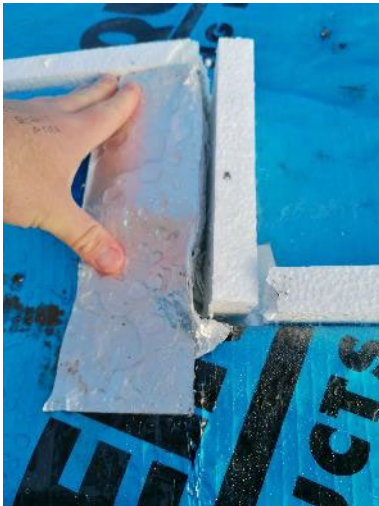
| INSPECTED ITEM | YES/NO | COMMENTS | PHOTOGRAPHED YES / NO |
|---|---|---|---|
| <b>Installation</b><br>Check that the membrane has been installed correctly across cavities, including correct jointing in these areas. | Y | Sufficient lap covering cavity. Gaps in 3 corners on previous visit. Correctly patched on return visit. | Y |

Figure 3 – Gaps in corners correctly patched.

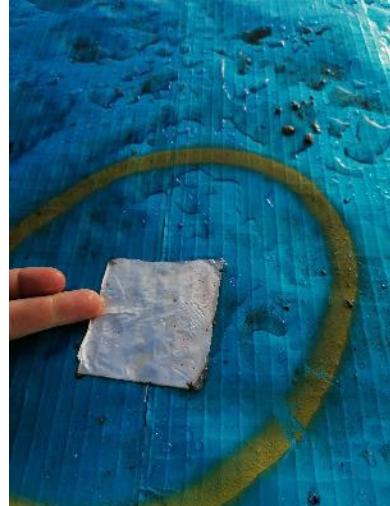
| INSPECTED ITEM | YES/NO | COMMENTS | PHOTOGRAPHED YES / NO |
|---|---|---|---|
| <b>Jointing</b><br>Check that all jointing has been carried out to the manufacturer's specification. | Y | Hand welded jointing. 14 gaps found in jointing on previous visit. Correctly patched on return visit. | Y |

Figure 4 – Gaps in welding have been correctly patched.

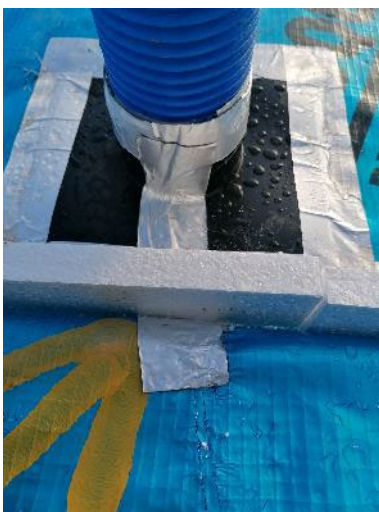
| INSPECTED ITEM | YES/NO | COMMENTS | PHOTOGRAPHED YES / NO |
|---|---|---|---|
| <b>Top Hat Installation</b><br>Check that top hats have been correctly installed around service entries, including jubilee clip around pipe and correct lapping and jointing to membrane at base. | Y | Gaps in the bases of all 6 top hats on previous visit. Correctly patched on return visit. | Y |

Figure 5 – Gaps in service entries have been correctly sealed.

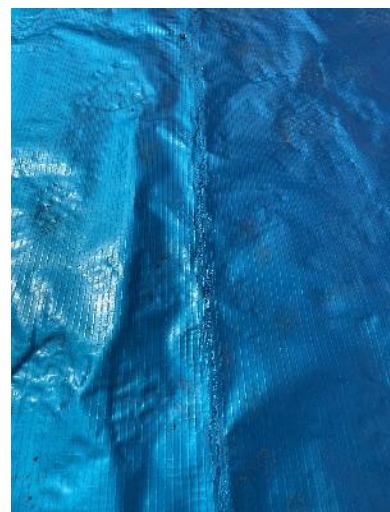
Figure 6 – Joints are hand welded.

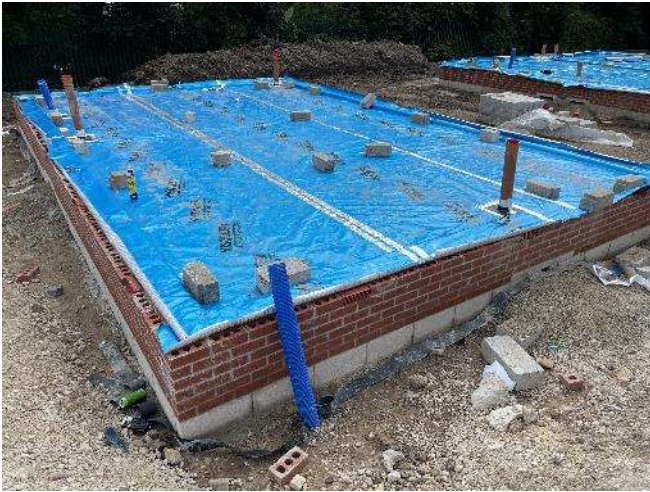
Figure 1 – General view of the plot. Sufficient coverage of cavities.

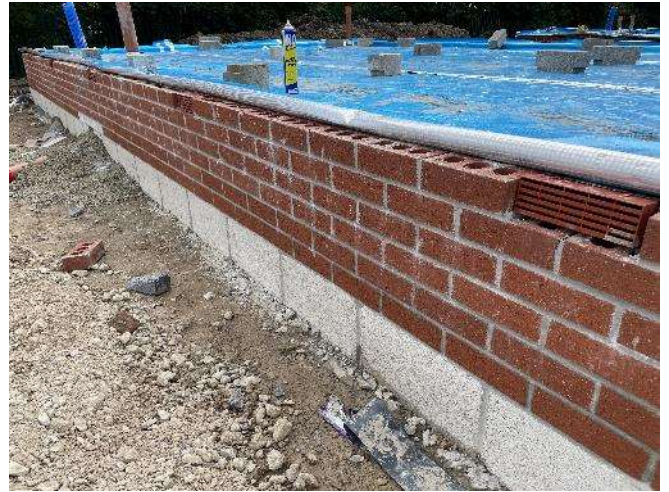
Figure 2 – Sufficient vents can be seen (every 2m).

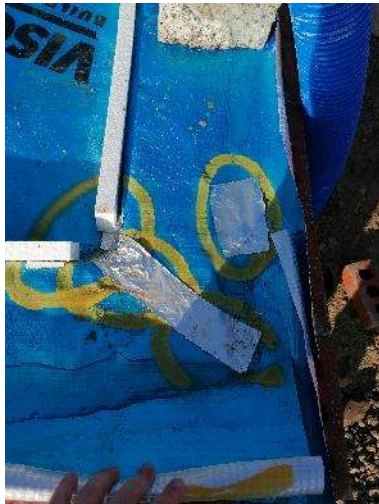
| INSPECTED ITEM | YES/NO | COMMENTS | PHOTOGRAPHED YES / NO |
|---|---|---|---|
| <b>Installation</b><br>Check that the membrane has been installed correctly across cavities, including correct jointing in these areas. | Y | Sufficient lap covering cavity. Gaps in 3 corners on previous visit. Correctly patched on return visit. | Y |

Figure 3 – Gaps in corners correctly sealed.

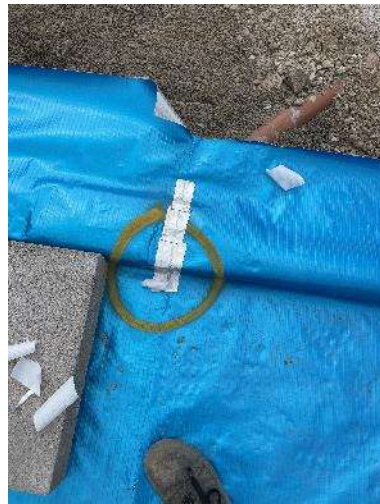
| INSPECTED ITEM | YES/NO | COMMENTS | PHOTOGRAPHED YES / NO |
|---|---|---|---|
| <b>Jointing</b><br>Check that all jointing has been carried out to the manufacturer's specification. | Y | Hand welded jointing. 14 gaps found in jointing on previous visit. Correctly patched on return visit. | Y |

Figure 4 – Multiple gaps found in hand welded jointing were correctly patched.

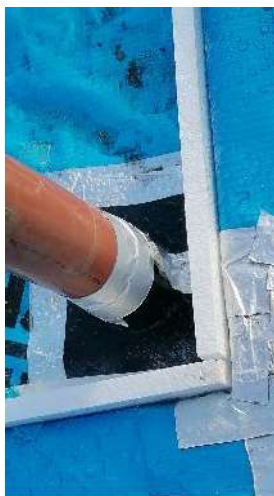
| INSPECTED ITEM | YES/NO | COMMENTS | PHOTOGRAPHED YES / NO |
|---|---|---|---|
| <b>Top Hat Installation</b><br>Check that top hats have been correctly installed around service entries, including jubilee clip around pipe and correct lapping and jointing to membrane at base. | Y | Gaps in the bases of 4 top hats on previous visit. Correctly patched on return visit. | Y |

Figure 5 – Gaps in service entry bases correctly sealed.

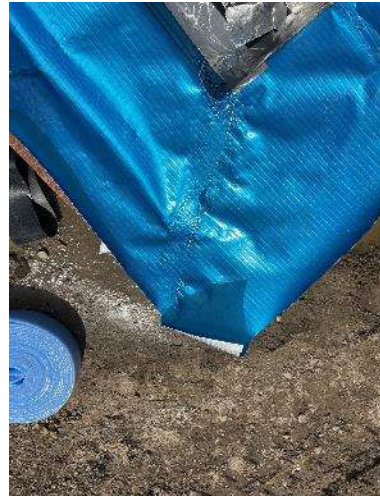
Figure 6 – Joints and corners are hand welded.

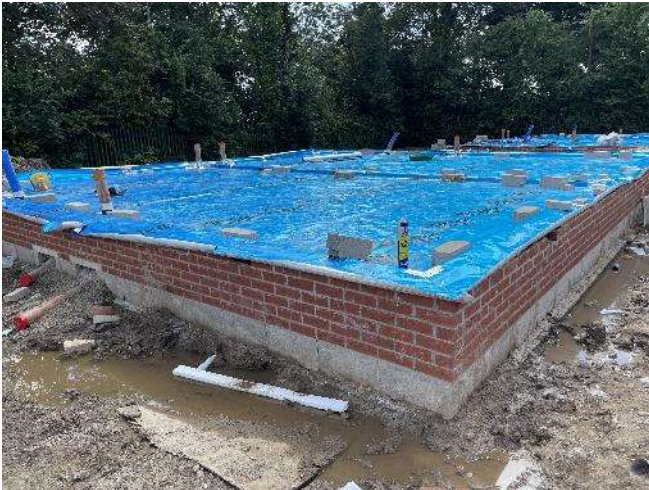
Figure 1 – General view of the plot. Sufficient coverage of cavities.

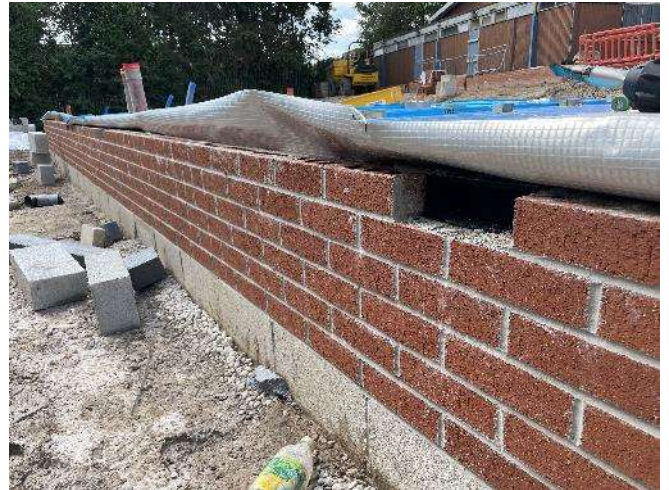
Figure 2 – Sufficient vents can be seen (every 2m) – air bricks to be added to periscopic vents.

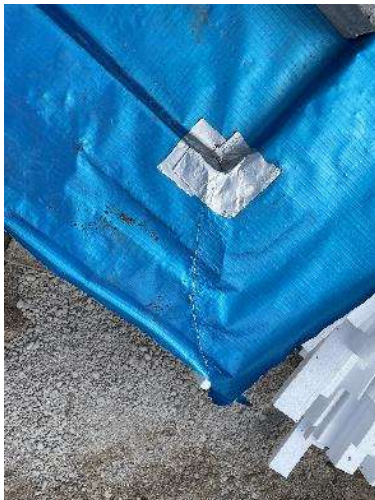
Figure 3 – Corners installed correctly using hand welding and detailing tape.

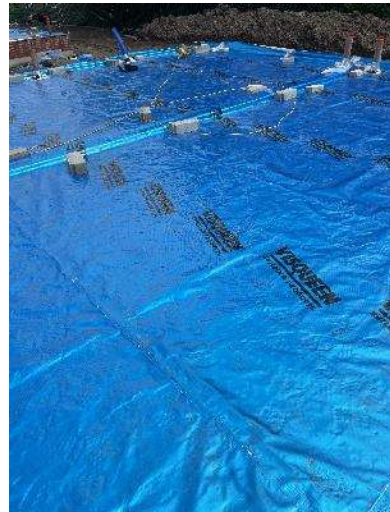
| INSPECTED ITEM | YES/NO | COMMENTS | PHOTOGRAPHED YES / NO |
|---|---|---|---|
| <b>General Condition</b><br>Inspect the general condition of the membrane for rips, tears and punctures. | Y | Two holes in membrane on previous visit. Correctly patched on return visit. | Y |

Figure 4 – Membrane in good condition.

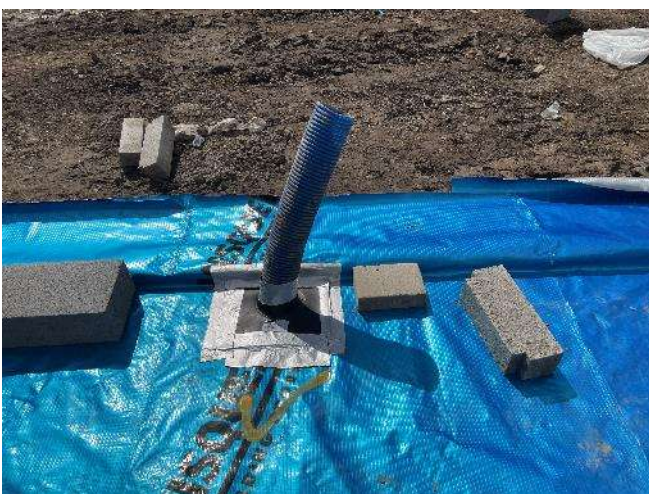
| INSPECTED ITEM | YES/NO | COMMENTS | PHOTOGRAPHED YES / NO |
|---|---|---|---|
| <b>Top Hat Installation</b><br>Check that top hats have been correctly installed around service entries, including jubilee clip around pipe and correct lapping and jointing to membrane at base. | Y | Gaps in the bases of 2 of 6 top hats on previous visit. Correctly patched on return visit. | Y |

Figure 5 – Service entries patched correctly.

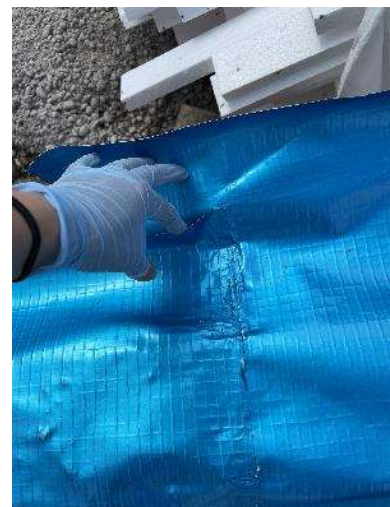
Figure 6 – Joints are hand welded.

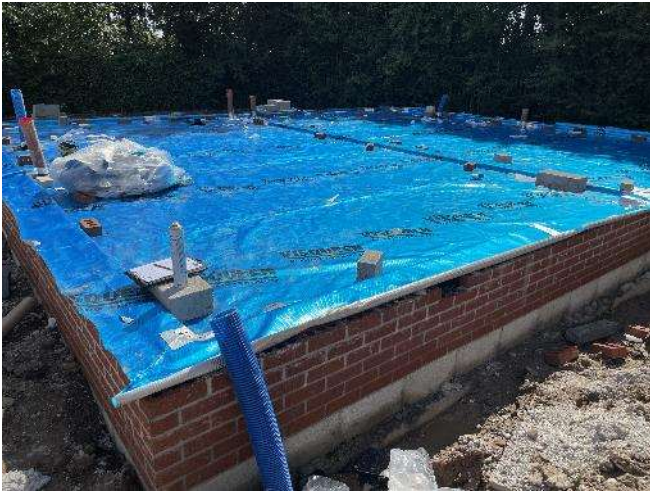
Figure 1 – General view of the plot. Sufficient coverage of cavities.

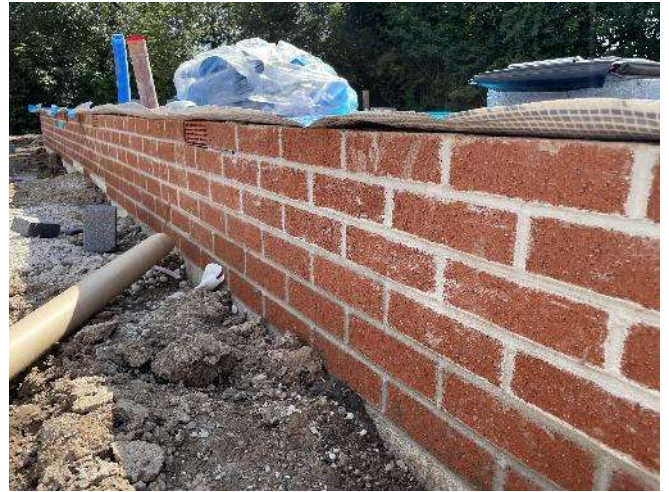
Figure 2 – Sufficient vents can be seen (every 2m).

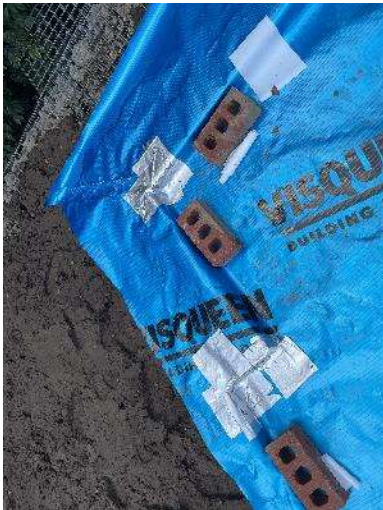
Figure 3 – Corners installed correctly using hand welding and detailing tape.

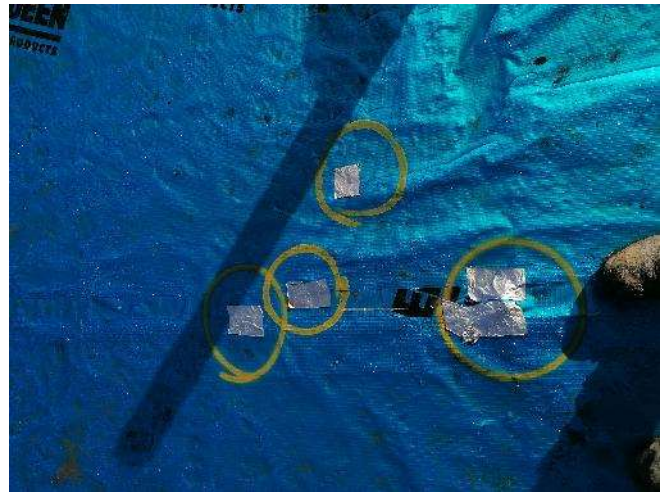
| INSPECTED ITEM | YES/NO | COMMENTS | PHOTOGRAPHED YES / NO |
|---|---|---|---|
| <b>Jointing</b><br>Check that all jointing has been carried out to the manufacturer's specification. | Y | Hand welded jointing. Three gaps found in jointing on previous visit. Correctly patched on return visit. | Y |

Figure 4 – Holes and gaps in jointing correctly patched.

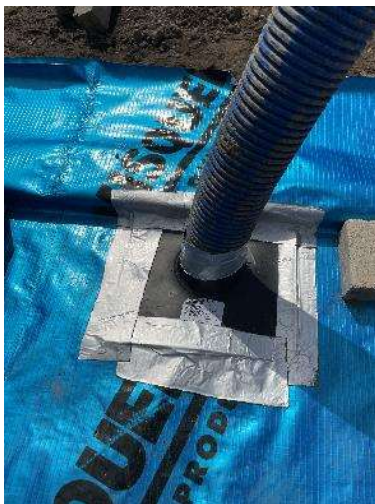
Figure 5 – Service entries sealed on return visit.

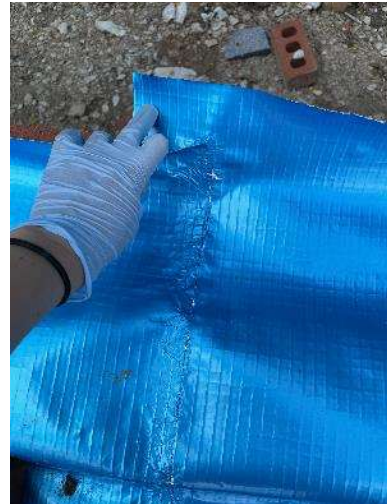
Figure 6 – Joints are correctly hand welded.

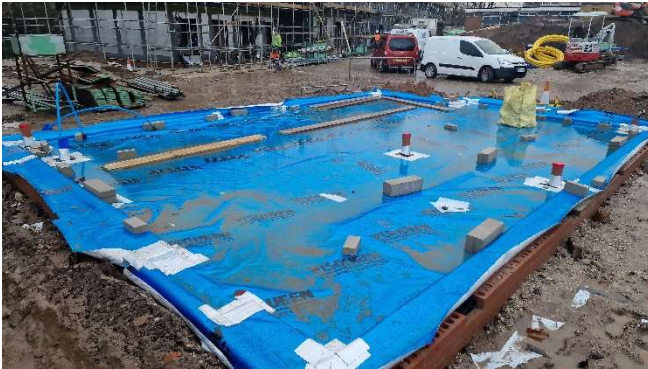
Figure 1 – General view of the plot. Sufficient coverage of cavities.

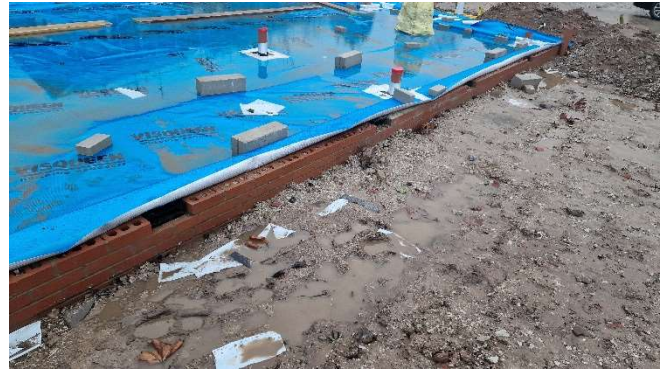
Figure 2 – Sufficient vents. Front fascia to be installed as brickwork progresses

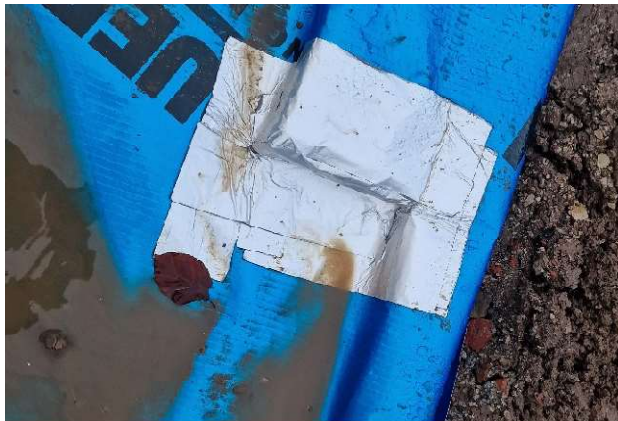
Figure 3 – Corners installed using detailing tape giving sufficient coverage of cavities

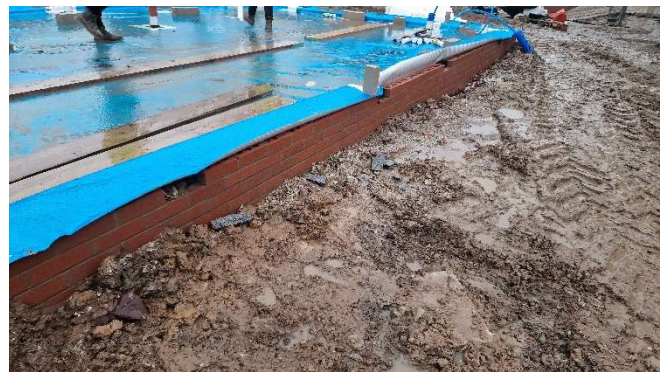
Figure 4 – Sufficient vents, also showing sufficient cavity cover.

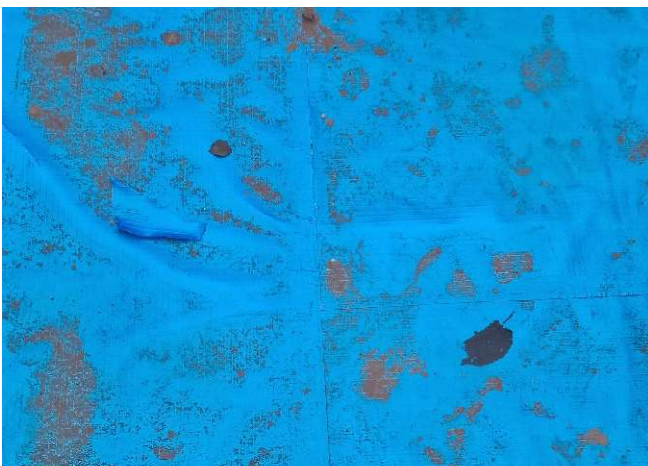
| INSPECTED ITEM | YES/NO | COMMENTS | PHOTOGRAPHED<br>YES / NO |
|---|---|---|---|
| <b>Jointing</b><br>Check that all jointing has been carried out to the manufacturer's specification. | Y | Hand welded jointing. gaps found adjacent to service penetration, limited to outer skin of brickwork, more membrane added and secured with detailing strip. Correct and witnessed during inspection. | Y |

Figure 5 – Hand Welded Seams

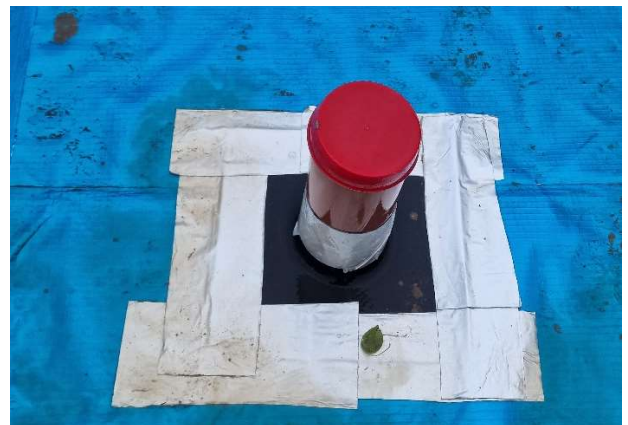
Figure 6 – Service entries sealed and secure.

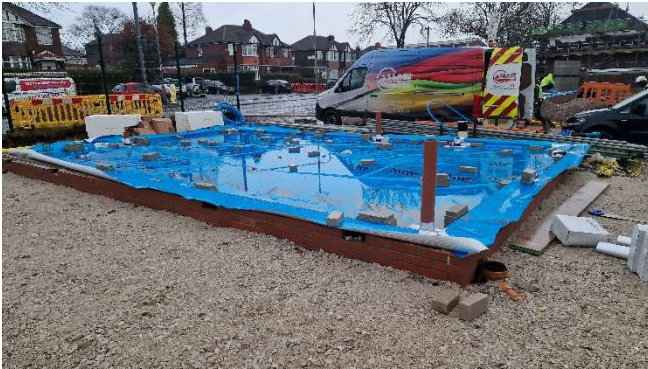
Figure 1 – General view of the plot. Sufficient coverage of cavities.

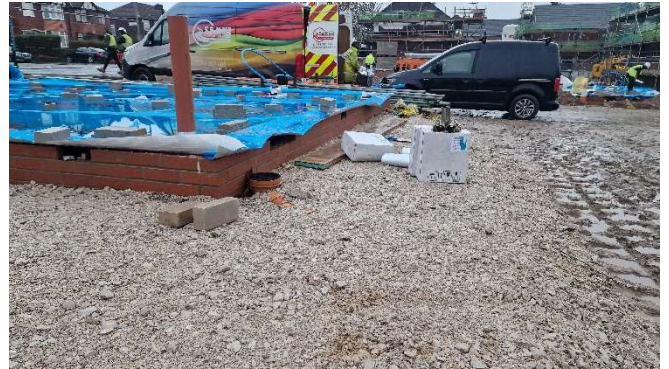
Figure 2 – Sufficient vents. Front fascia to be installed as brickwork progresses

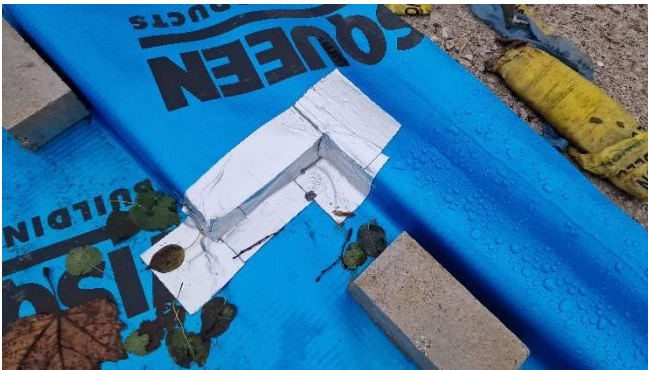
Figure 3 – Corners installed using detailing tape giving sufficient coverage of cavities

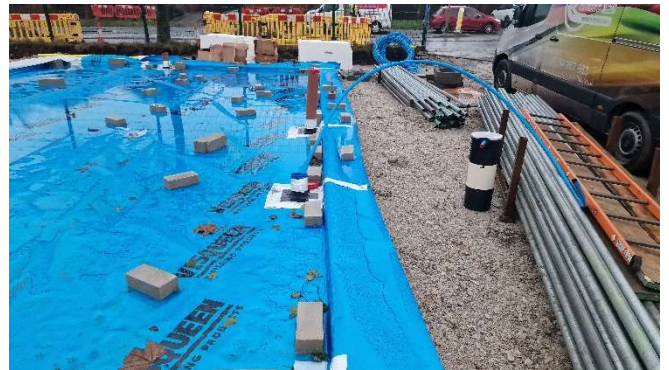
Figure 4 – Sufficient cavity cover.

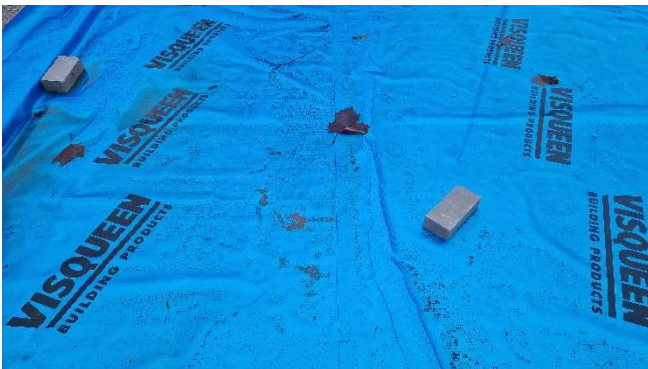
| INSPECTED ITEM | YES/NO | COMMENTS | PHOTOGRAPHED YES / NO |
|---|---|---|---|
| <b>Jointing</b><br>Check that all jointing has been carried out to the manufacturer's specification. | Y | Hand welded jointing. gaps found limited to outer skin of brickwork, more membrane added and secured with detailing strip. Correct and witnessed during inspection. | Y |

Figure 5 – Hand Welded Seams

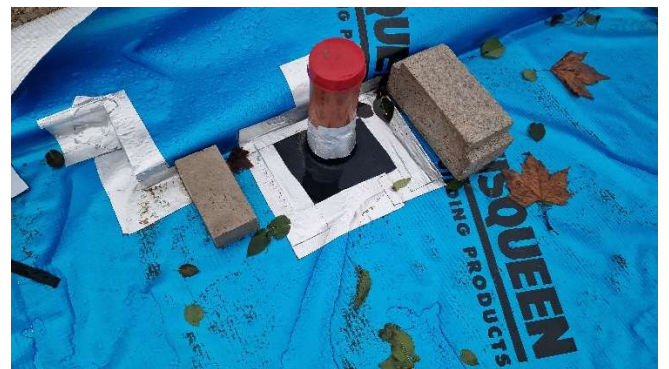
Figure 6 – Service entries sealed and secure.

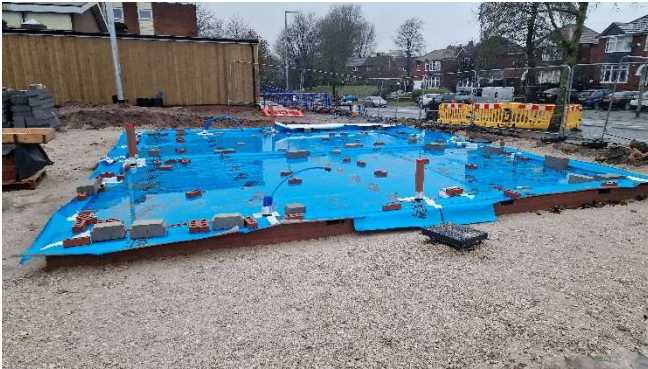
Figure 1 – General view of the plots.

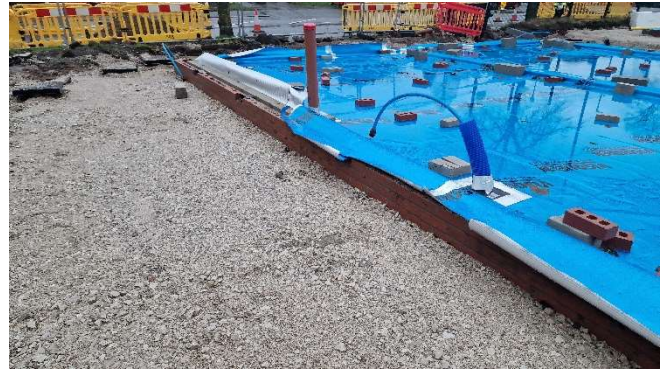
Figure 2 – Sufficient vents. Grill fascia to be installed as brickwork progresses

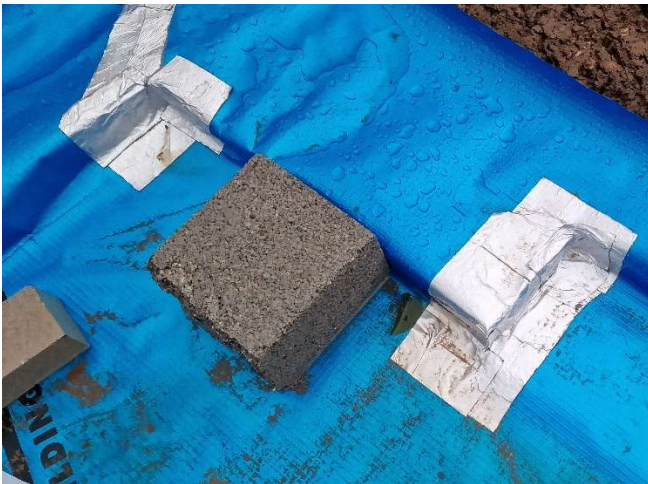
Figure 3 – Corners installed using detailing tape giving sufficient coverage of cavities

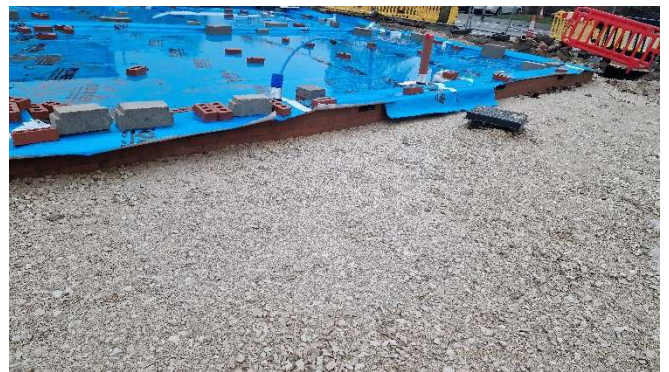
Figure 4 – Sufficient cavity cover.

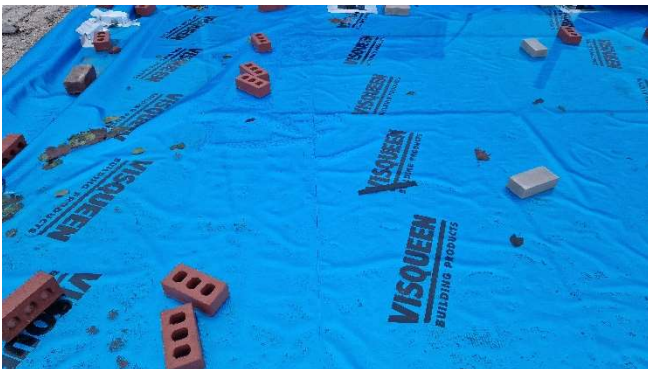
| INSPECTED ITEM | YES/NO | COMMENTS | PHOTOGRAPHED YES / NO |
|---|---|---|---|
| <b>Jointing</b><br>Check that all jointing has been carried out to the manufacturer's specification. | Y | Hand welded jointing. gaps found limited to outer skin of brickwork i.e. limited overlap, more membrane added and secured with detailing strip. Correct and witnessed during inspection. | Y |

Figure 5 – Hand Welded Seams

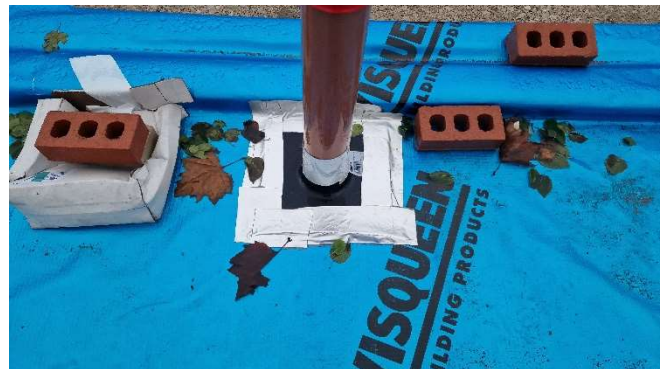
Figure 6 – Service entries sealed and secure.
