## SIM, Combined Projects – Gantry Repairs Methodology – Rev B 12.07.24

### Repair 1

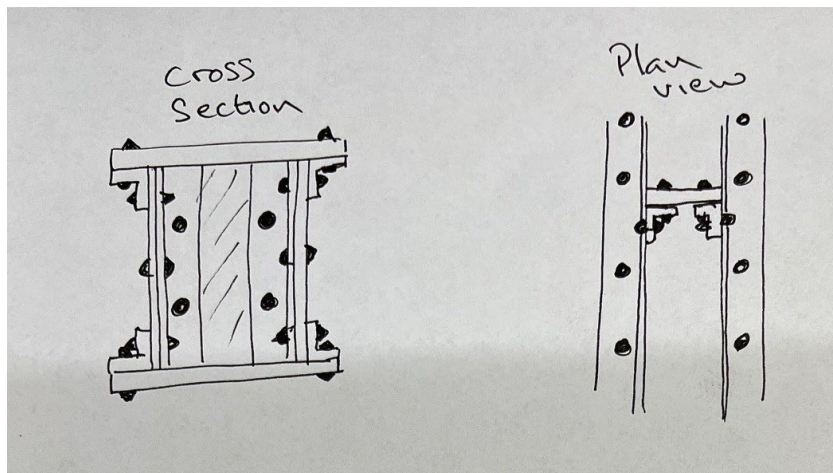
Existing detail of gantry steel sections:

1. Temporary propping installed to centre of beam prior to works commencing.
2. Carefully remove steel c-section to make repair more accessible. Store for reinstall once repair works are completed.
3. Identify extent of corroded steel by cutting back and using calipers to find where the steel thickness is matching the existing steel thickness.
4. Produce plate to match extent of steel removed. This will be fabricated off site.
5. Lay in the replacement steel plate into the section previously removed and fully weld the plate. See below sketch.
