# SITE INSPECTION REPORT

Ducie Street Manchester M1 2JQ  
BBL/1168/2022

Tuesday 22 August 2023

**Inspection Type:** Drainage

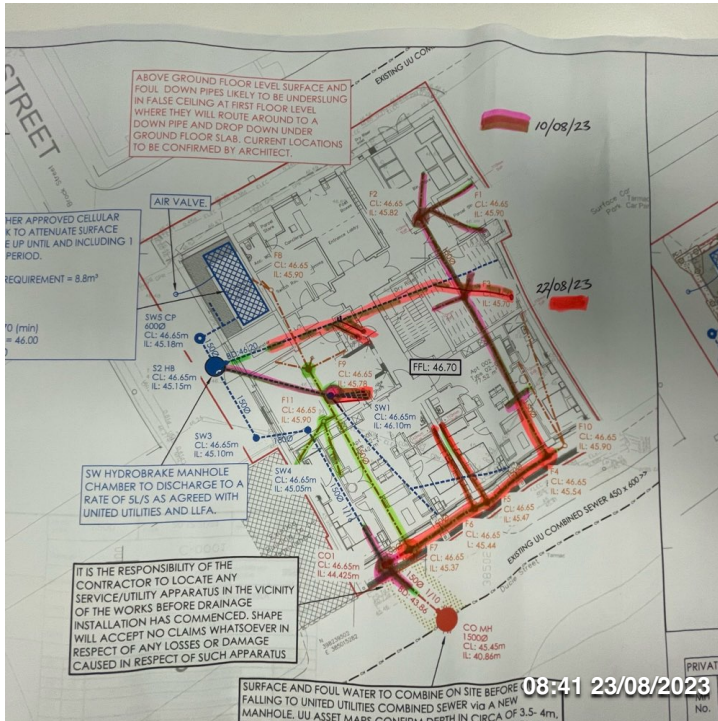
## Observation 1

See plan for actual drainage runs inspected today.

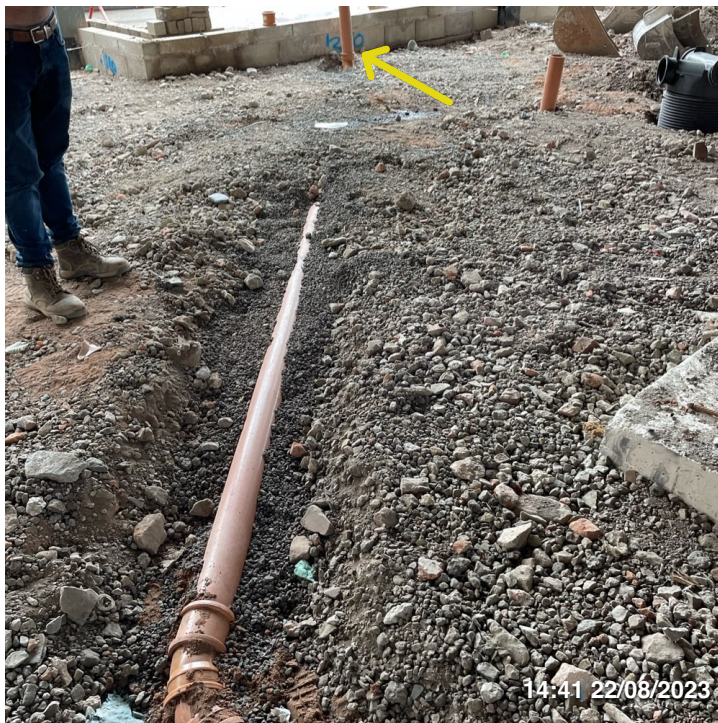
## Observation 2

Part of SW drainage line into S2HB (bend not shown on drainage), this length of drainage to be re-laid as drainage run has been laid without any fall.

Rodding eye required in base of vertical pipe (yellow arrow)

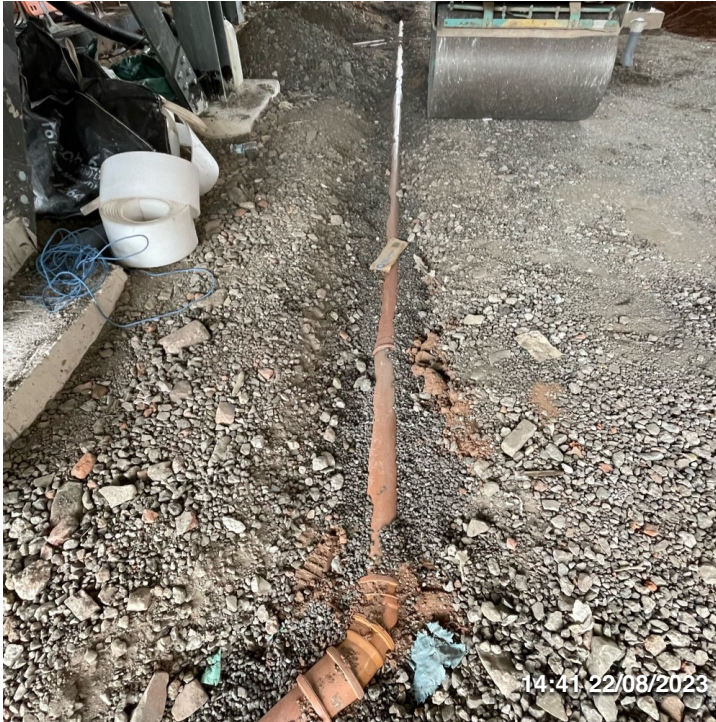
### Observation 3

part of SW drainage into S2HB, this section of drainage to be re-laid to achieve adequate fall, drainage presently laid level (without any fall).

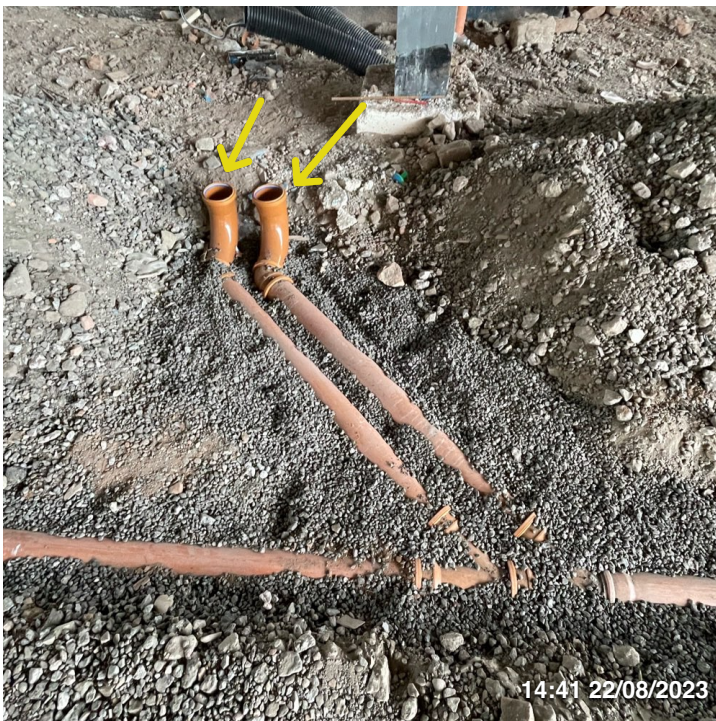
### Observation 4

branch connections into line into S2HB - rodding eyes required to base of vertical pipes to ensure adequate access into SW drainage - rodding access to be provided in the base of the vertical pipework (yellow arrows)

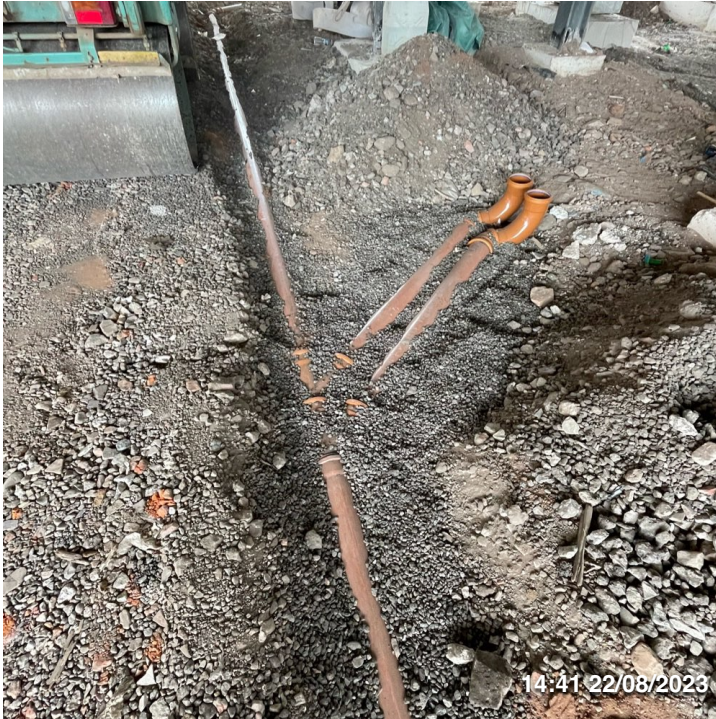
#### **Observation 5**

Drainage into S2HB needs to be re-laid with adequate fall

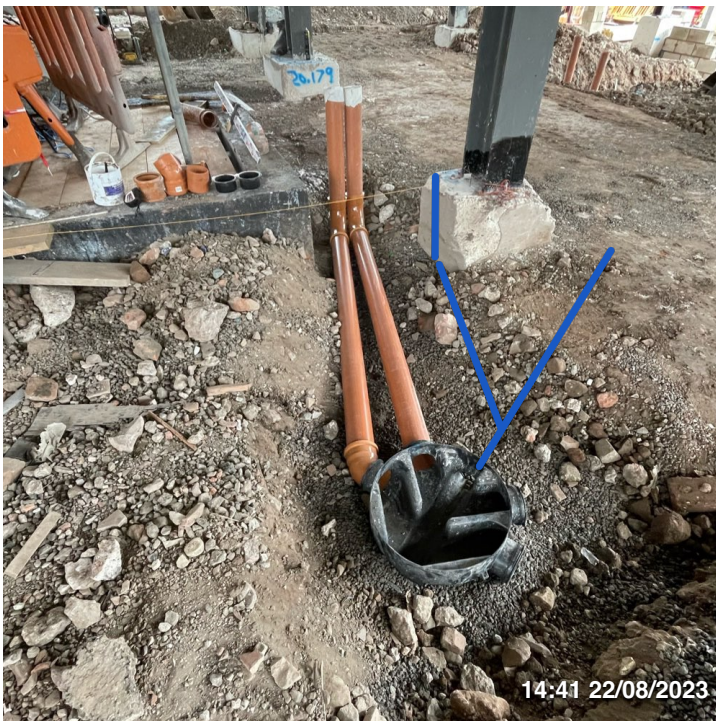
#### **Observation 6**

Drainage in progress - 3no connections into SW1, 3rd connection will be via 'Y' junction outside the manhole (3rd connection outside the manhole will need rodding access in the base of the vertical pipe)

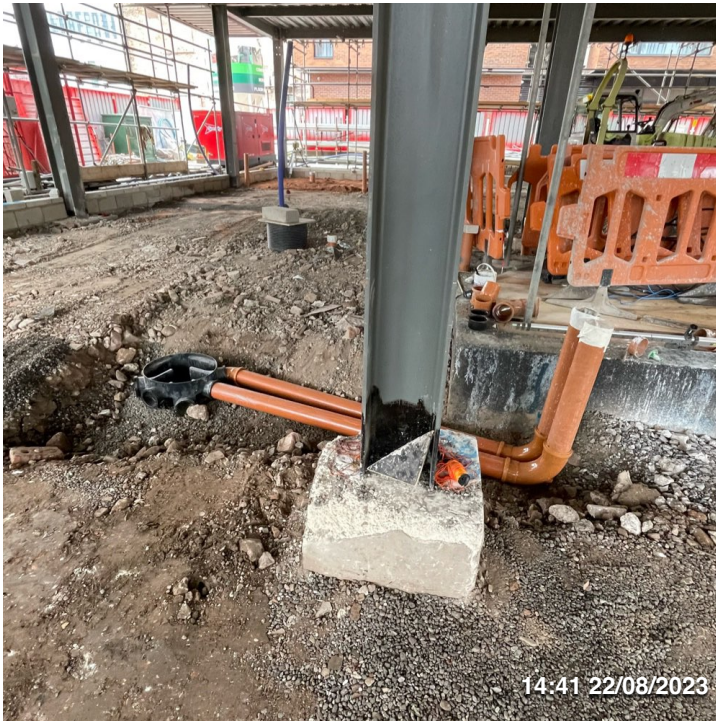
#### Observation 7

Drainage in progress - 3no connections into SW1, 3rd connection will be via 'Y' junction outside the manhole (3rd connection outside the manhole will need rodding access in the base of the vertical pipe)

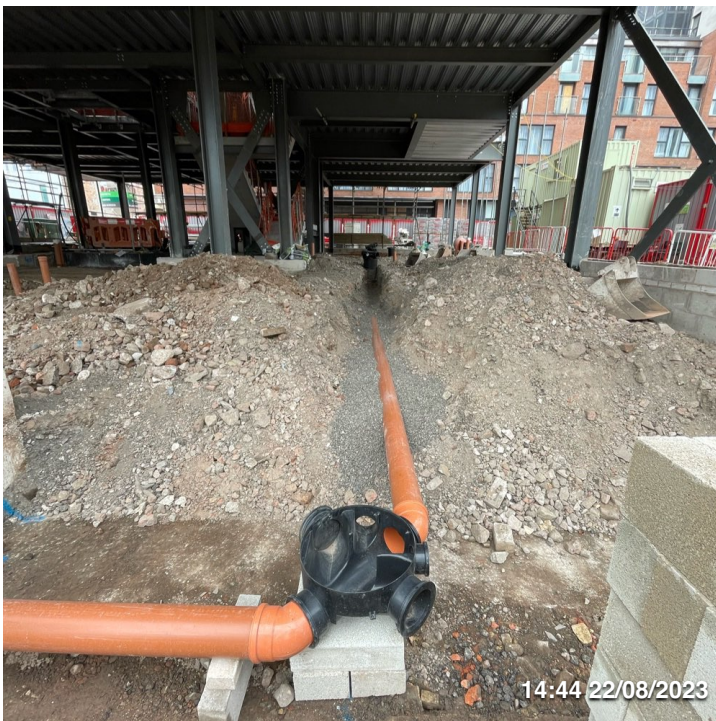
#### Observation 8

150mm foul drainage into F4, block supports just to set out drainage, correct bedding to be provided once retaining walls are built which will support bedding material.

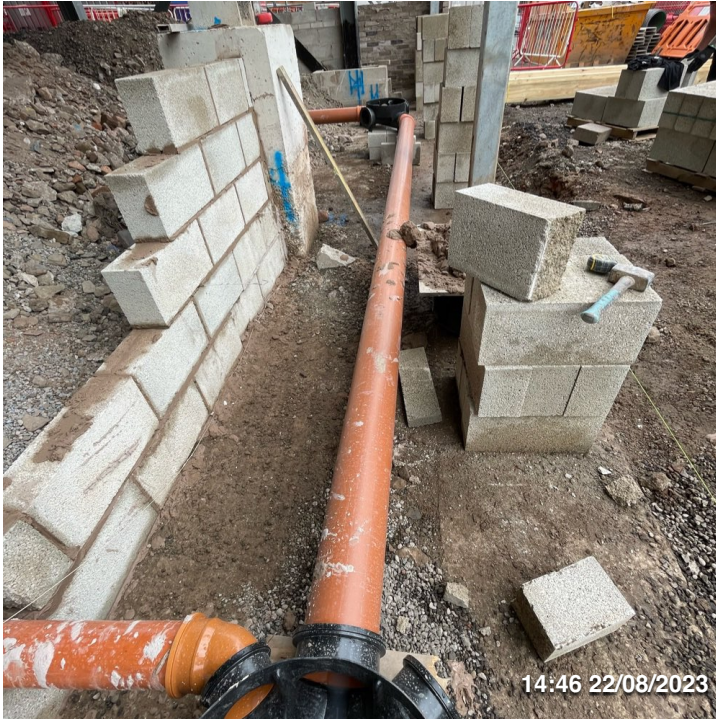
#### Observation 11

150mm drainage between F4 & F5, to be bedded on suitable bedding material, photo evidence required

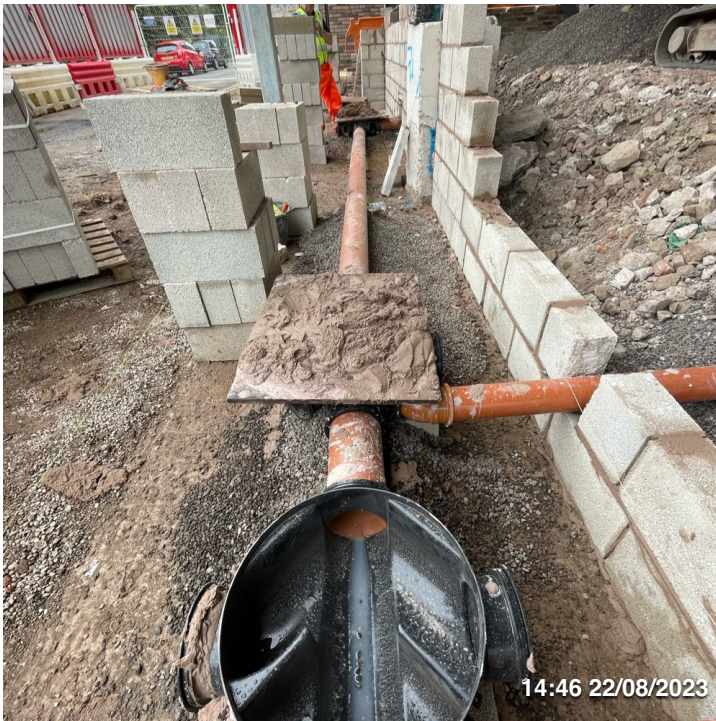
#### Observation 12

150mm drainage between F6 & F7, to be bedded on suitable bedding material, photo evidence required
