## DEFECT EXAMPLES

Castlefield Viaduct  
Phase 2

Remedials  
Longitudinal Beams  
End Connections

| ID | CVI-ARUP-ZZ-ZZ-DR-S-4005 | | |

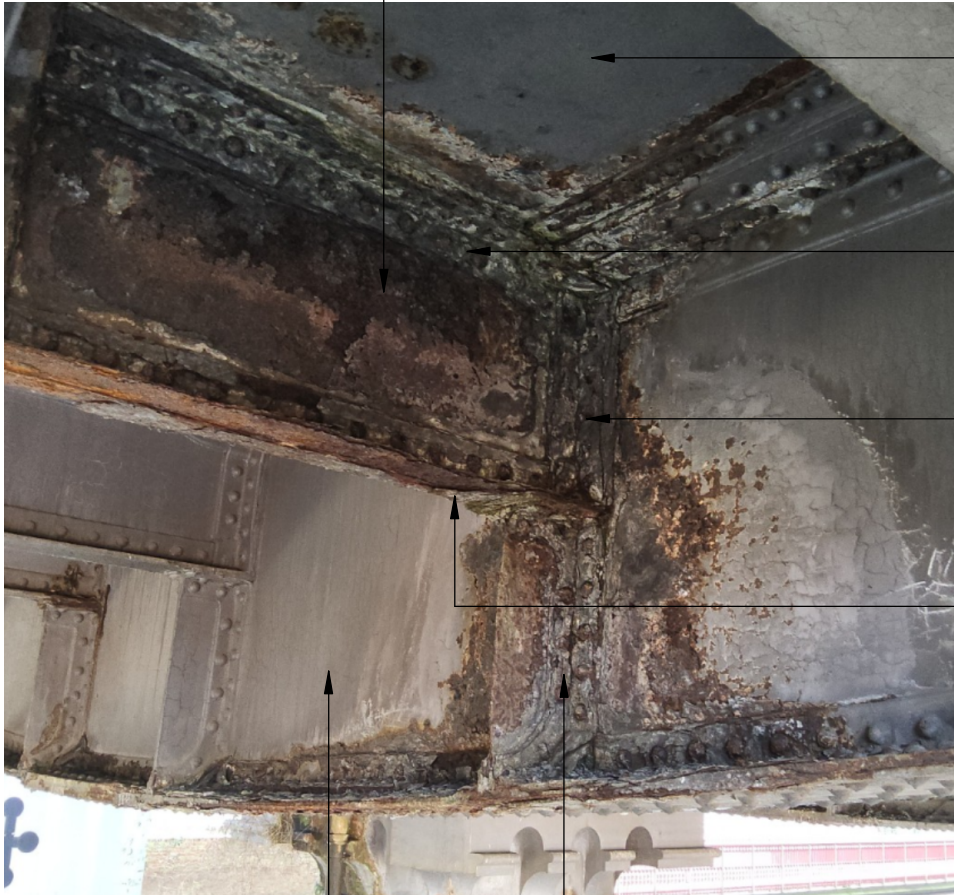
Example 1

Water ingress at presumed local failure to deck waterproofing

Corrosion and loss of thickness to bottom flange

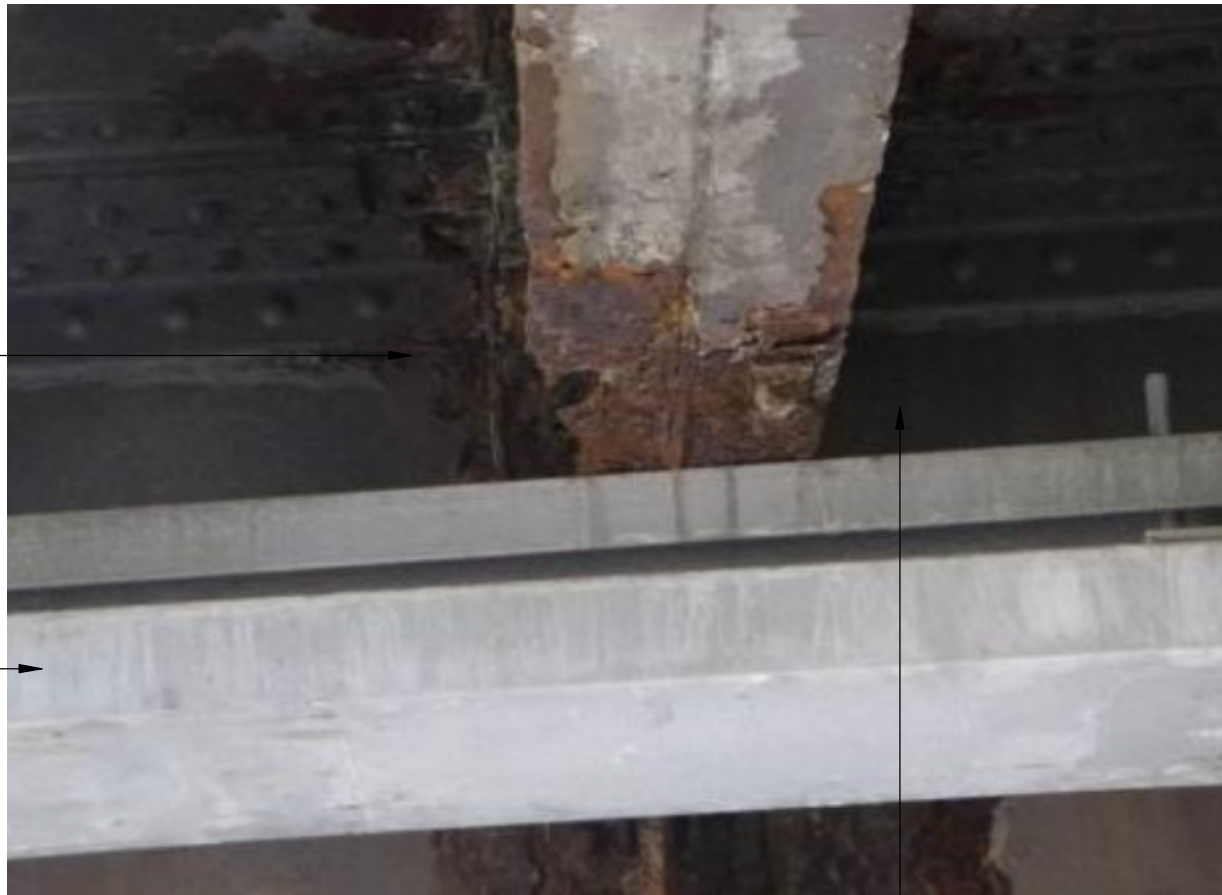
Example 2  
- from Balfour 2020

Transverse beam 19, Cornbrook elevation

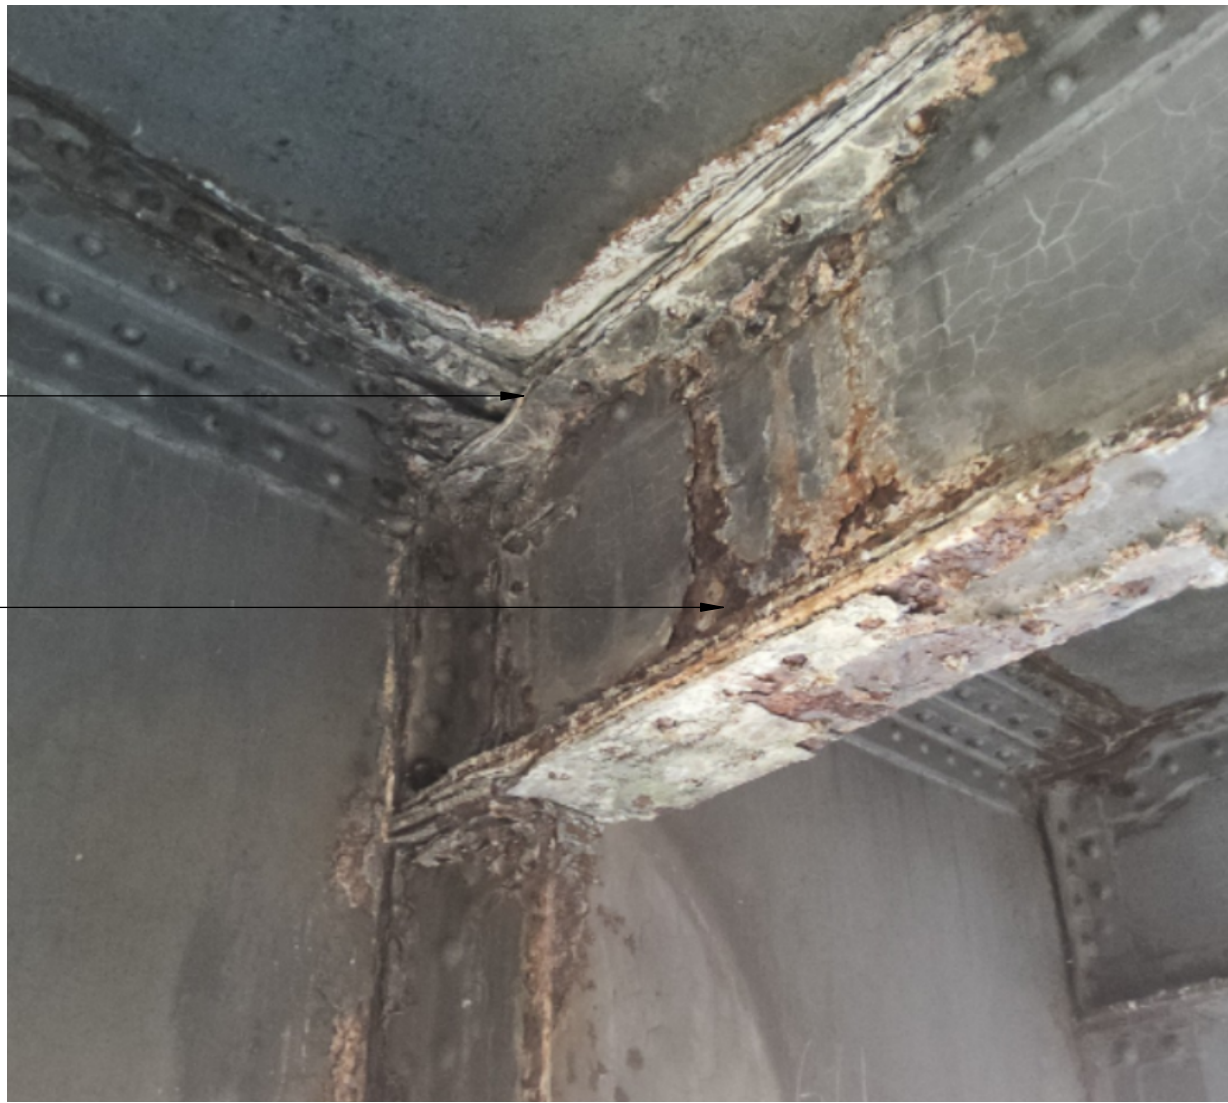
Example 4

Longitudinal beam top angles kinked around angles to transverse beam

Corrosion and loss of thickness to web plate

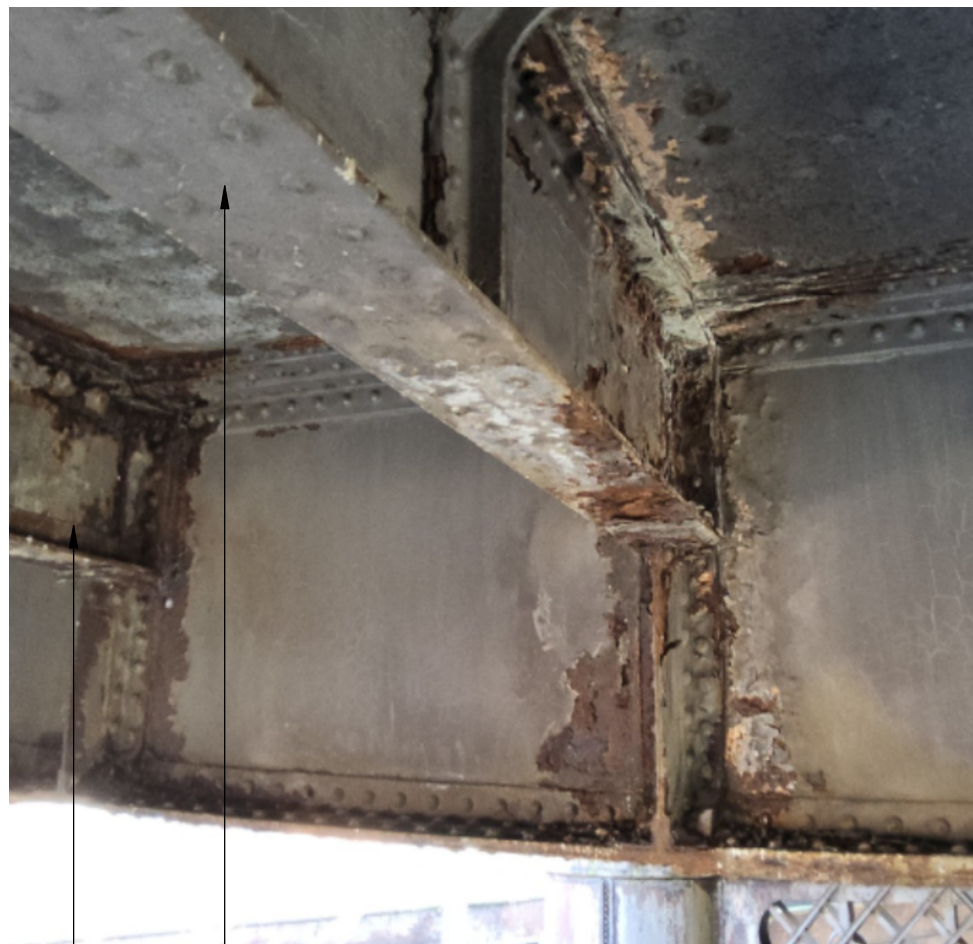
Example 3

Longitudinal beam spacing varies  
- 5' or 6' according to archive drawings

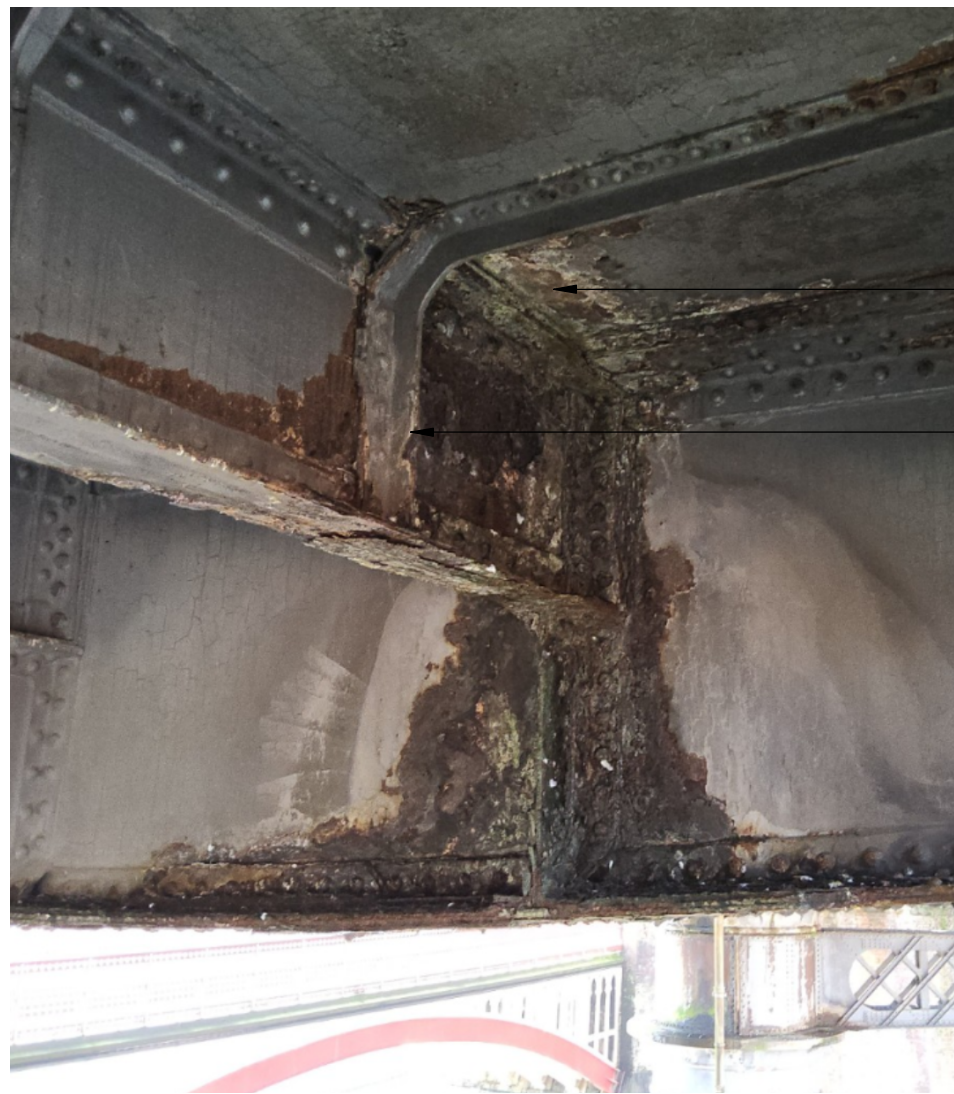
Example 5

Water ingress at presumed local failure to deck waterproofing

Possible loss of section to bottom flange

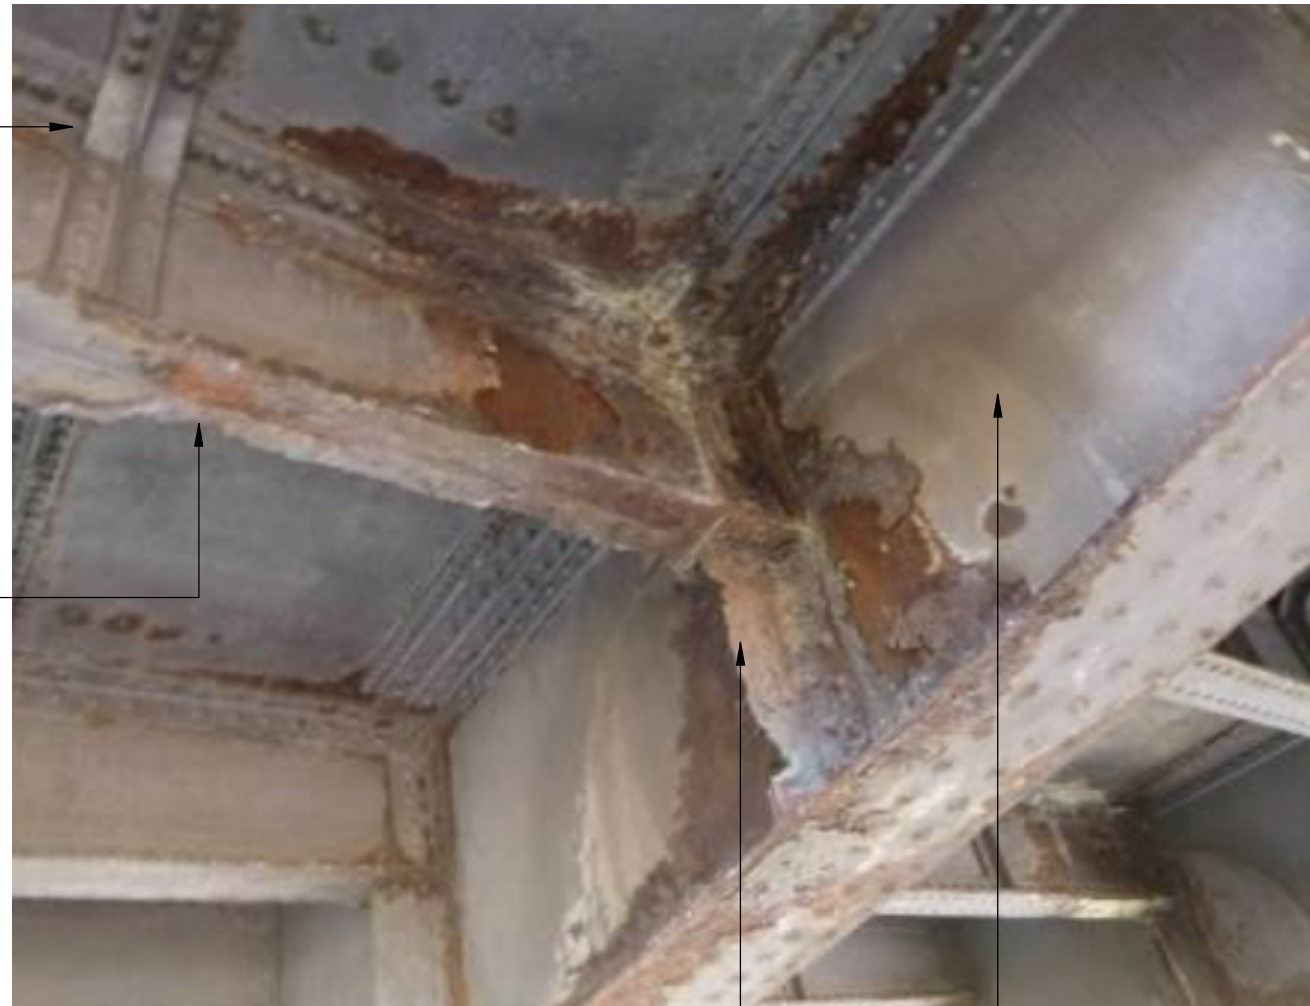
Example 6  
- from Balfour 2020

Loss of section to bearing stiffener

Transverse beam 21, Deansgate elevation
