Mosley Street

### Proposed Elevation - Mosley Street - Repairs

PROJECT REF. 1995  
DRWG NO. P(213)  
REVISION  
SCALE 1:100 @ A3  
DATE 1st May 24  
DRAWN HW

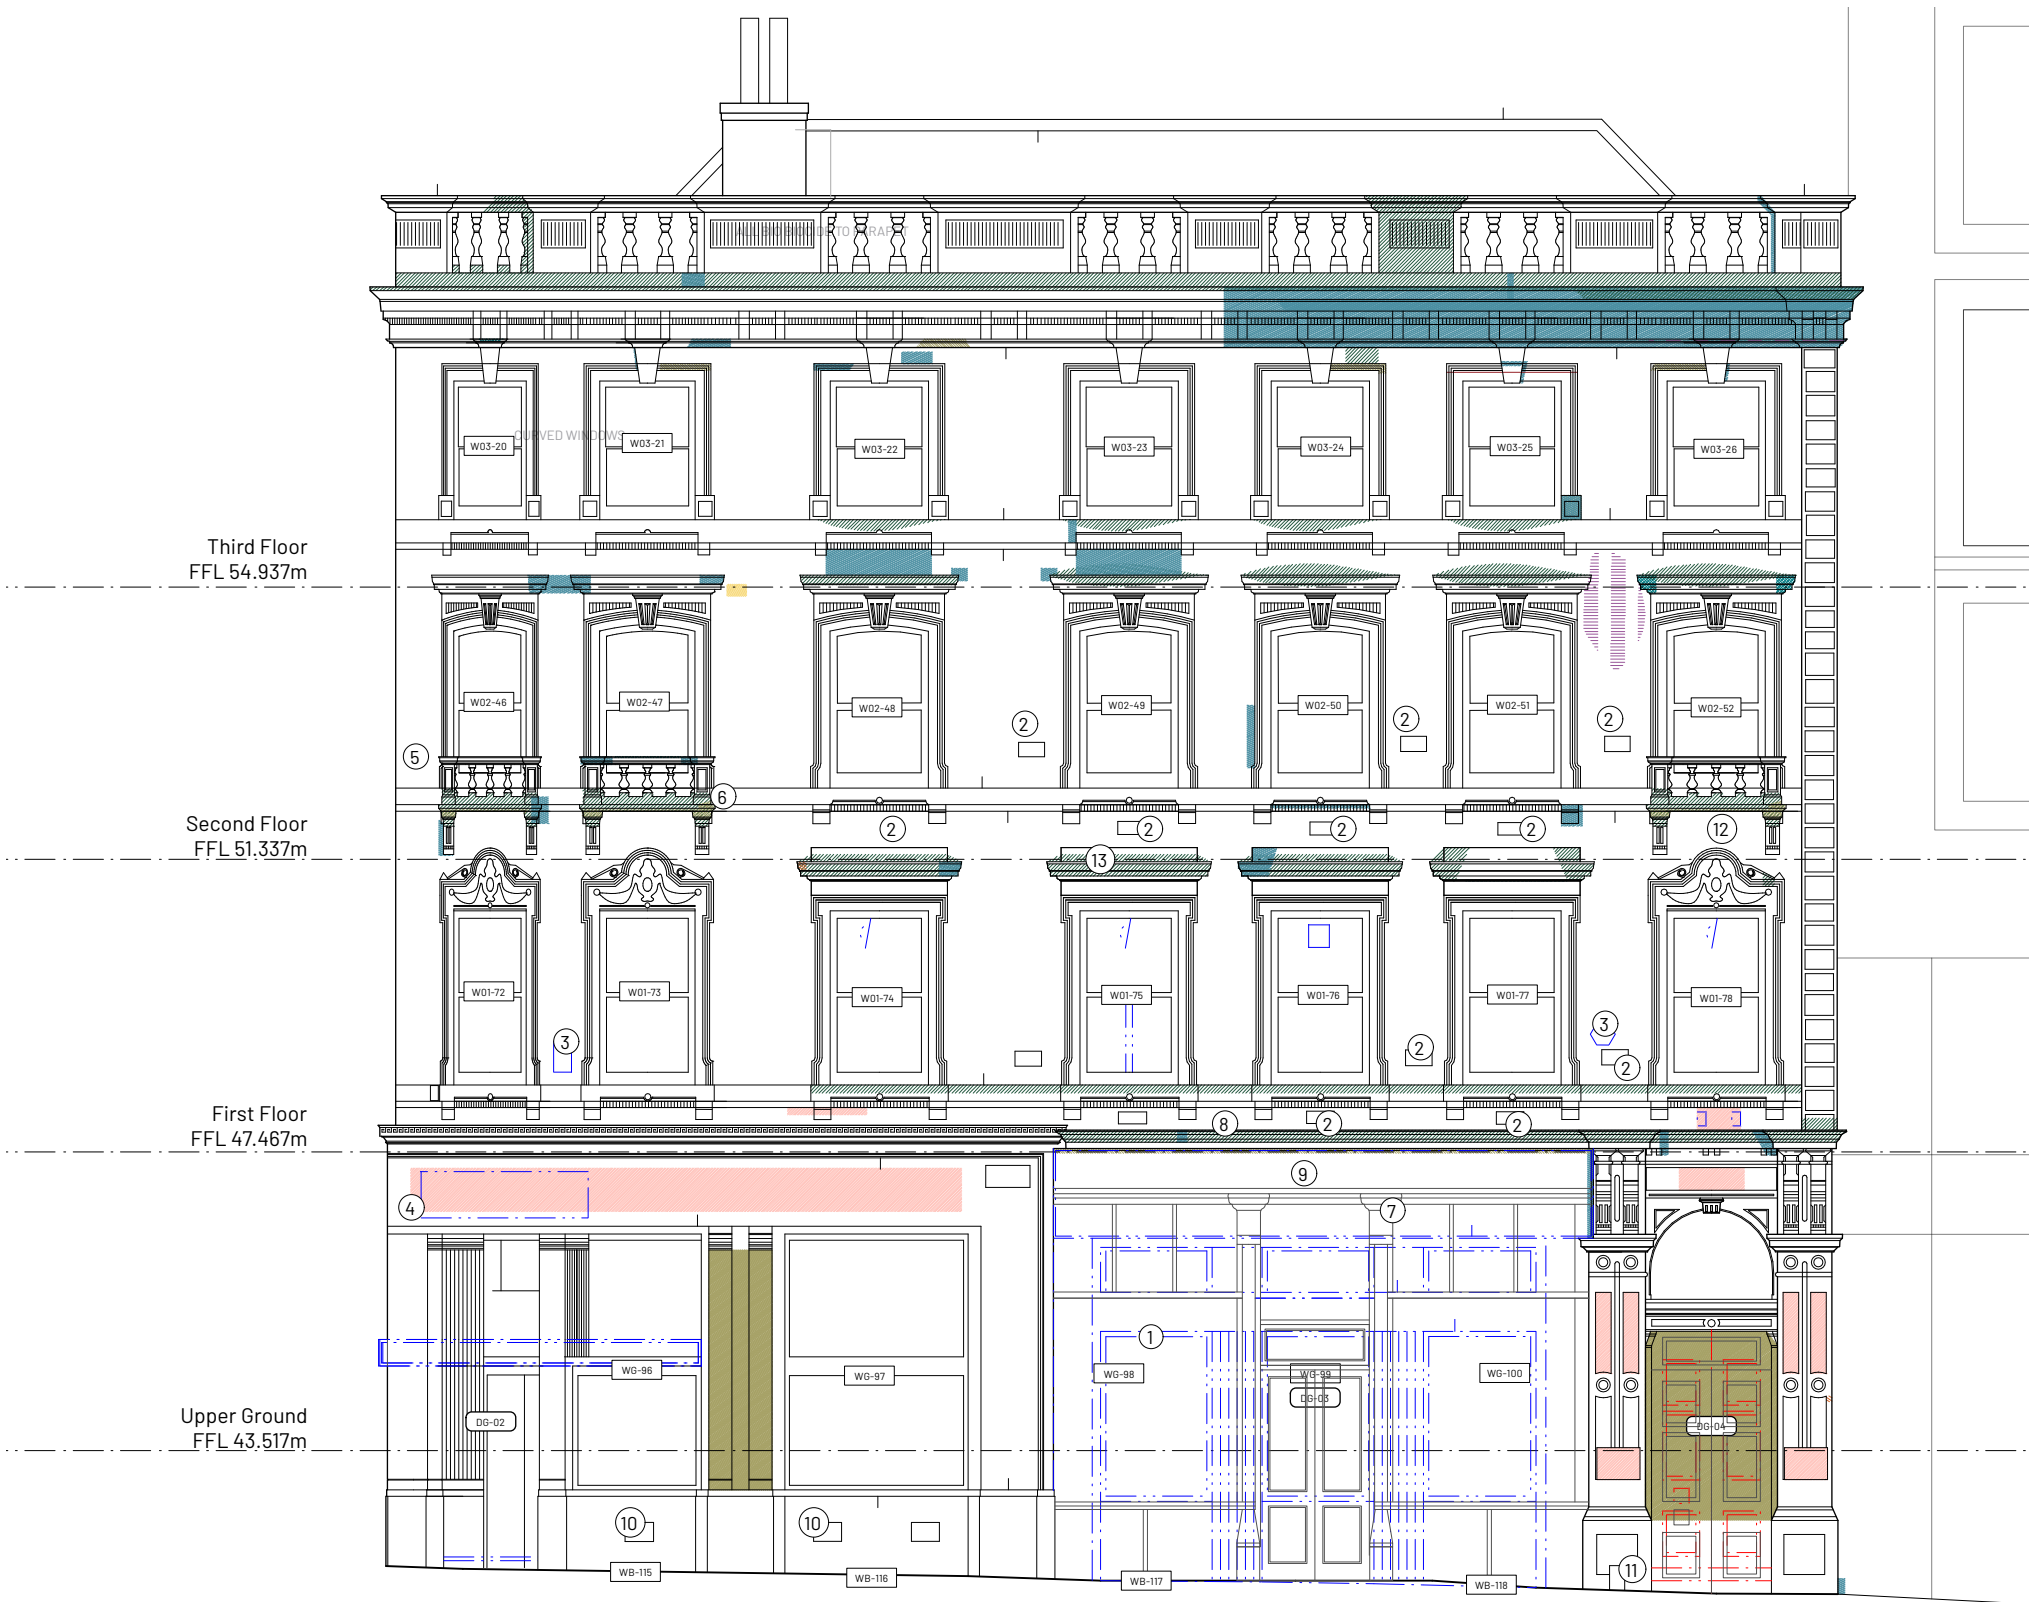
- Cracked stone - tap test required and then S.E. input to confirm whether it can be stitched or needs a new piece of matching stone.
- Where previously applied concrete is coming lose, carefully remove the reveal stone beneath

- Replacement air grill to match elsewhere.
- Repair iron inlet cover.
- Check internal lintel condition - due to pattern of brick cracking.
- Biological growth - likely to due water splash back onto brickwork rather than falling away from facade. Consider sacrificial mortar fill to slope lintel surface away from building line.

- Shopfront to be removed and fabric beneath made good to match existing. Details to be confirmed following strip-out works.
- Clean and repair cast iron vent.

- Redundant equipment/fixings removed and brickwork reinstated to match existing.
- Signage to be removed and fabric beneath made good to match existing.

- Remove redundant cabling.
- Replace plastic trim with lead flashing.
- Cleaning off loose peeling paint finish to stone and iron shopfront. Redecorate. All as per NBS Cl xxx.
