**King Street Chambers  
Manchester**  
Roof Repairs

### Elevation 1

PROJECT REF. 2050  
DRWG NO. P(200)  
REVISION  
SCALE 1:100 @ A3  
DATE 1st June 24  
DRAWN PL

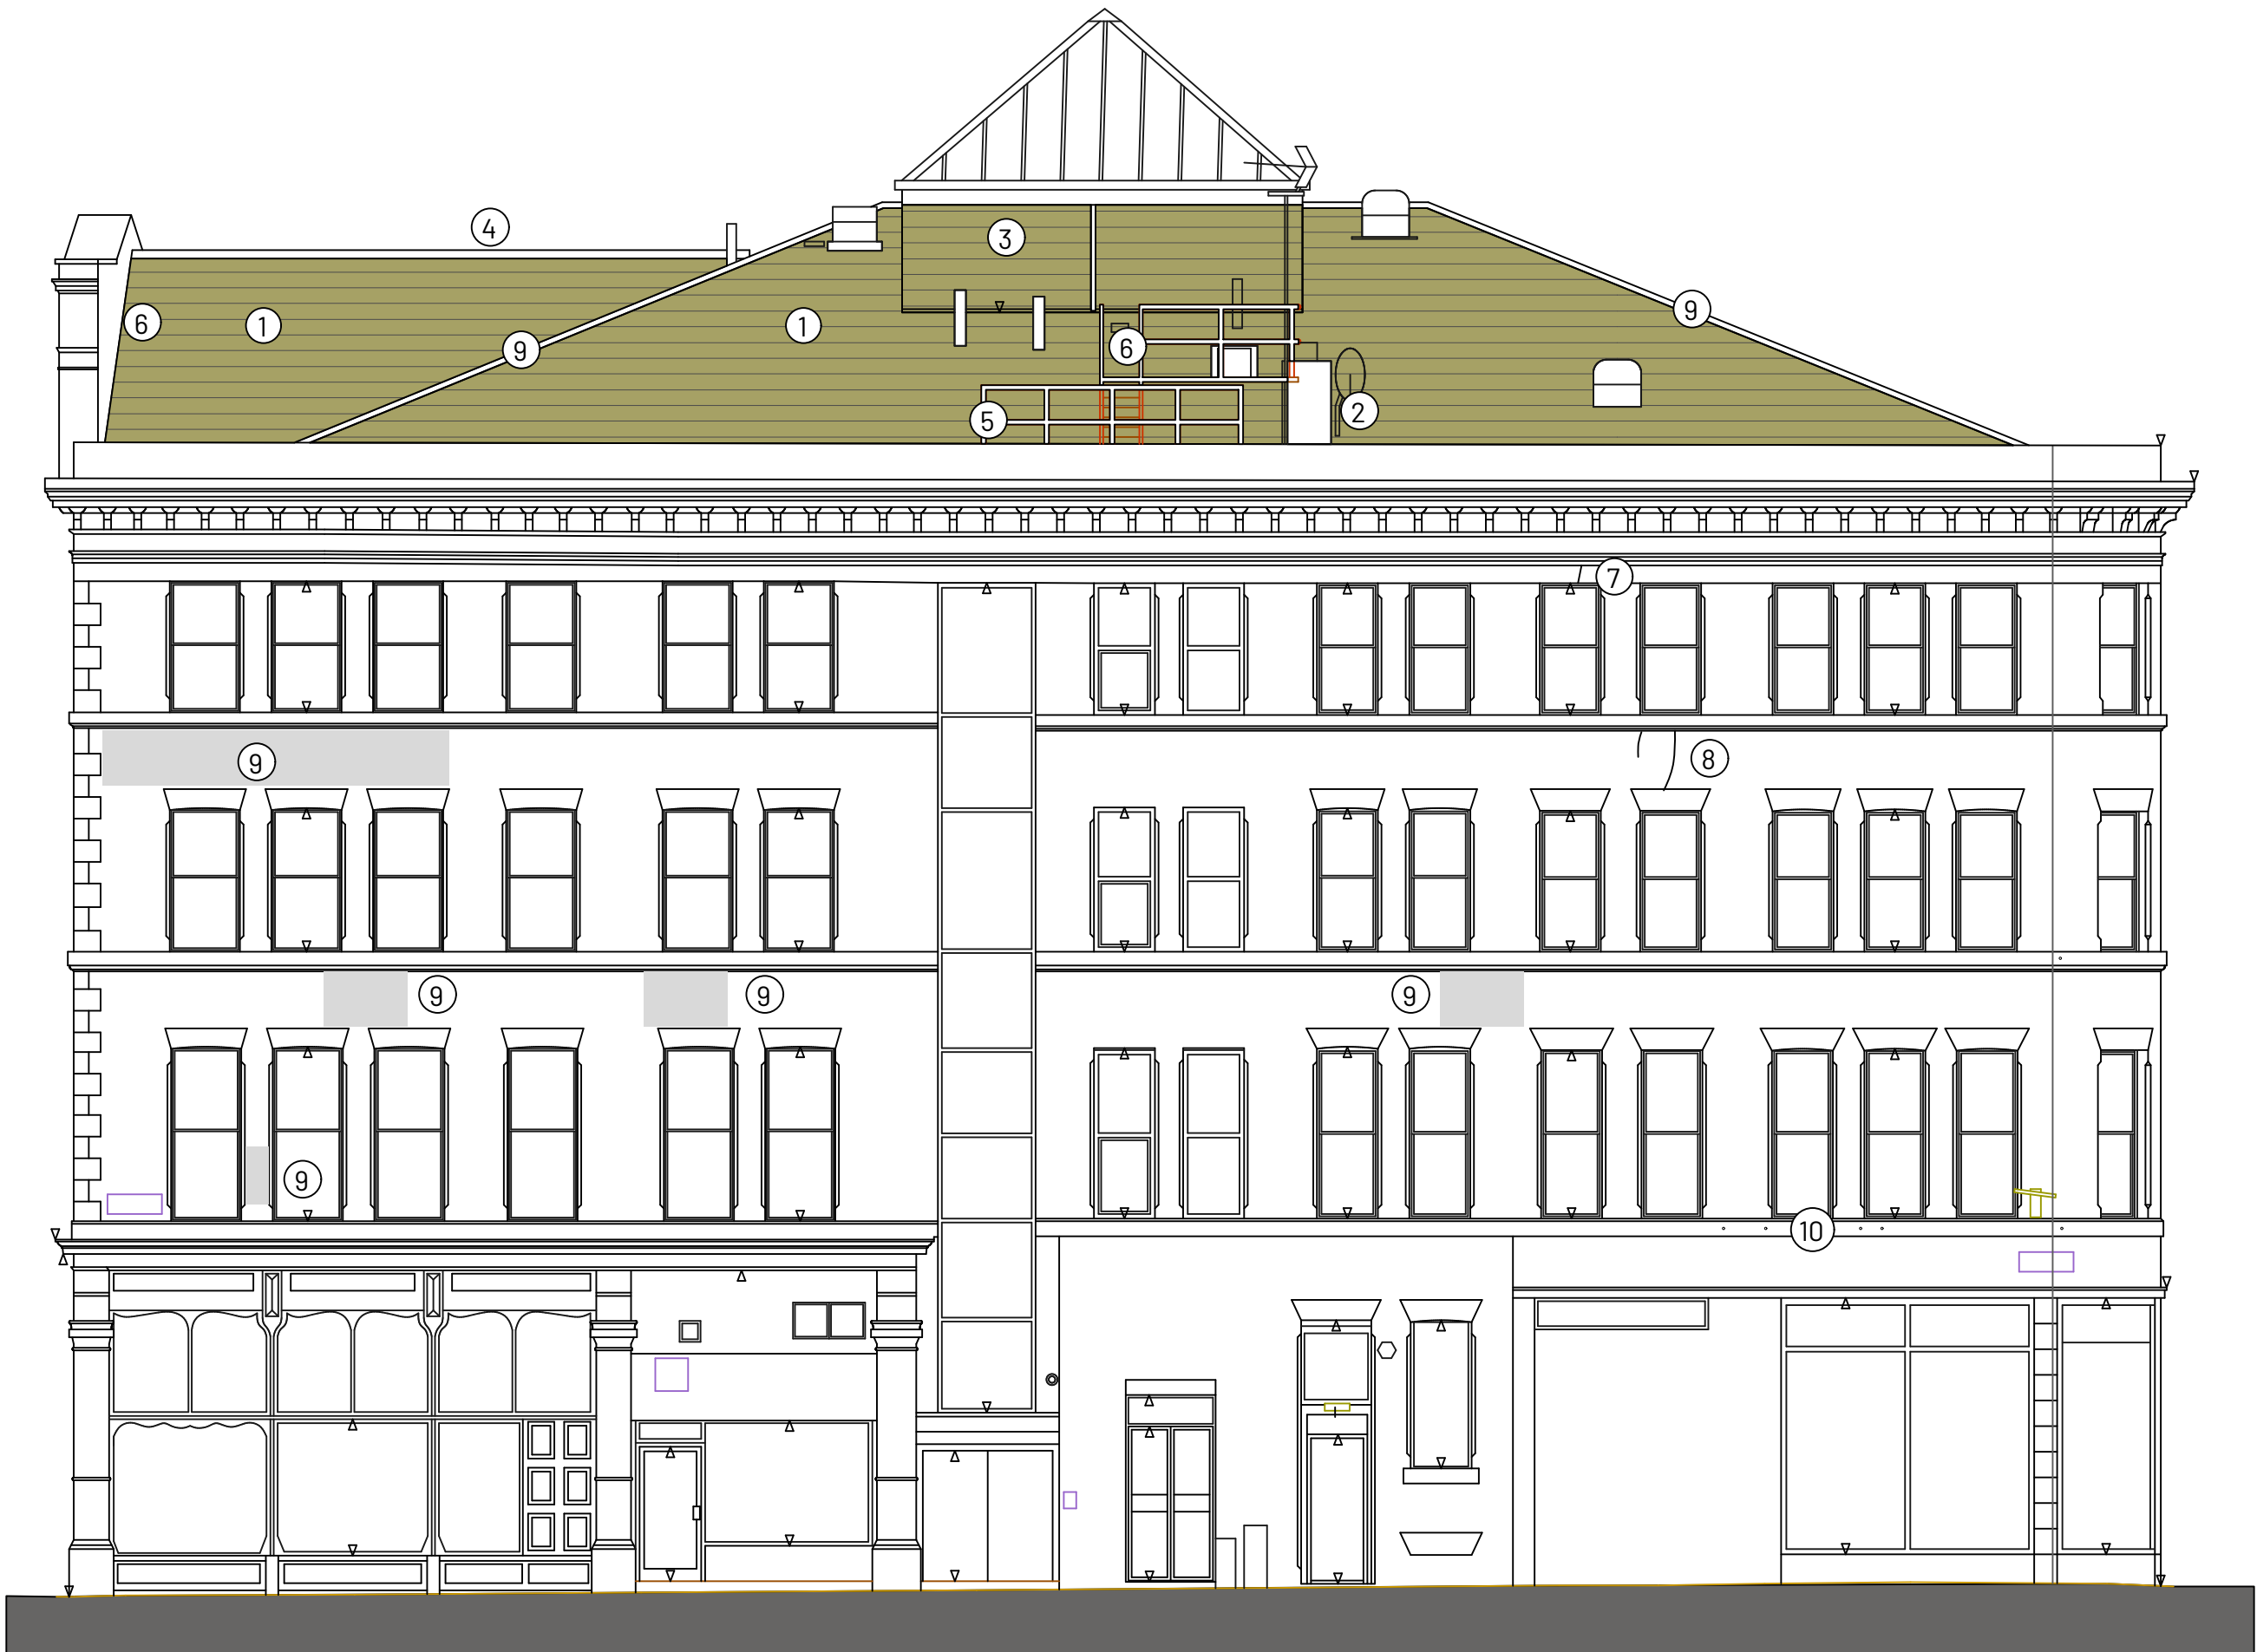
1 **Elevation 1**  
Scale: 1:100  
South King Street

All timber sash windows on First Second and Third floors to be prepared and repainted externally. All external sealant to be replaced.  
Stone dentil and cornice to be inspected following water damage and areas of delamination to be repaired

- Existing cementitious slates and sarking to be replaced with breathable sarking and natural slates. All roof penetration seals and flashing to be renewed.
- Existing lead stepped flashing to be removed and replaced with new Code 4 lead stepped flashings.
- Existing vertical slates to be removed and replaced with natural slate. Flashings at abutment with pitched roofs with be replaced with Code 4 lead flashing.
- Existing hip tiles to be replaced with lead roll hip with soakers
- Cables to be rerouted under replaced roof finish
- Steps and handrail to be temporary removed and reinstated on completion
- Cracked stone lintel to be repaired
- Cracked bricks to be replaced
- Brickwork to be repointed
- Open joints and holes in stonework to be grouted
