Client  
**The National Trust**

Project Title  
**Castlefield Viaduct Phase 2**

Drawing Title  
**Remedials  
Lattice Girders  
Diagonal Outstands**

| ID | CVI-ARUP-ZZ-ZZ-DR-S-4012 | | |

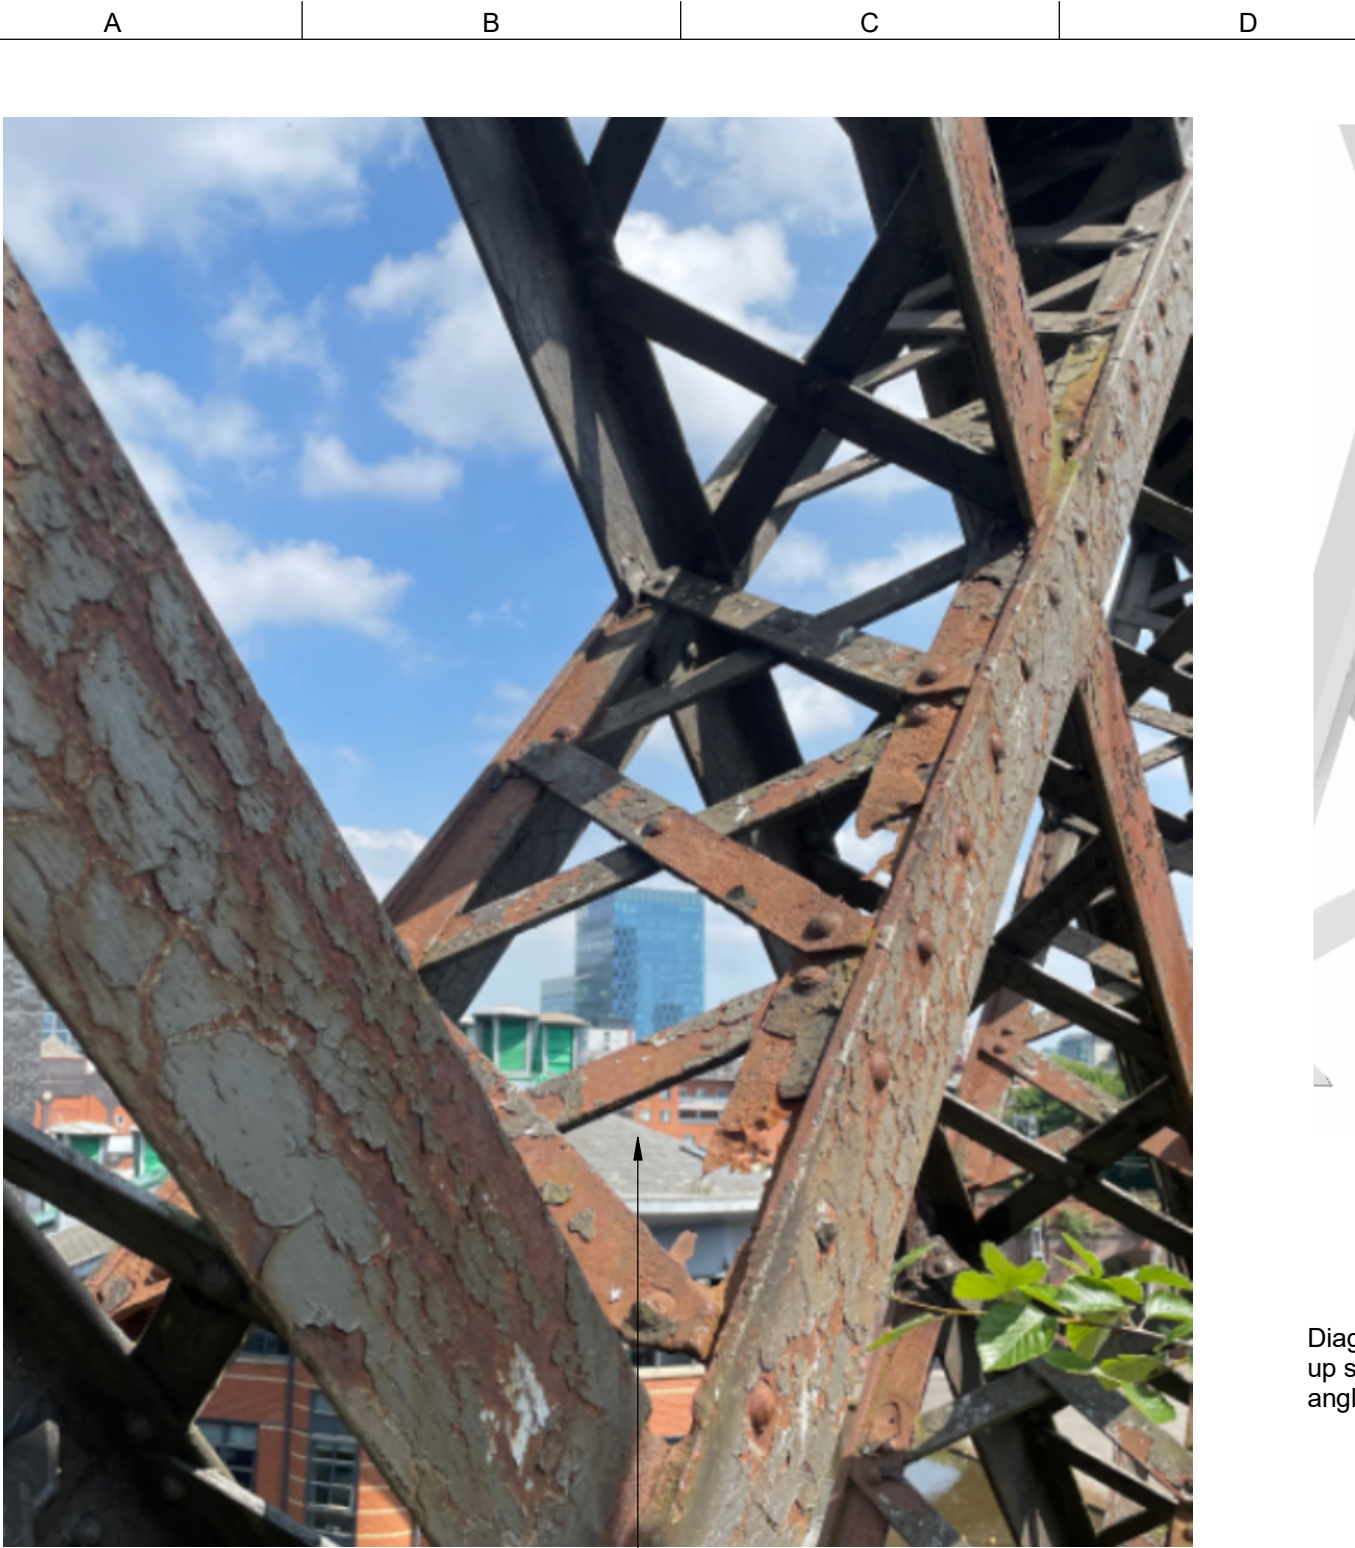
**Example 1**  
- outstand to built-up rivetted diagonal, with rivets for connection to incoming cross bracing  
- angle to inside runs between continuous diagonals in opposite direction, typically with 3 bays of X-bracing  
- at least 2 holes per length of outstand

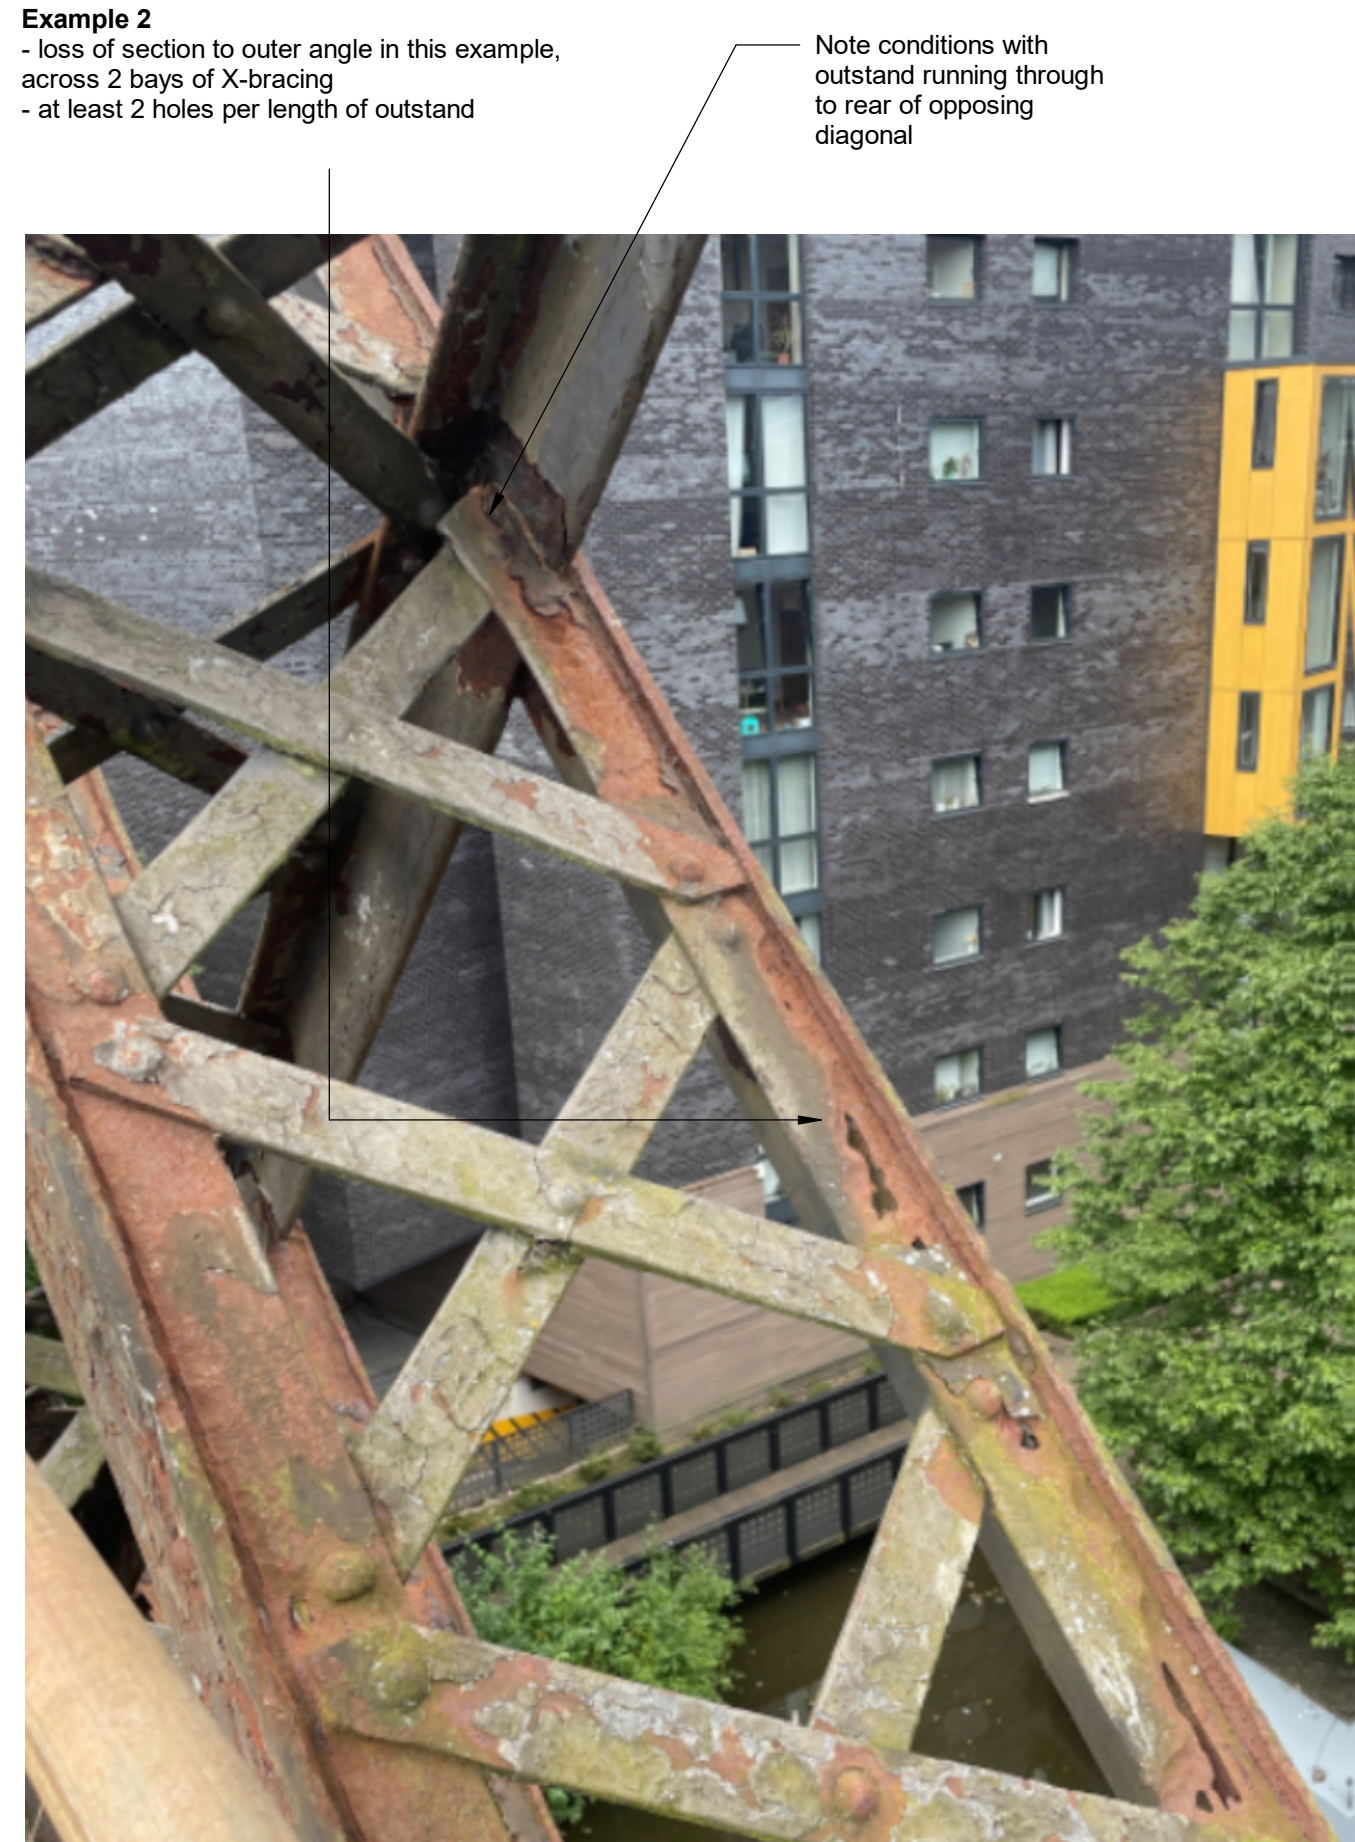
**Example 2**  
- loss of section to outer angle in this example, across 2 bays of X-bracing  
- at least 2 holes per length of outstand

Note conditions with outstand running through to rear of opposing diagonal

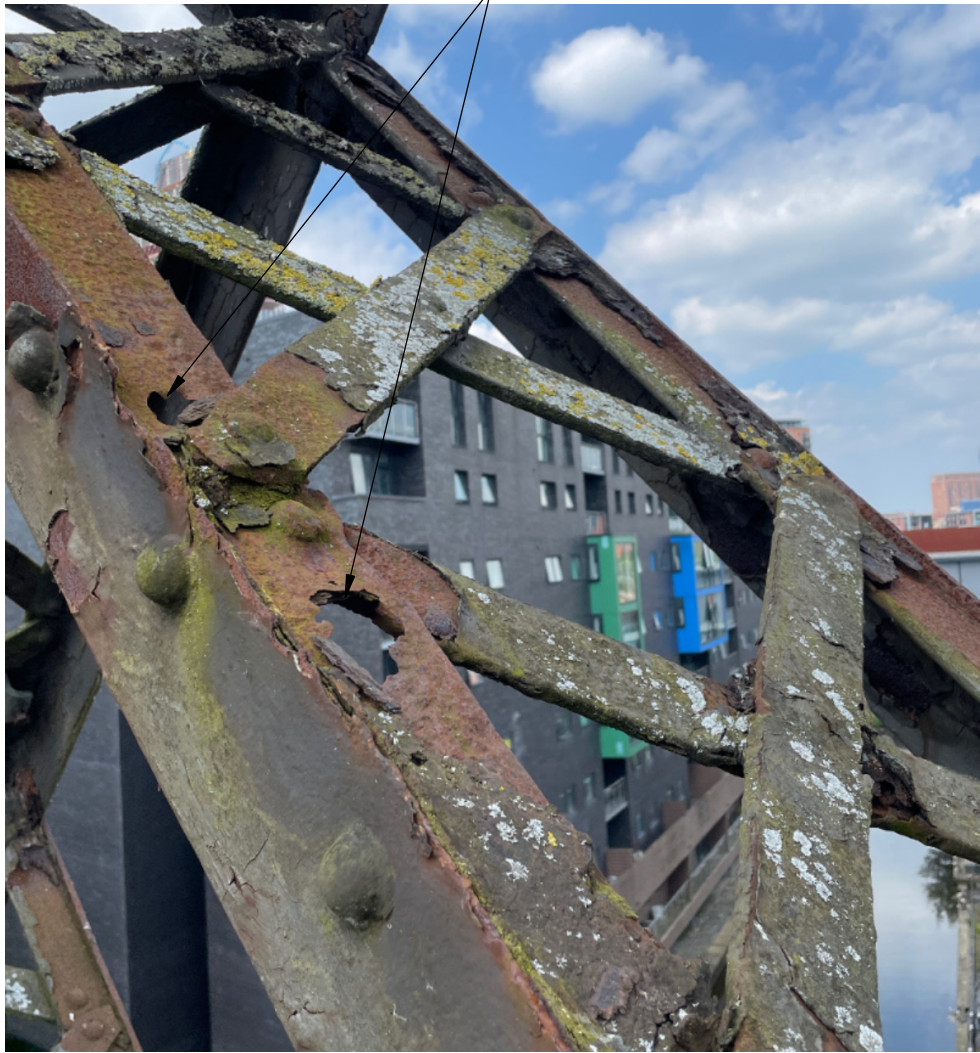
**Example 4**  
- minor loss of section to inner angle to local area only  
- only 1 hole per length of outstand  
- remaining plate in reasonable condition  
- no remedial required for this example

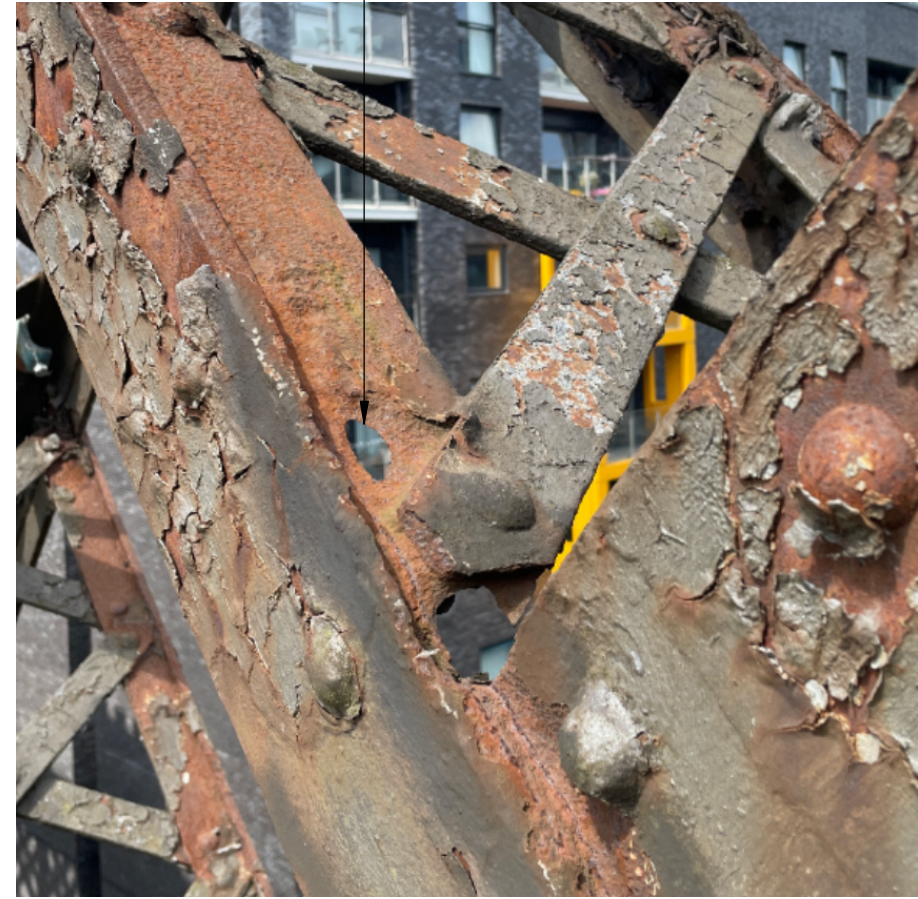
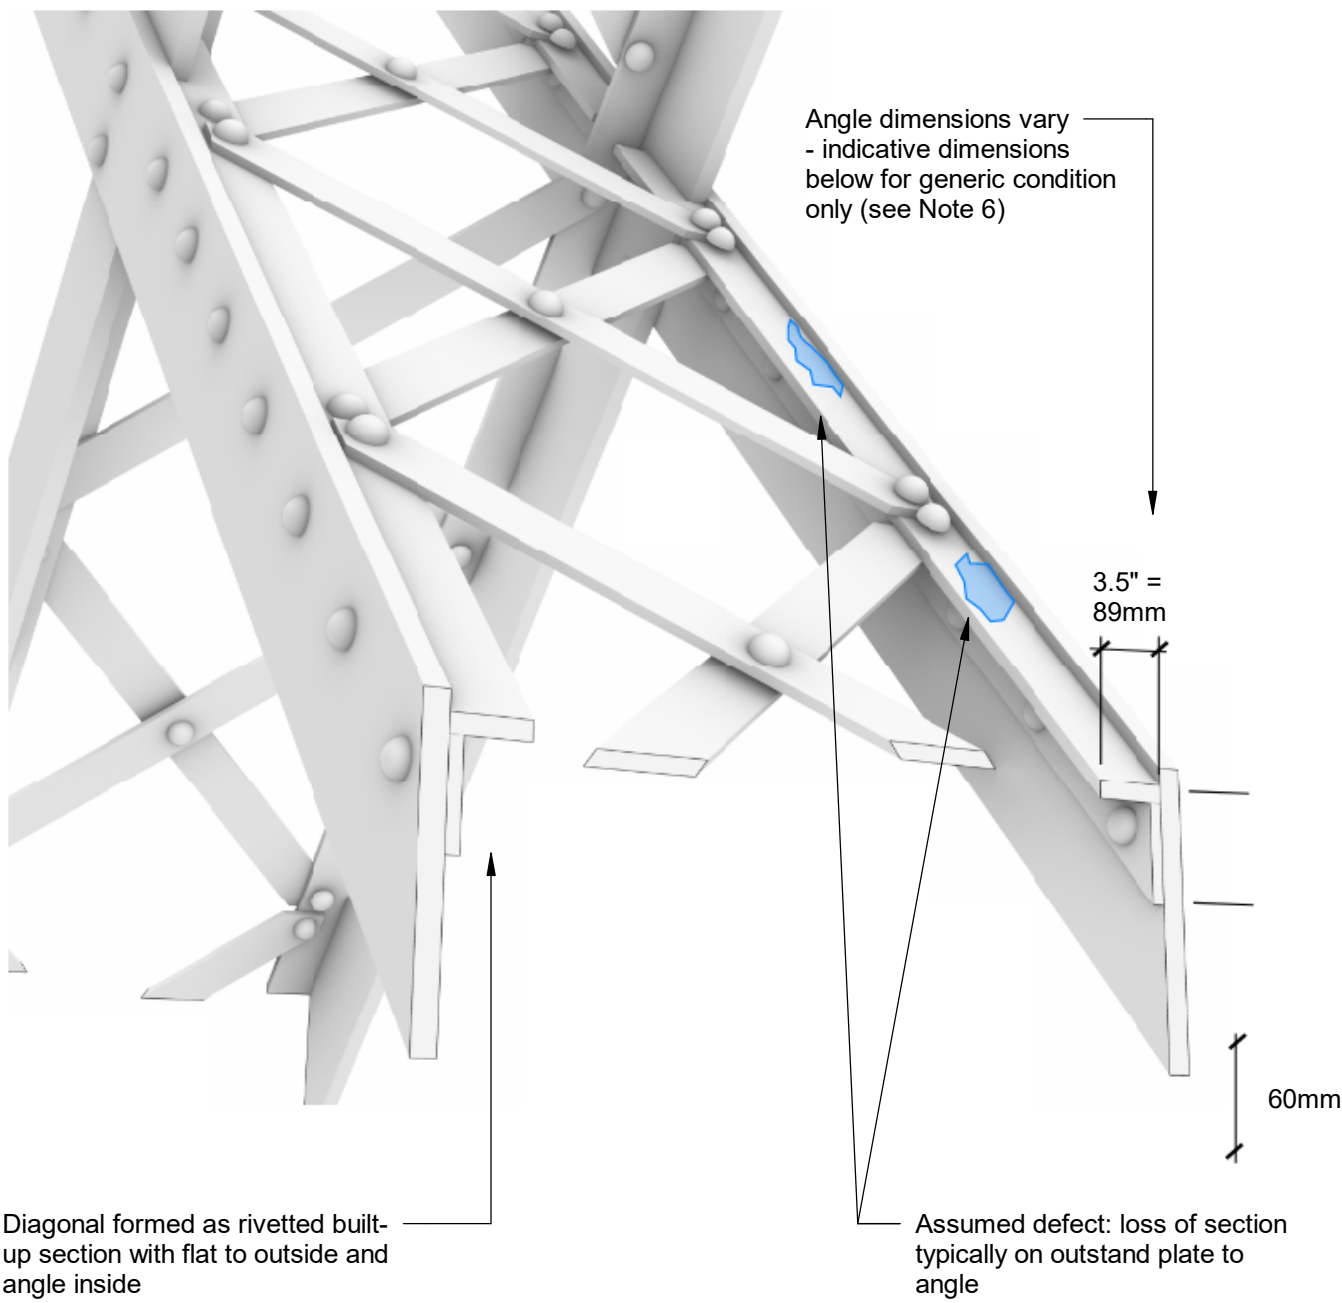
**Example 3**  
- loss of section to inner angle, either side of X-bracing connection  
- at least 2 holes per length of outstand

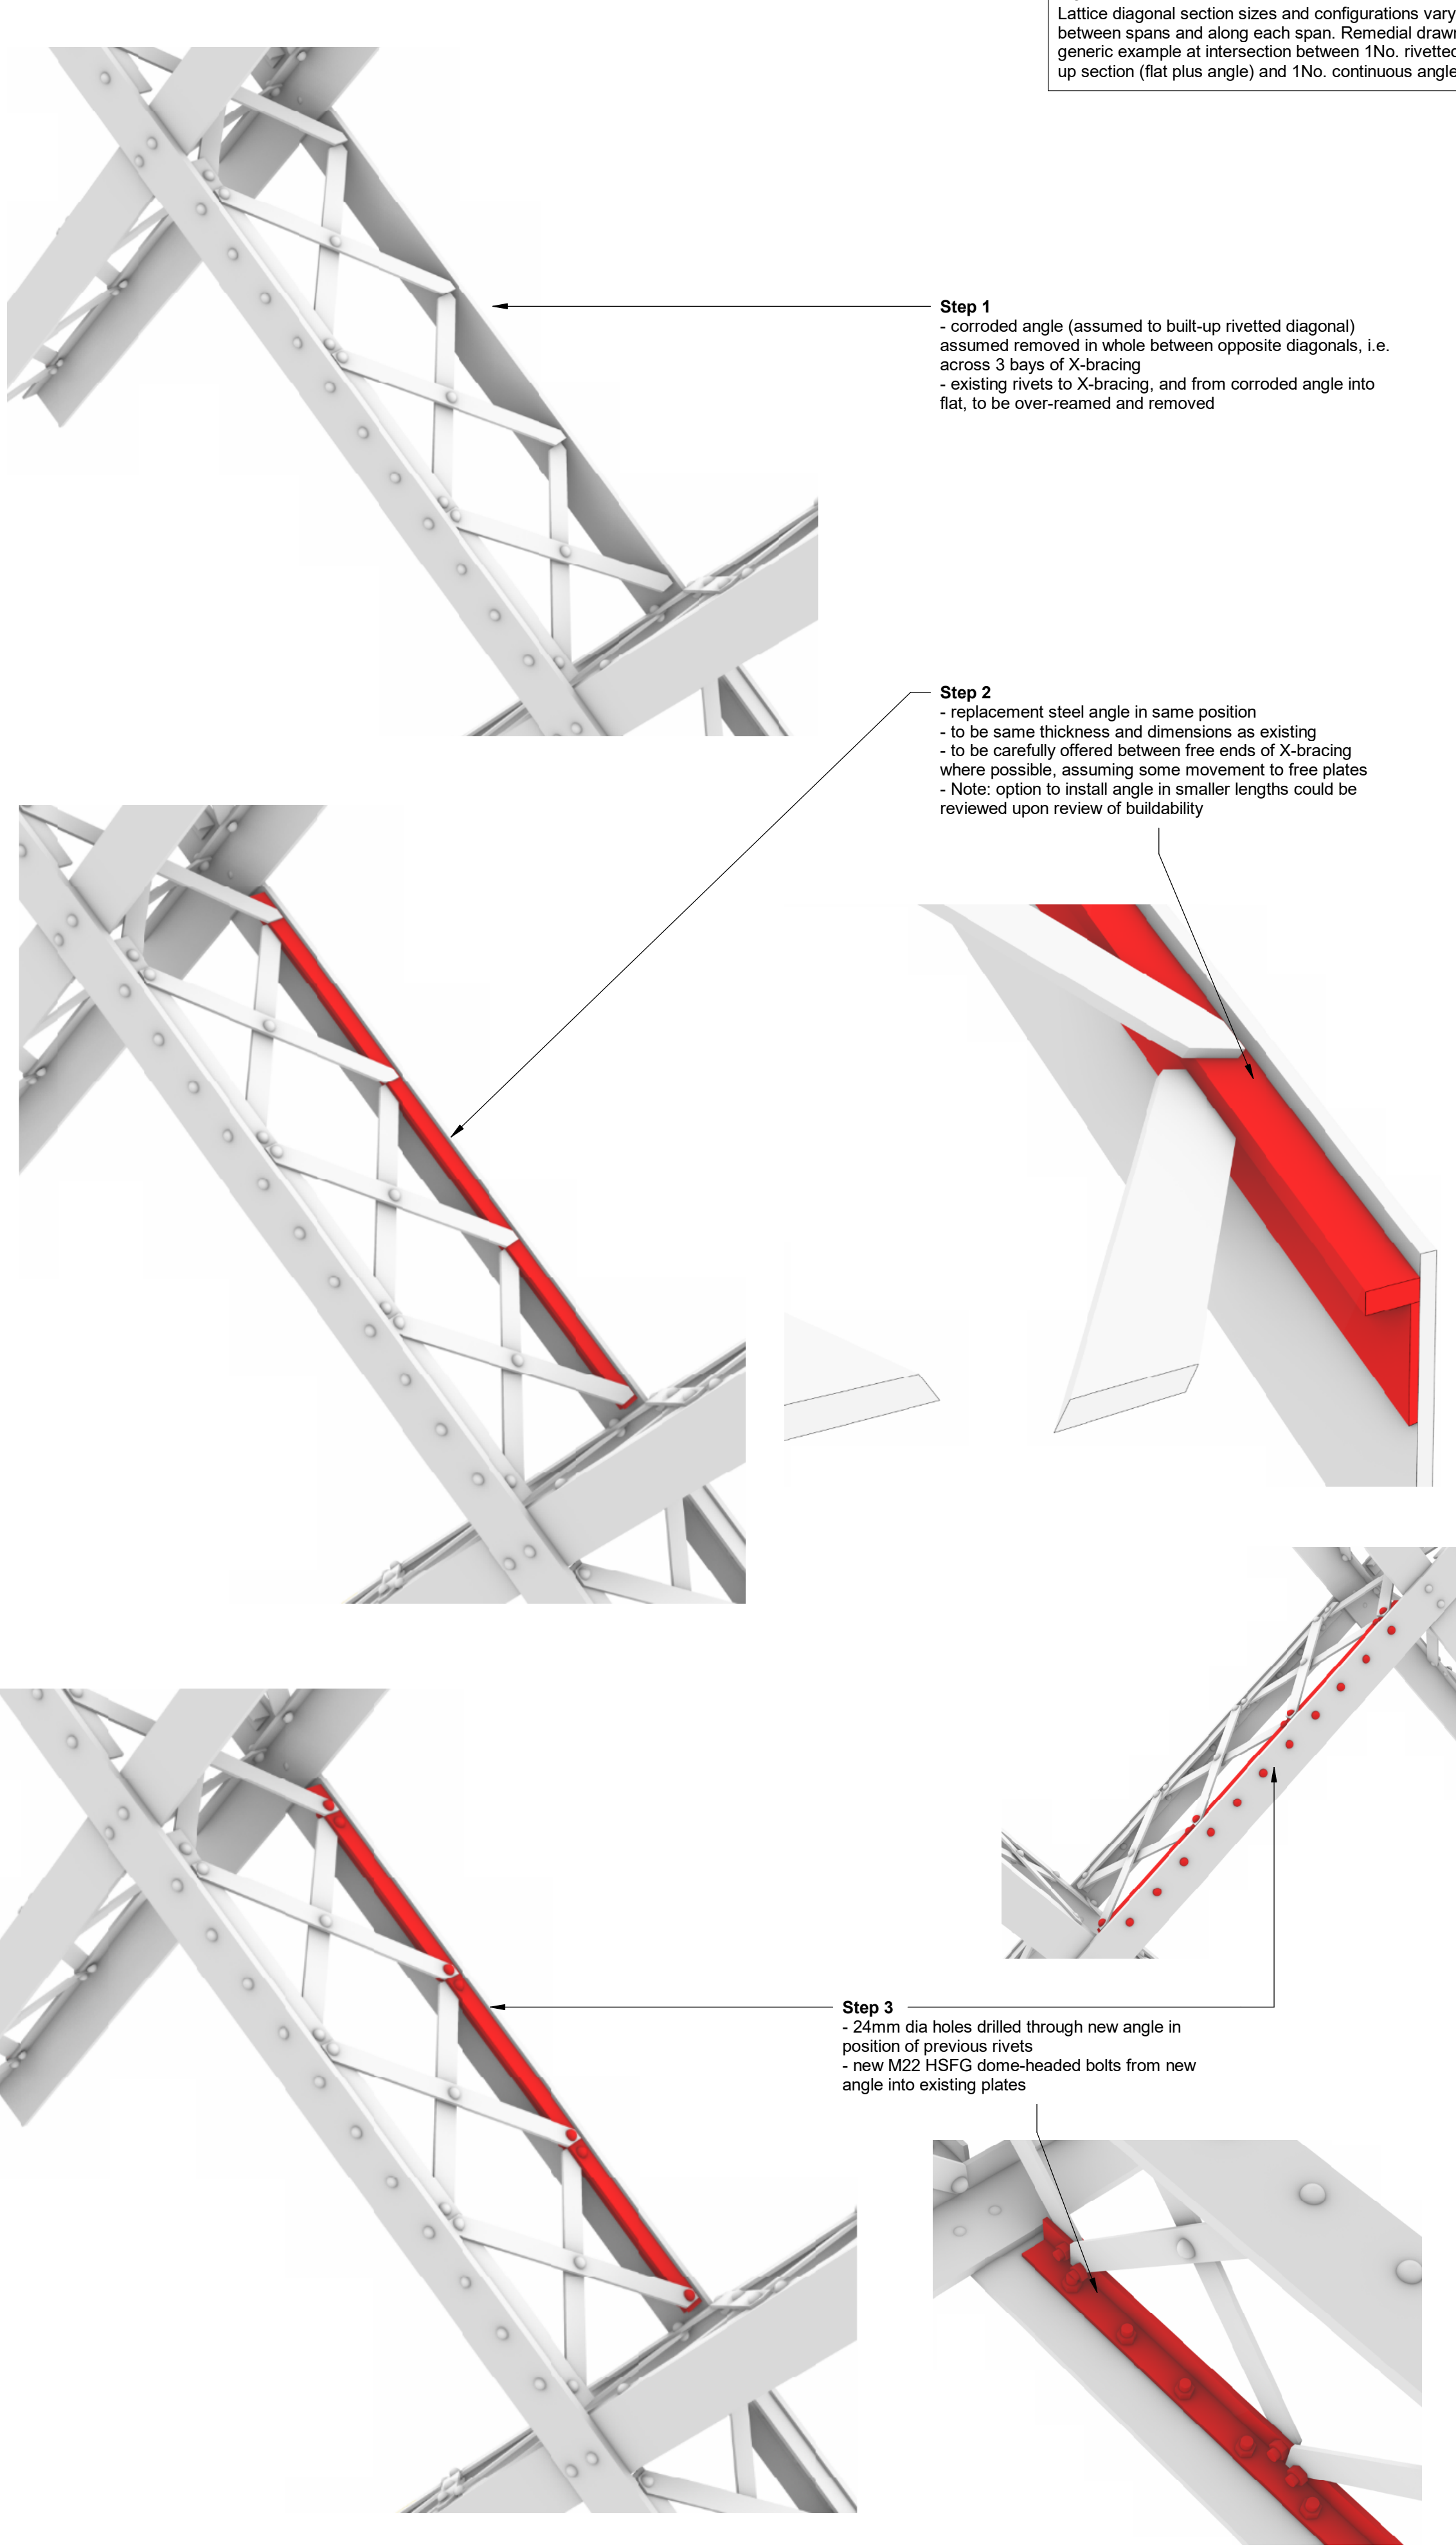
**REMEDIAL DETAIL**  
NTS

**NOTE:**  
The remedial details shown consider the most likely corrective intervention based on the expected type/extent of defect. Extent of defect to be confirmed pending future brush down, removal of debris, and subsequent tactile surveys. Further defect types and consequent remedials may also be identified.
