Ref: 3741D  
Date: 4th June 2024

**RE: Watching Brief Summary Report for site at No.12 Hinstock Crescent, Gorton, Manchester M18 8UU**

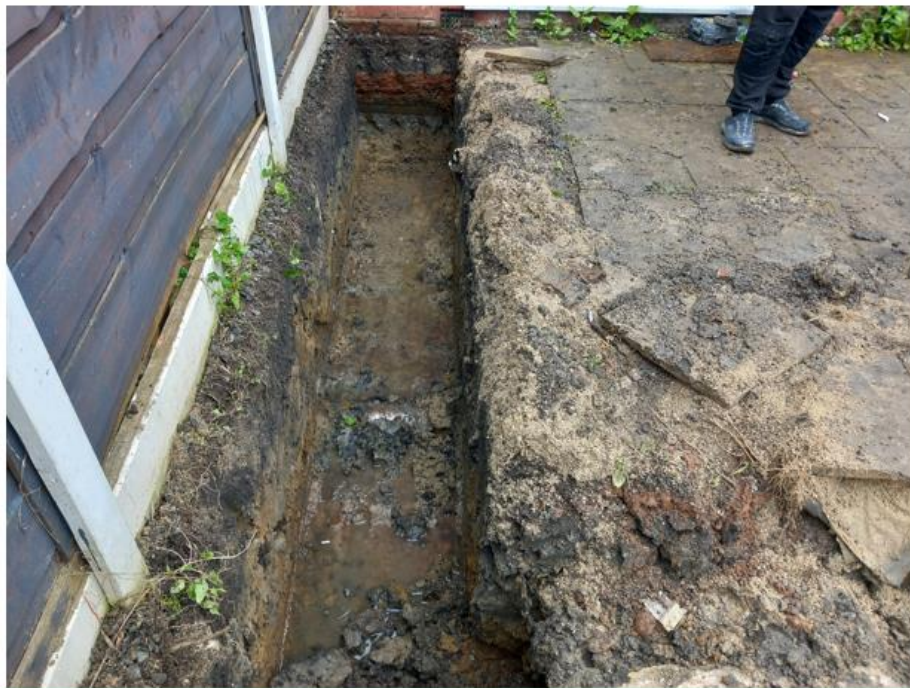
**Photo No.1: Facing west in the far SE corner of site showing the initial excavation progress (east-west section)**

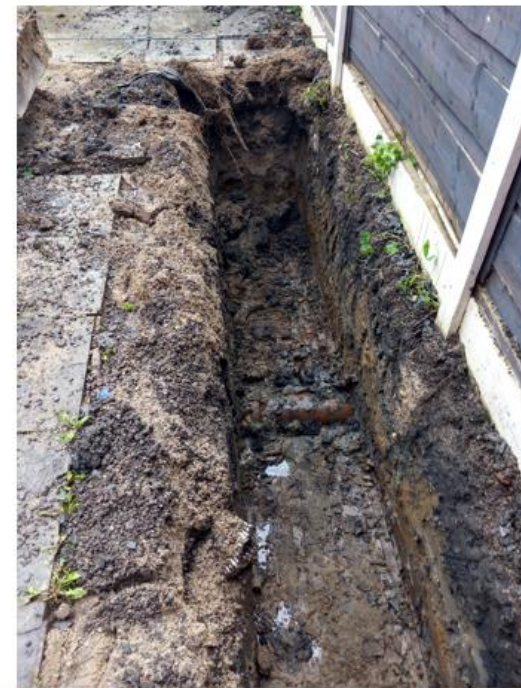
**Photo No.2: Facing east showing the same footing section**

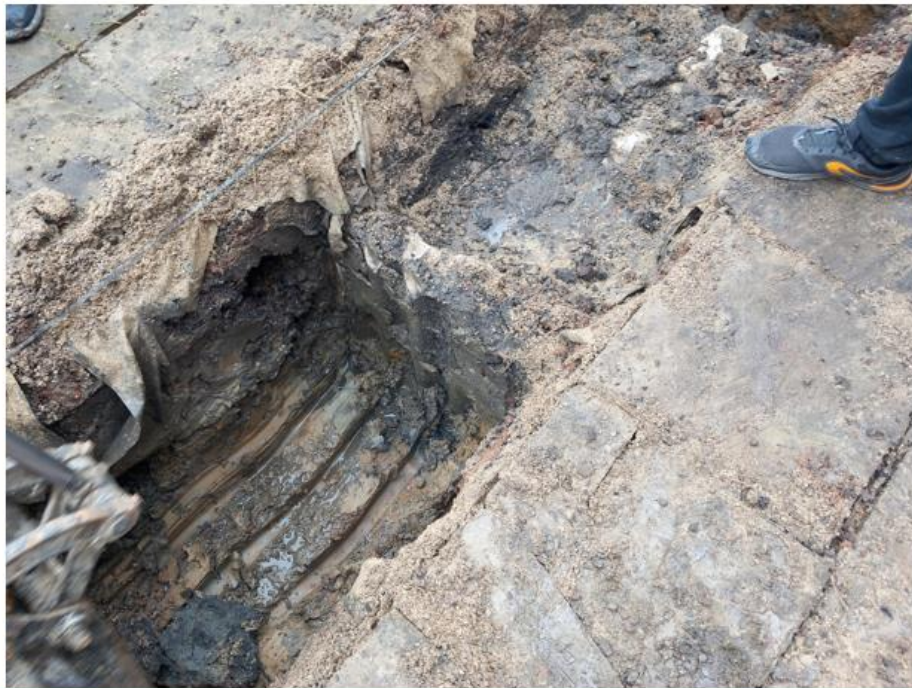
The excavation progressed from the south eastern extent of site, leading east, before turning north and then westwards. Towards the south eastern extent of site, a concrete obstruction was encountered. This feature (found in **Appendix A** as Photo Nos. 3, 4, 5, 6 & 7, respectively with a plan of the photographs found as **Appendix B**) resembled a former Anderson Bomb Shelter, evidenced as such by the size, dimensions and location (the former entrance would have been directly outside and inline with the rear exit of the dwelling), the imprint of corrugation on the remaining concrete, alongside the metal base remaining at 1.00m depth within the excavation. Furthermore, Manchester and its surrounding boroughs was, historically, commonly associated with former bomb and/or fallout shelters, associated with both World War II and the following Cold War, which lends further credence to this hypothesis. It was apparent that the former shelter had been backfilled with natural clay arisings (no evidence of significant brick or rubble fill noted within the footprint of the feature) and the associated concrete and metal base was broken out and removed, allowing the foundations to subsequently be cast in this area.

**Photo No.3: Concrete obstruction (possible former Anderson Shelter) in southern extent of north-south footing section**

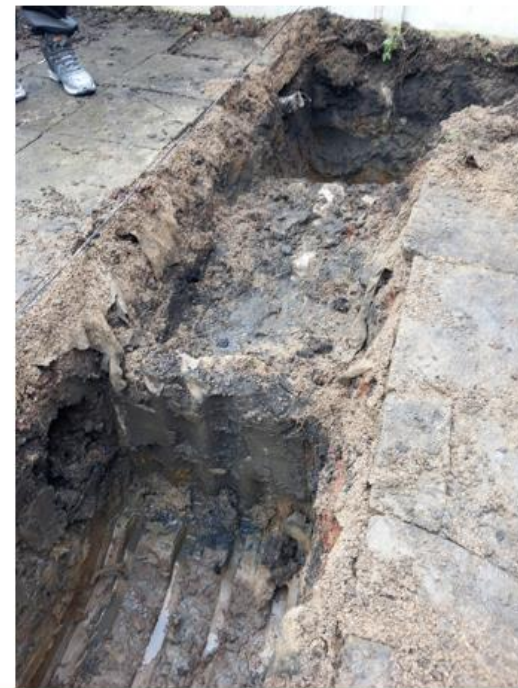
**Photo No.4: Second angle of obstruction showing corrugated imprint on concrete to either side of feature and clay infill**

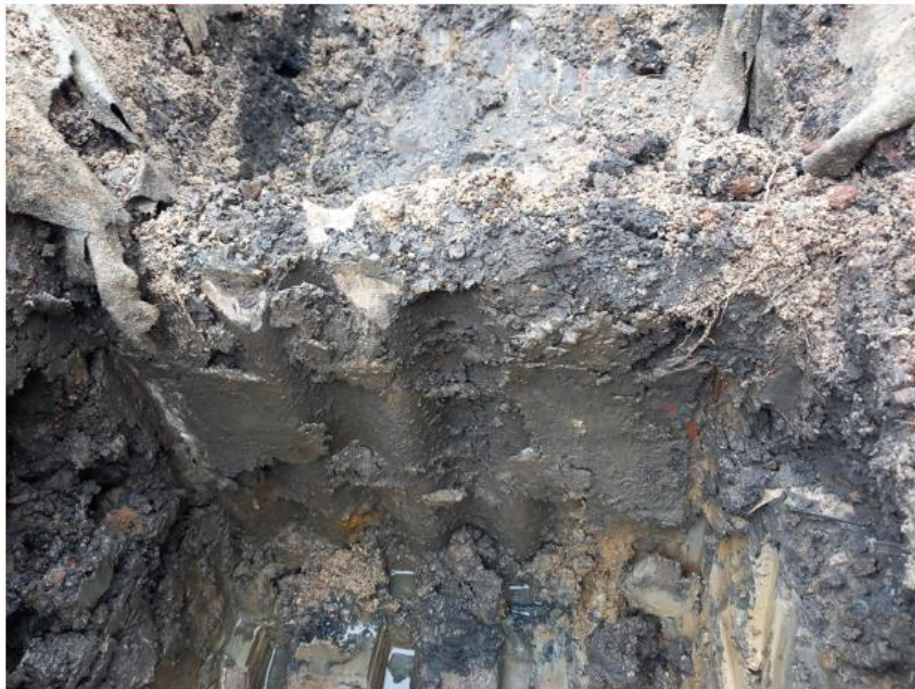
**Photo No.5: Close-up shot of corrugated imprint on concrete**

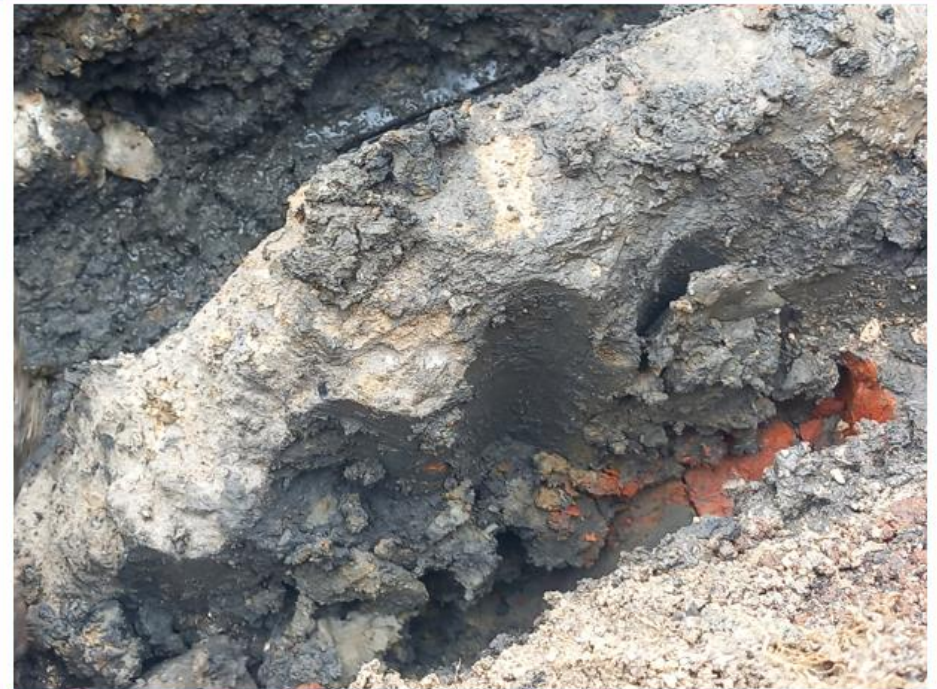
**Photo No.6: Close-up shot of corrugated imprint on concrete**

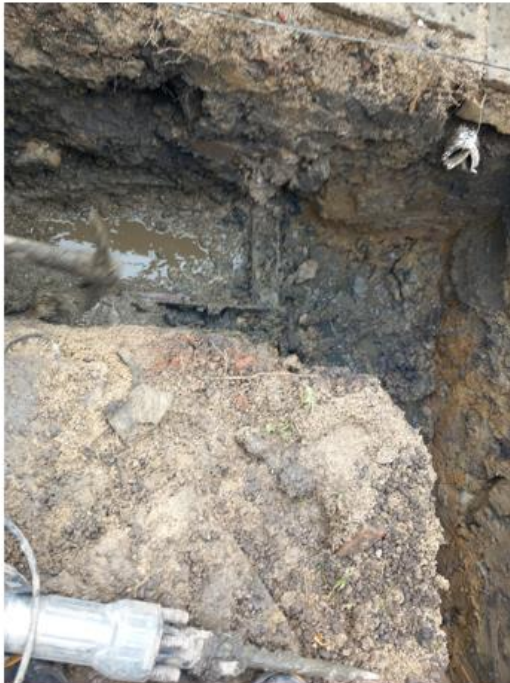
**Photo No.7: Concrete obstruction removed exposing the former metal structuring / base to likely corrugated tin**

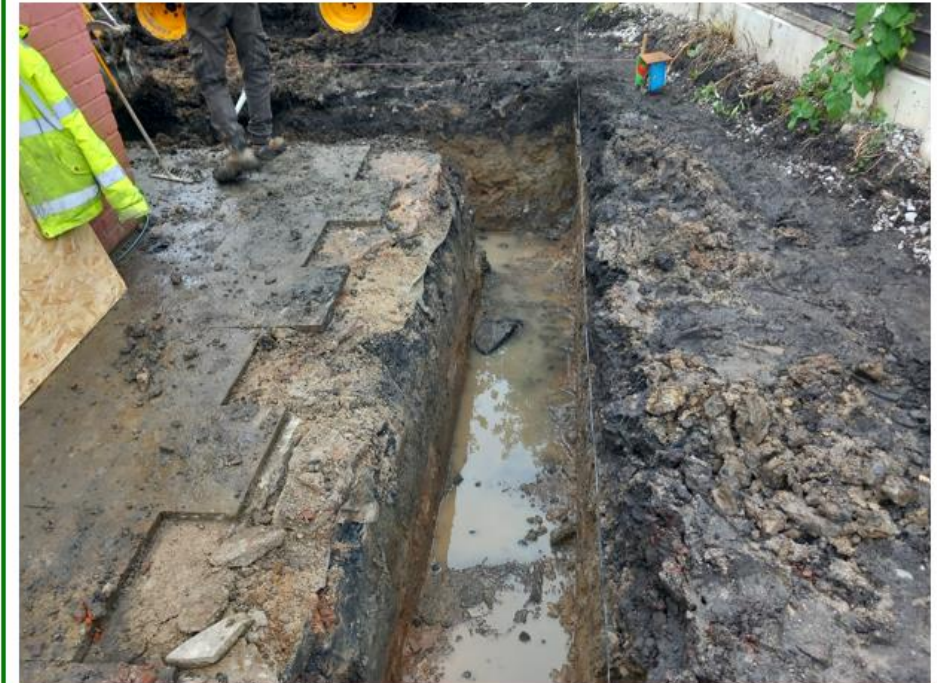
**Photo No.8: Facing north along the north-south footing section**

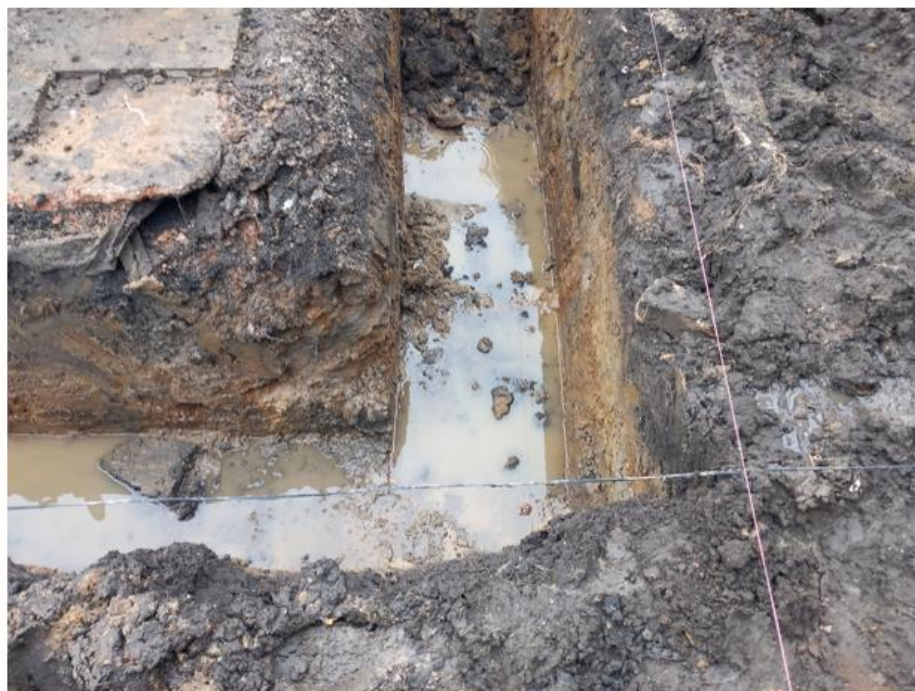
**Photo No.9: Facing west showing the corner section (NE extent of footings)**

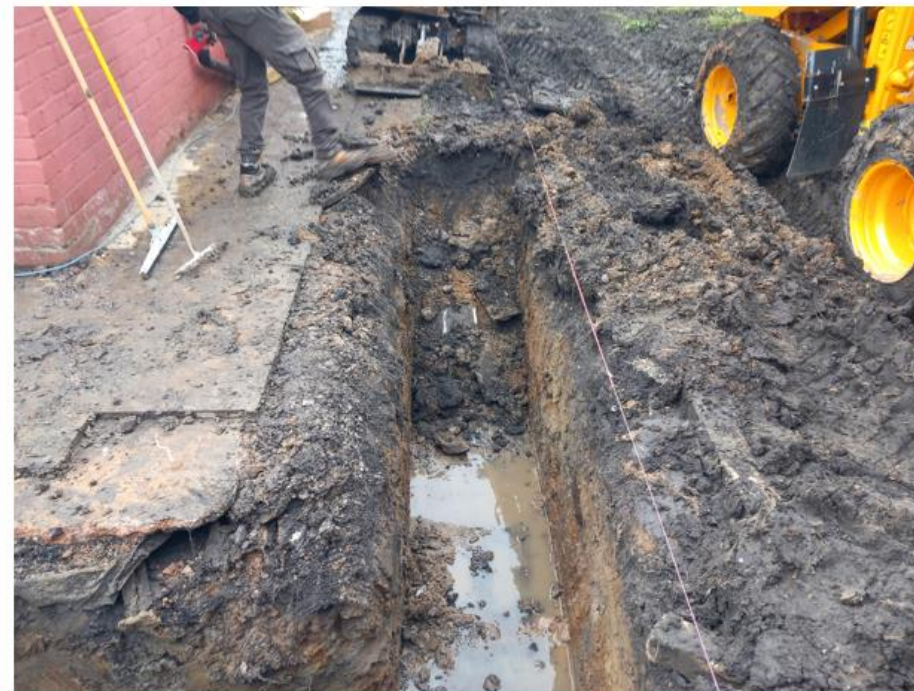
**Photo No.10: Facing west from the NE extent of the footings**

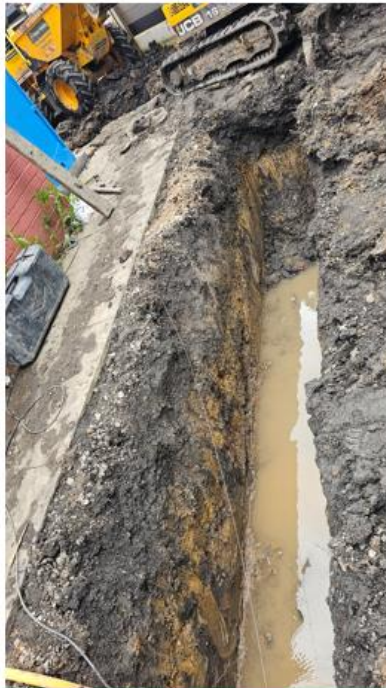
**Photo No.11: Facing slightly SW showing remaining footing excavation (east-west second section)**

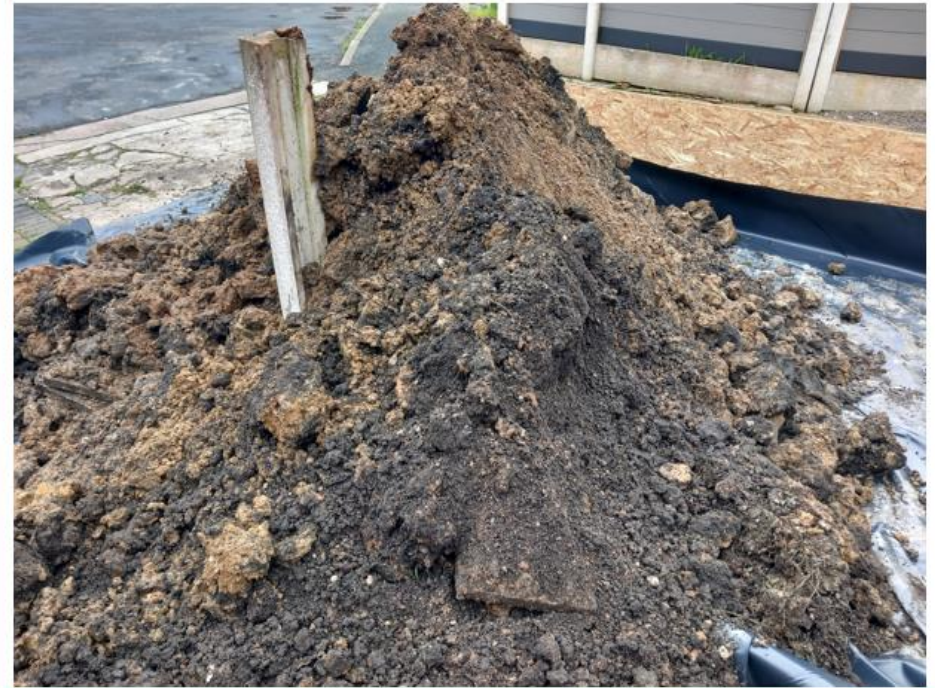
**Photo No.12: Arisings heap ready for removal offsite showing relict topsoil material and natural, sandy Clays**
