**Report Reference No: EL-01287**

**Riverpark Trading Estate / Former Abattoir Site,  
Riverpark Road,  
Manchester M40 2XT.**

## **Asbestos Demolition Survey Report**

**Date 25/02/2024**

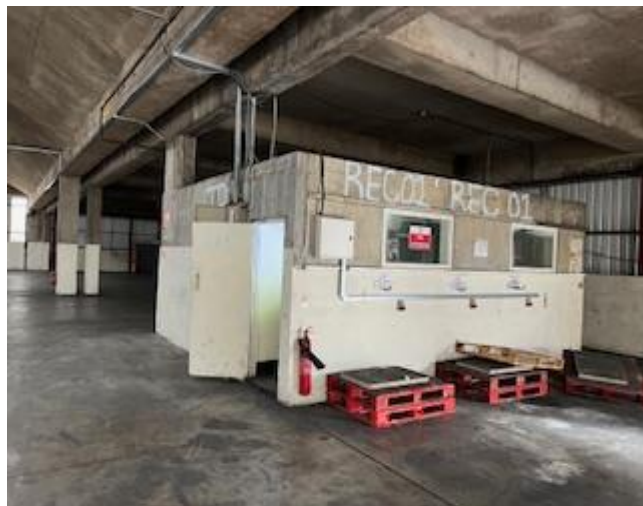
| Location: | W/C / stores / corridor / stairs | | |
| Item: | Spray coating debris beneath paint to ceiling | | |
| Approx. Extent: | 30m2 | Score: | |
| Product Type: | Spray coating | 2 | |
| Condition: | Fair | 1 | |

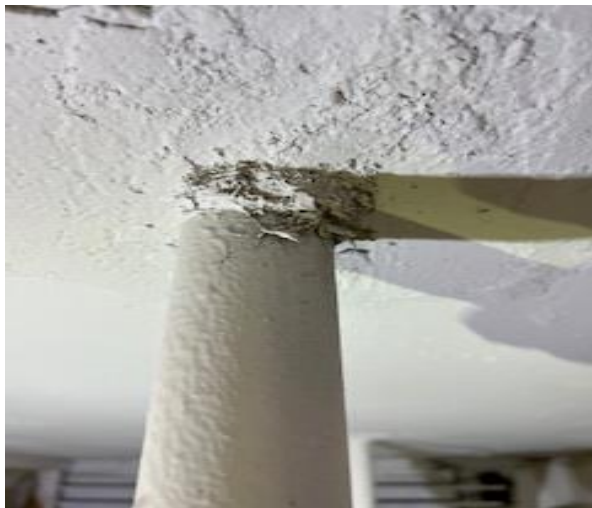
| Location: | W/C / stores / corridor / stairs / office / rooms 1/2/3 | | |
| Item: | Spray coating debris beneath paint to ceiling | | |
| Approx. Extent: | 160m2 | Score: | |
| Product Type: | Spray coating | 2 | |
| Condition: | Fair | 1 | |

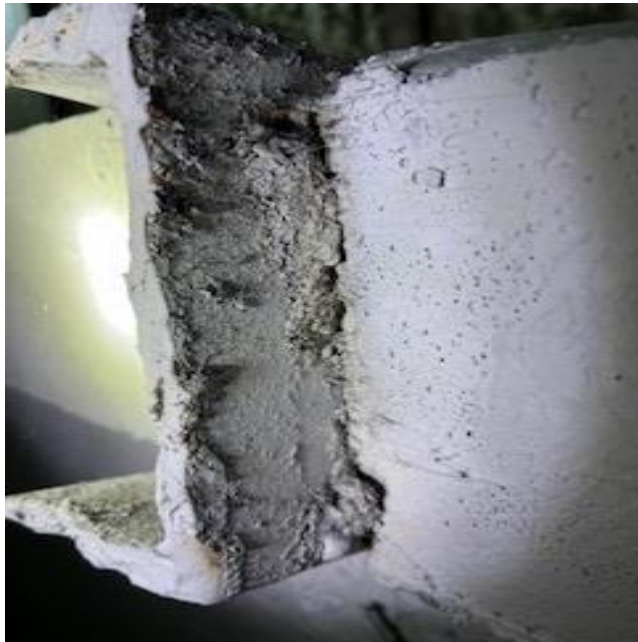
| Location: | Block 2 – Throughout | | |
| Item: | Concrete pillars high level – Spray coating & debris behind paint | | |
| Approx. Extent: | 160m2 | Score: | |
| Product Type: | Spray coating | 2 | |
| Condition: | Fair | 2 | |

All cracks / crevasses & voids to be treated as spray coating is present.

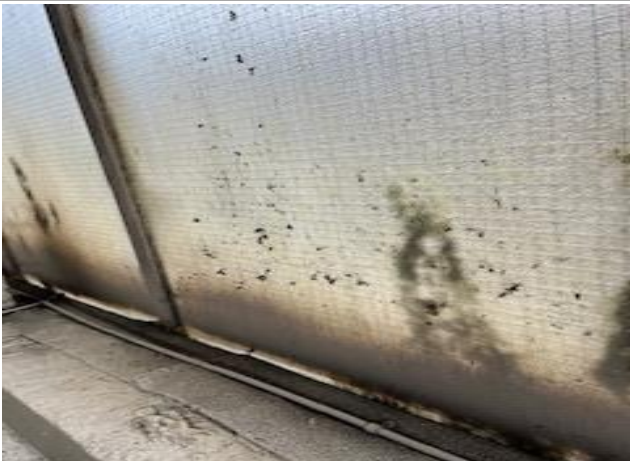
| Location: | Block 2 – Throughout | | |
| Item: | Rope seals to windows – North lights | | |
| Approx. Extent: | 700 windows | Score: | |
| Product Type: | Woven | I | |
| Condition: | Fair | I | |

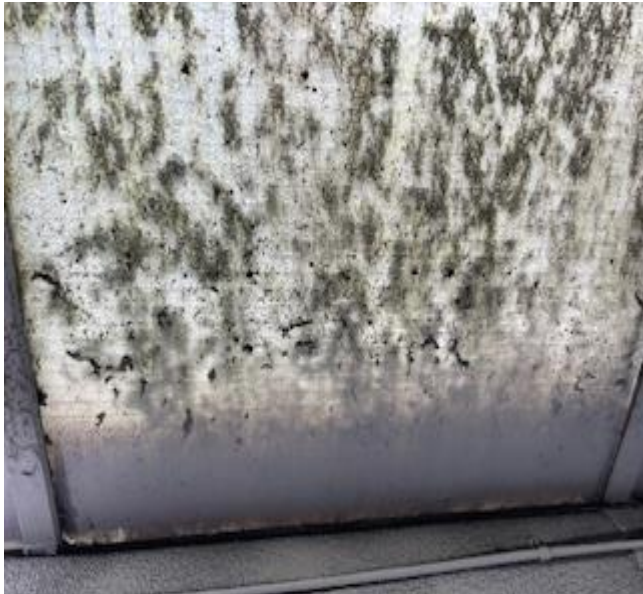
| Location: | Block 2 – Throughout | | |
| Item: | North lights and tin sheets – Spray coating & debris | | |
| Approx. Extent: | 160m2 | Score: | |
| Product Type: | Spray coating | 2 | |
| Condition: | Fair | 2 | |

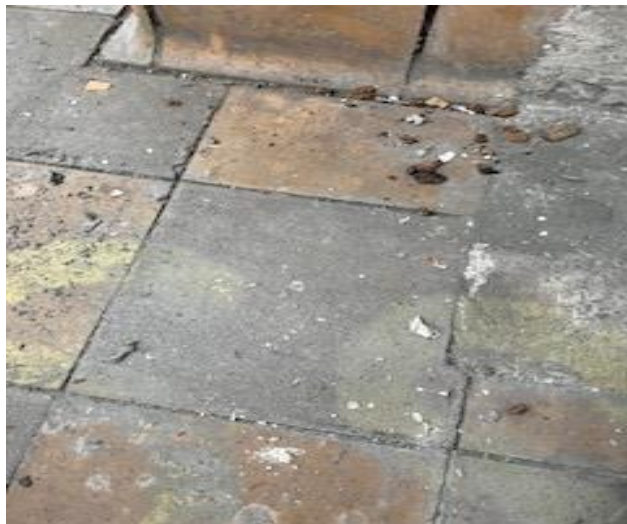
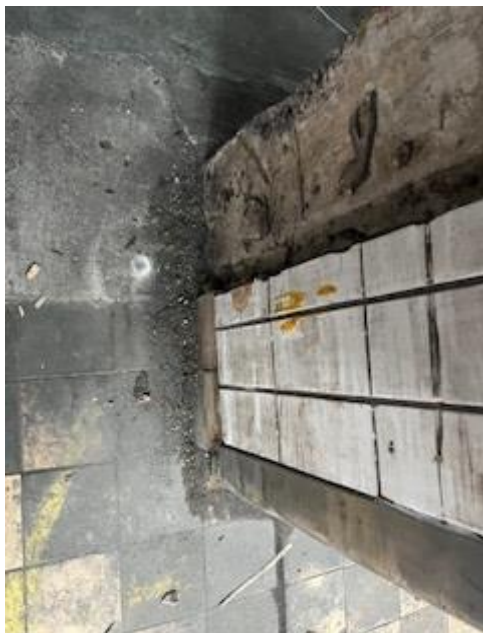
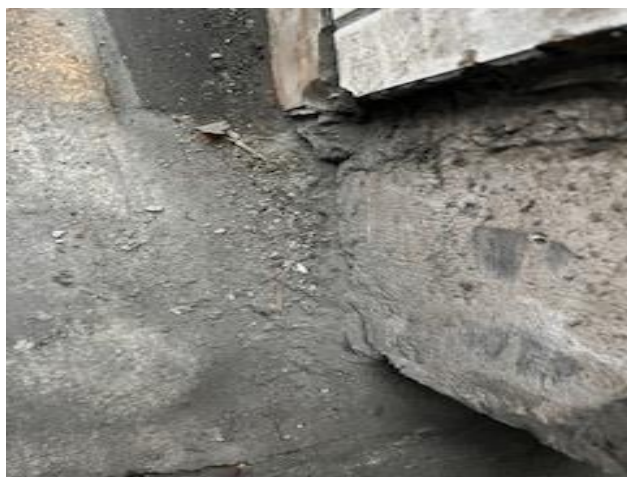
| Location: | Block 2 – Throughout | | |
| Item: | Floor / Bottom of columns – Dust and debris | | |
| Approx. Extent: | 3000m2 | Score: | |
| Product Type: | Spray coating | 2 | |
| Condition: | Fair | 2 | |
| Asbestos Type(s): | Amosite | 2 | |

| Action: | <p>Remove by a licenced asbestos removal contractor in accordance with the 2012 asbestos regulations.</p> <p>Dust samples were taken in various locations – mainly around bottom of columns. Samples came back positive. – All the floor should be treated as contaminated.</p> <p>All cracks / crevasses &amp; voids to be treated as spray coating is present.</p> <p>Access to this area should not be permitted – this area should be treated as contaminated with signage and physical barriers to stop access.</p> | | |

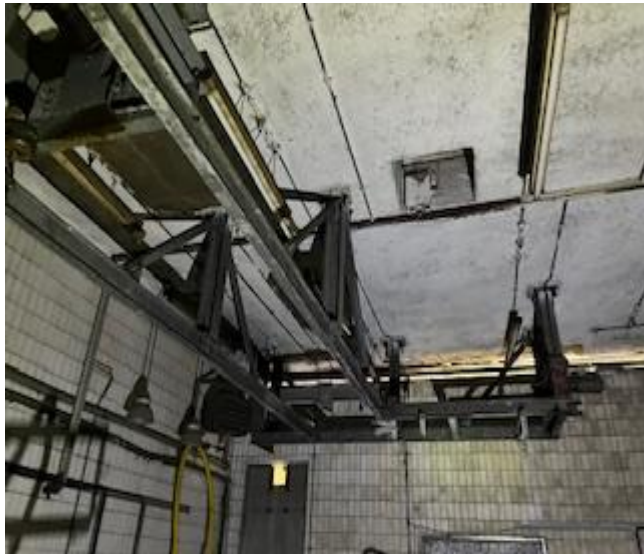
| Location: | Block 2 – Workshop / Boiler Room / Corridor | | |
| Item: | Spray coating to workshop ceiling and dust and debris throughout workshop / corridor and boiler room. | | |
| Approx. Extent: | 200m2 | Score: | |
| Product Type: | Spray coating | 2 | |
| Condition: | Fair | 2 | |

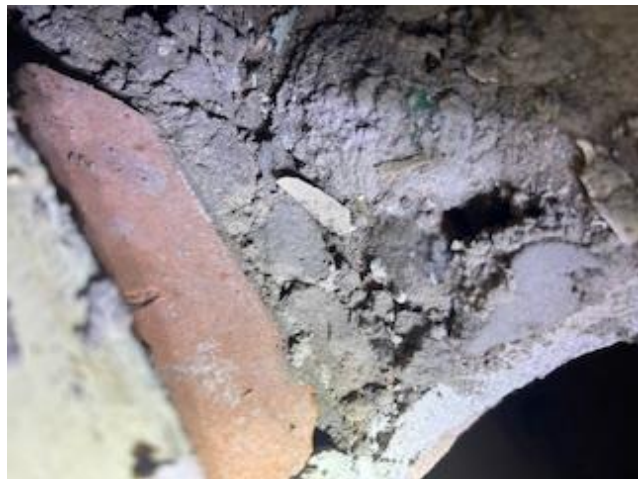
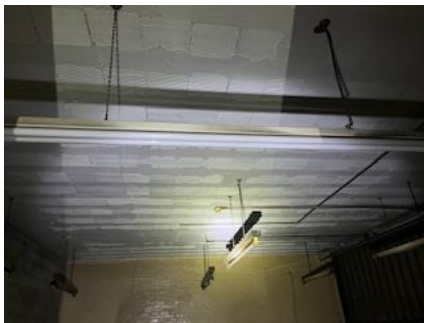
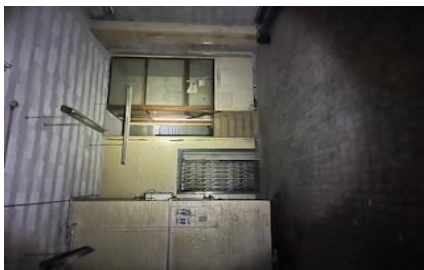
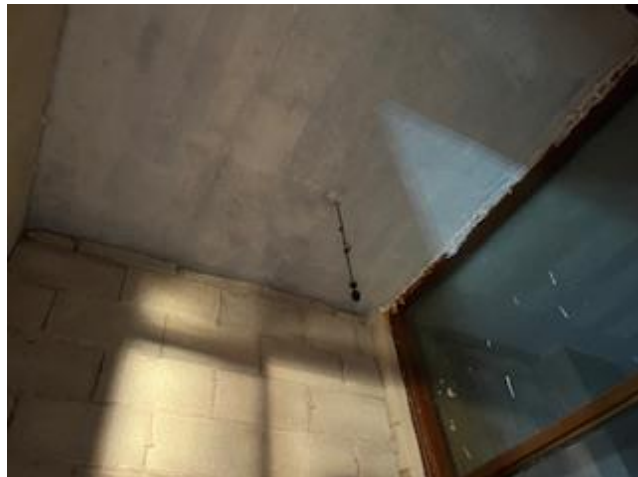
| Location: | Electrical Room & Engineering | | |
| Item: | Spray coating debris below painted ceilings – Dust and debris throughout | | |
| Approx. Extent: | 200m2 | Score: | |
| Product Type: | Spray coating | 2 | |
| Condition: | Fair | 2 | |

| Action: | <p>Remove by a licenced asbestos removal contractor in accordance with the 2012 asbestos regulations.</p> <p>Spray coating debris has been identified above to painted ceiling / debris throughout<br/>Signs of asbestos enclosures that had not removed properly still in situ.</p> <p>All cracks / crevasses &amp; voids to be treated as spray coating is present.</p> <p>Access to this area should not be permitted – this area should be treated as contaminated with signage and physical barriers to stop access.</p> | | |

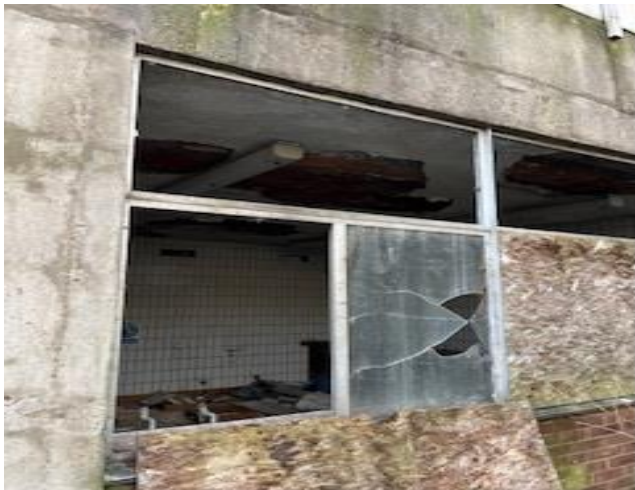
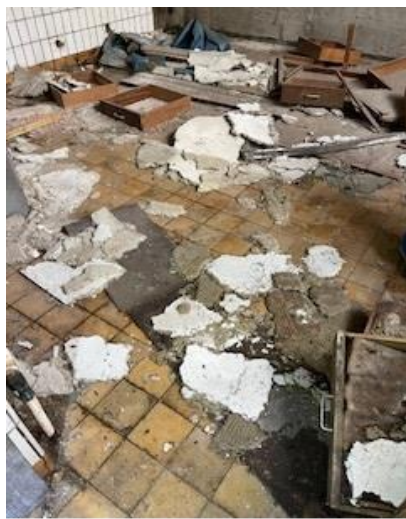
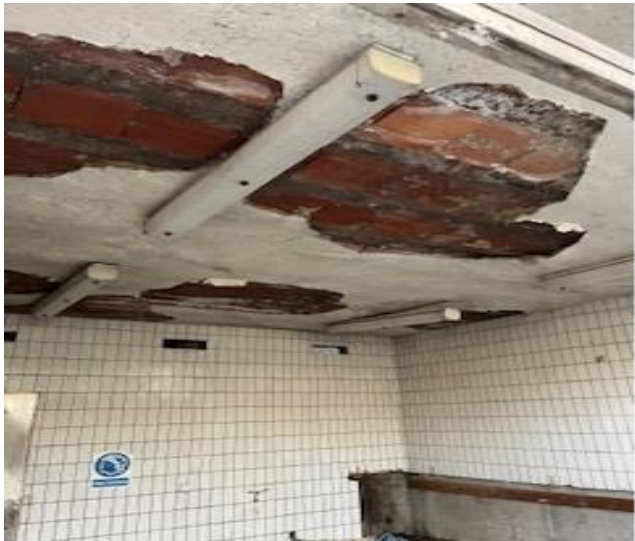
| Location: | Block 2 – Kitchen and 2 x rear rooms (Adjacent Rooms) | | |
| Item: | Spray coating to kitchen ceiling and dust and debris throughout adjacent rooms | | |
| Approx. Extent: | 200m2 | Score: | |
| Product Type: | Spray coating | 2 | |
| Condition: | Fair | 2 | |
| Asbestos Type(s): | Amosite | 2 | |

| Action: | <p>Remove by a licenced asbestos removal contractor in accordance with the 2012 asbestos regulations.</p> <p>Raw asbestos spray coating to kitchen ceiling and associated rooms – Badley damaged debris to floor – heavily contaminated throughout</p> <p>All cracks / crevasses &amp; voids to be treated as spray coating is present.</p> <p>Access to this area should not be permitted – this area should be treated as contaminated with signage and physical barriers to stop access.</p> | | |

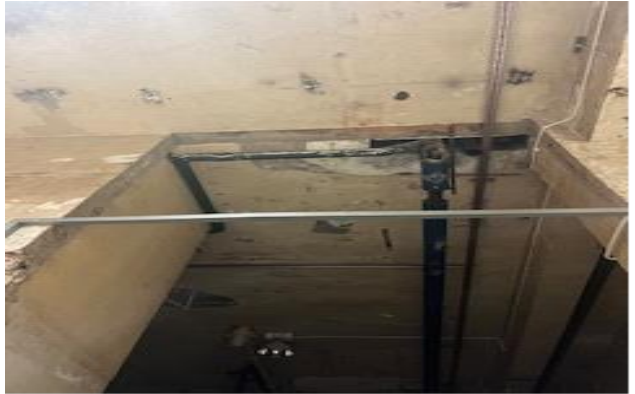
| Location: | Ground | | |
| Item: | Insulation to pipework high level | | |
| Approx. Extent: | 6LM | Score: | |
| Product Type: | Insulation | 2 | |
| Condition: | Fair | 1 | |

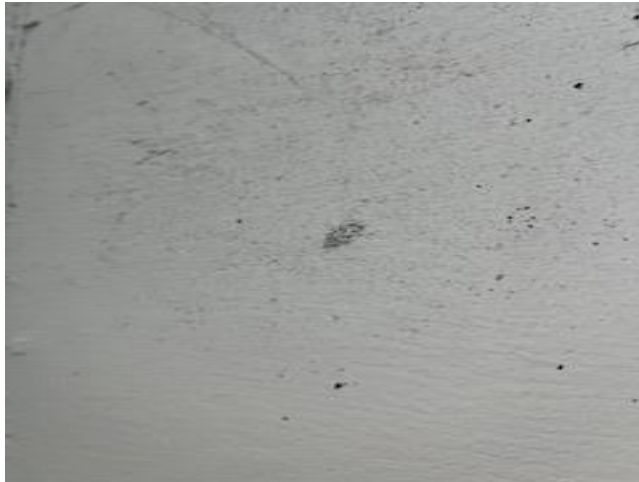
| Location: | Block 2 – Toilets | | |
| Item: | Spray coating to toilets ceiling underneath paint. | | |
| Approx. Extent: | 30m2 | Score: | |
| Product Type: | Spray coating | 2 | |
| Condition: | Fair | 2 | |

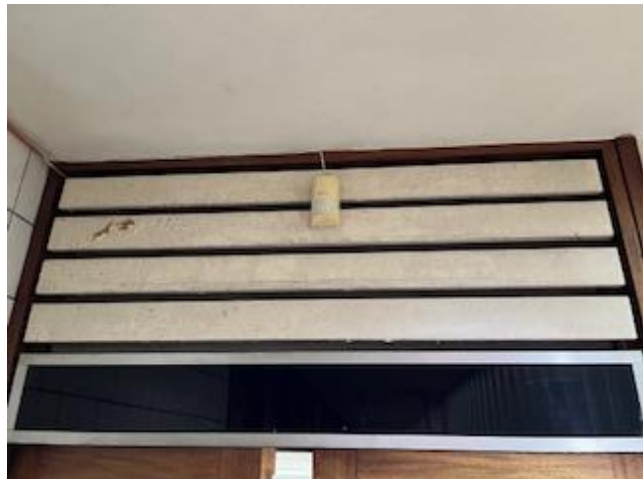
| Location: | Block 2 – Office | | |
| Item: | Board to top of door | | |
| Approx. Extent: | 2m2 | Score: | |
| Product Type: | AIB | 2 | |
| Condition: | Fair | 1 | |

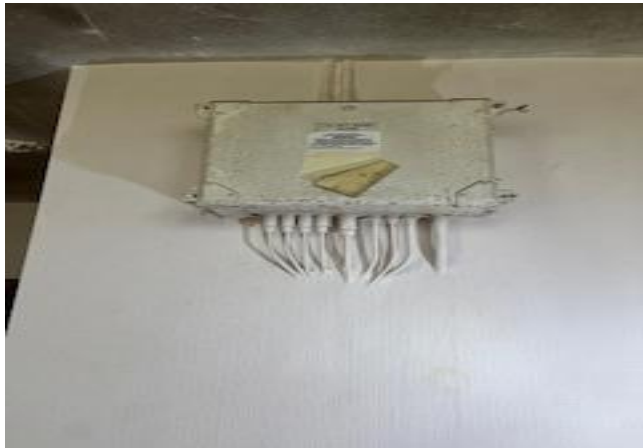
| <b>Location:</b> | Block 2 – Office | | |
| <b>Item:</b> | Fuse Boxes | | |
| <b>Approx. Extent:</b> | 2 x Units | <b>Score:</b> | |
| <b>Product Type:</b> | Woven | I | |
| <b>Condition:</b> | Fair | I | |

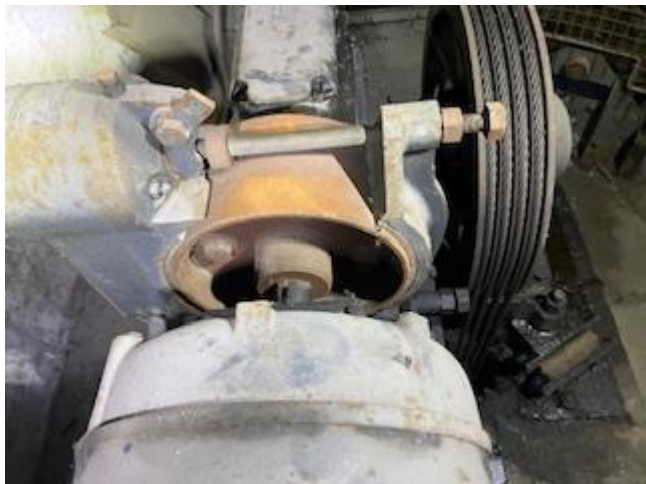
| Location: | Block 2 – Office | | |
| Item: | Break Shoes | | |
| Approx. Extent: | 2 x Units | Score: | |
| Product Type: | Woven | I | |
| Condition: | Fair | I | |

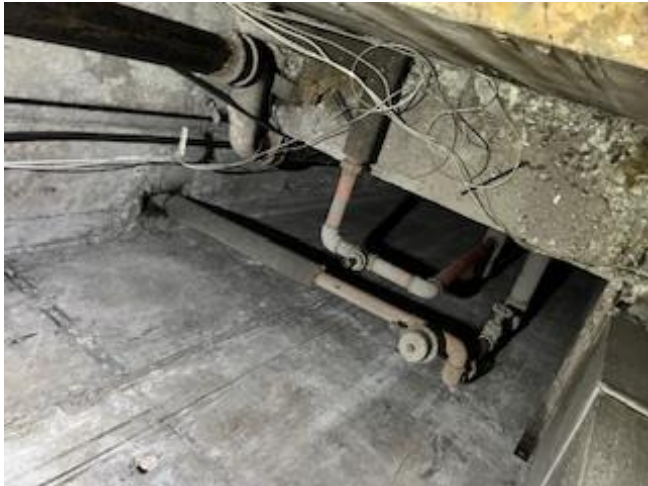
| <b>Location:</b> | Office | | |
| <b>Item:</b> | Insulation to pipework joints | | |
| <b>Approx. Extent:</b> | ILM | <b>Score:</b> | |
| <b>Product Type:</b> | Insulation | 2 | |
| <b>Condition:</b> | Fair | 1 | |

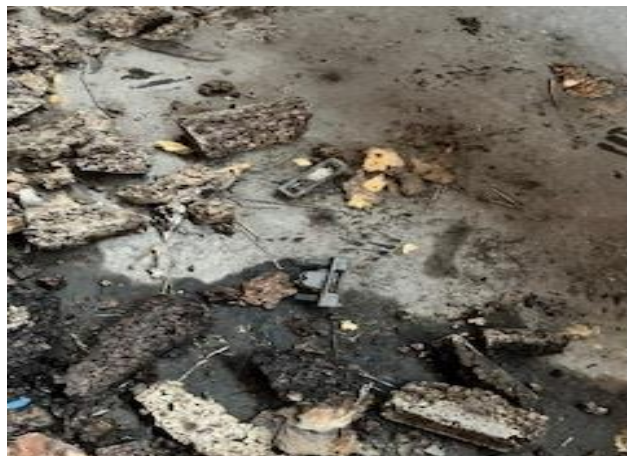
| Location: | Tank Room | | |
| Item: | Fuse Pads | | |
| Approx. Extent: | Throughout | Score: | |
| Product Type: | Woven | I | |
| Condition: | Fair | I | |

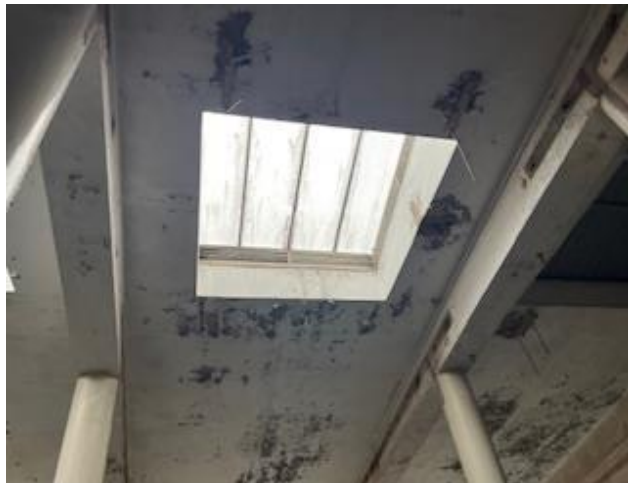
| Item: | Window Putty / Rope Seals | | |
| Approx. Extent: | 4 linear metres x 36 skylights | Score: | |
| Product Type: | Woven | I | |
| Condition: | Fair | I | |

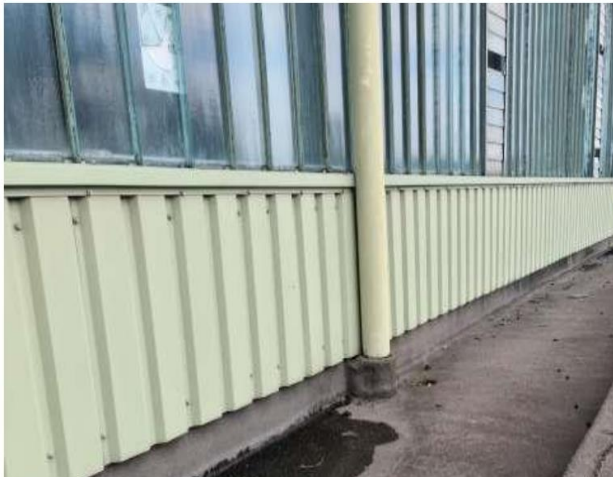
| Item: | Windows | | | |
| Approx. Extent: | 1280<br>Windows | Score: | | |
| Product Type: | Woven | I | | |
| Condition: | Fair | I | | |

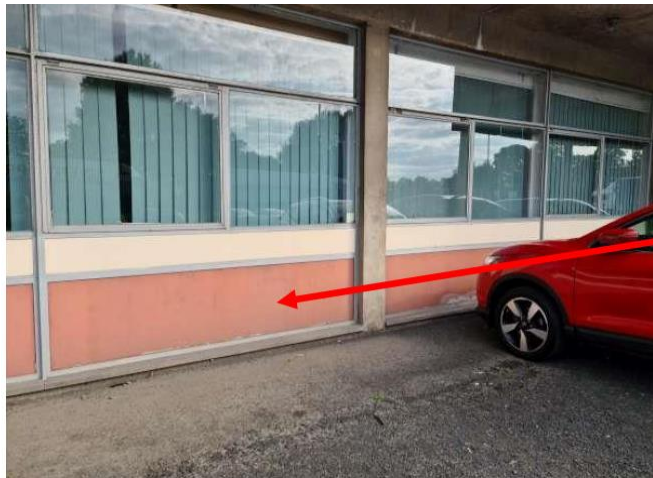
| Item: | Windows Panels | | |
| Approx. Extent: | 30 M2 | Score: | |
| Product Type: | AIB | I | |
| Condition: | Fair | I | |

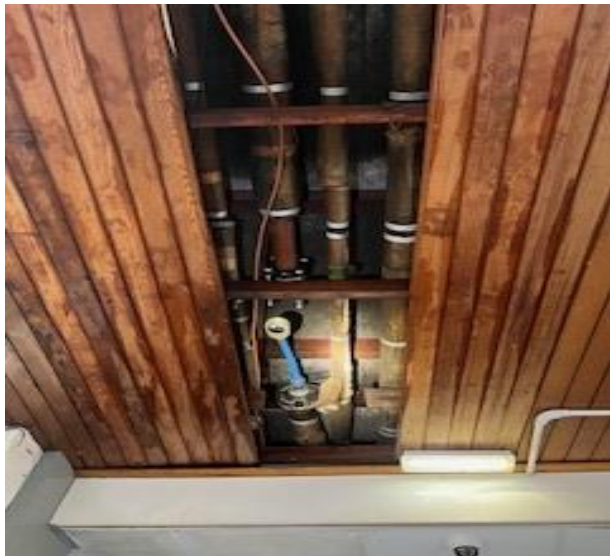
| <b>Item:</b> | Gaskets | | |
| <b>Approx. Extent:</b> | I Unit | <b>Score:</b> | |
| <b>Product Type:</b> | Woven | I | |
| <b>Condition:</b> | Fair | I | |

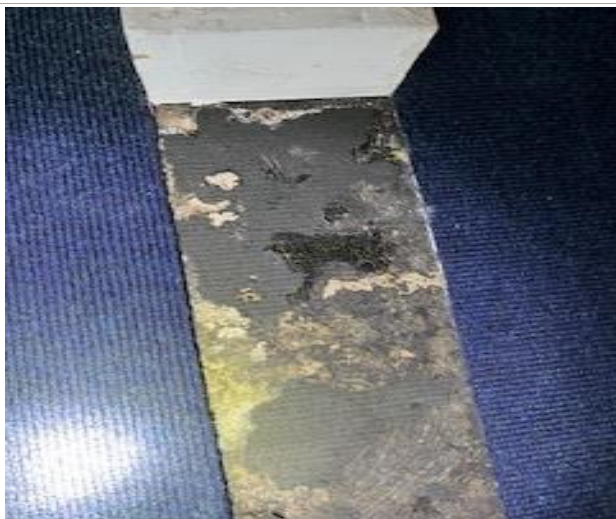
| <b>Item:</b> | Bitumen Screed | | |
| <b>Approx. Extent:</b> | 550M2 | <b>Score:</b> | |
| <b>Product Type:</b> | Bitumen | I | |
| <b>Condition:</b> | Fair | I | |

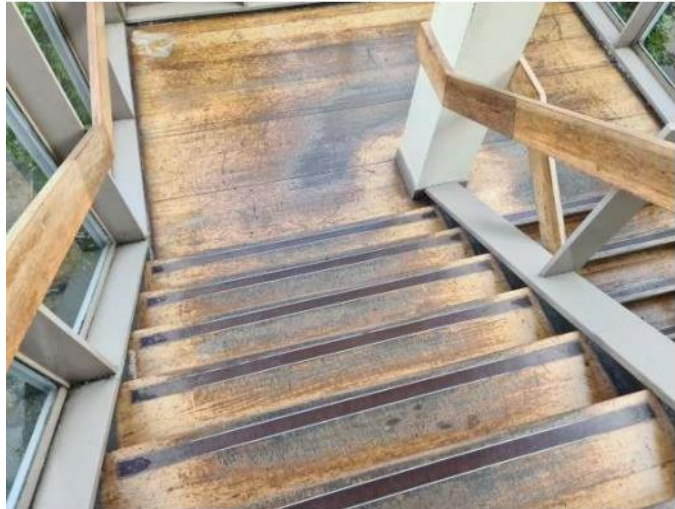
| <b>Item:</b> | Stair nosing treads | | |
| <b>Approx. Extent:</b> | 50 LM | <b>Score:</b> | |
| <b>Product Type:</b> | Bitumen | I | |
| <b>Condition:</b> | Fair | I | |

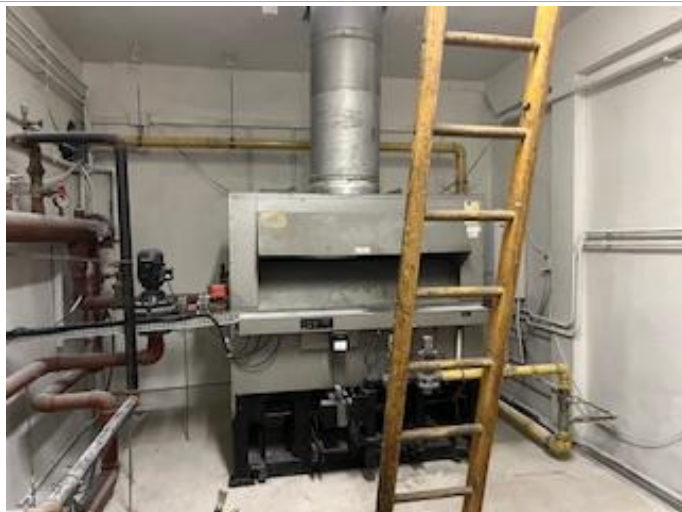
| <b>Item:</b> | Gaskets to boiler / rope seals | | |
| <b>Approx. Extent:</b> | | <b>Score:</b> | |
| <b>Product Type:</b> | Woven | I | |
| <b>Condition:</b> | Fair | I | |

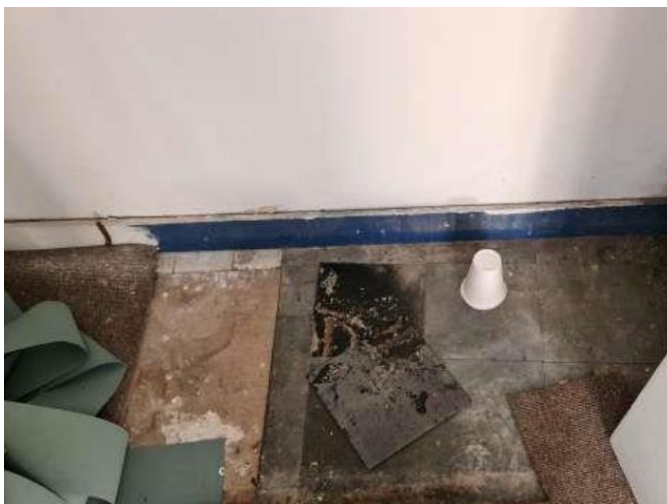
| <b>Item:</b> | Floor Tiles and Bitumen | | |
| <b>Approx. Extent:</b> | 2 M2 | <b>Score:</b> | |
| <b>Product Type:</b> | Vinyl | I | |
| <b>Condition:</b> | Fair | I | |

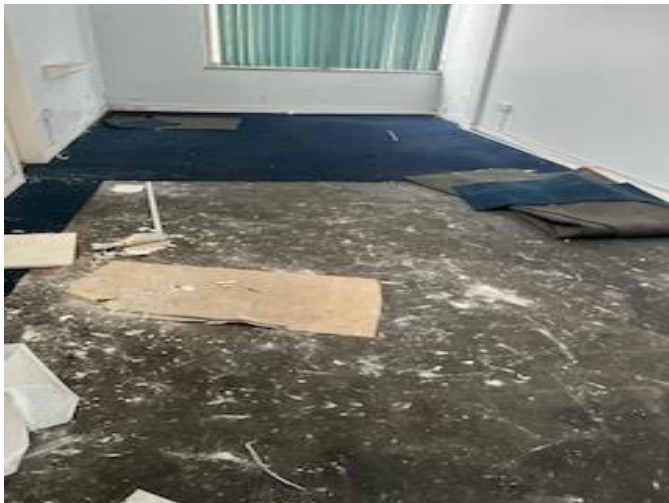
| Item: | Bitumen Floor Covering | | |
| Approx. Extent: | 1205 M2 | Score: | |
| Product Type: | Bitumen | I | |
| Condition: | Fair | I | |

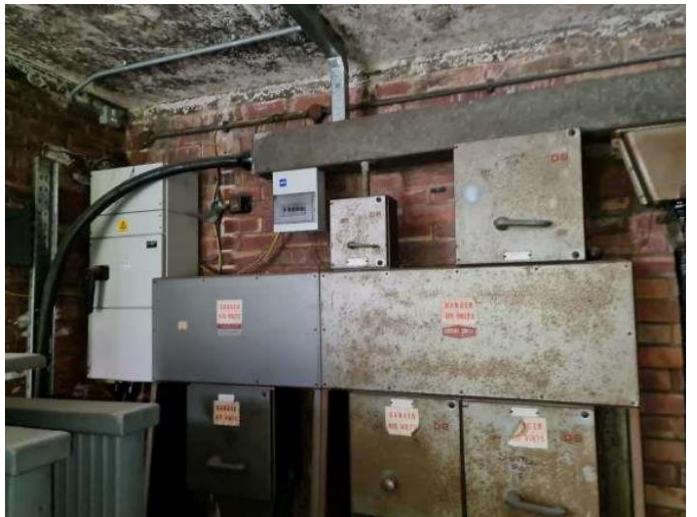
| Item: | Electric Boxes | | |
| Approx. Extent: | 6 Units | Score: | |
| Product Type: | Woven | I | |
| Condition: | Fair | I | |

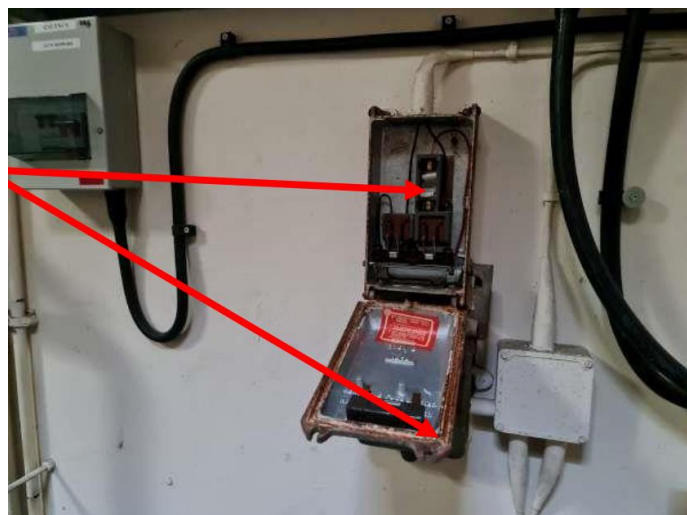
| Item: | Electric Boxes | | |
| Approx. Extent: | Throughout | Score: | |
| Product Type: | Woven | I | |
| Condition: | Fair | I | |
