Mosley Street

## Proposed Elevation - Princess Street - Repairs

PROJECT REF. 1995  
DRWG NO. P(223)  
REVISION  
SCALE 1:100 @ A3  
DATE 1st May 24  
DRAWN HW

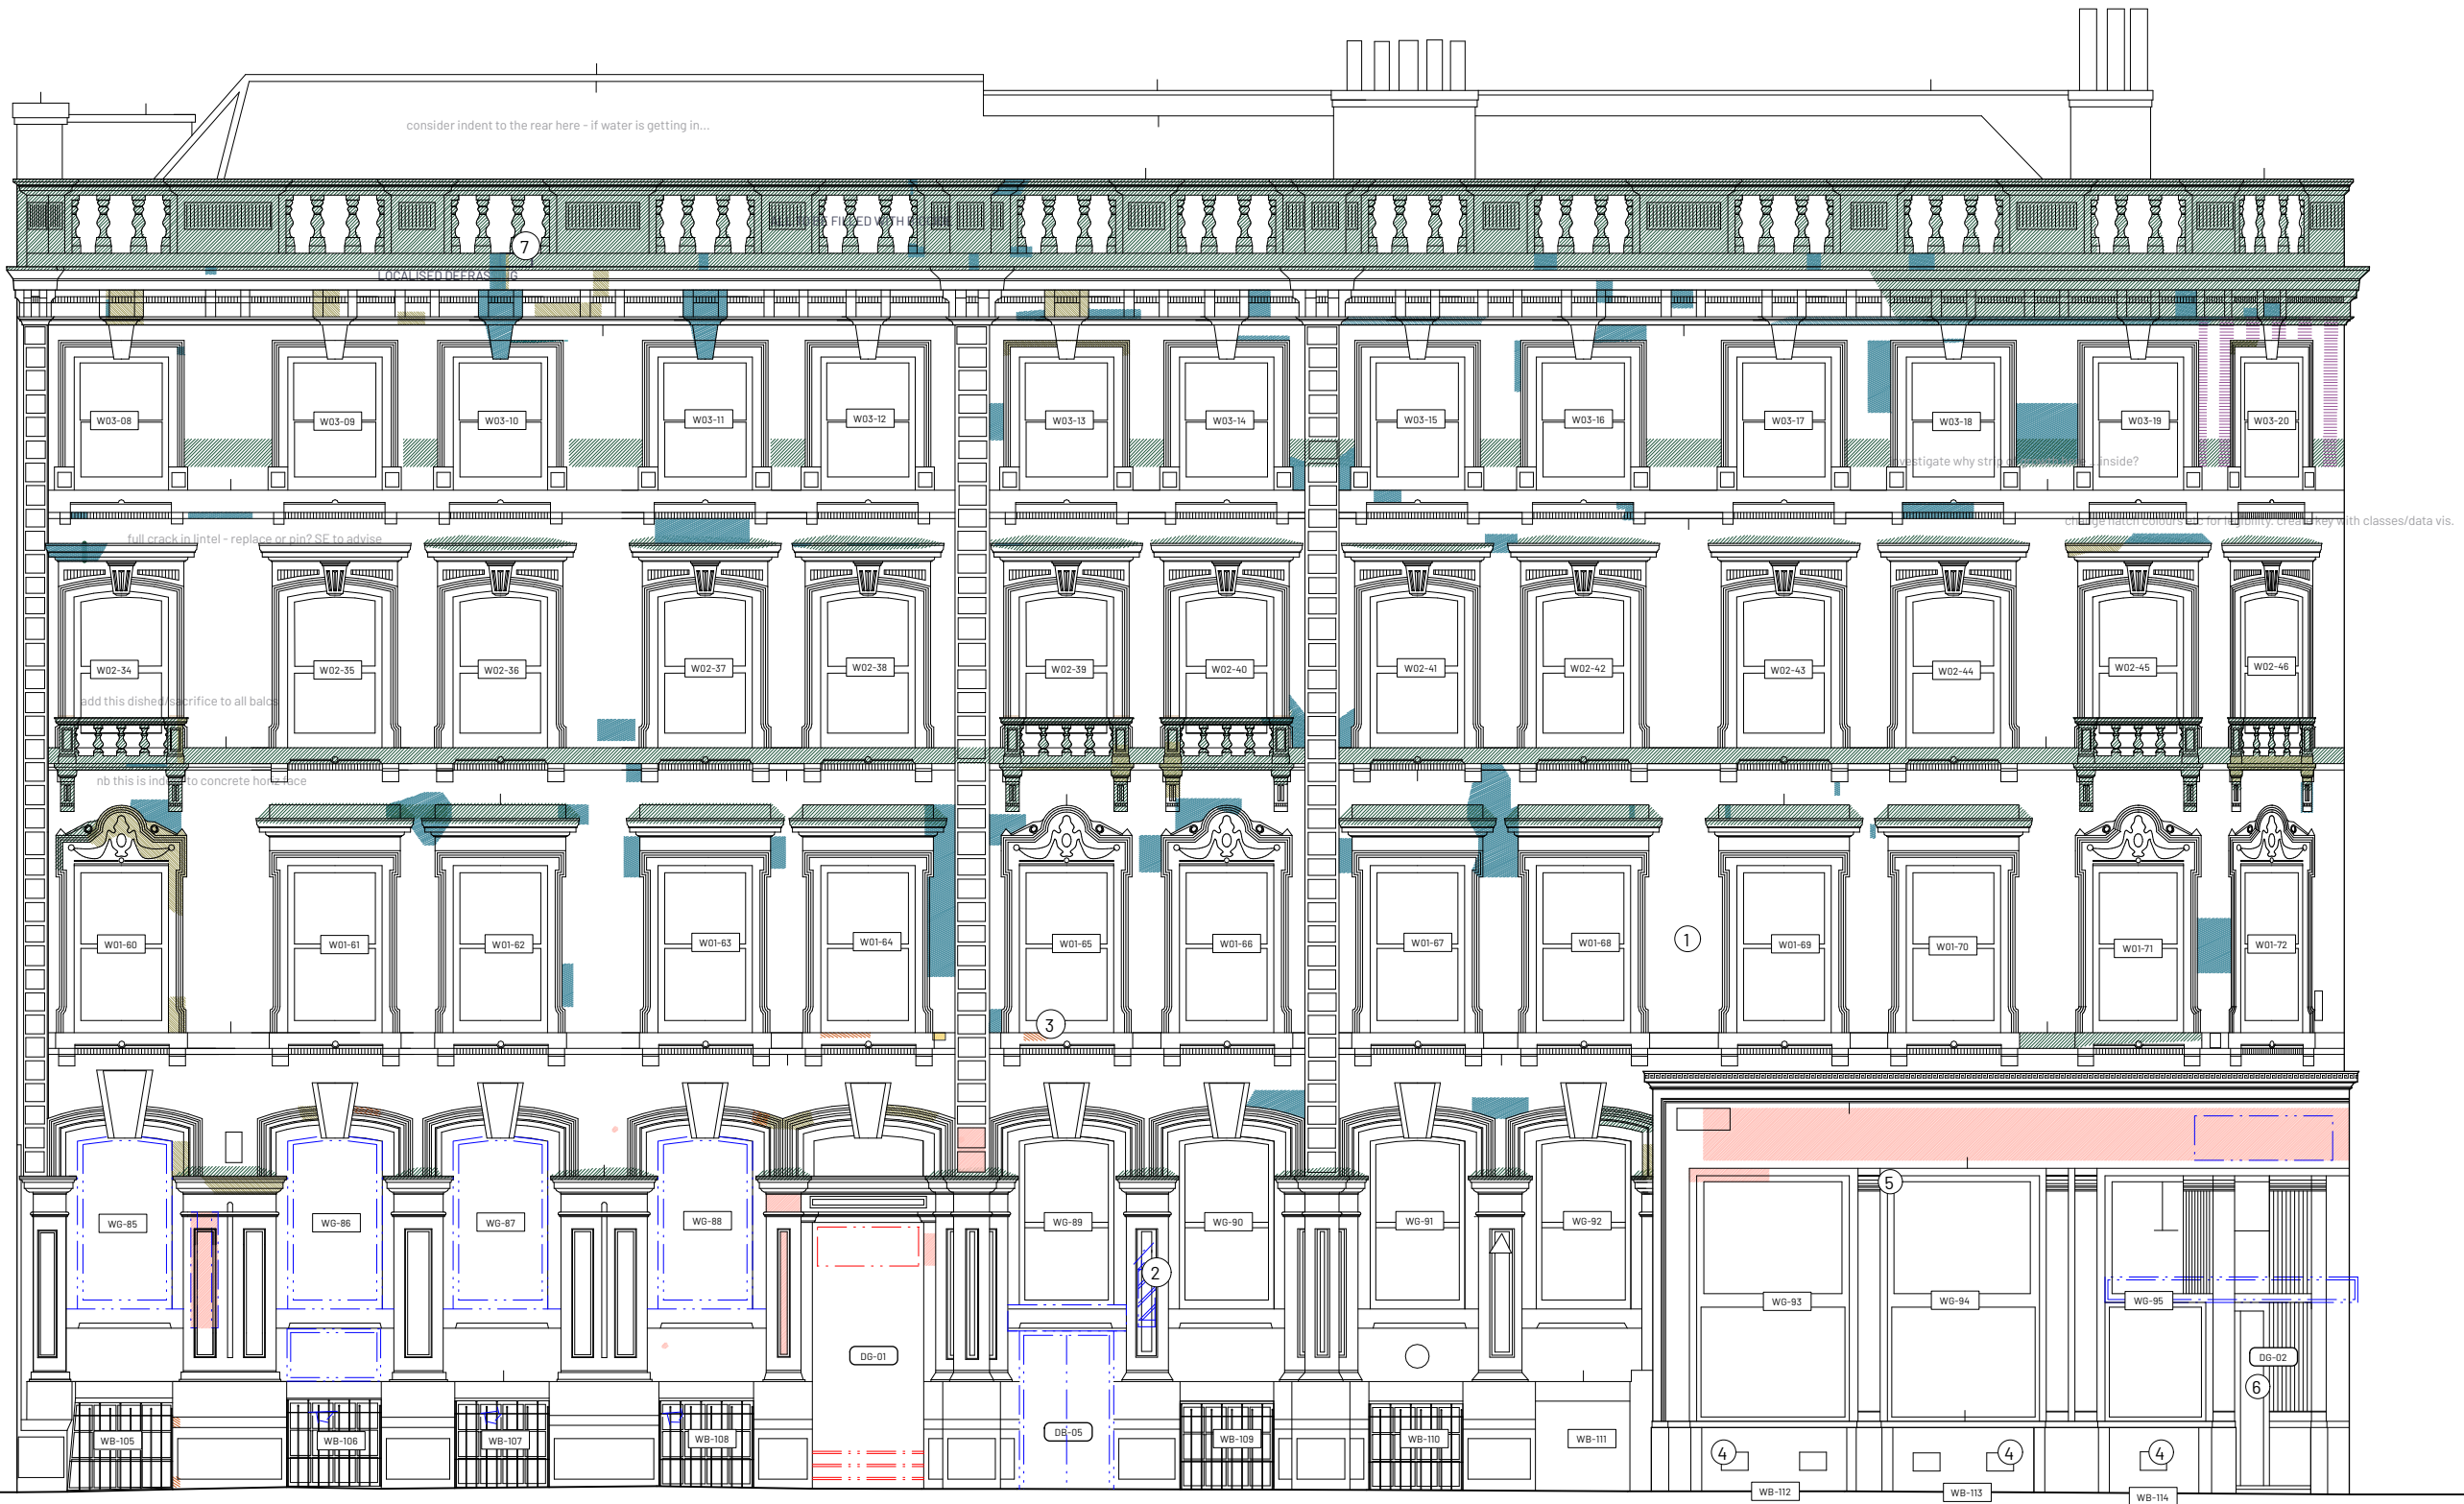
- Various areas of concrete fill to redundant fittings. These do not appear to be causing harm to surrounding fabric. Leave but observe.
- Signage to be removed and fabric beneath made good to match existing.
- Consider stone indent - however, extent of erosion given age is not extensive.
- Replacement air grill to match elsewhere.
- Timber frames - clean off peeling finish.
- Cleaned off adhered material/adhesive
- Large piece of stone missing behind - indent only required if water ingress locally.

- AtMB - Repair -Remove biological growth
- AtMB - Repair -Replace brick
- AtMB - Repair -Repointing
- AtMB - Repair -Stone indent or sacrificial mortar fill
- AtMB - Repair -Stone indent repair
- AtMB - Repair -Remove loose hard mortar with brush
- AtMB - Repair -Clean to remove guano deposits
- AtMB - Repair -Cracked brick. Mortar fill.
- AtMB - Repair -Mortar fill redundant fixing hole
- AtMB - Repairs -Clean off graffiti paint
- AtMB - Repair - Descale
- AtMB - Repair -Structural repair to S.E. details
