# Design Note

Project SIM - Gantry Conservation  
 Subject Conservation Philosophy  
 Project no 054704  
 Date 28 June 2023

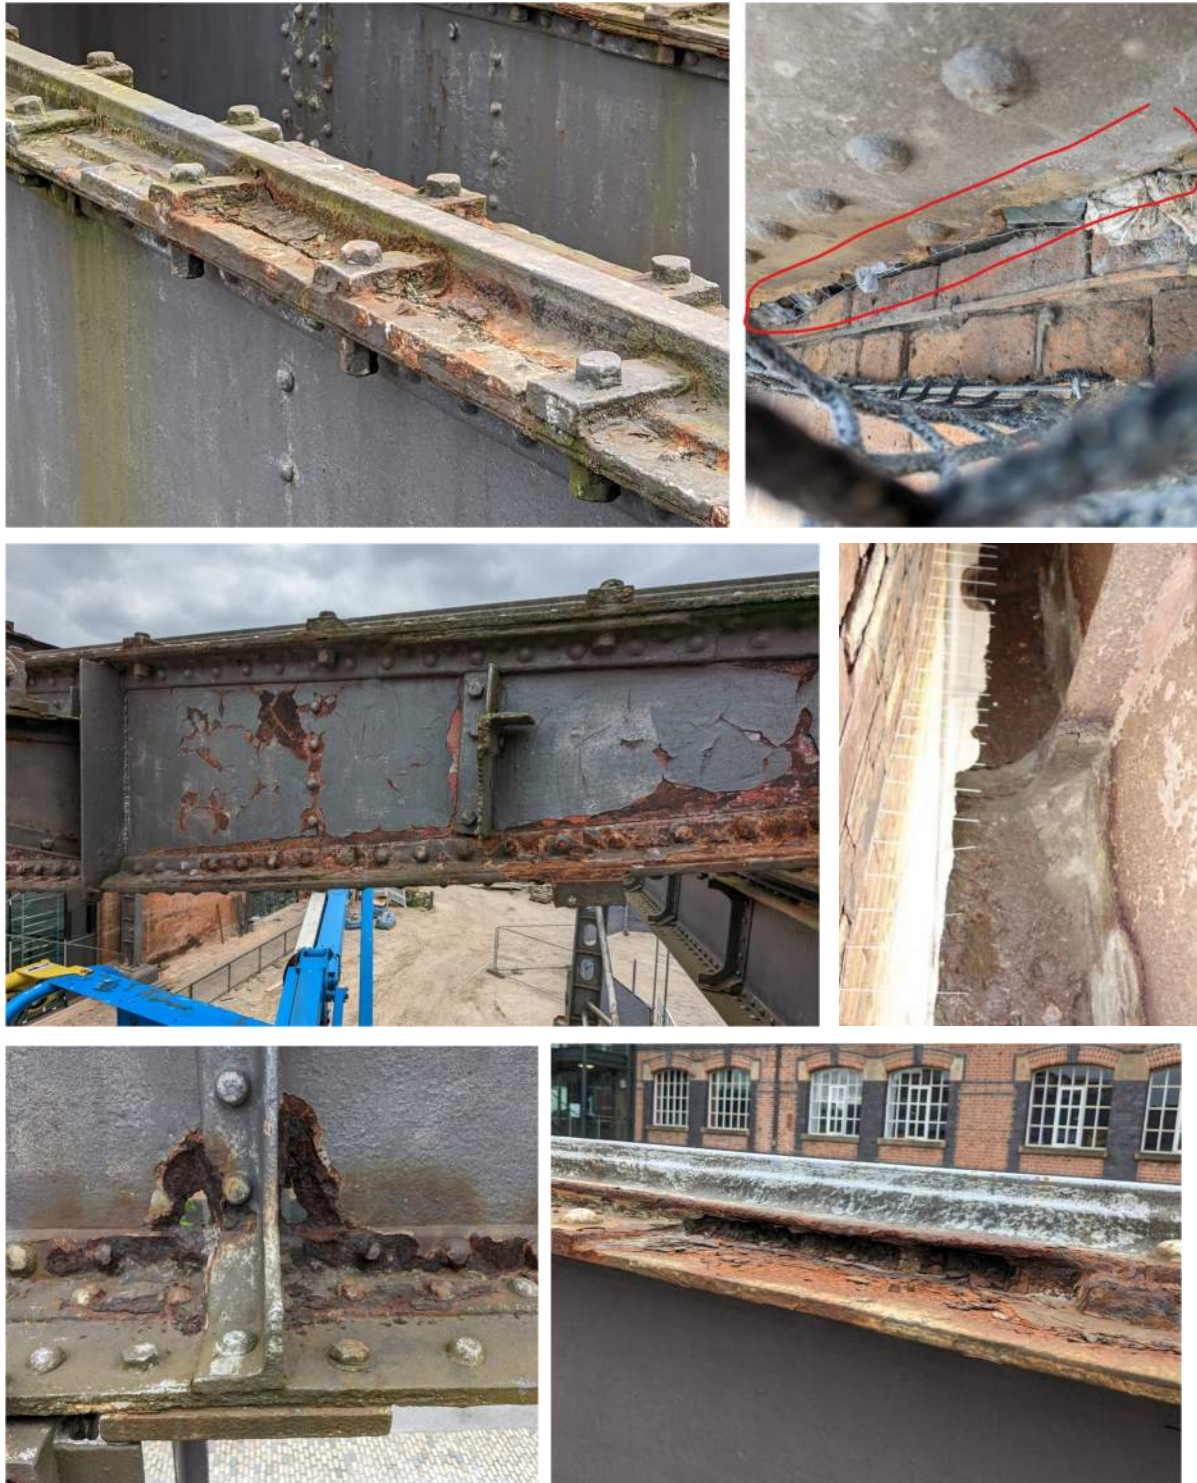
Figure 2-1 Typical examples of corrosion from structural survey

- The Gantry superstructure is widely corroded due to failed paint coatings. The severity of corrosion varies. In some places the level of corrosion is judged to have led to a reduction in structural capacity. In other areas corrosion may be less significant, but unless addressed will lead to future problems. See Figure 2-1 for examples.

- Longitudinal Gantry beams show widespread evidence of corrosion, ranging from minor surface corrosion to localised severe corrosion and loss of structural capacity. Corrosion can generally be grouped into 3 types:

- Southern face of south beams. Severe corrosion of the top and bottom flanges has reduced the section width by up to 50mm.
  - Lower part of beam web, at stiffener/column head locations – south and north. These areas appear to have trapped water leading to moderate/severe corrosion in most instances along the length of the beams.

- Top face of the beams – south and north. Moderate/severe corrosion is present across the Gantry in these locations, particularly affecting the rail section which allows movement of the crane beams.

- The 4 no. crane beams also show widespread corrosion, ranging from minor to localised severe cases, which can be categorised into 3 types:
  - Moderate/severe corrosion to the lower section of the beams along their full length. Similar to the Gantry beams this typically affects the angle which connects the web to the bottom flange, but also includes corrosion of the web and flange themselves.

- Minor/moderate corrosion to the beam webs – particularly affecting the outside faces of beams 2 and 3.
  - Moderate severe corrosion to the top face of beams, with details as per the Gantry beams.

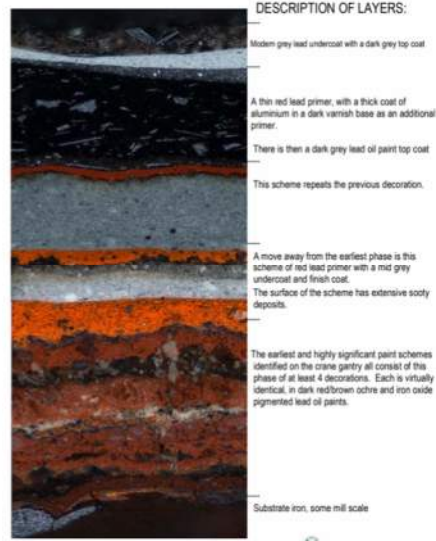
Figure 3-1 Paint sampling for Gantry beam

A properly installed, appropriately specified paint finish is the Gantry structure’s most important line of defence against corrosion and future decay. Failure of the current paint finish is the primary reason for the widespread corrosion present on the Gantry. It is understood that the last re-painting took place in the 1980’s, and as such it is not surprising that the existing paint covering has failed. Properly applied paint finishes typically have a design life of 20-25years, meaning that the finish applied in the 1980’s is c. 20 years beyond its anticipated design life. Paint sampling carried out for the Gantry shows that the 1980’s finish was also applied directly over the top of the previous paint layers which was likely detrimental to its longevity (see Figure 3-1).

All of the Crane Gantry samples showed the same surviving history or traces of, that tie in with the representative sample shown here.

To safeguard the Gantry superstructure against future deterioration a new paint coating is required. To achieve the maximum design life and reduce the risk of failures it is proposed that this should be applied onto the prepared bare metal of the Gantry, rather than over existing coatings. Failure to properly prepare the surface is likely to have a detrimental effect on the life of any applied coating, and it is unlikely that an adequate warranty could be provided for coatings applied over existing paint finishes.

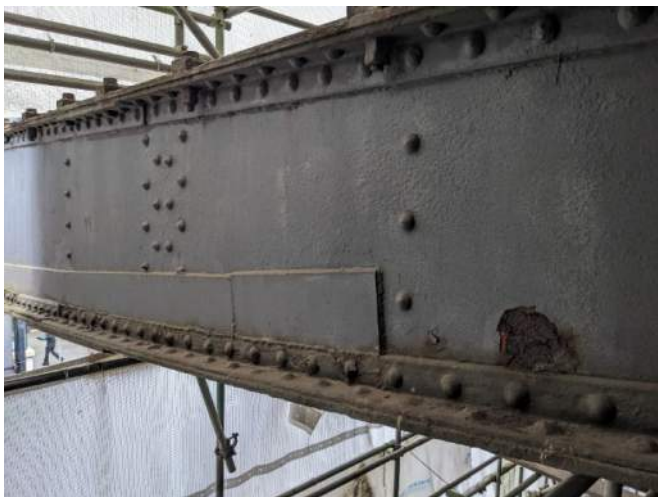
Figure 3-3 Typical example of previous repair

- There is evidence of previous repair work in several locations across the Gantry. These are visually obvious and would not necessarily be considered best practice by modern conservation standards due to the use of face-welded plates.

It is proposed that previous repairs are retained as part of the visual history of the Gantry structure. As there is no sign that these repairs are failing, there is no structural reason for their alteration. See Figure 3-3.

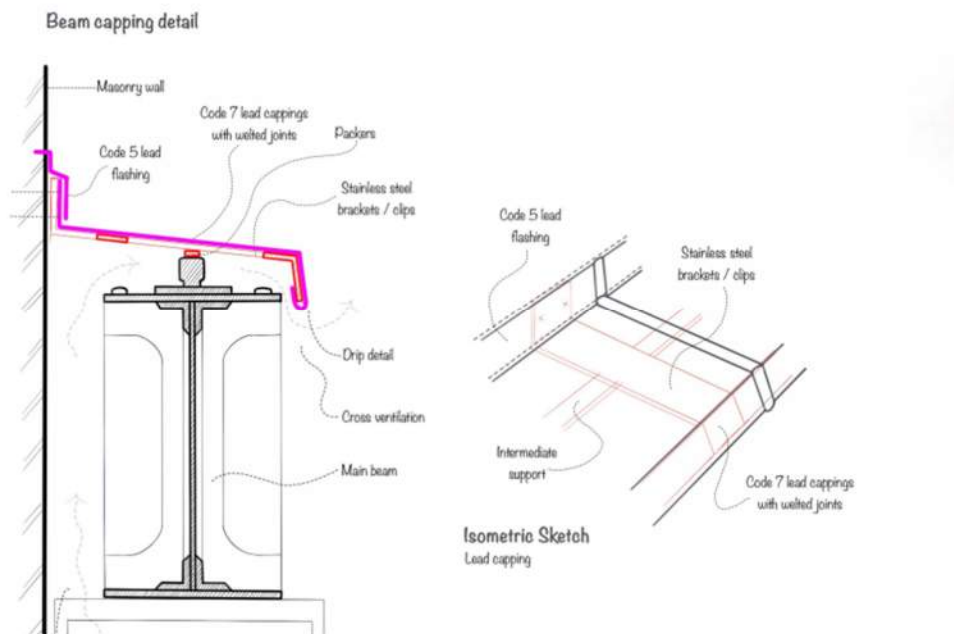
**Figure 3-4 Proposal for canopy to southern Gantry beam**

Much of the current corrosion has been exacerbated by details within the design of the Gantry which cause water to pool at certain locations. Two specific interventions are proposed to address this:

- New canopy to be installed to cover the southern Gantry beam to divert rainwater away from the superstructure. As the southern beam directly abuts the Power Hall's northern elevation applying coatings to the rear face is extremely challenging. This has led to widespread serious corrosion of the rear of the southern beam. Whilst it is judged that adequate structural capacity remains, stopping further deterioration is a priority and diverting water away from this area is the most robust way of achieving this. It is unlikely that this face will be able to be properly protected by painting and so diverting water away appears to be the most robust means to safeguard. Details of the proposed canopy are included in the architectural information, with an extract shown in Figure 3-4 below.

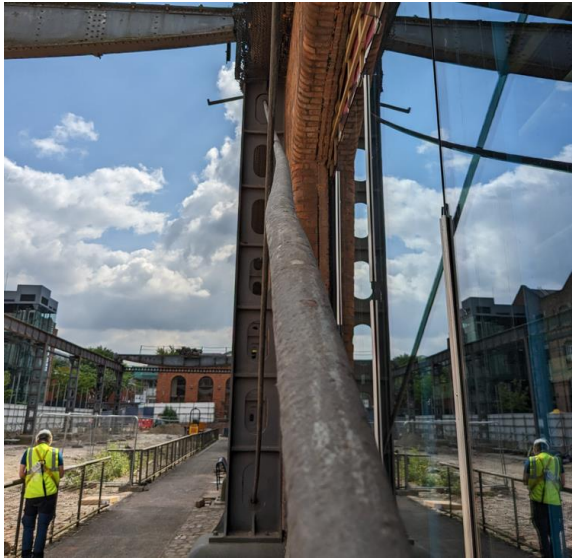
- Bracing to the southern columns shows signs of historic surface pitting but appears to be generally free from current corrosion. Braces are distorted along their length suggesting that they are no longer functional in resisting lateral loads, without first allowing significant movement. Figure 2-18.
- Bracing to the northern columns appears to be in good condition, with little sign of corrosion.

Figure 2-18 South cross bracing showing pitting & deformation

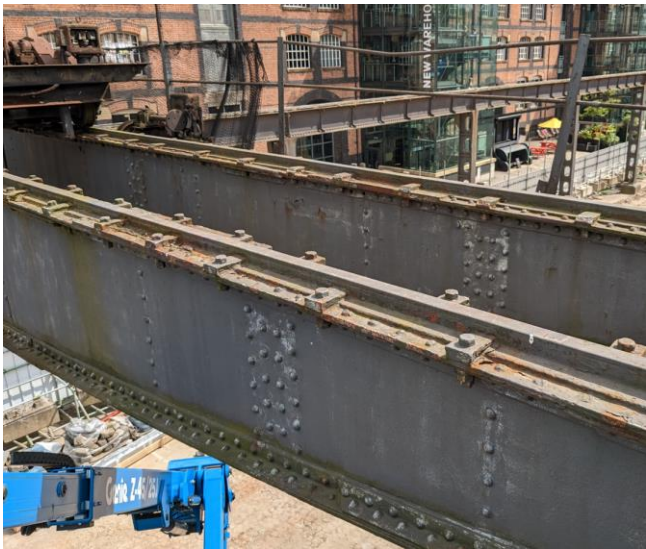
- As with the Gantry beams, the crane beams show widespread corrosion, ranging from minor to localised severe cases. Figure 2-22 to Figure 2-27
- 3 main types of corrosion are present on the crane beams:
  - Moderate/severe corrosion to the lower section of the beams along their full length. Similar to the Gantry beams this typically affects the angle which connects the web to the bottom flange, but also includes corrosion of the web and flange themselves.
  - Minor/moderate corrosion to the beam webs – particularly affecting the outside faces of beams 2 and 3.
  - Moderate severe corrosion to the top face of beams, with details as per the Gantry beams.
- Crane beams are understood to be hollow and the lack of drain holes means that they are likely to trap water, leading to internal corrosion. This is likely exacerbated by internal stiffeners which will trap water at various

Figure 2-22 Corrosion to top face crane beam

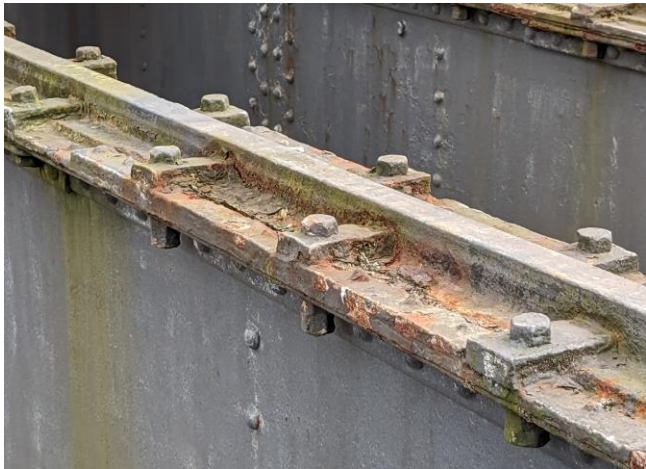
Figure 2-23 Corrosion top face crane beam

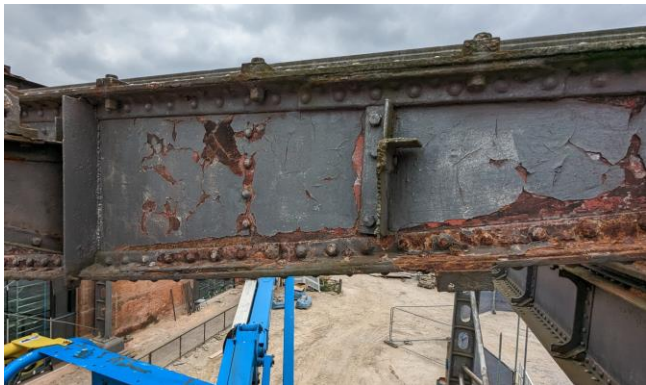
Figure 2-24 Corrosion to side face crane beam (western)

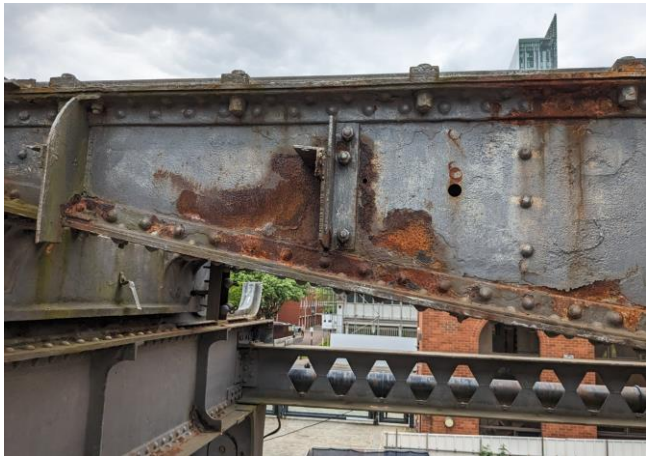
Figure 2-25 Corrosion to side face crane beam (eastern)

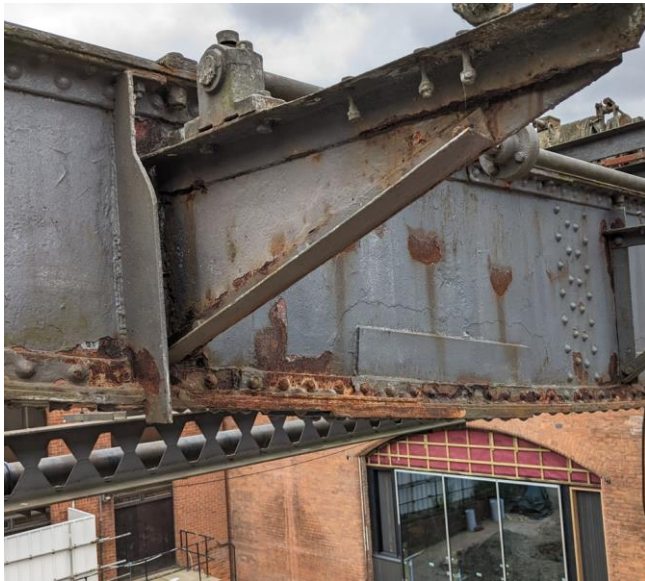
Figure 2-26 Corrosion to bottom of crane beam

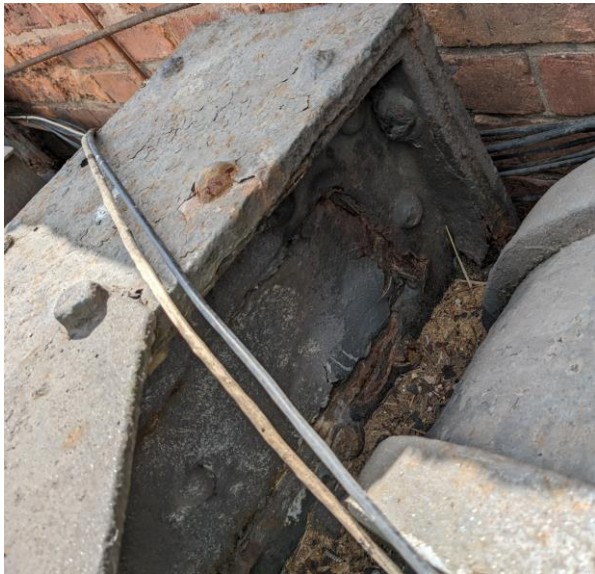
Figure 2-27 Crane beam end corrosion

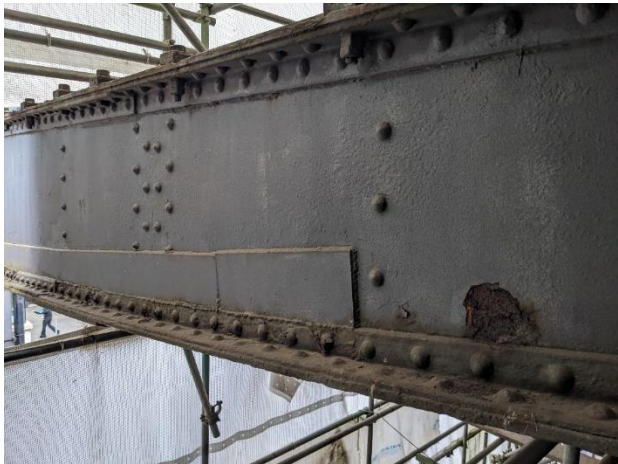
- Many of the crane beams show evidence of previous repairs. There typically include welded plates to replace lost sections of metalwork. It is worth noting that most of these repairs would not be considered to be appropriate for conservation work due to their appearance.

Figure 2-28 – Previous repair to crane beam

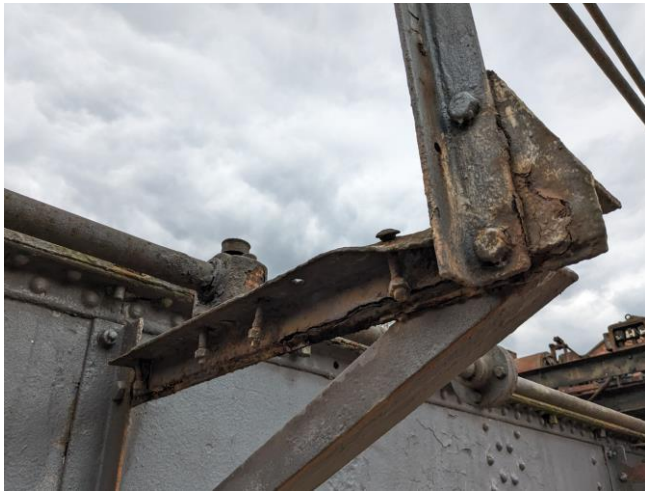
- The crane beams include several secondary structures including balustrades and lifting gear. Figure 2-29 & Figure 2-30.
    - Balustrades are typically in poor condition due to deformation and corrosion and can no longer considered to be functional. However, it is assumed that they no longer need to fulfil this function. Assuming they are retained as part of the exhibit they will require remedial measures to address corrosion.

Figure 2-29 Crane beam balustrade – corrosion & deformation

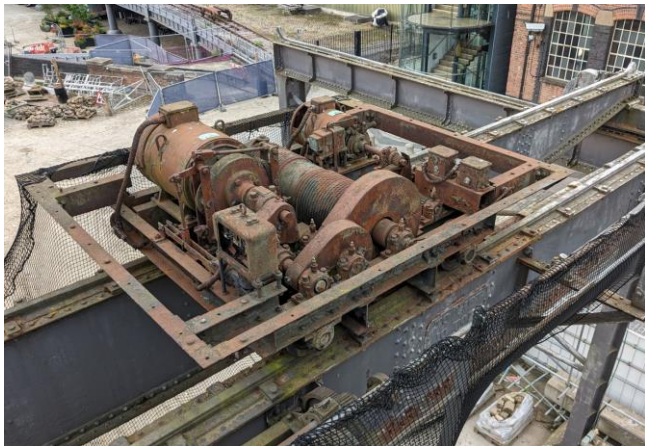
- The lifting gear appears to be sound, but with widespread minor corrosion. As the gear supports cabled hooks etc, it is suggested that this apparatus is inspected by a craneage specialist subcontractor who can advise on how best to preserve and make safe the gear.

Figure 2-30 Lifting gear to western crane beam

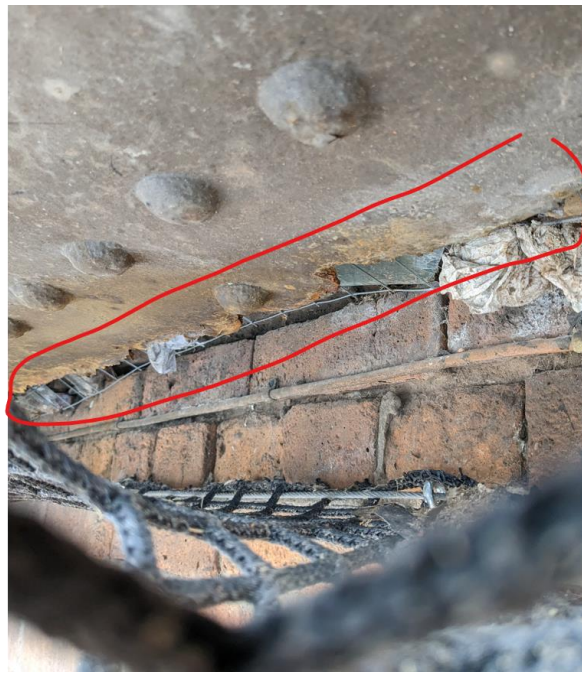
- width by up to 50mm. This is more prevalent at the western end of the Gantry, but is present across the whole length. Figure 2-31 to Figure 2-33.
- Lower part of beam web, at stiffener/column head locations – south and north. These areas appear to have trapped water leading to moderate/severe corrosion in most instances along the length of the beams. This typically affects the angle which connects the web to the bottom flange, but also includes corrosion of the web and flange themselves.

Figure 2-31 Severe corrosion & loss of section width – southern face of south Gantry beam, bottom flange

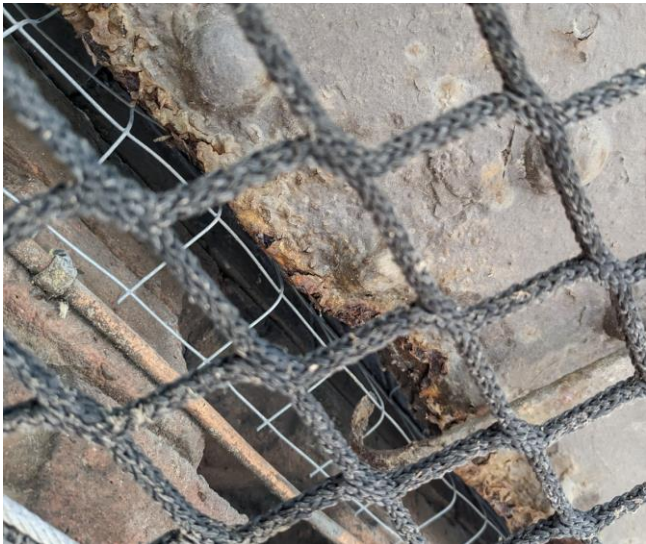
Figure 2-32 Severe corrosion & loss of section width – southern face of south Gantry beam, bottom flange

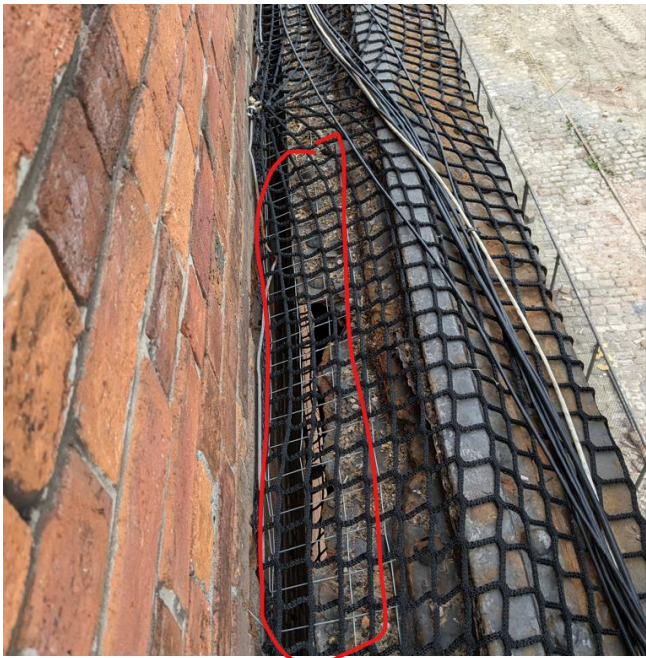
Figure 2-33 Severe corrosion & loss of section width – southern face of south Gantry beam, top flange

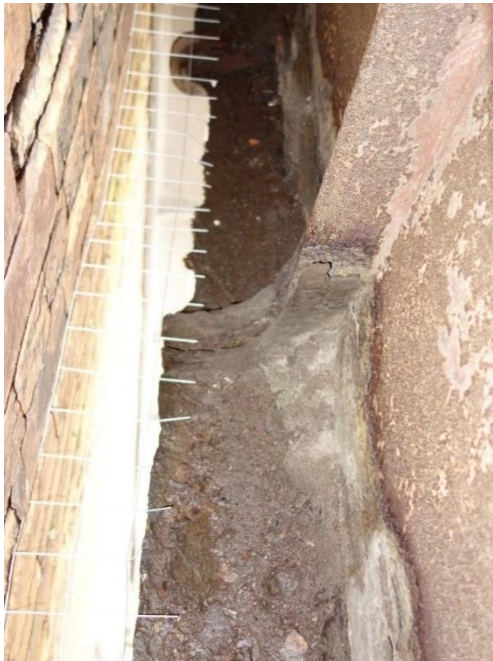
Figure 2-34 Corrosion and lack of protection to southern face of south Gantry beam

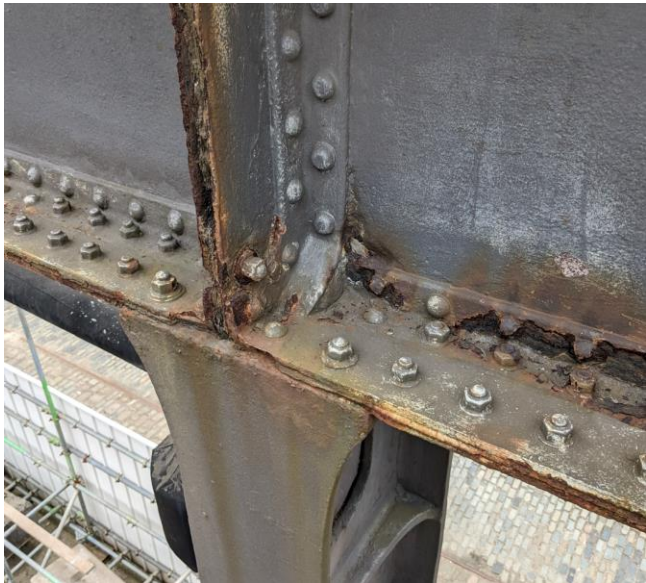
- Gantry beams show widespread evidence of corrosion, ranging from minor surface corrosion to localised severe corrosion and loss of structural capacity. Figure 2-35 to Figure 2-40.
- There are 3 main areas of corrosion to the Gantry beams:
  - Southern face of south beams. Severe corrosion of the top and bottom flanges has reduced the section

Figure 2-35 Typical corrosion to Gantry beam at column head

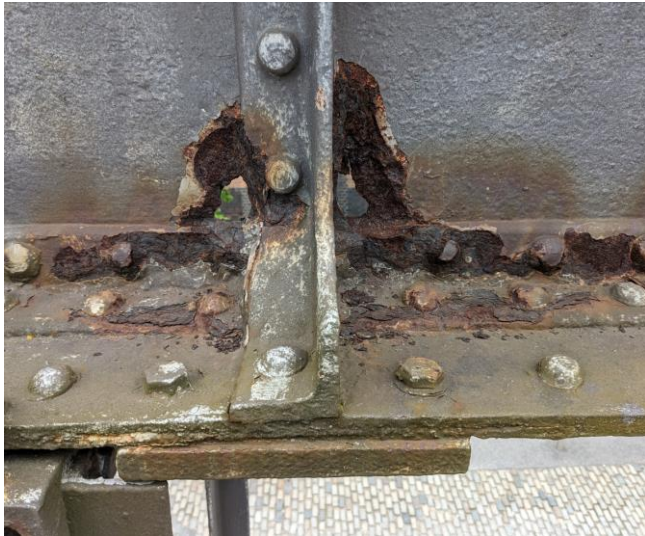
Figure 2-37 Severe corrosion to Gantry beam at stiffener

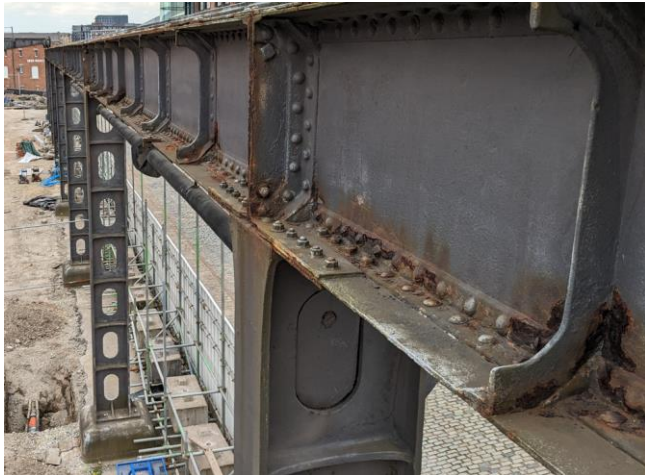
Figure 2-38 Typical corrosion to Gantry beam

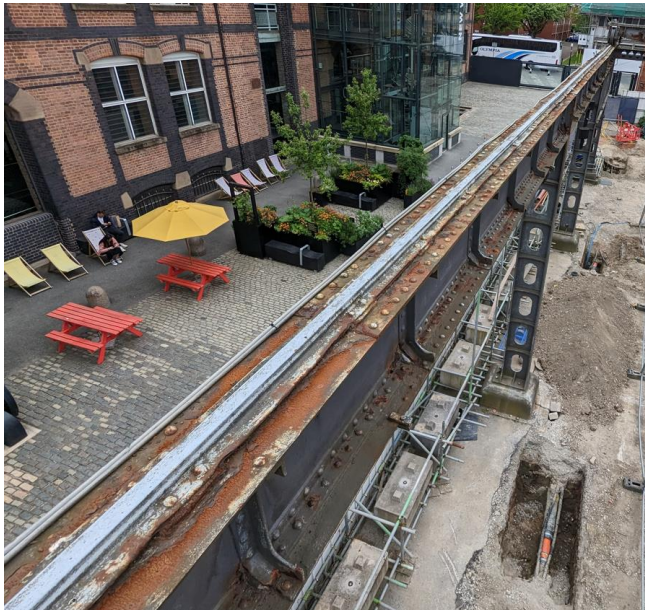
Figure 2-39 Typical corrosion to top face Gantry beam

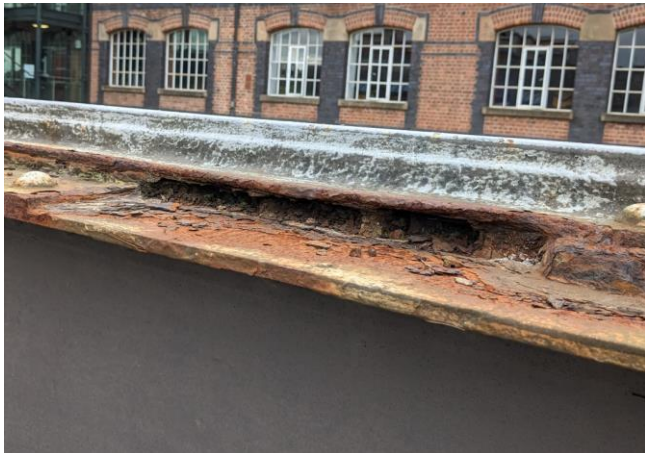
Figure 2-40 Moderate corrosion to top face Gantry beam
