## **Upper Camfield Market Hall, Barton Street, Manchester, M3 4NN**

### **Planning Condition – Bespoke Trigger No 5**

### **Contractors Response: -**

#### **Rational and current condition of existing gates**

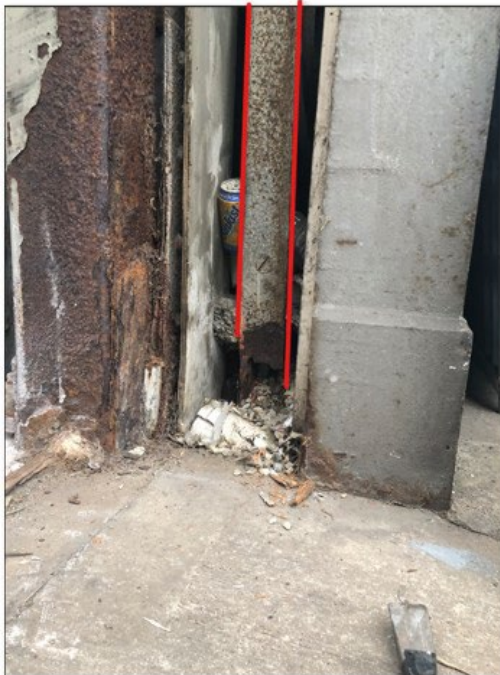
- The gates are currently inoperable and set in circa 100mm of concrete below FFL, and a further 100mm of concrete above FFL behind the plinth upstand.
- Evidence of rust at the base of the existing gates. (see below)

To restore functionality as per design intent we propose the following:

- Remove the excess (rusted) portion of the gate (circa 200mm) and bring in line with FFL and ramp level.
- The desired level of alteration uses the existing architectural language of the adjacent railings which it shares its resemblance with. (green line in snip below)
- The specialist designer proposes to fix to the underside of the cast iron rail with new fixings and attach a bottom section in mild steel with new wheels that can support the weight. An additional track is to be installed at the top for additional stability and safety of use.
