King Street Chambers  
Manchester  
Roof Repairs

### Elevation 3

| DRWG NO. | P(202) |

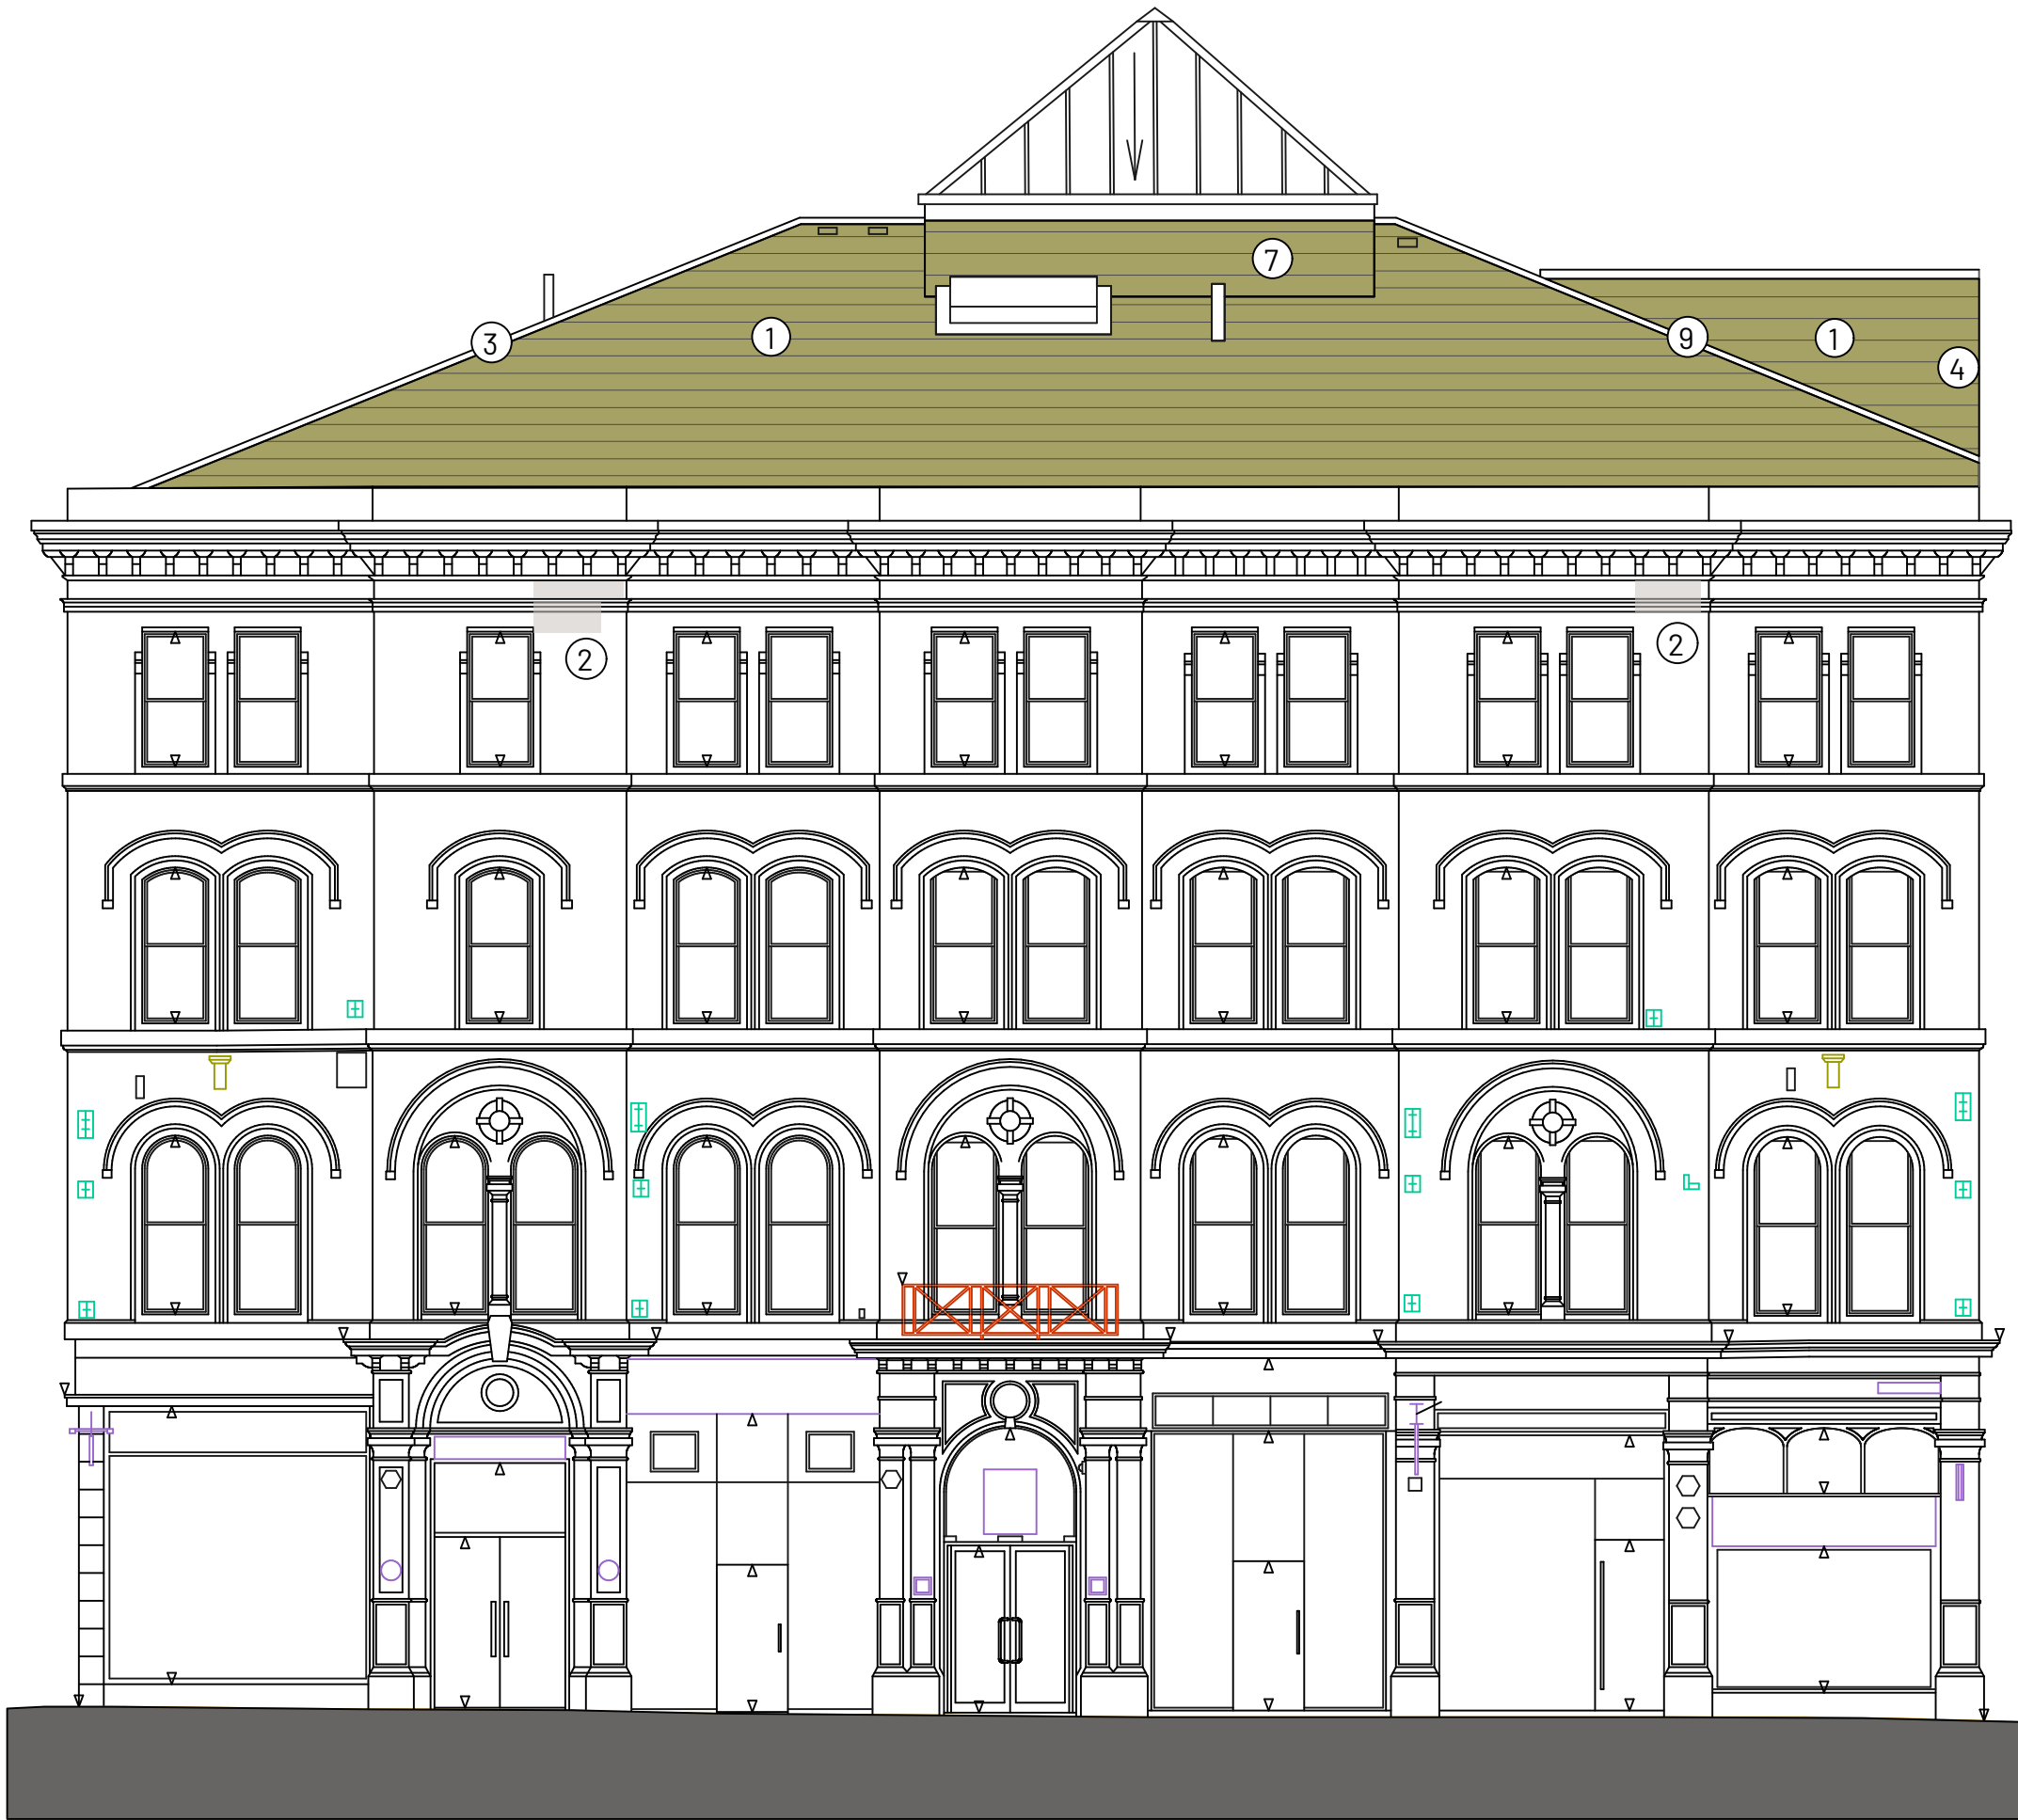
### Elevation 3

All timber sash windows on First Second and Third floors to be prepared and repainted externally. All external sealant to be replaced.  
Stone dentil and cornice to be inspected following water damage and areas of delamination to be repaired

- Existing cementitious slates and sarking to be replaced with breathable sarking and natural slates. All roof penetration seals and flashing to be renewed.
- Delaminated stone to be patch repaired
- Existing hip tiles to be replaced with lead roll hip with soakers
- Existing lead stepped flashing to be removed and replaced with new Code 4 lead stepped flashings.
