Gas Membrane Installation  
Validation Report  
Alan Hong  
23 Bosworth Street  
Manchester  
M11 3AW

## Appendix 1 – Site Survey Sheets

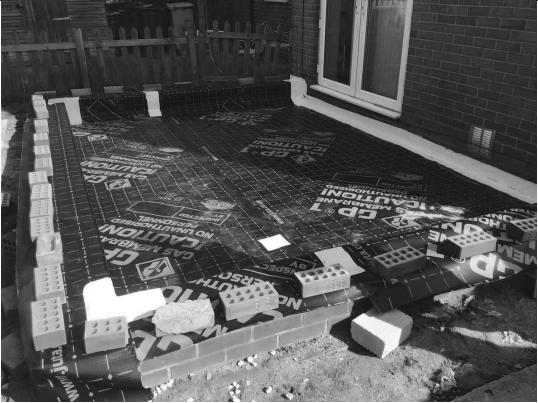
Overview to extension line out installation

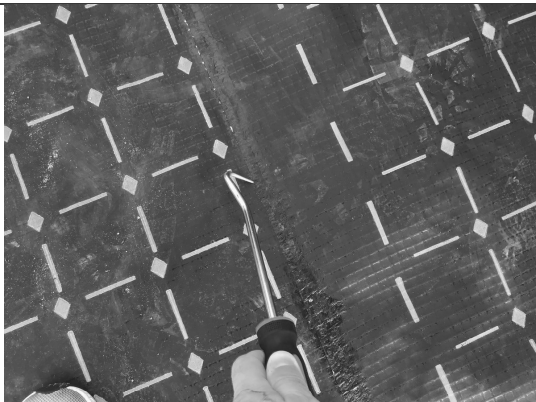
| Housebuilder Name: Alan Hong | | Date: 19/07/2024 | |
|---|---|---|---|
| Material Jointing Method: The membrane has been overlapped sufficiently to achieve a sound joint, the joint is clean and dry and has been joined by means of hand welding with a hot air gun and neoprene roller, the width of the welded joint is a minimum of 30mm. | | | |

Probe testing hand welded membrane lap joints

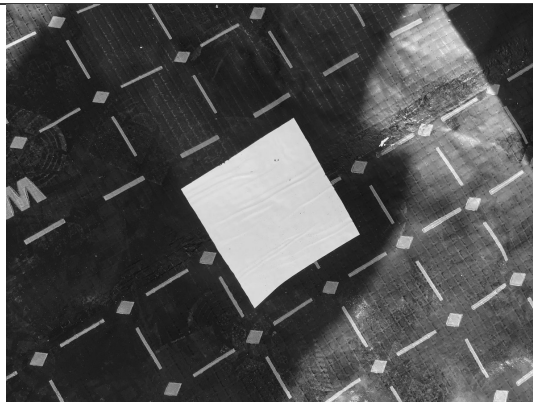
Sealed patch repair made under the installers CQA using Juta GP SAM

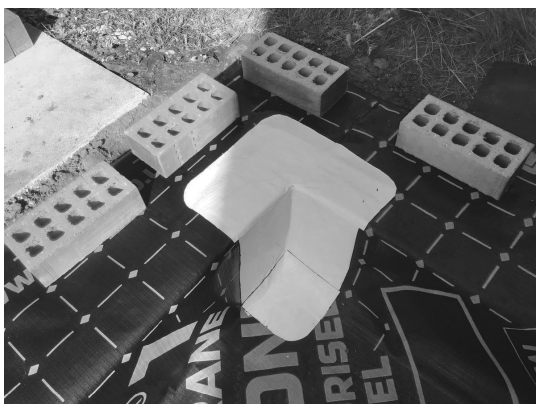
| Housebuilder Name: Alan Hong | | Date: 19/07/2024 | |
|---|---|---|---|
| Corner Seal Method: Corners have been sealed using strips of self-adhesive gas membrane, this is an approved and recognised method in CIRIA C735 | | | |

Corner detailing sealed using Juta GP SAM

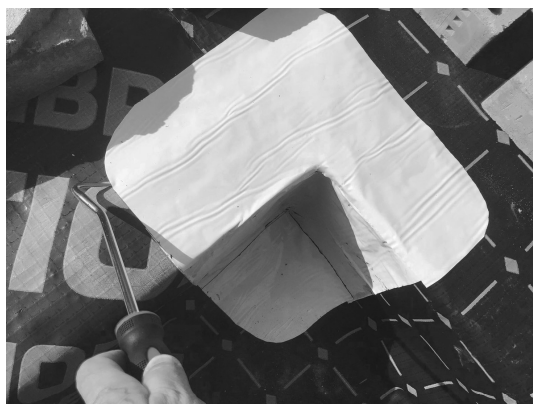
Probe test to corner detailing

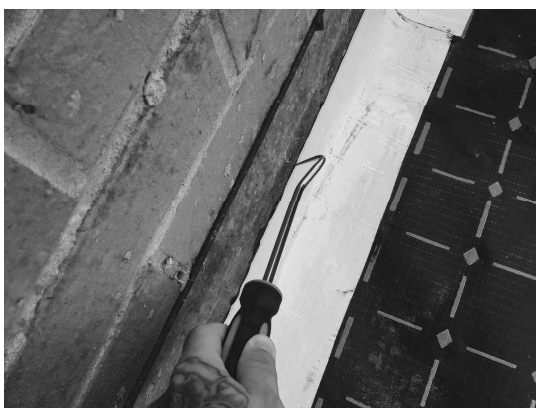
Probe test to retro fit detailing

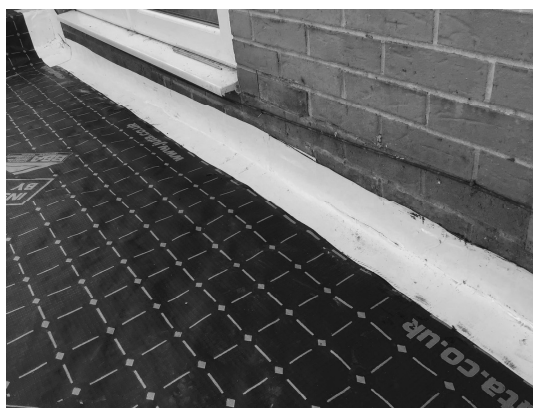
| Housebuilder Name: Alan Hong | | Date: 19/07/2024 | |
|---|---|---|---|
| Others Please List: Retro fit detailing carried out sealing the membrane to the existing building using Juta GP SAM and heat applied to the pre primed brickwork | | | |

Retro fit detailing sealing the membrane onto the pre primed existing wall using Juta GP SAM
