| SIM, Combined Projects | | |
| Proposed Gantry Repairs - Repair 2 | | |
| 585-02 | | Construction |

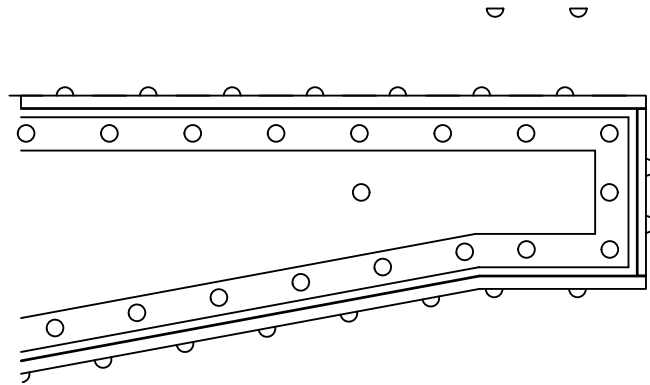
Detail 1 - Original detail

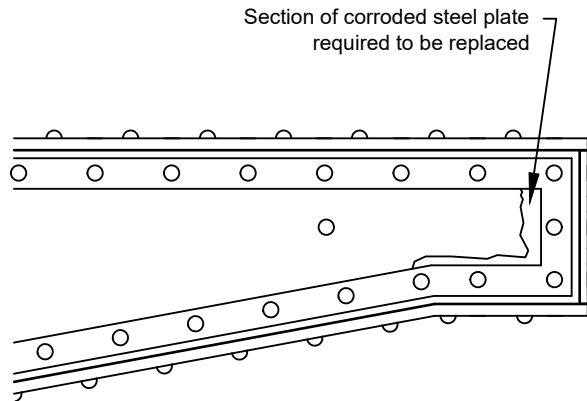
Detail 2 - Current condition

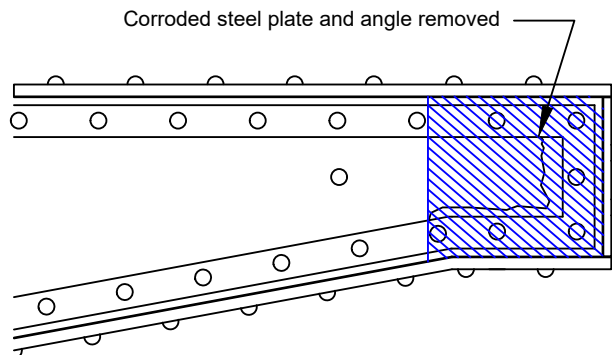
Detail 3 - Section of existing steel to be removed

1. Length of material removed in each location varies from circa 250mm to 750mm. Exact length to be confirmed onsite as removal is completed.
2. If repair continues past stiffener these will be reinstated with full structural capacity
3. Following removal of corroded plate exposed internal beam areas will be blast cleaned, primed and painted before reinstatement commences.
4. Load path of repairs is through welds. Welds used are butt weld and fillet weld as per methodology.
