# PICCADILLY WAREHOUSE, MANCHESTER

## Preliminary Bat Roost Assessment Report

*June 2024*

*Project Name:* Piccadilly Warehouse Manchester  
*Project Reference:* CW20-1659  
*Report Title:* Preliminary Roost Assessment Report  
*Report Reference:* CW20-1659 RPT 001  
*Printing Instructions:* Print at A4 Portrait, Double Sided.

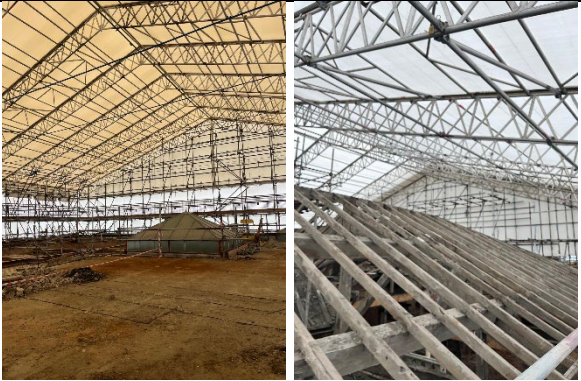
3.2.2. Both buildings consisted of five floors with an open and accessible roof space, the roof space of both buildings was made up of scaffolding and covered in sheets.

| <p>Top scaffolding area of both buildings</p> | |

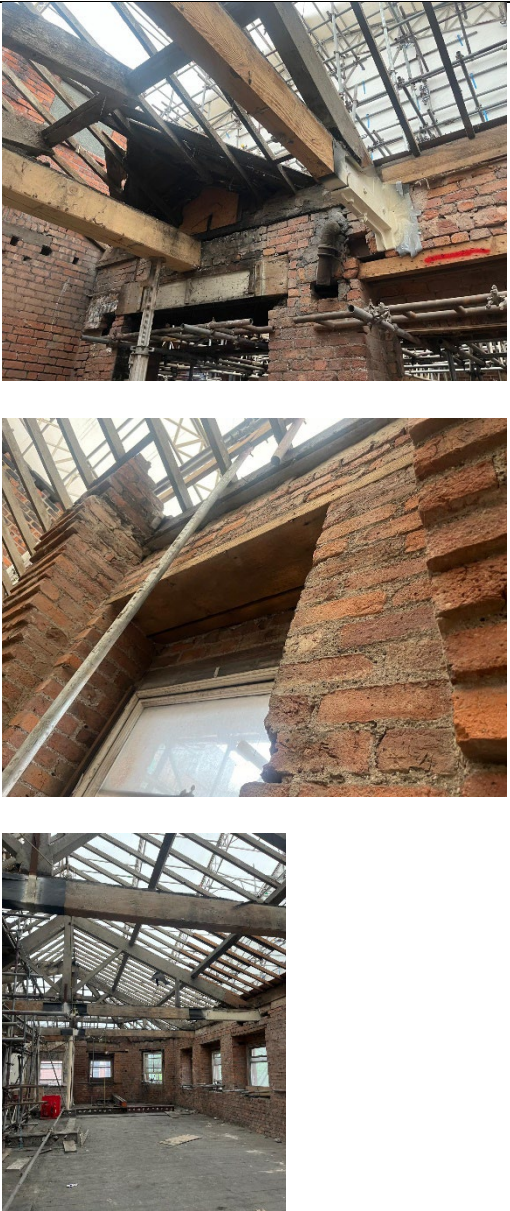
| <p>B1</p> | |

3.2.5. B1 consisted of exposed brickwork along the top floor due to the previous works that had ceased on site. The exposed brickwork created small gaps throughout the walls, these were identified as a PRF.

3.2.6. The windows throughout the top floor of the building were not in a state of disrepair and did not provide access points into the building. The window frames were found to be in poor condition internally and small gaps were located surrounding the windows. These were identified as a PRF.

3.2.9. A previous, assumed lift vault was located throughout the centre of the building and was surrounded by scaffolding. The brickwork was exposed where holes were also identified, this was identified as a PRF. It was also noted that due to the scaffolding positioning, PRFs could have been missed.

- 4.1.2. It is recommended that the survey is undertaken internally along the top floor, where bats are able to access the PRFs due to the scaffolded and sheet roof.

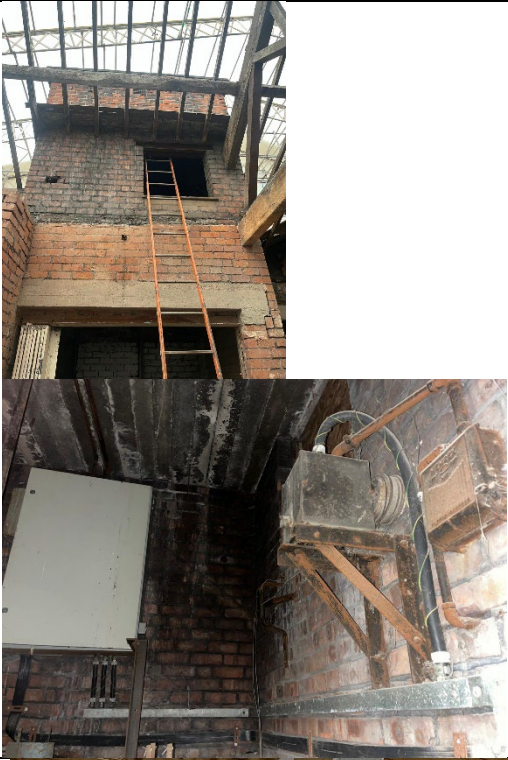
3.2.7. A small boiler room was located within the top floor with an access ladder. This consisted of a small room that could not be fully accessed due to the amount of bird faeces which was assessed as a health and safety risk. This was not considered a constraint to the assessment as the room was small and was fully visible. The room was well sealed and there were no roosting features identified from what it could be inspected. It is anticipated that this room does create a suitable nesting area for pigeons.

| <p>Boiler room in B1</p> | |

- 4.2.1. Nesting pigeons are anticipated to be present within the building. Pigeons were identified across the building and can nest all year round. A suitably qualified ecologist should undertake a nesting bird check no more than 48 hours prior to removal. If nesting activity is observed, the nest(s) should be left in situ until the young have fledged. A suitable buffer will be maintained and determined by the ecologist.

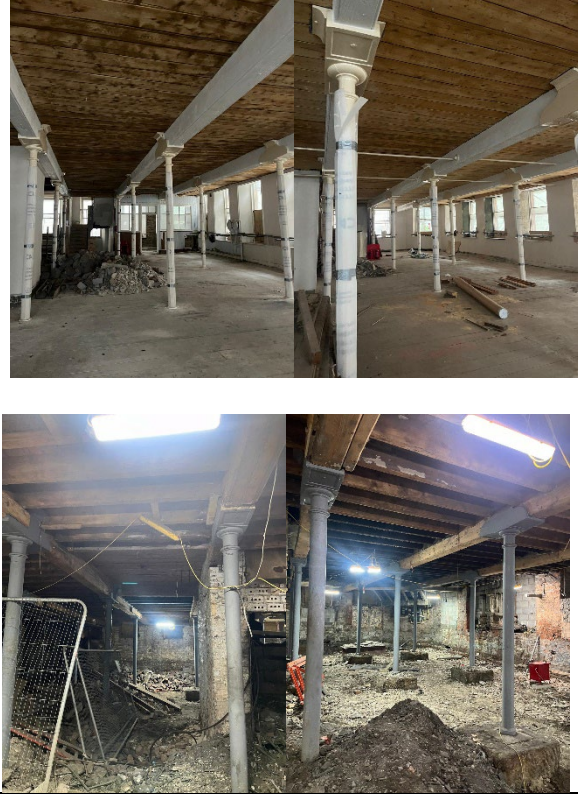
3.2.10. The remaining floors of the building and basement also had some exposed areas due to the previous works

3.2.11. The external walls and windows were sealed along the building providing limited access points to the internal aspect. Bats are not anticipated to access the remaining areas of the building due to the presence of the scaffolding and associated sheeting.

| <p>B1 Remaining floors.</p> | |

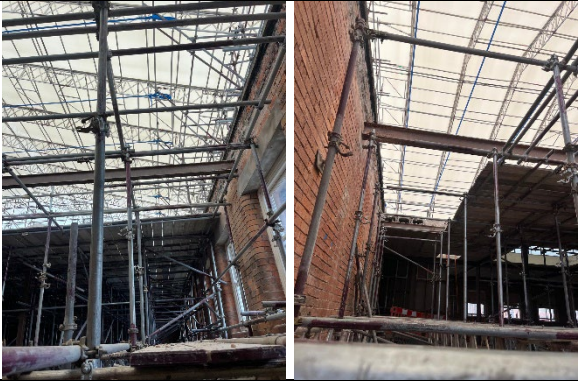
| <p>B2</p> | |

3.2.12. Internally, B2 also consisted of areas of exposed brickwork with some holes throughout the walls which were identified as PRFs. The scaffolding covered areas of the walls and it is anticipated that further features could have been present. The roof of the top floor was also open as identified in B1 with no secure roofing, this was also covered in scaffolding and associated sheets. Gaps between the scaffolding could also provide access points into B2.

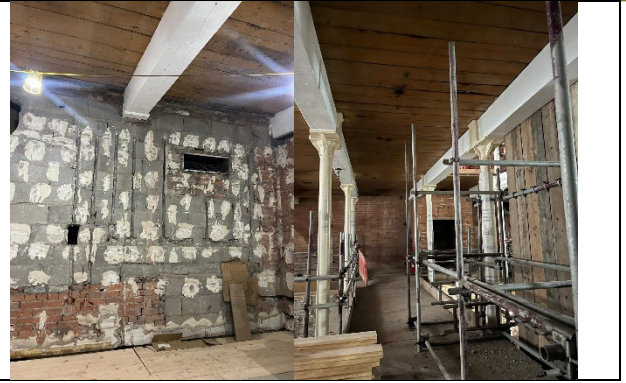
3.2.13. The remaining floors of the building had also previously been worked on with areas of exposed brickwork located throughout the building. The windows and main walls were well sealed with no obvious access points into these areas, bats are not anticipated to be present within the remaining areas of the building due to limited access points.

*B2 Remaining floors.*
