## **Arboricultural Assessment & Report**

20th July 2023

St Bede's College  
Alexandra Road South  
Manchester  
M16 6HX

Andrew McLoughlin  
Treestyle Consultancy Ltd  
[info@treestyleconsultancy.co.uk](mailto:info@treestyleconsultancy.co.uk)

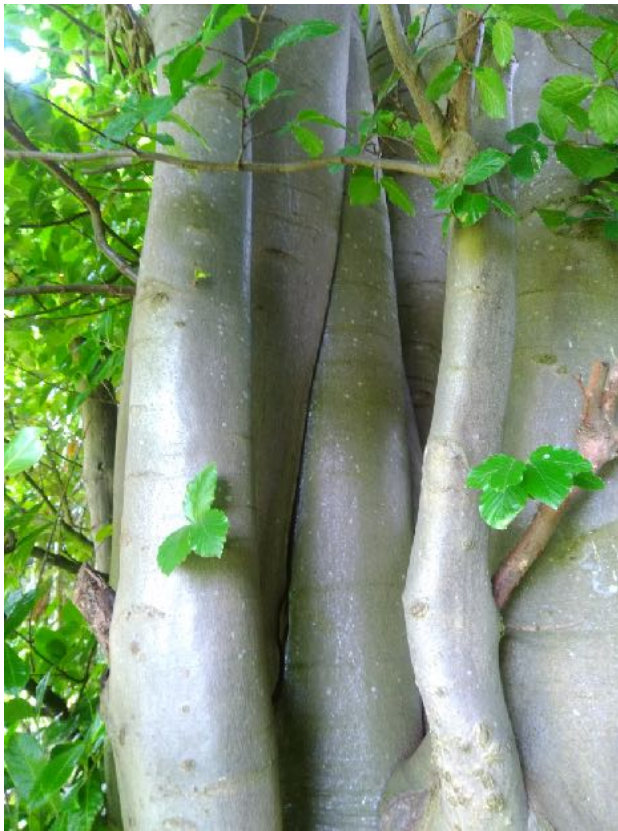
*Left is an example of a V union with bark inclusion on a beech tree. These mechanically weak structures have limited life potential. Whilst an upright form has reduced failure potential its proximity to targets must be identified and the level of risk assessed.*

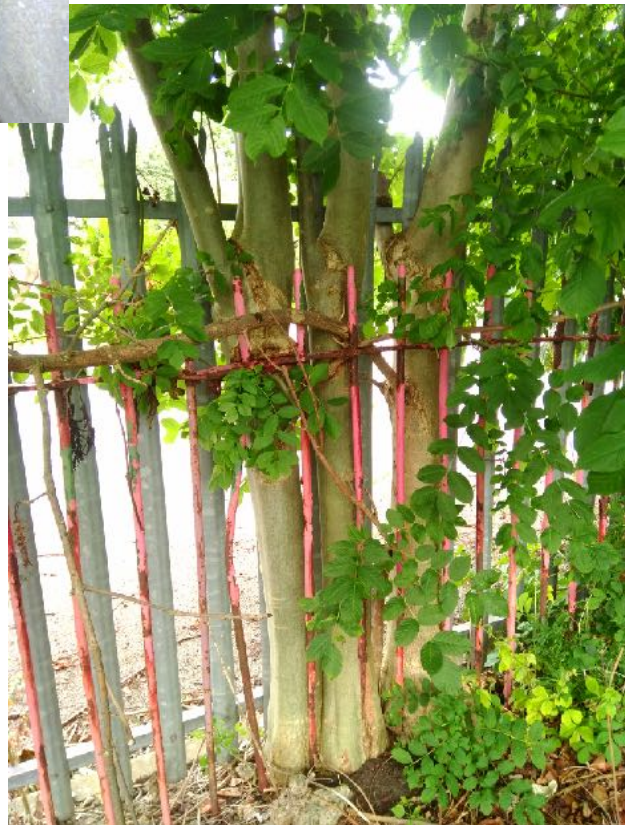
*Below can be seen self seeded trees growing through and damaging fencing. These too have limited life potential and have mechanically weak structures which will need to be managed accordingly.*

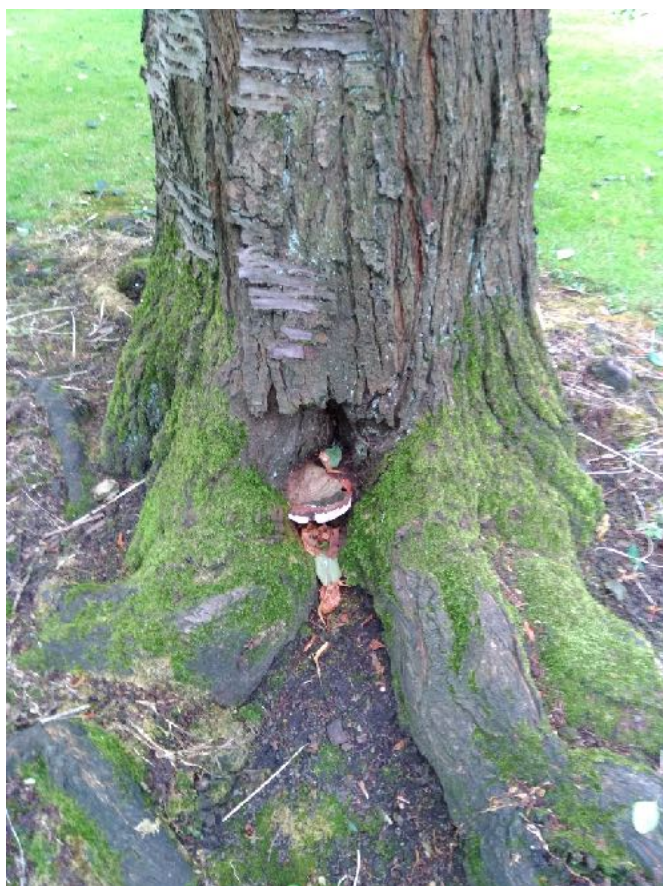
Left can be seen bracket fungi from ganoderma where biological infection will cause large areas of internal decay. Whilst not always an immediate risk of failure again the risk level with its proximity to a target must be assessed.

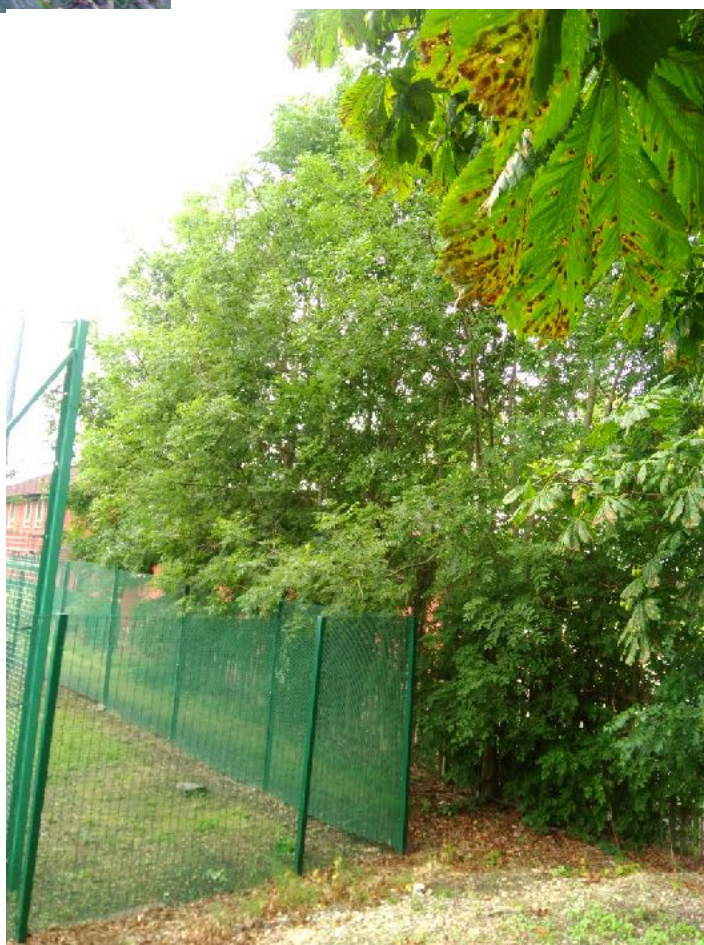
Below can be seen a group of third party ash trees with the initial stages of ash dieback (Hymenoscyphus fraxineus). Proactive management is essential in dealing with this disease.
