Project Title  
Castlefield Viaduct  
Phase 2

Drawing Title  
Remedials  
Transverse Beams  
Bearing Stiffeners

| ID | CVI-ARUP-ZZ-ZZ-DR-S-4001 | | |

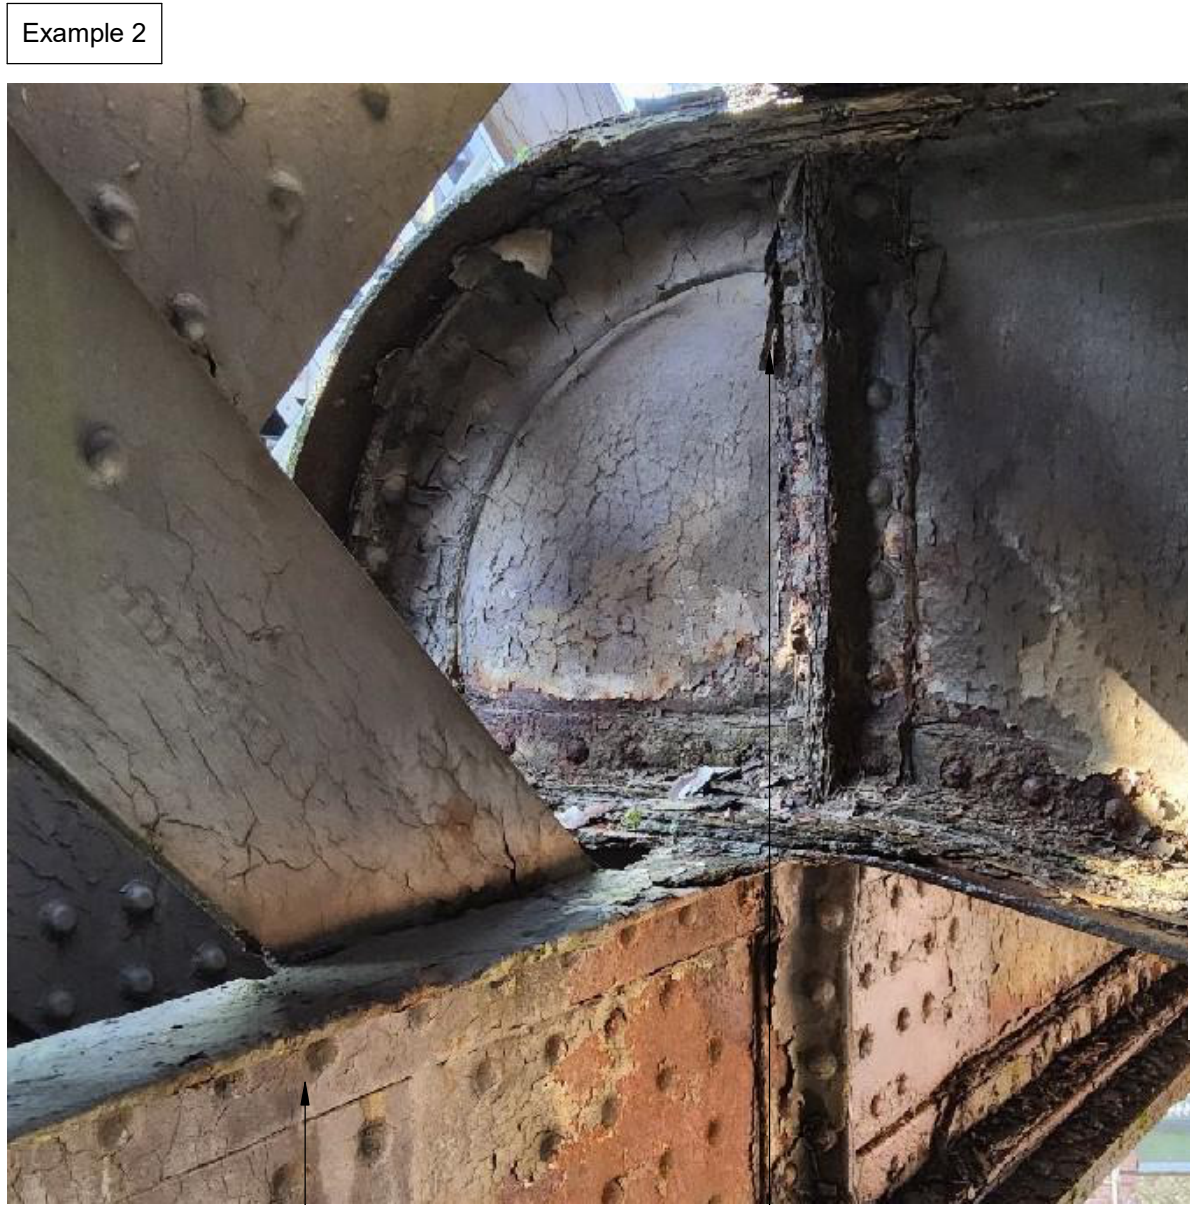
Lattice girder  
bottom chord

Corrosion typically where  
transverse beam extends  
beyond weathering  
protection of deck plate

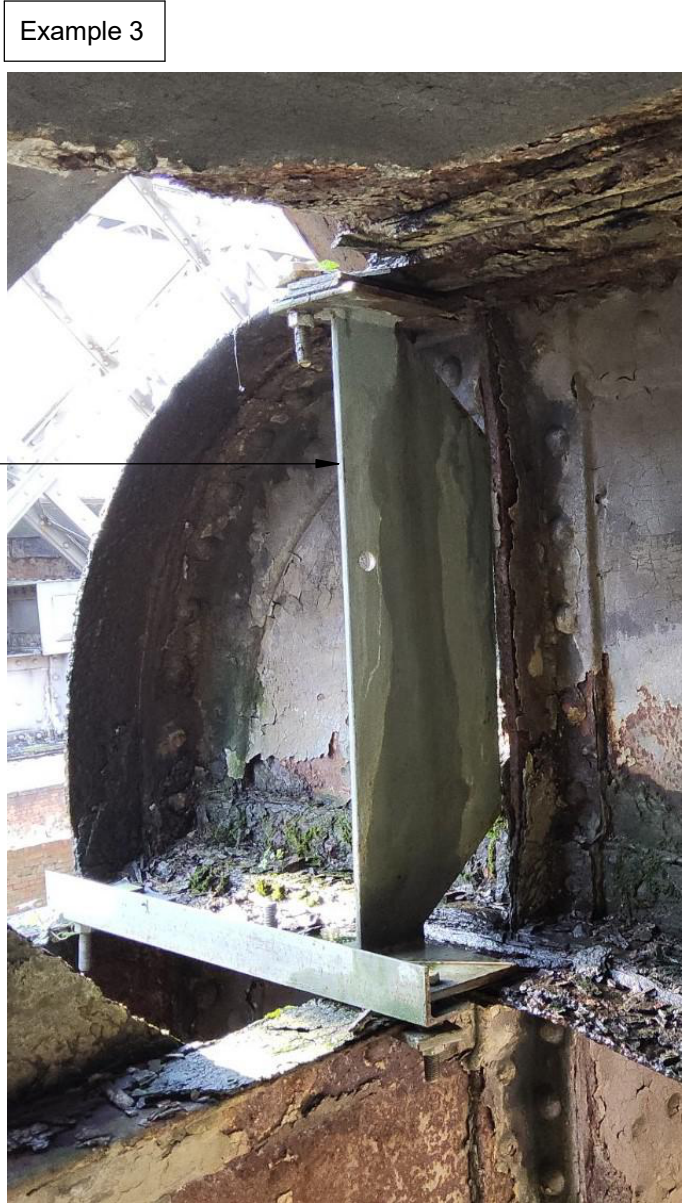
Remedial stiffeners installed  
during Ph1, to transverse  
beam (TB) ends as follows:  
- TB 25 - north and south  
- TB 27 - north and south  
- TB 29 - north  
- TB 35 - north  
- TB 36 - north  
- TB 37 - north  
- TB 38 - north  
- TB 39 - north  
- TB 40 - north  
(11No. total)

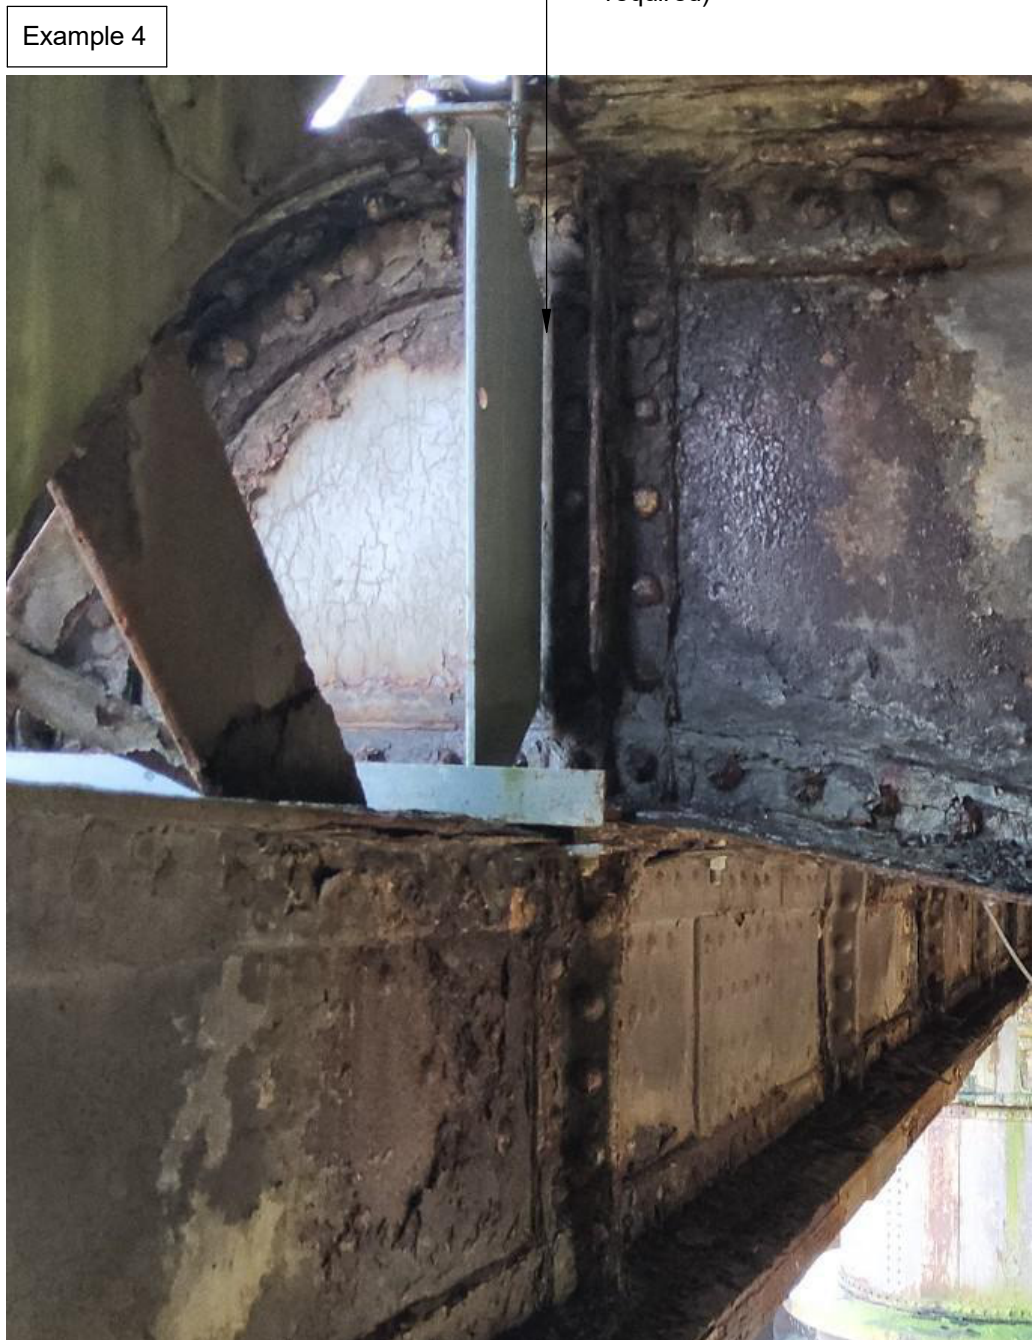
Air gap between stiffener  
and web plate  
- not as per 2022 detail  
which showed contact  
required)

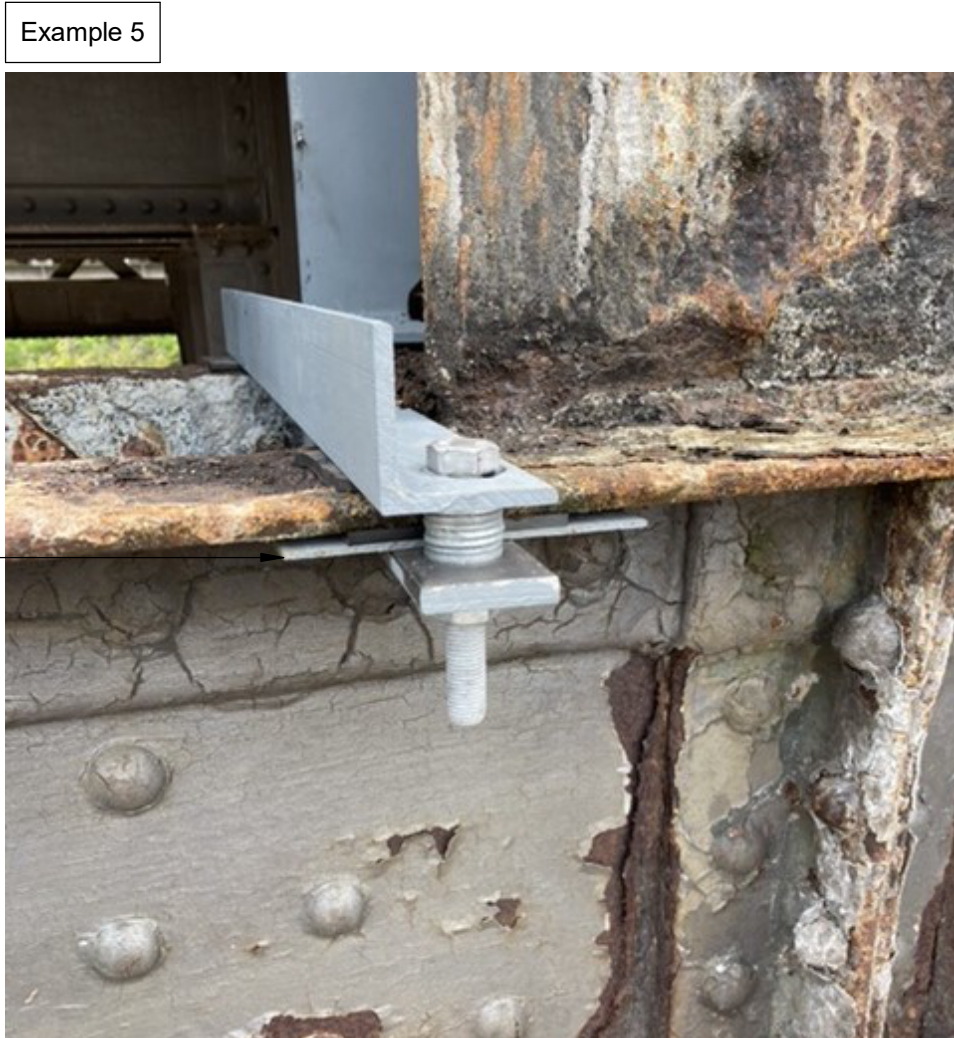
Washers as packers  
across top flange of  
bottom chord
