# Historic Building Watching Brief

33 Thomas Street  
Manchester  
M4 1NA

Conducted and written by Hannah Kernychnyj  
February 2024

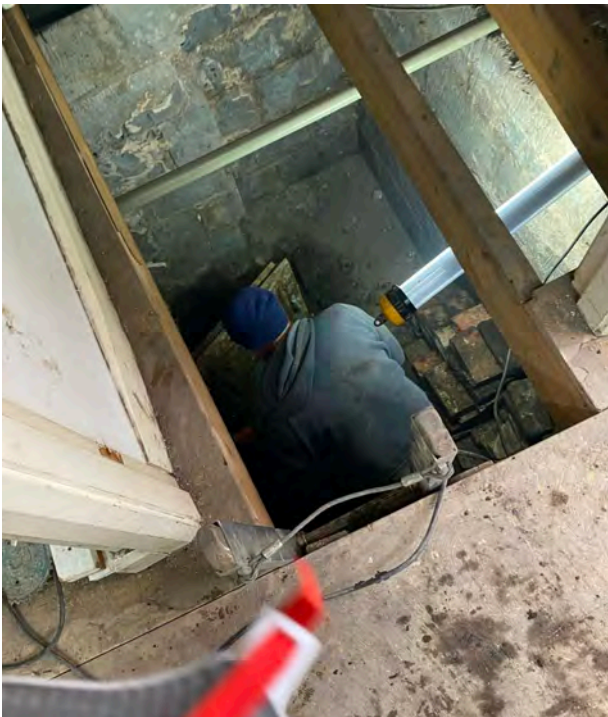
This room at the back of the building was filled to ceiling level with rubble and bricks. Due to the area being overly congested material had to be removed from above. On excavating it appeared that the rubble may have come from previous building work as most of the materials were modern, perhaps from the extension on the ground floor. The floor of this space was filled with concrete and the walls are constructed from breeze block. The only find was two old safes possibly used for the jewellery shop. (Fig.1 and Fig.2)

Fig.1 Opening in Ground floor, floor boards lifted to remove material from rear storeroom in basement. Breeze block walls and concrete visible.

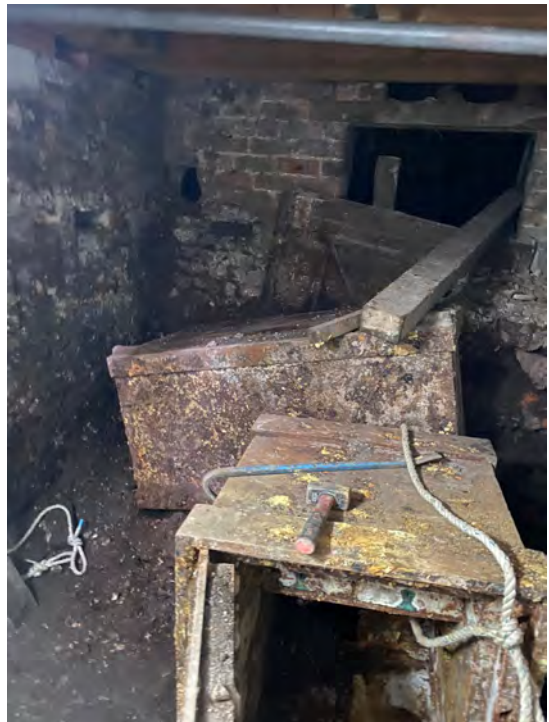
Fig.2 Two old safes found in basement rear storeroom.

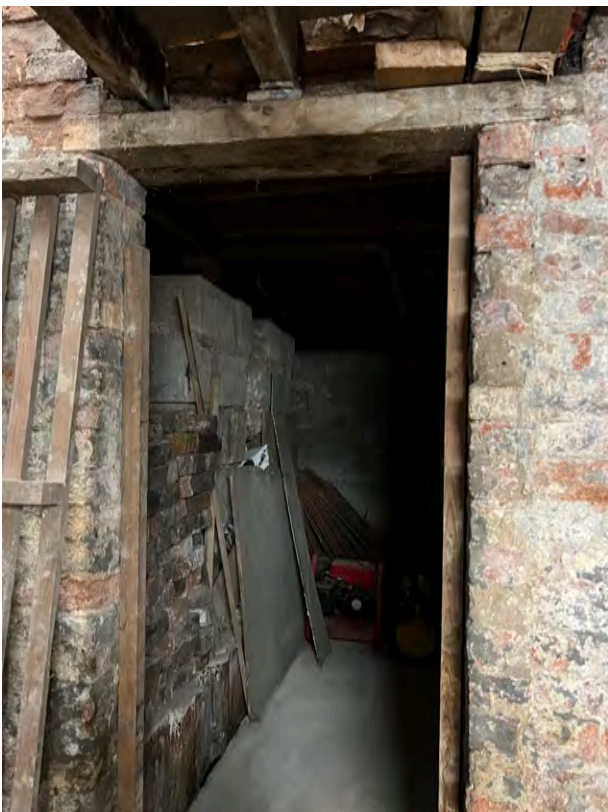
Fig.3 View into cleared rear store room. Salvaged bricks stacked on left side.

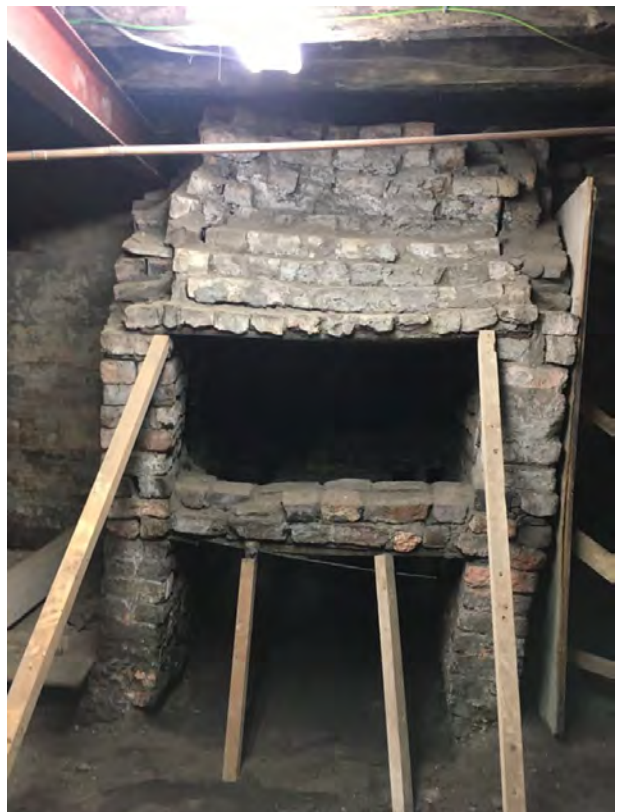
Stephen Levrant heritage consultants identified this precarious structure as a blacksmiths oven. A measured survey and laser scan of the oven were taken by Christians Ltd. The hazardous nature of the oven meant this had to be carried out first as it was being propped up by timber struts and a large fracture in the brick work was developing. (Fig. 4 and Fig. 5)

Fig.4 Basement oven being propped up due to unstable nature.

The opening out works to 33 Thomas Street has allowed for original features to be exposed and some discoveries made, such as hand painted lettering on the beam situated on the ground floor. Unfortunately the basement oven can't be saved as the structure is too insecure and hazardous. All other openings and findings will remain exposed and conscientiously repaired and restored to allow for future enjoyment of the historic building.

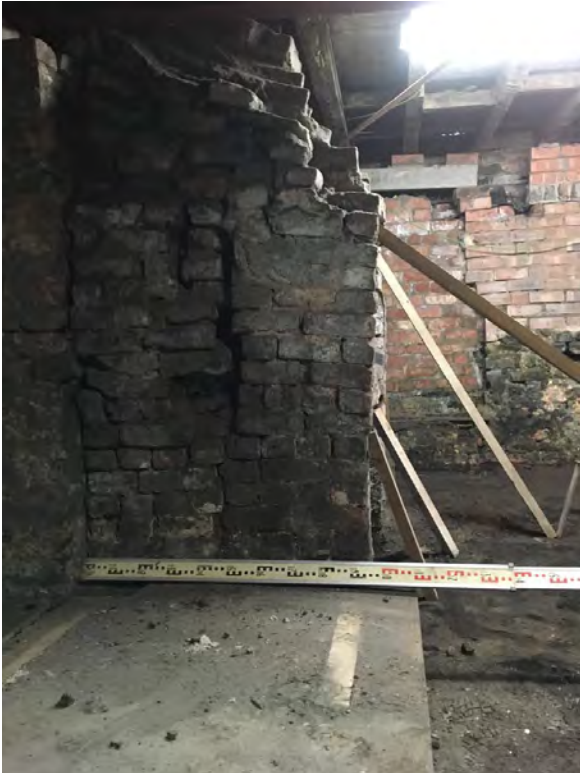
Fig 5. Side of Basement oven showing large fissure and movement away from the structure.

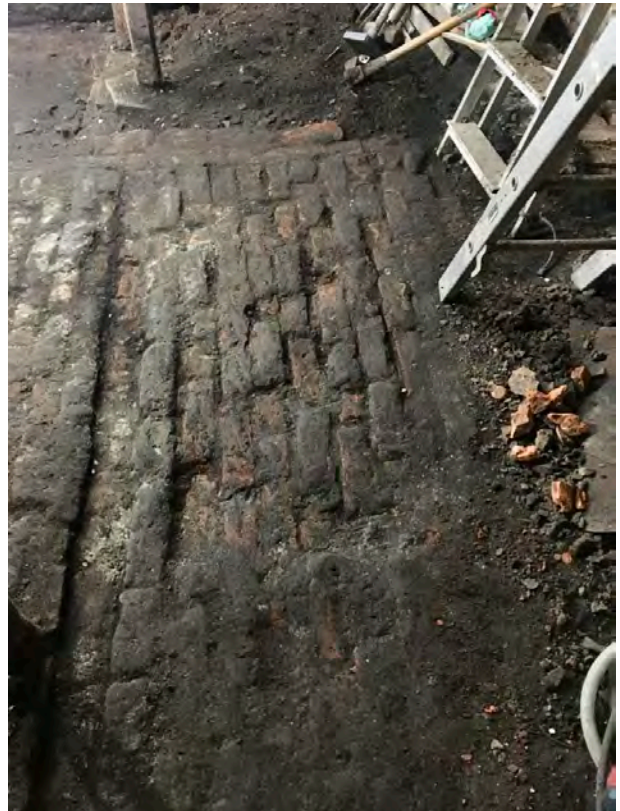
Fig 6. Recording of the pattern of brick flooring so it can be relayed in the same pattern.

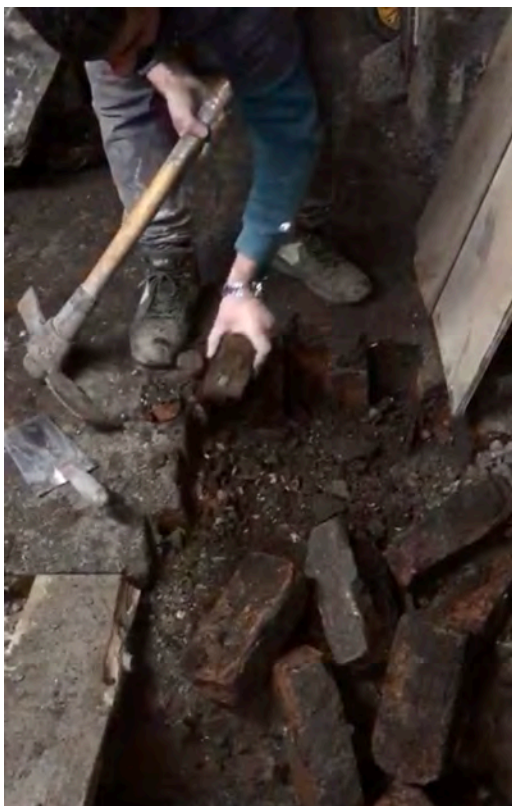
The floor was partially covered by red solid bricks. The bricks were very soft and crumbling when being lifted by hand. Any lifted whole have been saved to be reused. Underneath the bricks virgin clay was exposed.

Fig 9. Bricks lifted by hand.

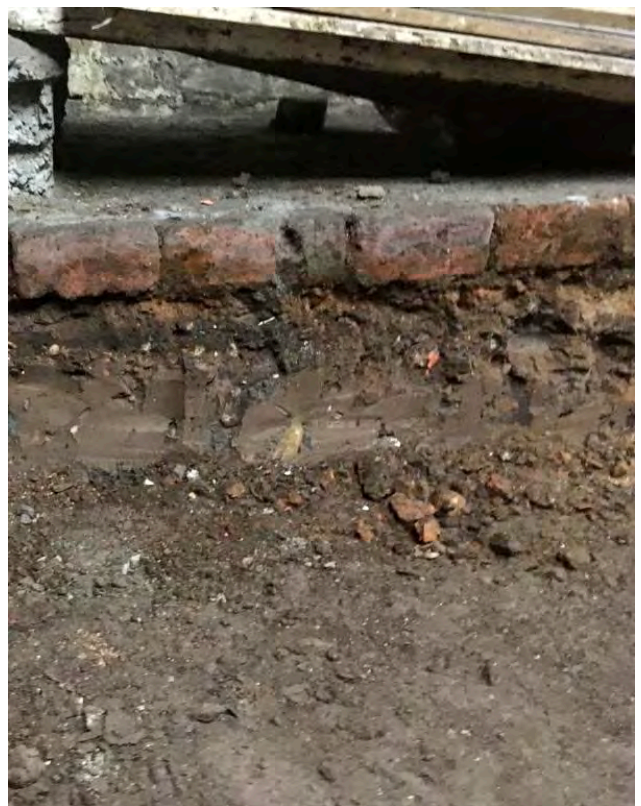
Fig 8. Virgin clay below bricks.

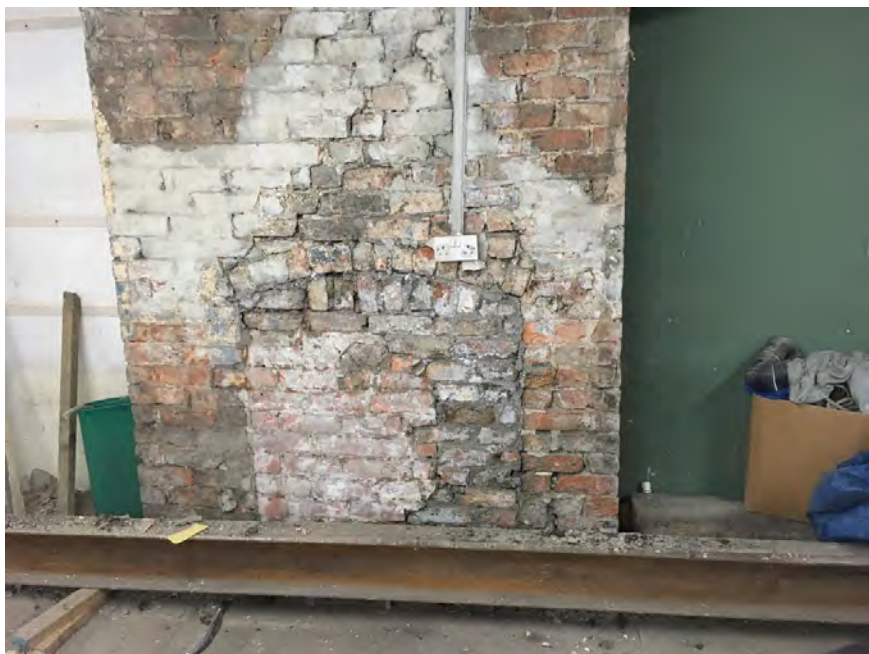
Fig 9. Rear Fireplace  
modern plaster removed.

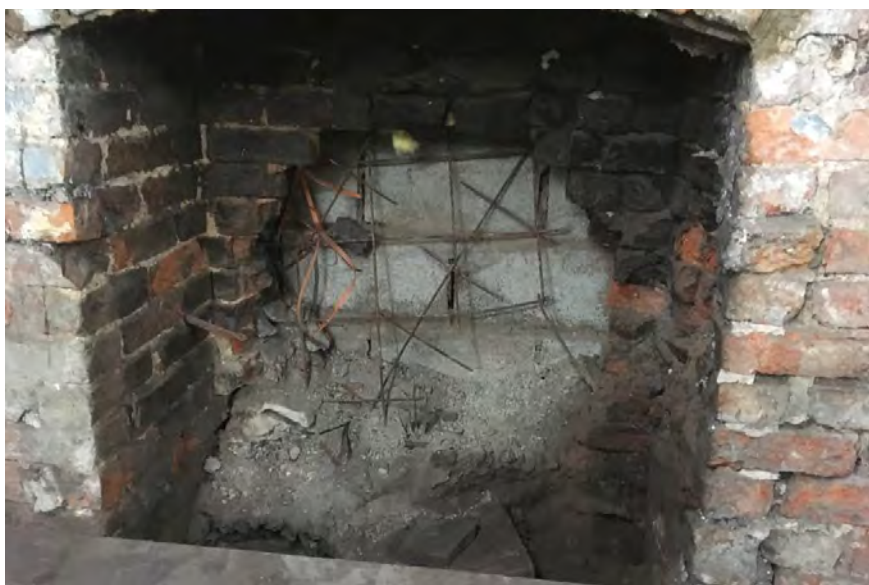
Upon removing modern plaster and bricks the exposed fireplace revealed breeze blocks at the back of the chimney, which is the wall of The Bay Horse Public House.

Fig 10. Back of rear fireplace  
showing broken chimney and  
breeze block work from The  
Bay Horse Public house.

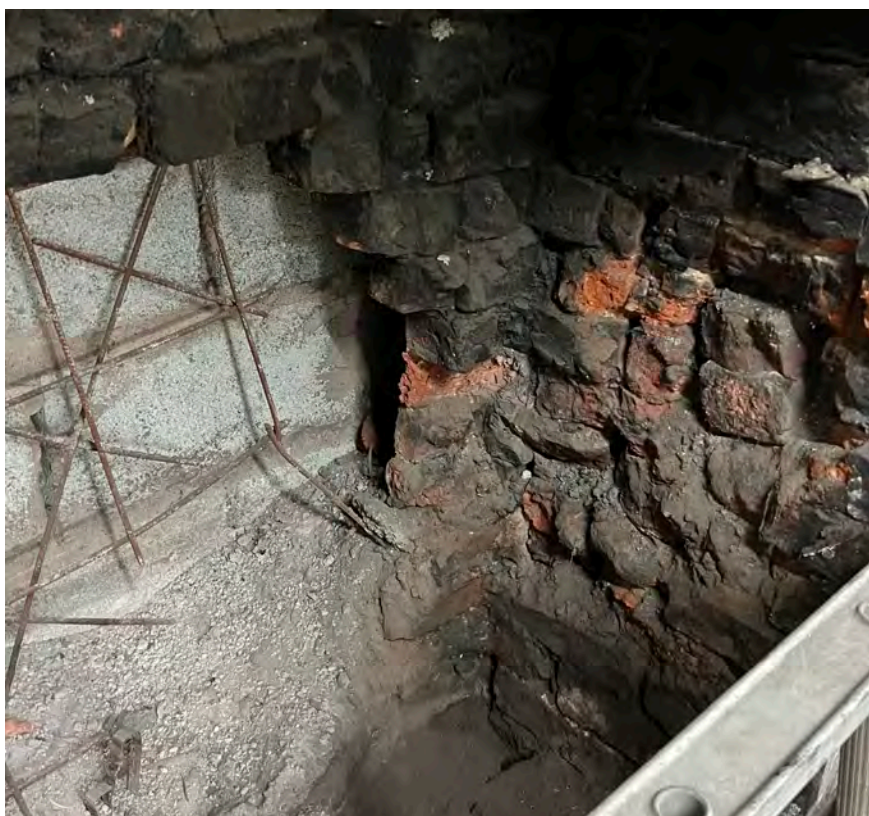
Fig 11. View inside rear Fireplace

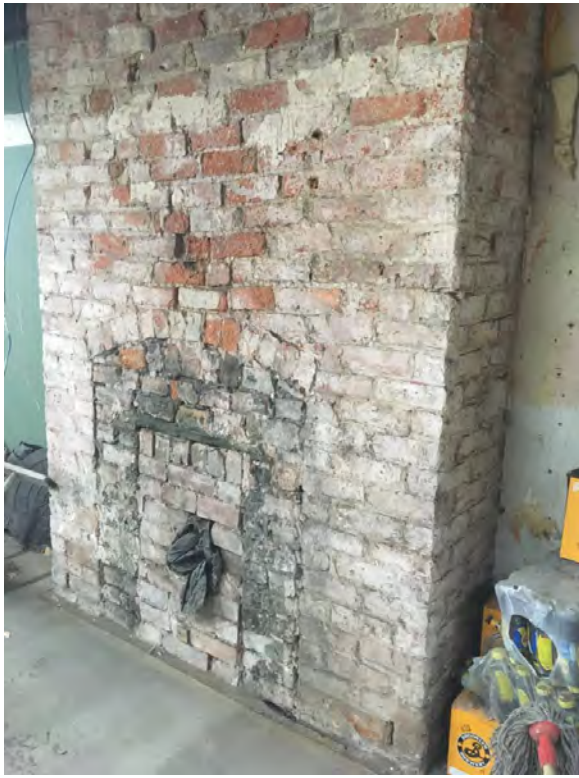
Removing the modern plaster exposed the original brick arch and a smaller infill. No other findings.

Fig 11. Front Fireplace modern plaster removed

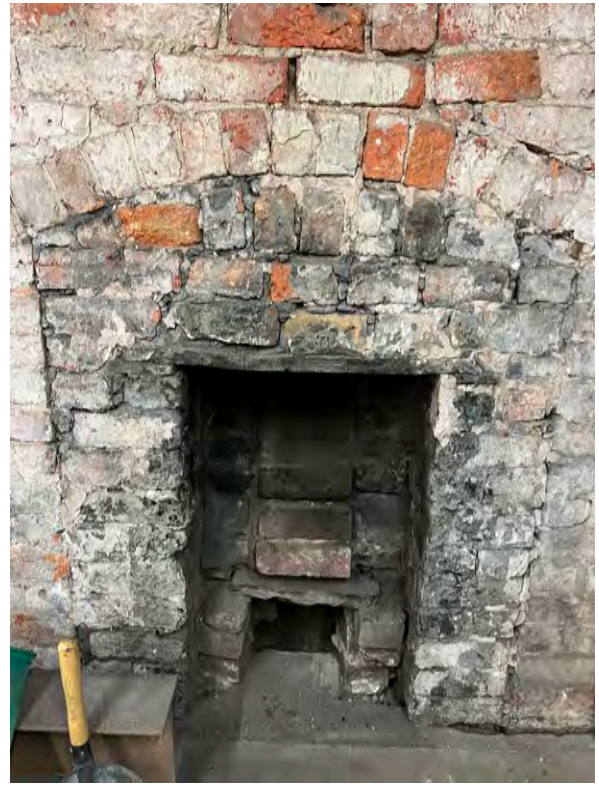
Fig 12. Small fireplace exposed, larger arch can be seen.

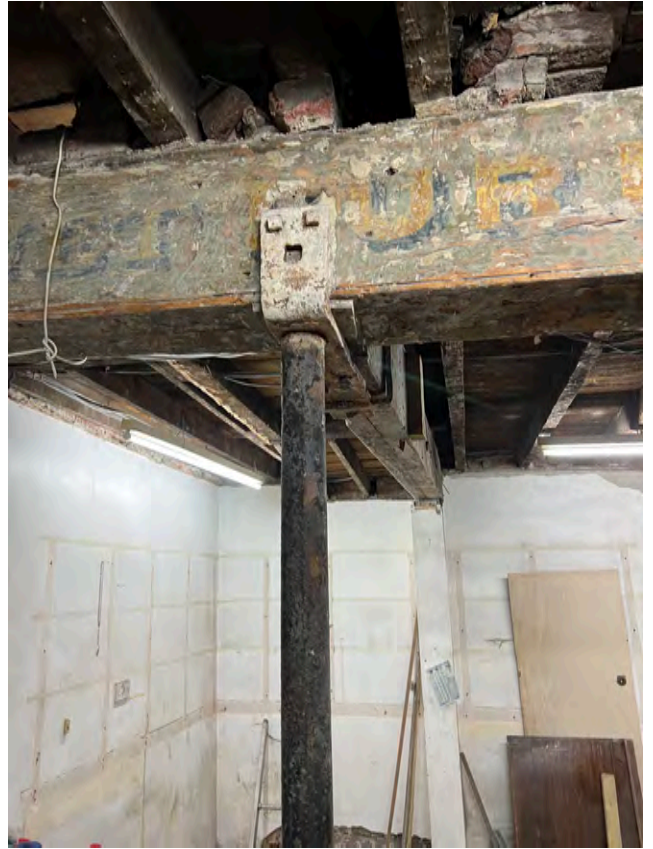
An investigation into the pillar revealed a boxed in metal column holding the beam above. Exposing the original wooden beam, which had also been boxed in, revealed that perhaps it had been recycled from another building as the hand painted lettering on the front of the beam

Fig 15. Pillar exposed meeting beam above

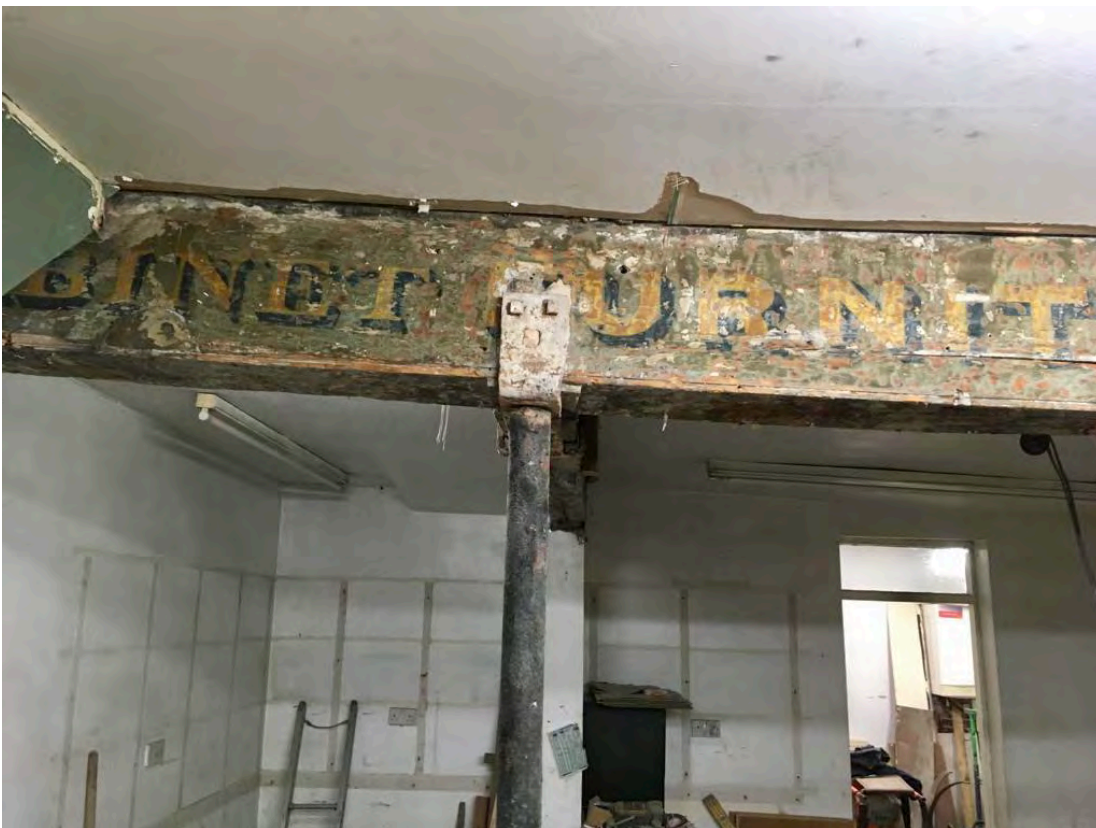
revealed a sign for a 'cabinet furniture warehouse' which is part concealed by the bracket attaching pillar to beam. (Fig. 15)

Fig 16. Original signage of suspected recycled beam. 'Cabinet furniture warehouse' Bracket covering part of original lettering.

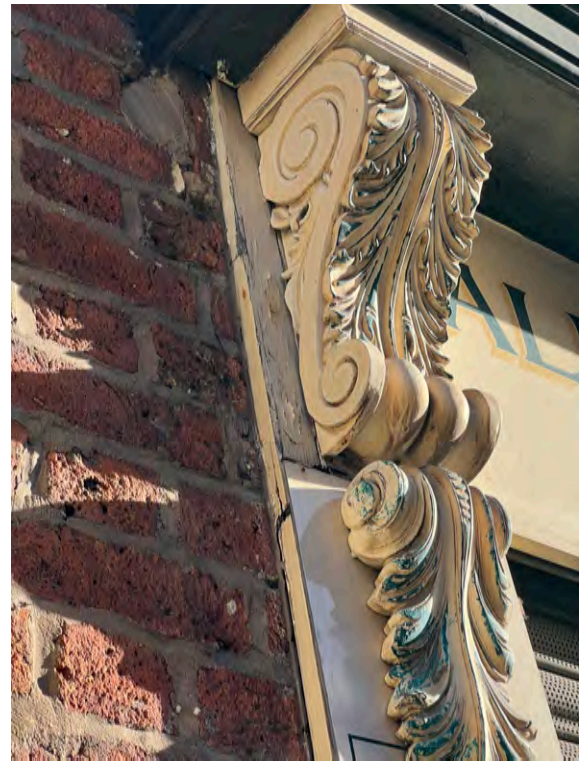
Fig 18. Close up of moulding revealed it was stuck onto new signage and not original.

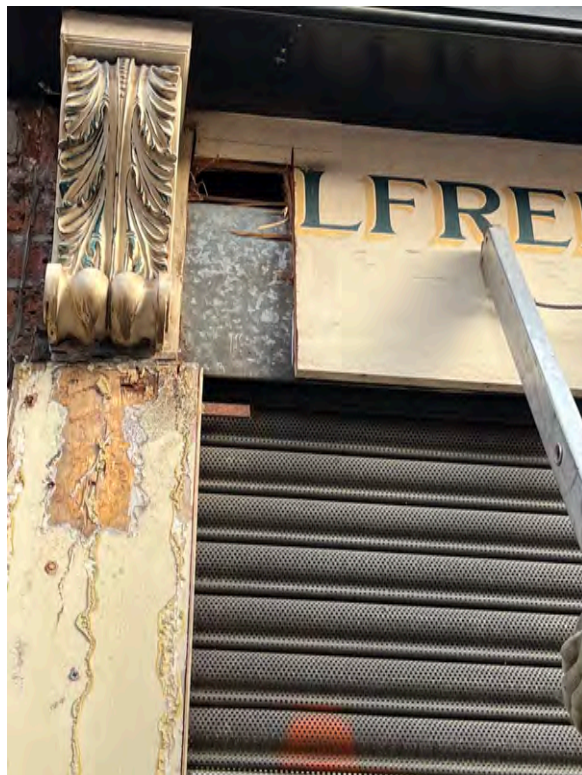
It was suggested by the previous owner that the original signage was under the current facade, but exploration only uncovered the metal box which houses the roller shutter mechanism and a steel beam.

Fig 18. Behind the signage the metal housing of the roller shutter was revealed.

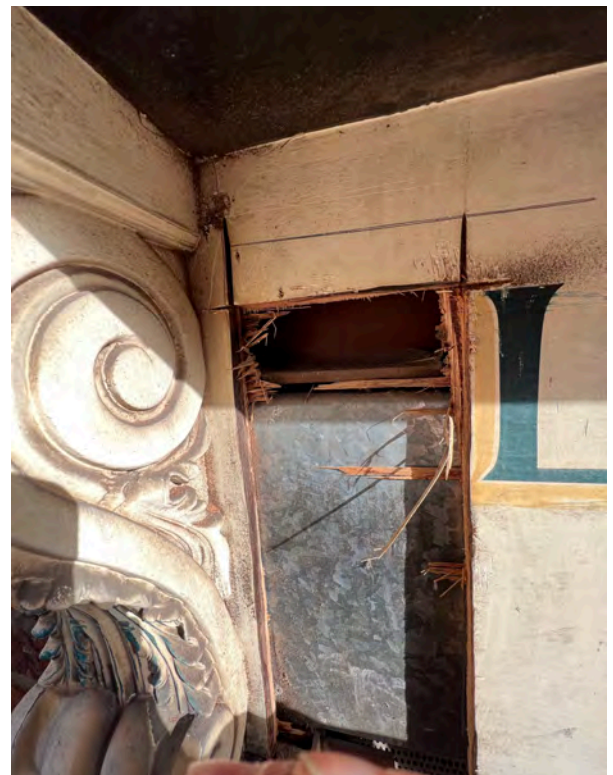
Fig 19. Above the metal roller shutter is a steel lintel, unfortunately no original signage found.

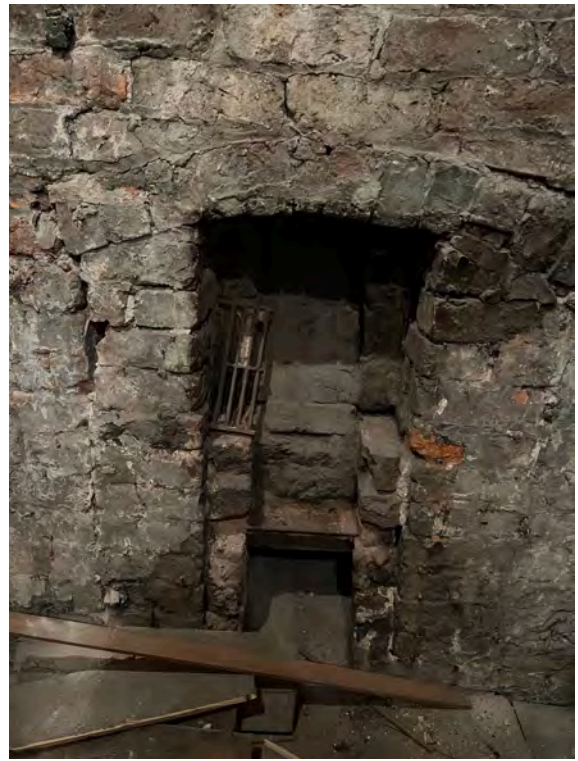
Opening this fireplace revealed a brick arch and the original cast iron grate, part of which is broken.

Fig 21. Rear fireplace opened to reveal broken iron grate.

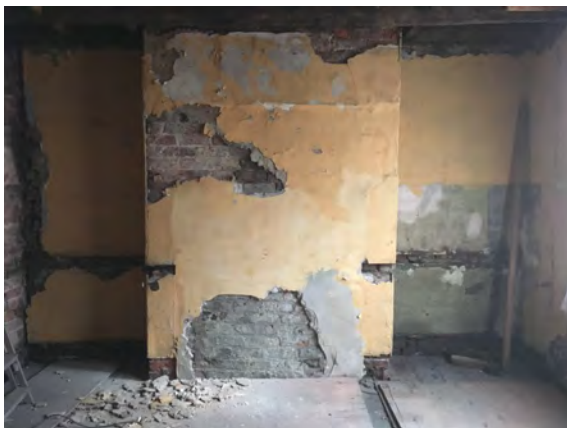
Fig 22. Front Fireplace, very loose plaster.

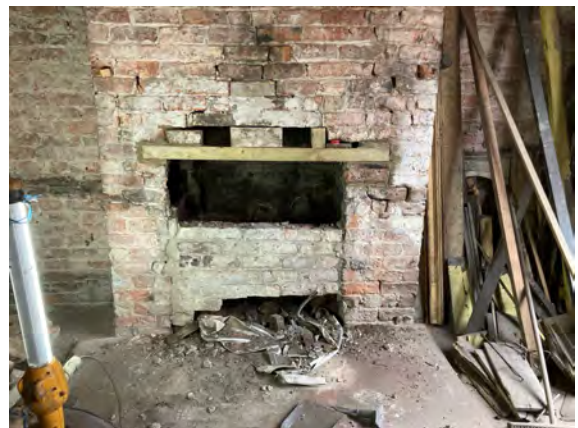
This fireplace was more difficult to expose as the lintel had been removed and there is a crack in the brickwork travelling up the chimney breast. A temporary wooden beam was inserted to allow it to be exposed. Unfortunately the cavity was fill with bricks and soot, no original ironwork was found.

Fig 23. Removal of plaster revealed missing lintel, temporary one put in place for support.

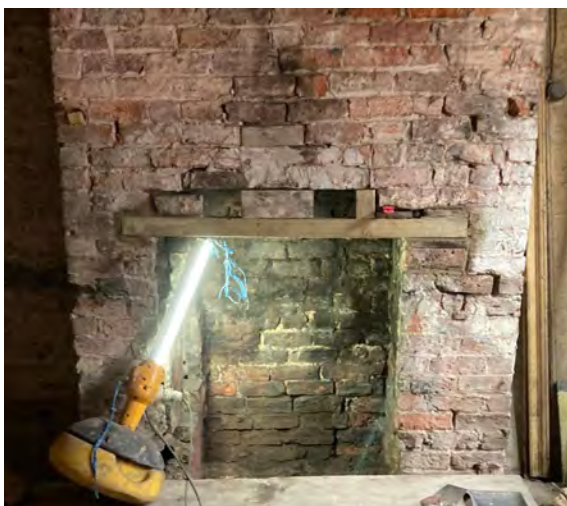
Fig 24. Front Fireplace, unfortunately no original findings.

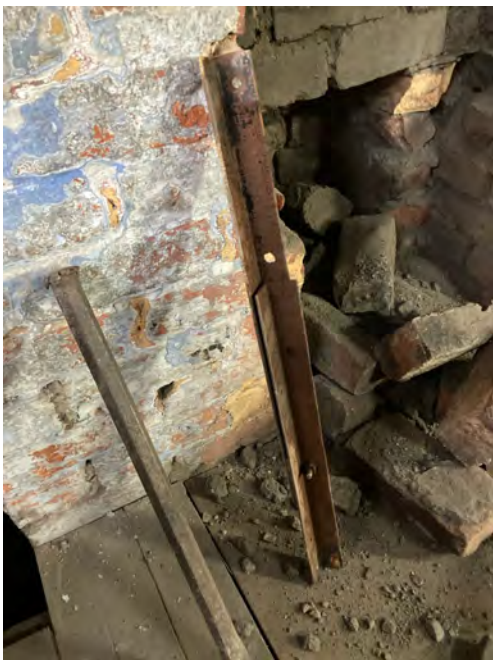
Small Fireplace opened to find original broken cast iron grate and slate tiles. An angle iron was placed below the brick arch.

Fig 27. Angle iron from rear fireplace.

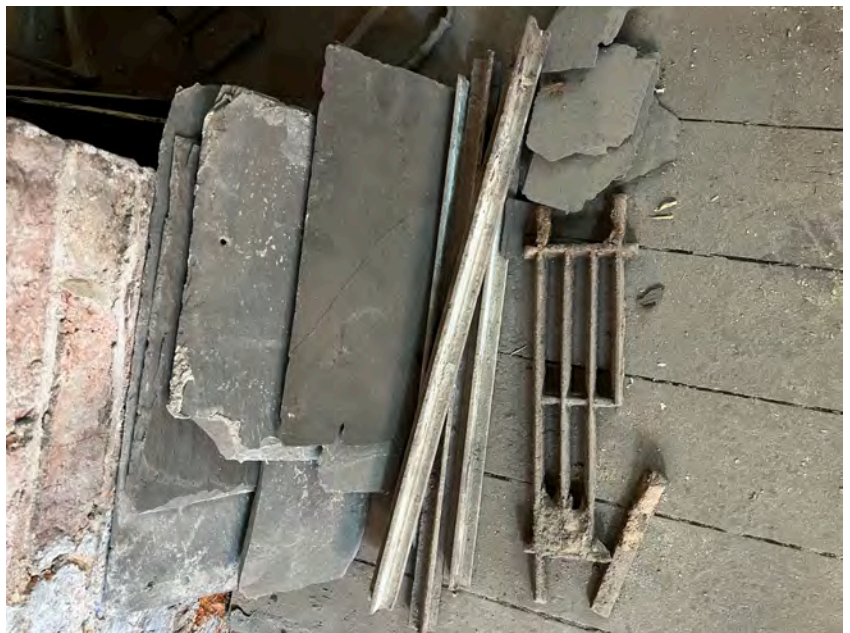
Fig 28. Finds from inside rear fireplace, slates and broken iron grate.

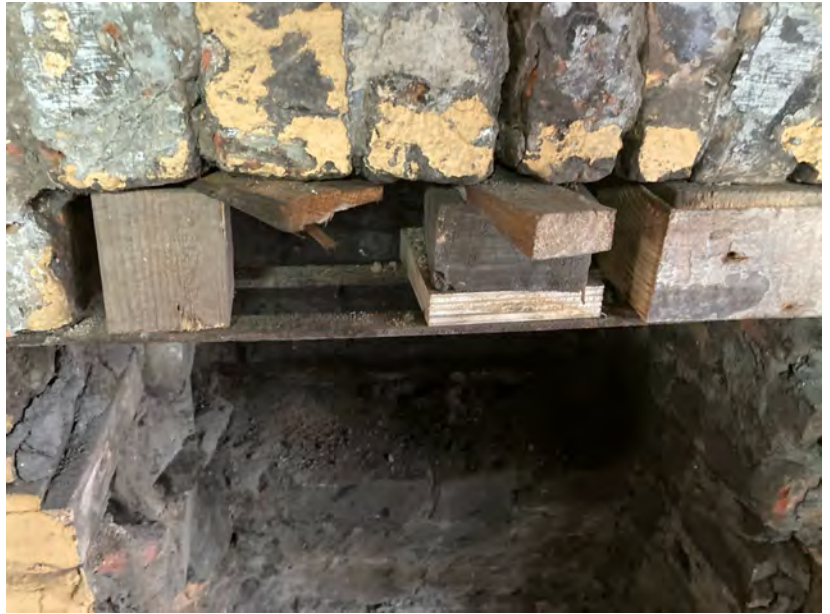
Fig 30. The brick arch steadied with timber packers as it was in a delicate state. Repair required.

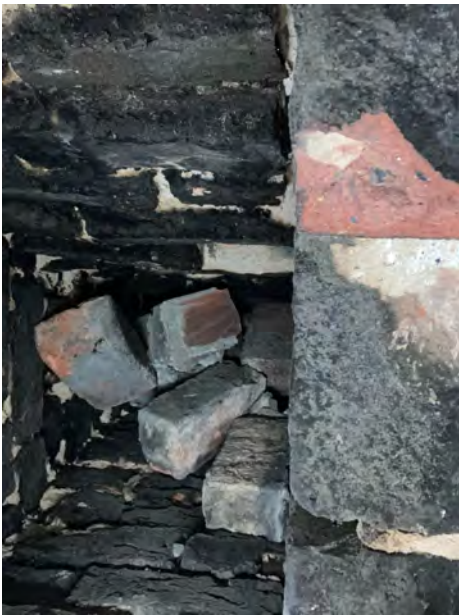
Small Fireplace only revealed the chimney breast full of bricks and slate.

Fig 31. Photo of inside chimney of front fireplace filled with bricks

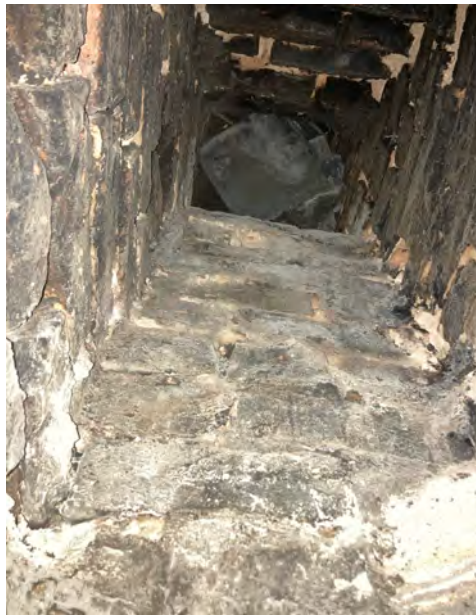
Fig 32. Removal of bricks exposed slates placed at the top.
