Client  
The National Trust

Project Title  
Castlefield Viaduct  
Phase 2

Drawing Title  
Remedials  
Piers

| ID | CVI-ARUP-ZZ-ZZ-DR-S-4021 | | |

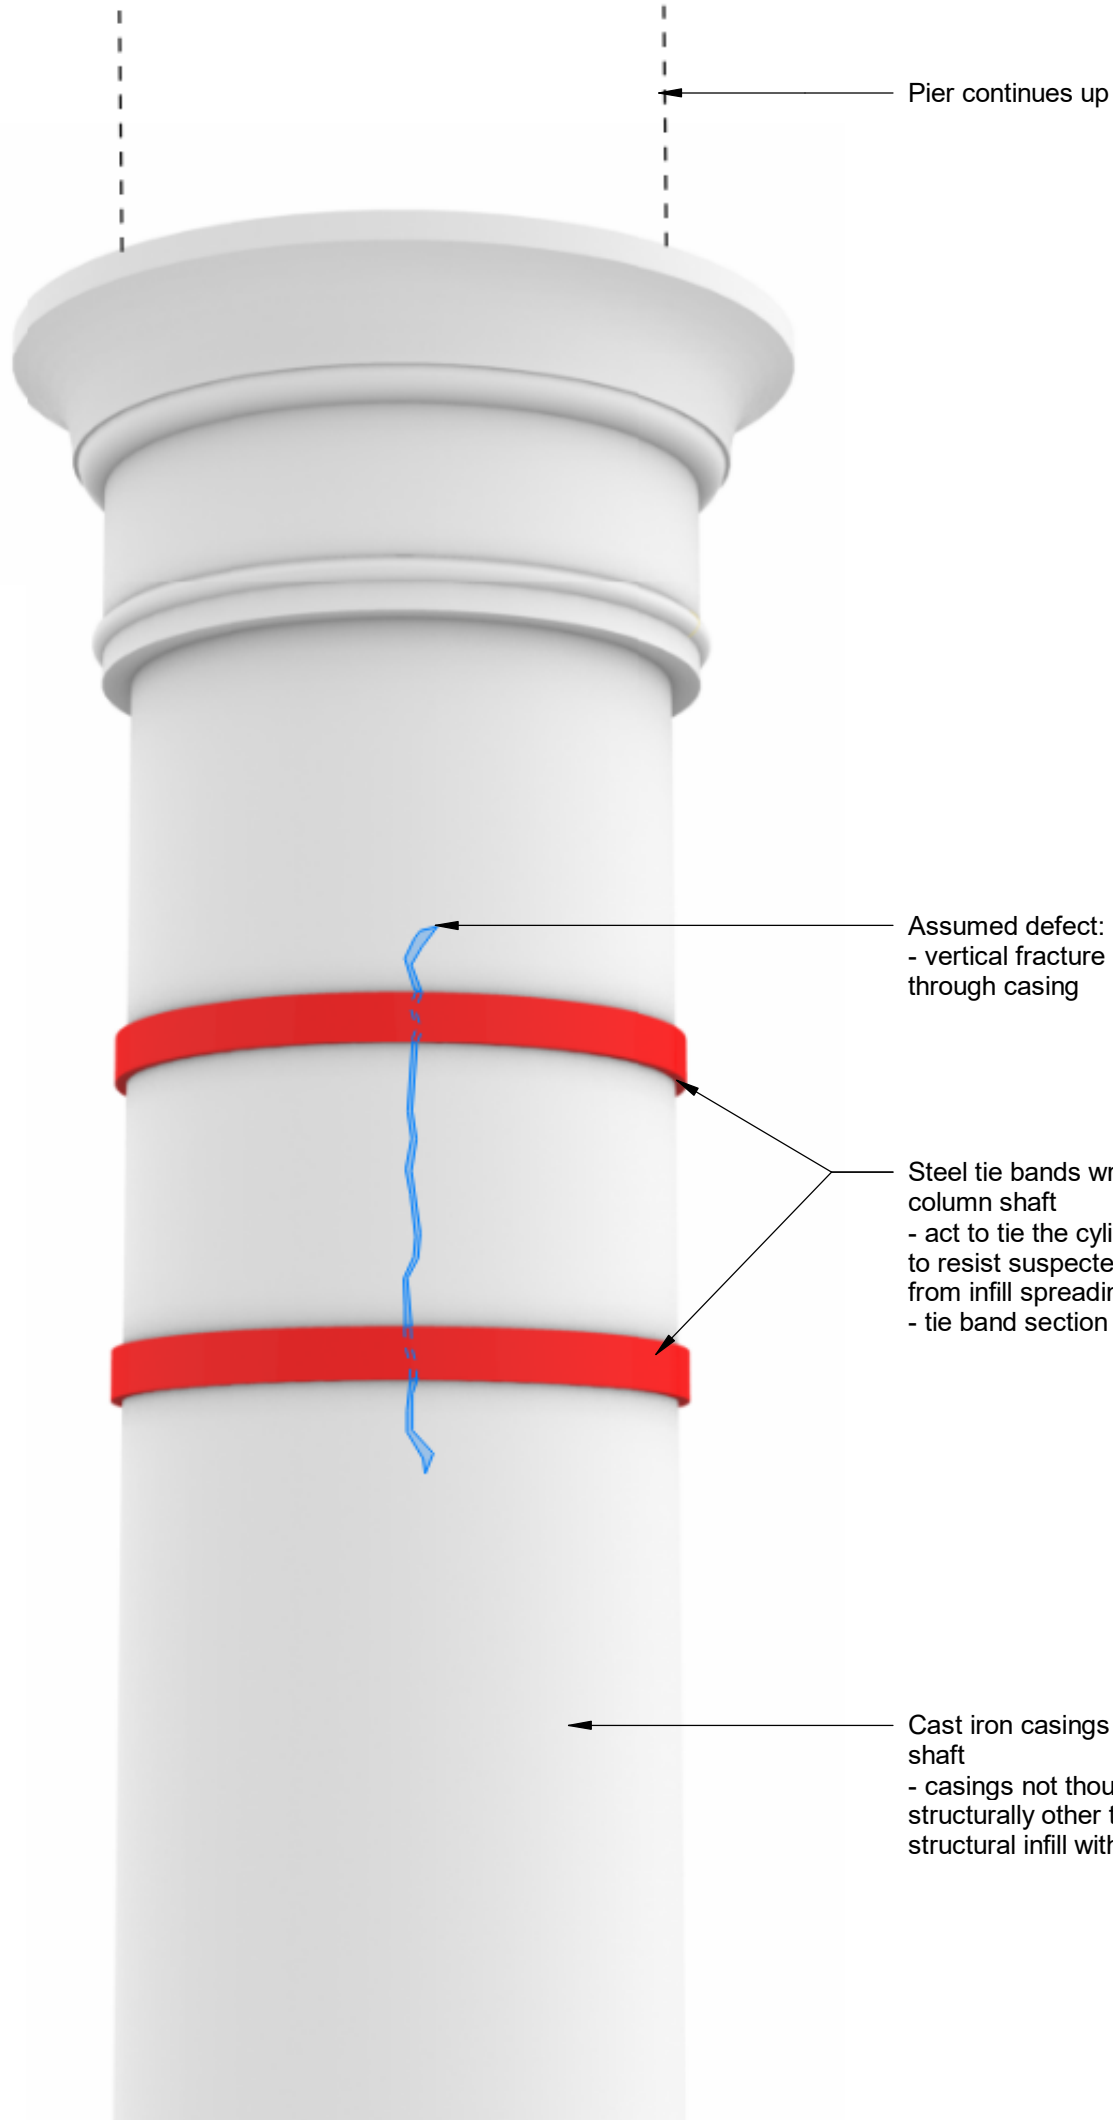
Assumed defect:  
- vertical fracture  
through casing

Cast iron casings to main column  
shaft  
- casings not thought to be acting  
structurally other than to contain  
structural infill within

Brick and cement infill  
- according to archive  
original drawings

Steel tie bands wrapping around  
column shaft  
- act to tie the cylinder across crack,  
to resist suspected outwards force  
from infill spreading  
- tie band section TBC

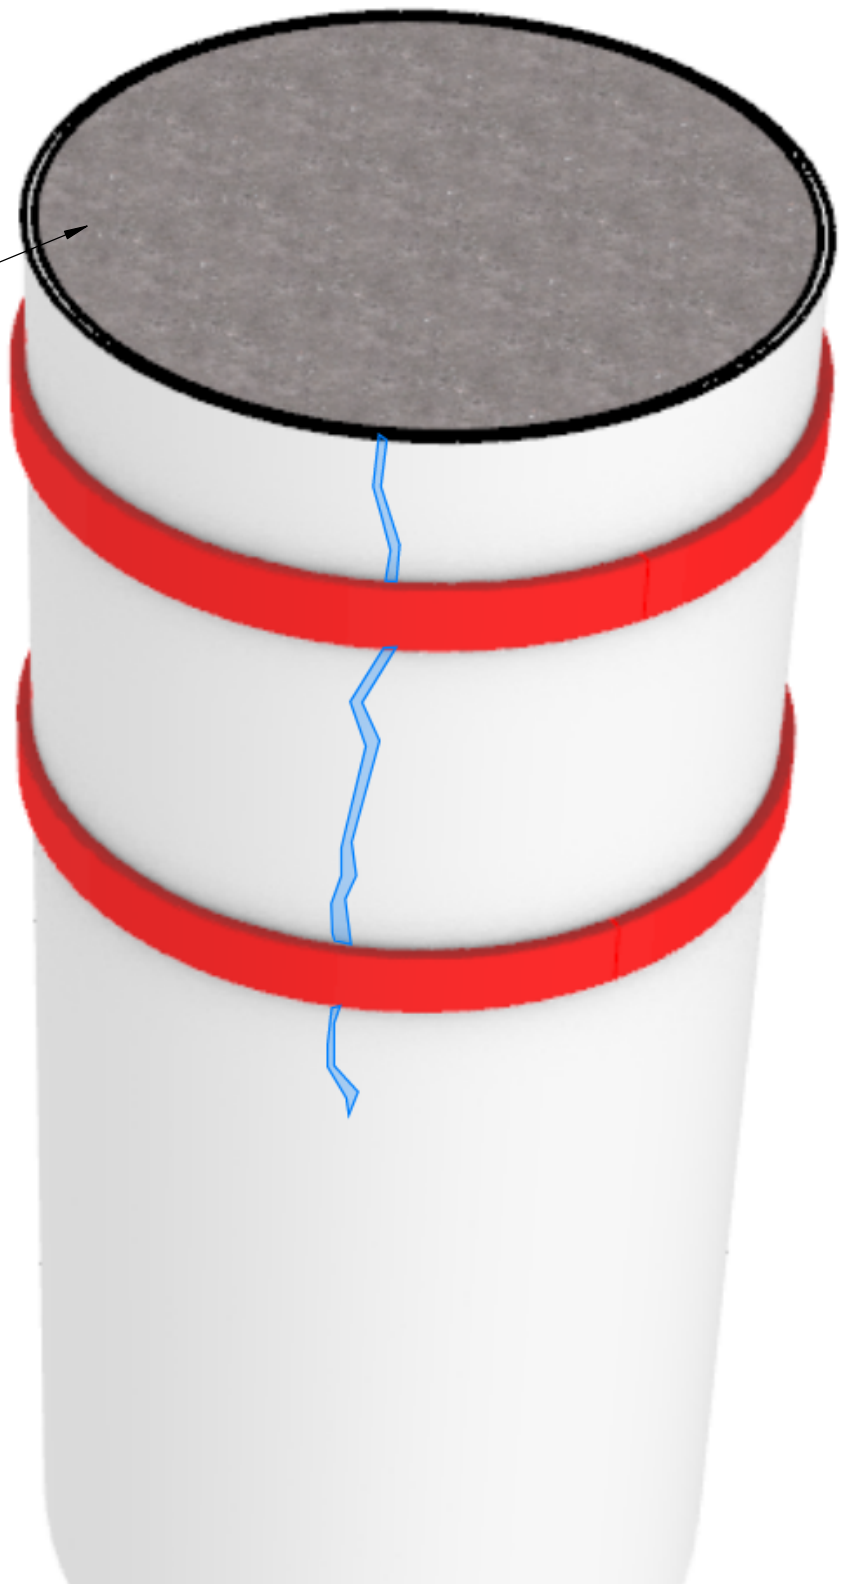
Horizontal and vertical  
joints between casing  
segments

Vertical fractures in casing segments

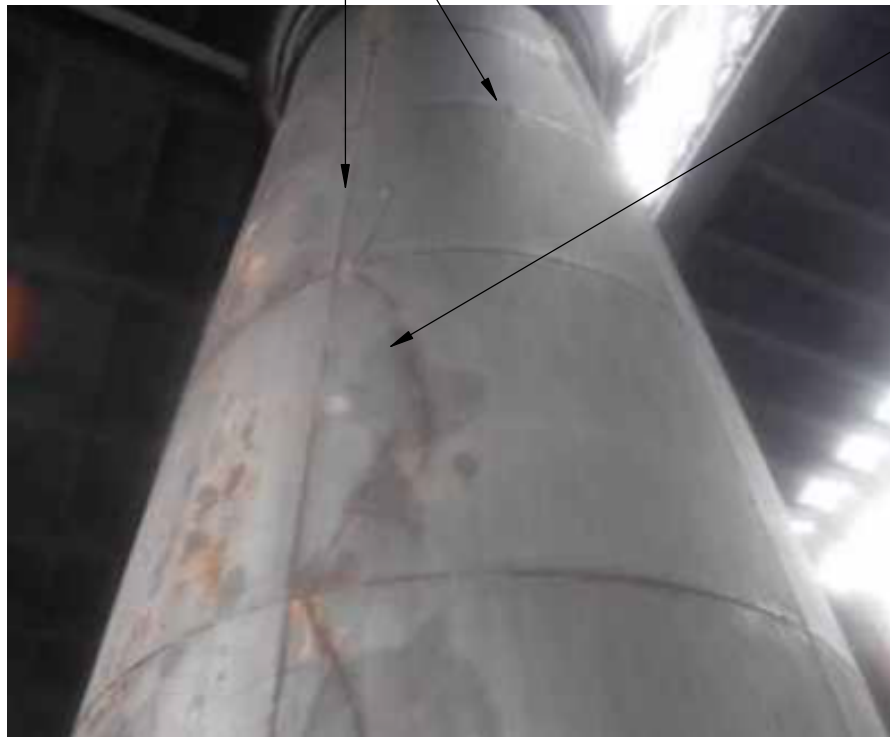
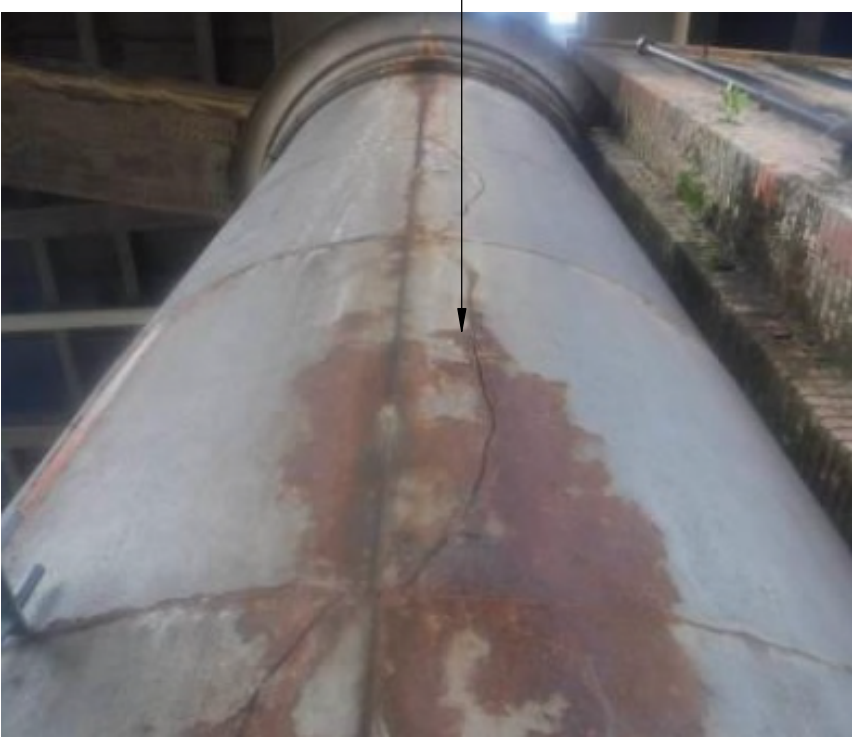
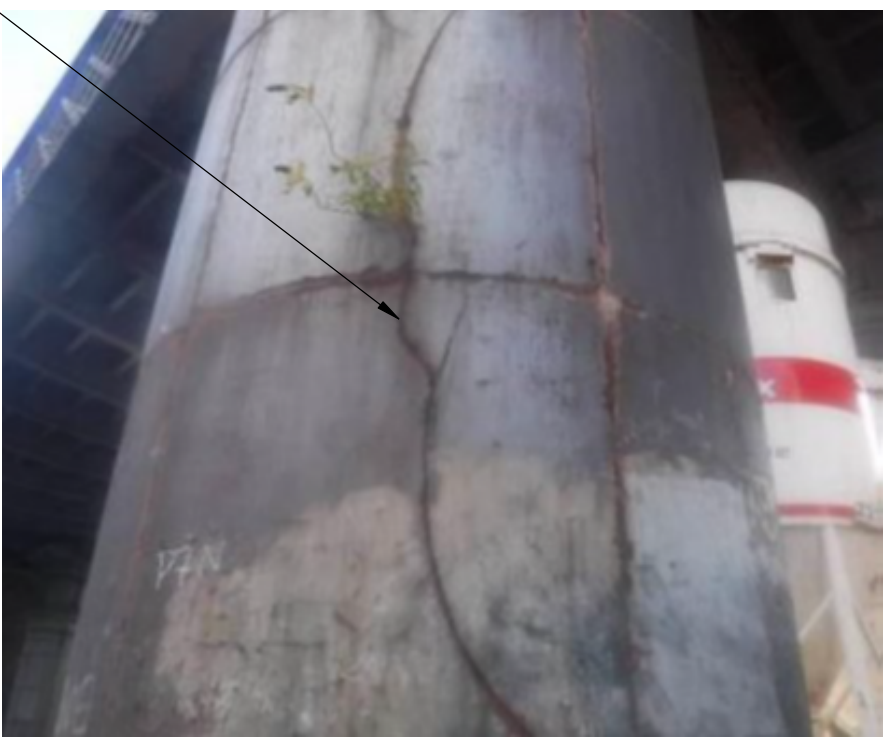
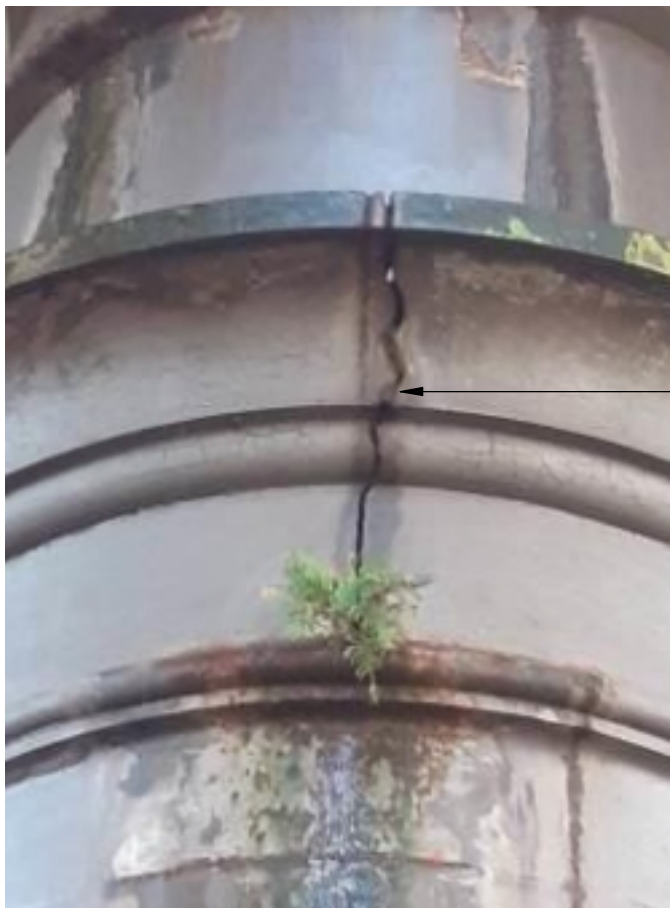
Vertical fracture to column head  
flaring

Vertical corrosion  
- no fracture
