# Outline Shopfront & Elevation Specification

Installation of new external shop front with local elevational repairs and cleaning.

Address: 28-30 Oldham Street, Manchester,

Issue Date: 25 July 2024

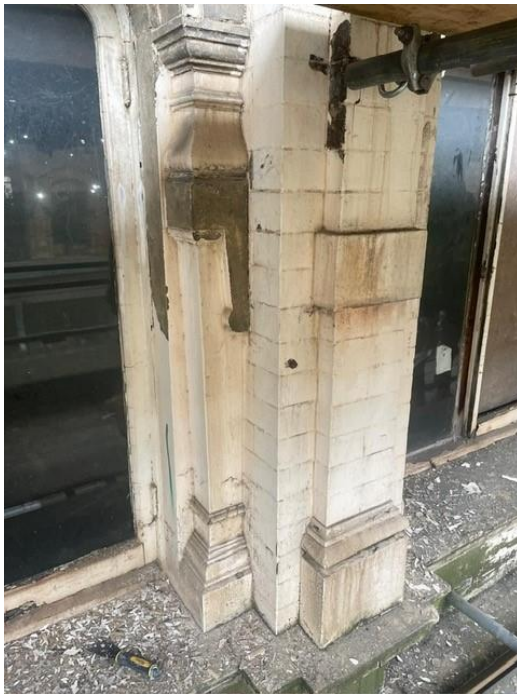
#### **Example no. 1 – left hand photo showing second floor central pilaster**

*Overall average condition to the pilaster itself, however examples either side of failed and rotten timber windows frames, flaking paintwork and weathered stone cills.*

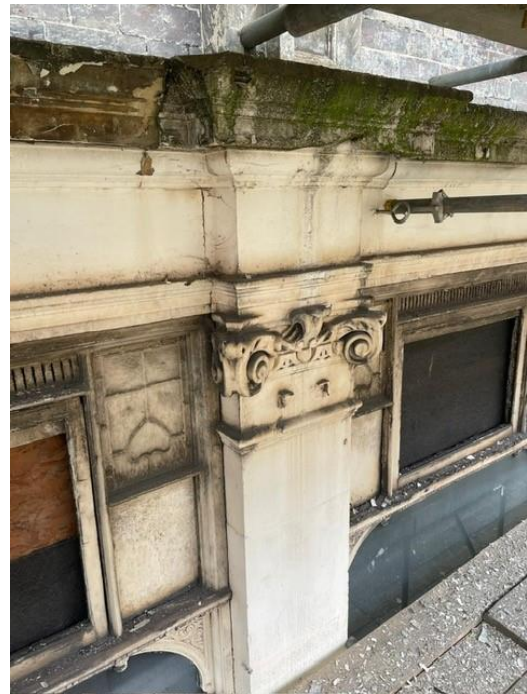
#### **Example no. 2 – right hand photo showing first floor central pilaster**

*Overall average condition to the pilaster and decorative moulding itself, however example of flaking, failed and blown cornice detail with empty window openings to leaded window details*

*either side of pilaster either side of failed and rotten timber windows frames, flaking paintwork and weathered stone cills.*

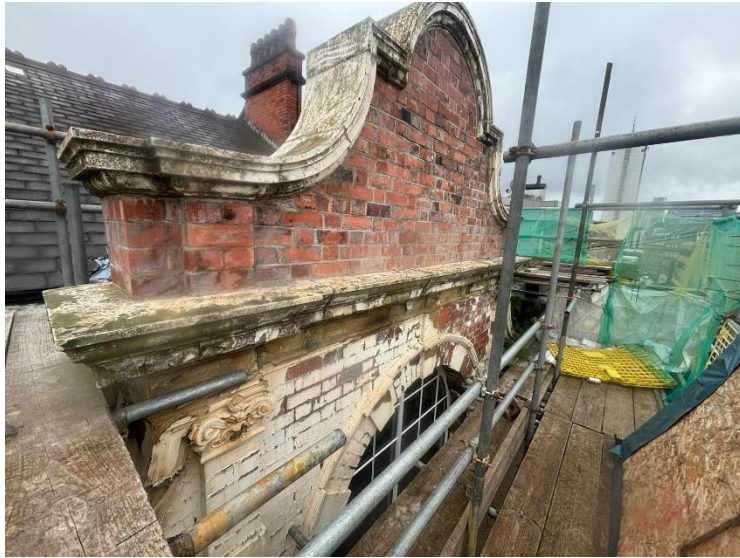
**Example no. 3 – photo above showing third floor upper parapet dormer feature**

*Overall poor condition, parts of the parapet wall element has been dismantled and rebuilt due to perished brickwork resulting in loss of overall stability of the parapet. Parts of the cornice detail have blown and failed, together with weathering, flaked paintwork and signs of vegetation at the far end of the parapet feature. Note the arched dormer window has been replaced as this was formerly an empty opening causing damage to the upper floor internal area due to weather ingress.*

- The dismantling and rebuilding of the parapet masonry wall (see photo example no. 3).
- Scraping back and removal of perished / defective paintwork.
- Façade / brickwork evaluation in order to identify areas of significant deterioration, spalling and, cracking and mortar erosion.

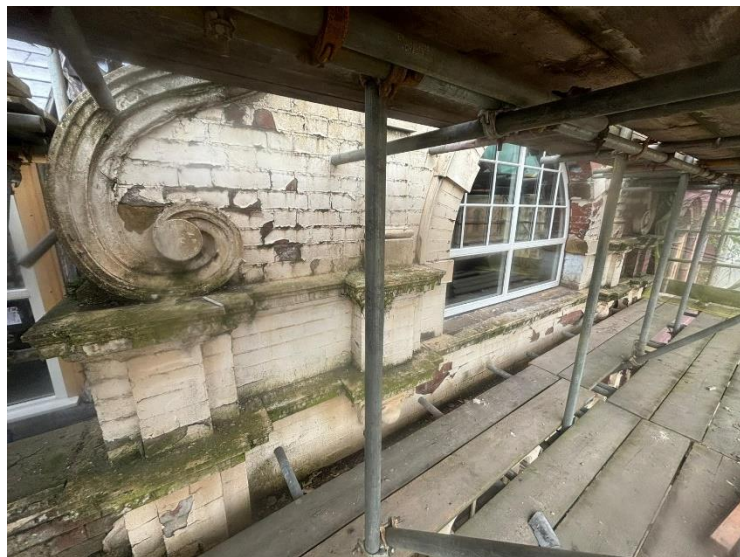
**Example no. 4 – photo above showing third floor lower parapet dormer feature**

*Overall average condition showing flaking paintwork, weathering and very poor condition in the lower bottom left corner indicating brickwork with no mortar joints and cracked / blown stone cills.*

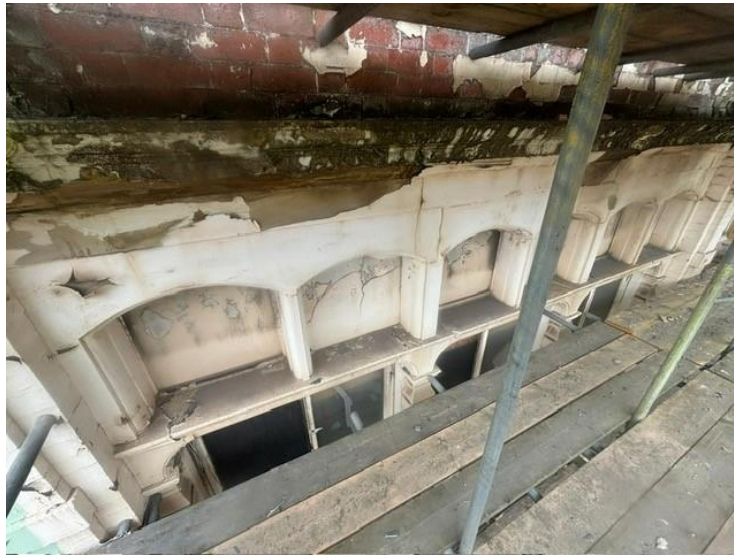
**Example no. 5 – photo above showing upper second floor arched windows**

Overall average condition showing flaking paintwork, weathering and blown stone cornice detail.

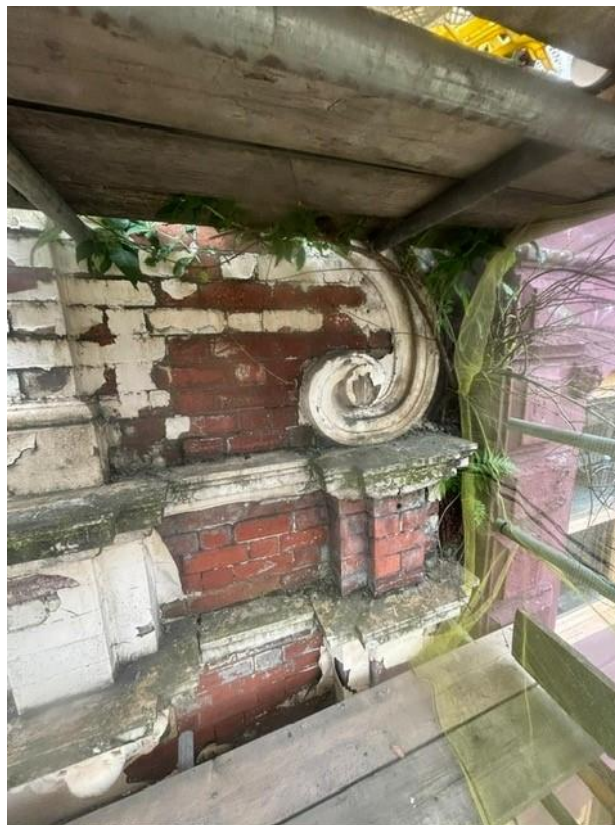
**Example no. 6 – photo above showing lower right hand third floor dormer feature**

Overall poor condition showing flaking paintwork, weathering, failed mortar joints to brickwork and abutting stone cills and vegetation growing in-between the building.

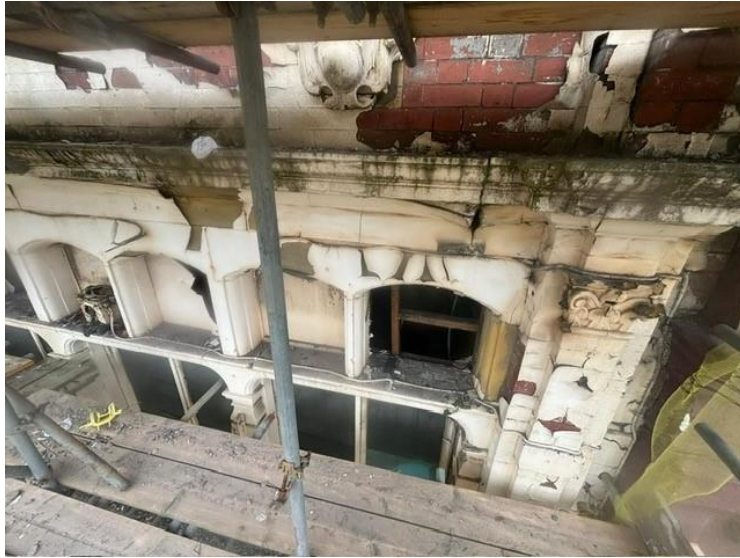
**Example no. 7 – photo above showing second floor right hand upper windows**  
Overall poor condition showing flaking paintwork, weathering and severe crack in stone cornice feature.

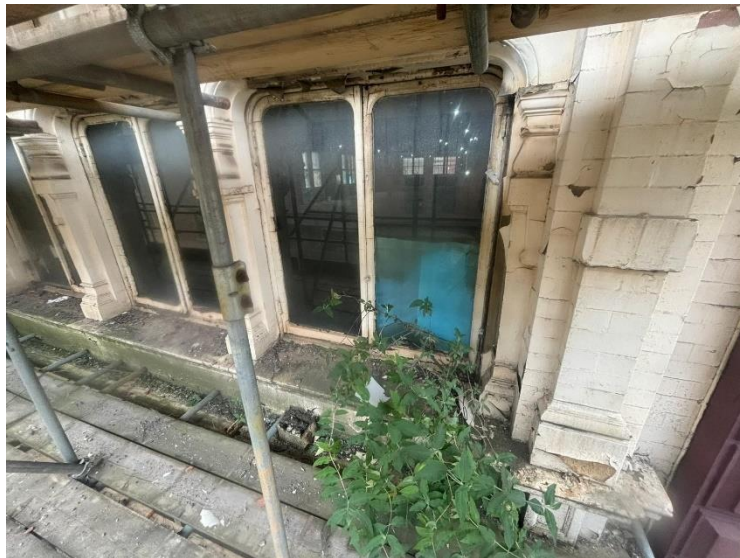
**Example no. 8 – photo above showing second floor right hand lower windows**  
Overall average condition showing flaking paintwork, weathering and vegetation growth.

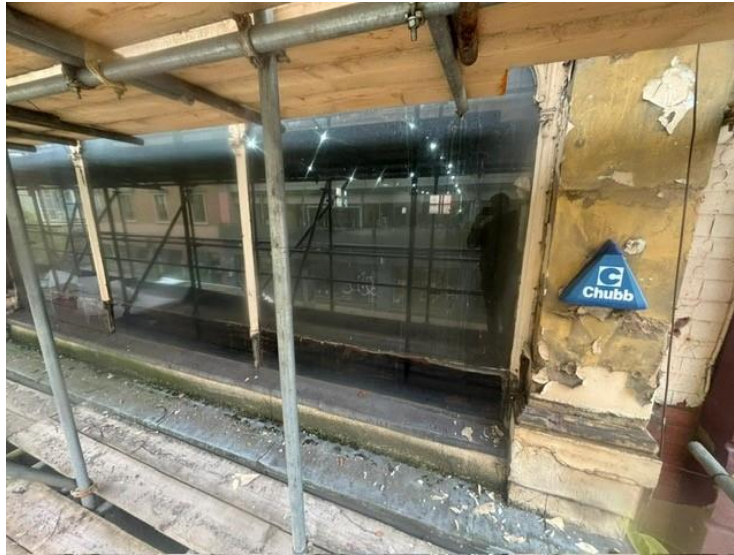
**Example no. 9 – photo above showing first floor right hand lower windows**  
Overall poor condition showing rotten timber window mullions.

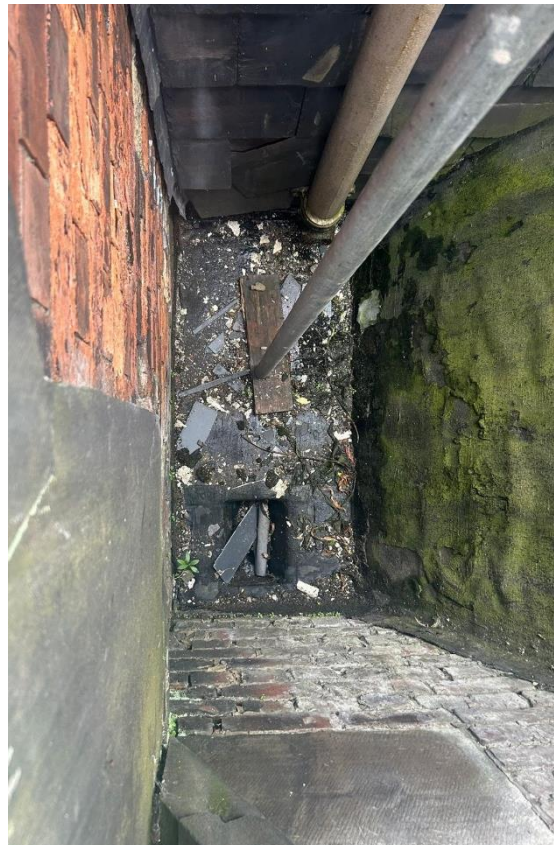
**Example no. 10 – photo above showing rainwater outlets at parapet roof level**  
Overall poor condition showing blown brickwork to other side of parapet wall, weathering and blocked rainwater roof outlet.

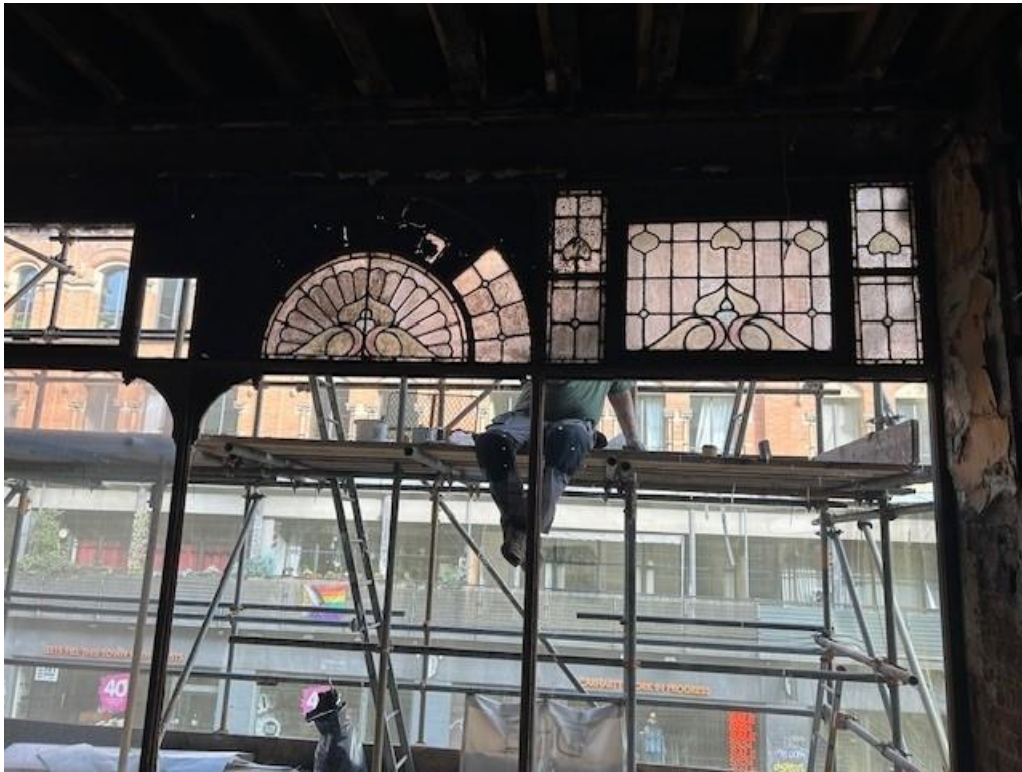
**WIP example no. 1 above** – cleaning and revealing of original first floor leaded windows

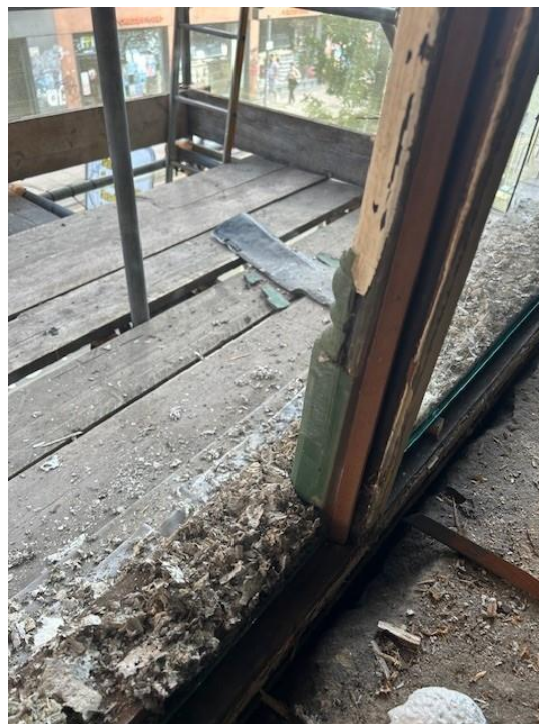
**WIP example no. 2 above** – combination of epoxy and slice repairs to rotten timber window frame mullions
