## 48 King Street Planning Comments – 140293/LO/2024

Project: 48 King Street,  
Manchester.

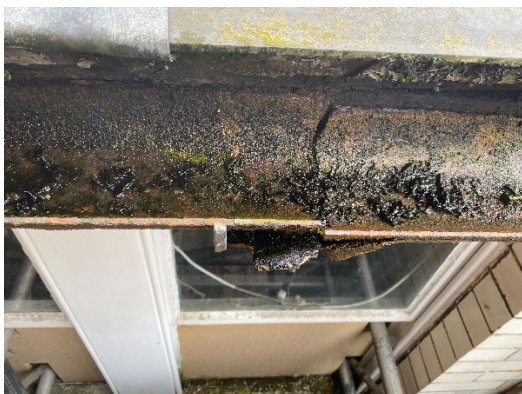
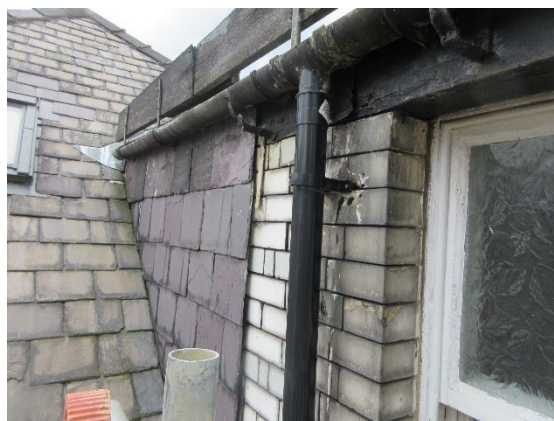
Most rainwater goods are cast iron and will be overhauled. Other works:

- 1no. split cast iron half round gutter to be replaced
- 1no. uPVC gutter and downpipe in repair, so no plans to replace them currently, but obtaining costs if instructed by client to replace them.

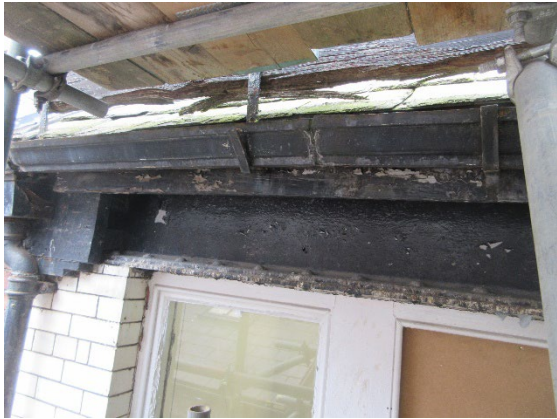
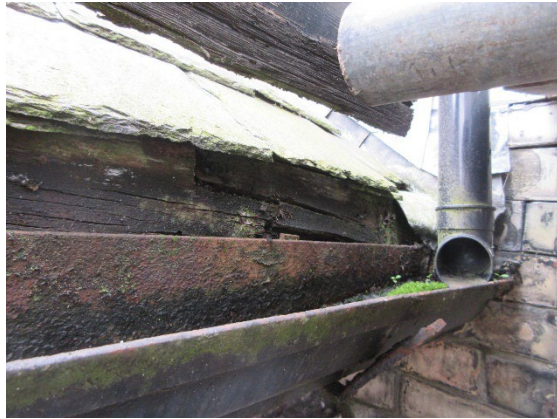
Fascia to one side of the lightwell is in poor condition with decay evident. Works to include:

Rest of fascias are structural timber wall plates and are in sound condition, albeit decoration required.

- replace with new planed softwood timber to match existing in profile and thickness (min 16mm thickness).
- Prime and decorated with Johnstones Stormshield flexible primer and Satin Paint. Colour black.

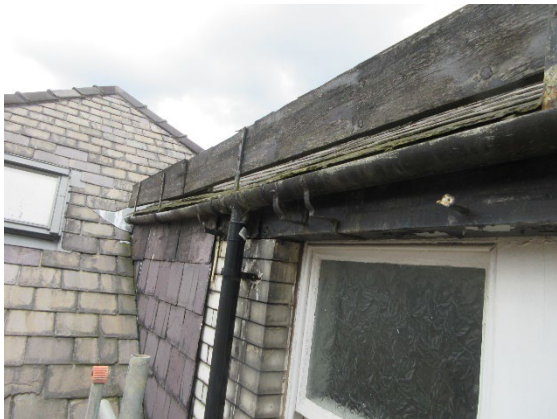
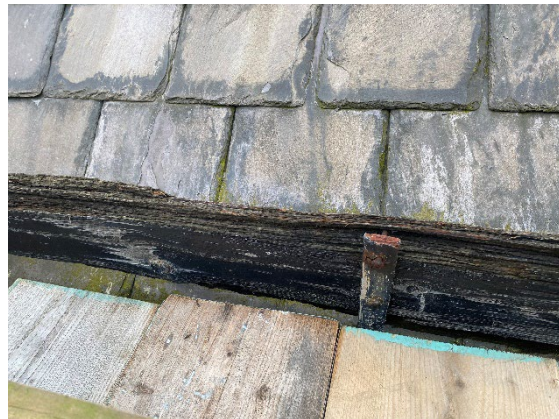
Snow Guards Fascia are in poor condition with decay evident. Works to include:

- replace with new planed softwood timber to match existing in profile and thickness (min 16mm thickness).
- Prime and decorated with Johnstones Stormshield flexible primer and Satin Paint. Colour black.

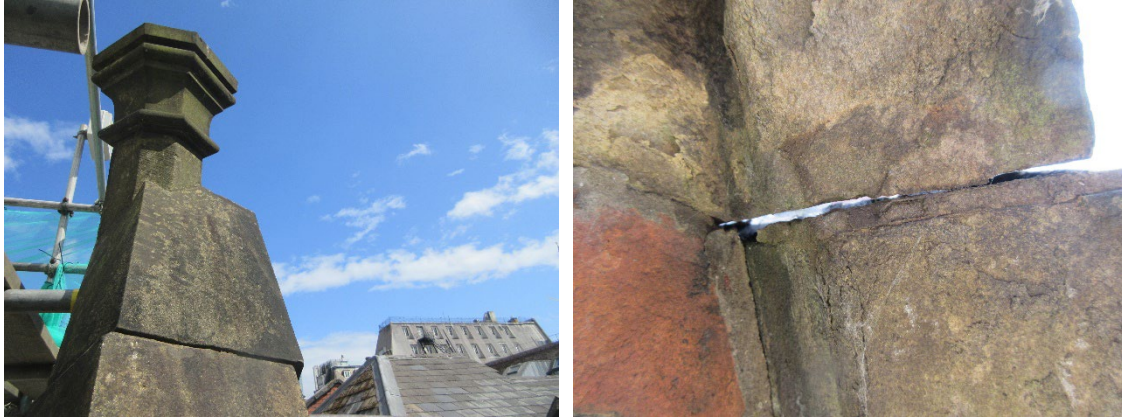
C&W Drawing 10 Ex Elevation drawing – repairs

Top section of stone apex to the front elevation is dislodged and requires securing.

See Quadriga repair methodology/specification in Appendix 2:

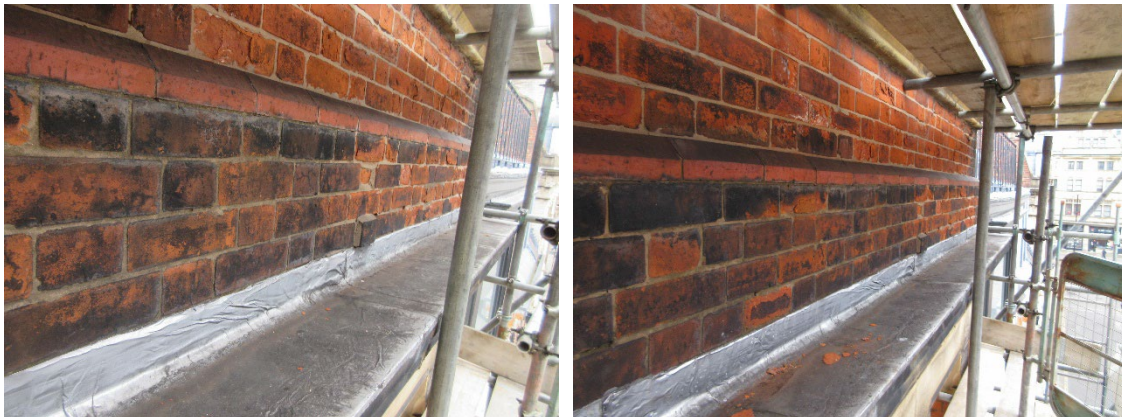
C&W Drawing 10 Ex Elevation drawing – repairs.

Inappropriate repairs to cornices with use of flashband.

See Quadriga repair methodology/specification in Appendix 2:

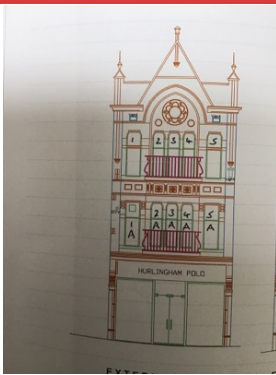
### WINDOW 1

No Repairs necessary, 5.9 LM Mastic required.

Top sash painted shut requires easing for painting purposes.

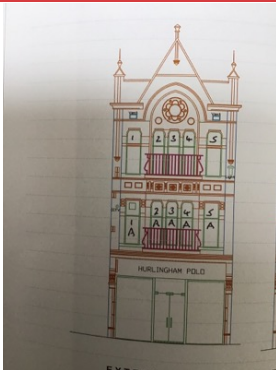
### WINDOW 2

Cracked glass to bottom sash 455 x 1270 mm.

5.5 LM of mastic required.

Top sash painted shut requires easing for painting purposes .

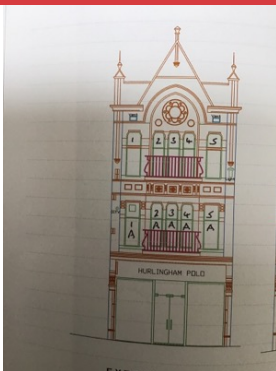
### WINDOW 3

No repairs necessary, 5.5 LM of mastic required .

Top sash painted shut requires easing for painting purposes.

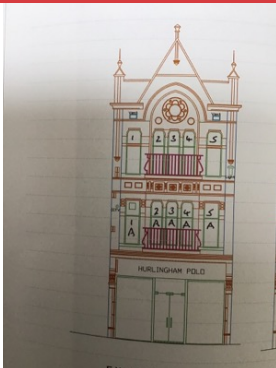
### WINDOW 4

No repairs required, 5.5 LM of mastic required .

Top sash painted shut requires easing for decoration purposes.

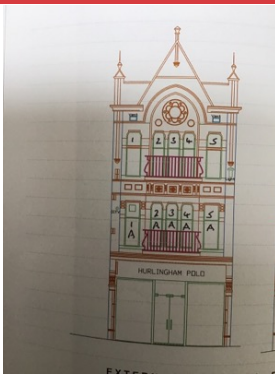
### **WINDOW 5**

No repairs required, 5.9 LMtrs off mastic required.

Top sash painted shut requires easing for decoration purposes.

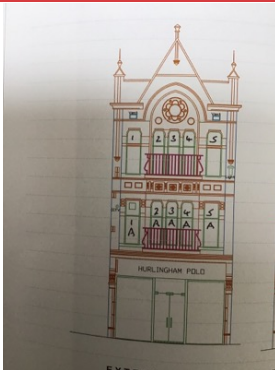
### **WINDOW 1A**

No repairs required, 5.9 LM of mastic required.

Top sash painted shut requires easing to allow for decoration purposes.

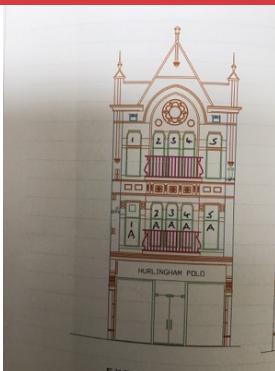
### **WINDOW 2A**

No repairs required, 5.5 LM of mastic required .

Top sash painted shut requires easing for decoration purposes.

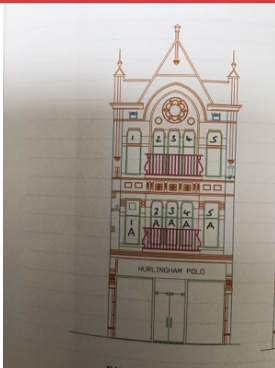
### **WINDOW 3A**

5.5 LM of mastic require .

Top sash painted shut requires easing for decoration purposes.

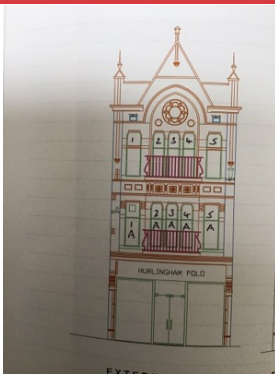
## WINDOW 4A

5.5 LM of mastic required .

Top sash painted shut requires easing for decoration purposes.

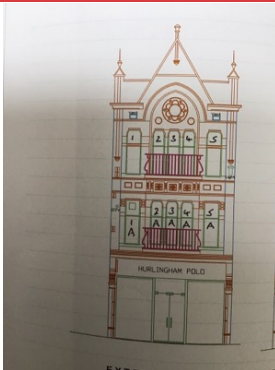
## WINDOW 5A

5.9 LM of mastic required.

Top sash painted shut requires easing for decoration purposes.

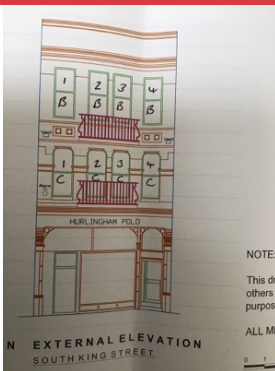
## WINDOW 1B

Parting bead missing to left hand side .

6.2 LM of mastic required.

Top sash painted shut requires easing for decoration purposes.

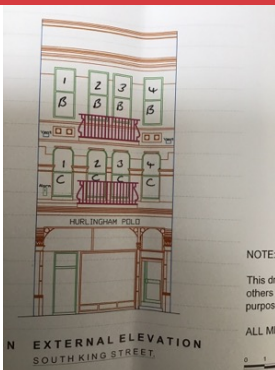
## WINDOW 2B

No repairs required, 6.2 LM of mastic required.

Top sash painted shut requires easing for decoration purposes.

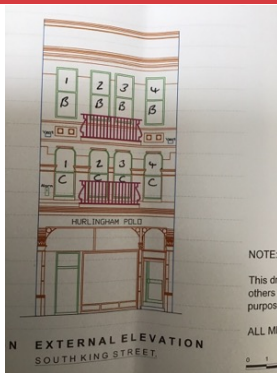
### WINDOW 3B

Replace window cill @900 mm.

Cracked glass to top sash @ 815 x 985 mm.

6.2 LM of mastic required.

Top sash painted shut requires easing for decoration purposes.

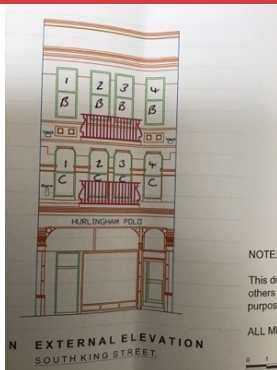
### WINDOW 4B

No repairs required, 6.2 LM of mastic required.

Top sash painted shut requires easing for decoration purposes.

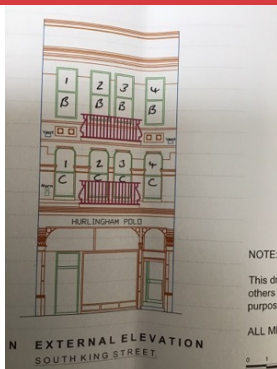
### WINDOW 1C

No repairs required, 6.2 LM of mastic required.

Top sash painted shut requires easing for decoration purposes.

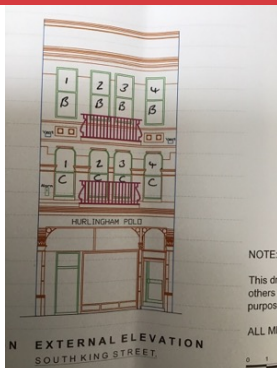
### WINDOW 2C

No repairs required, 6.2 LM of mastic required.

Top sash painted shut requires easing for decoration purposes.

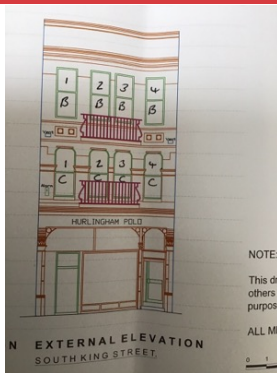
### WINDOW 3C

Cracked glass to top sash @ approx 1050 x 830

Template required.

Top sash painted shut requires easing for decoration purposes.

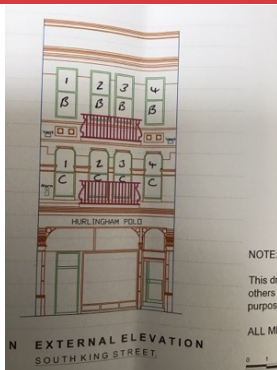
### WINDOW 4C

No repairs required, 6.2 LM of mastic required.

Top sash painted shut requires easing for decoration purposes.

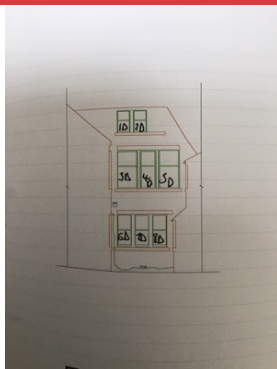
### WINDOW 1D

Both sashes painted shut require easing for decoration purposes.

Sash cord missing.

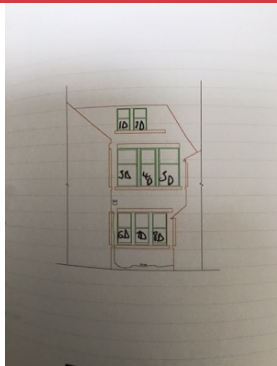
### WINDOW 2D

Top and bottom sashes painted shut requires easing for decoration purposes.

Sash cord missing .

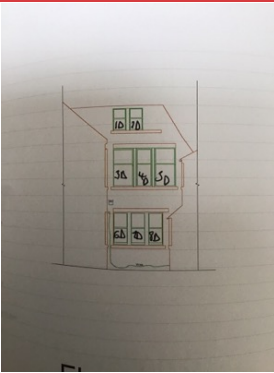
### **WINDOW 3D**

No repairs required,

Top sash painted shut requires easing for decoration purposes.

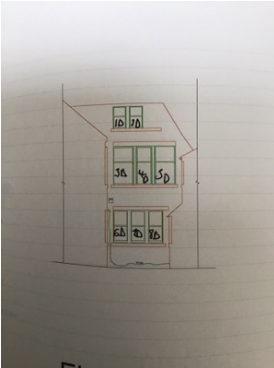
### **WINDOW 4D**

No repairs required.

Top sashes painted shut requires easing for decoration purposes.

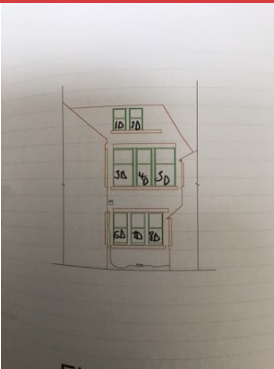
### **WINDOW 5D**

Cracked glass to bottom sash @ 1065 x 1055 mm .

Top sash painted shut requires easing for decoration purposes.

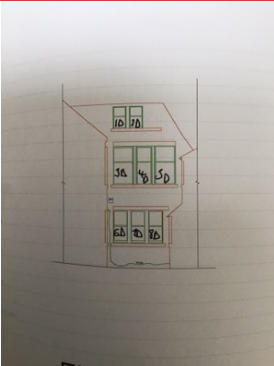
### **WINDOW 6D**

No repairs required,

Top sash painted shut requires easing for decoration purposes.

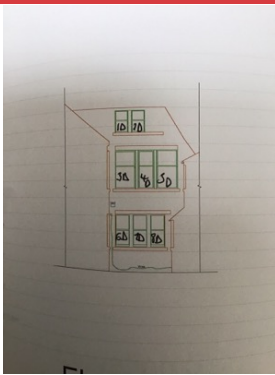
### **WINDOW 7D**

No repairs required

Top sash painted shut requires easing for decoration purposes.

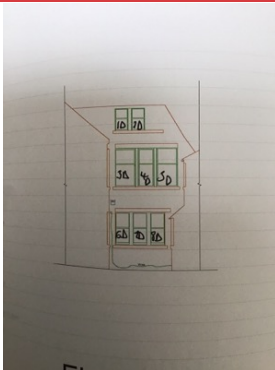
### **WINDOW 8 D**

Parting bead requires replacement 1 mtr

Top sash painted shut requires easing for decoration purposes.

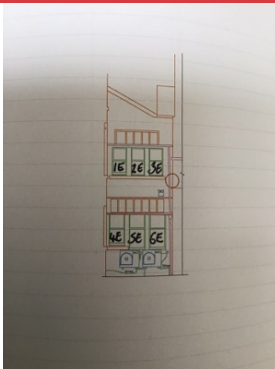
### **WINDOW 1E**

Small splice to parting bead required.

Top sash painted shut requires easing for decoration purposes.

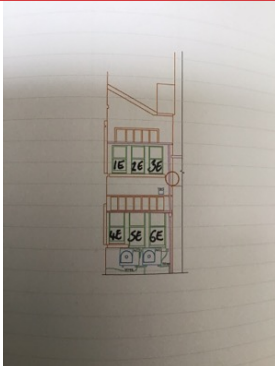
### **WINDOW 2E**

2 small splices required to parting bead.

Top sash painted shut requires easing for decoration purposes.

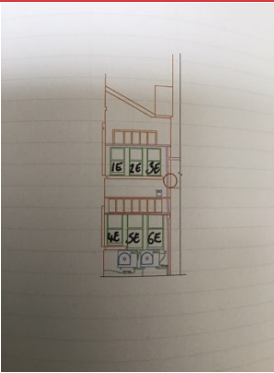
### WINDOW 3E

Broken glass to bottom sash @ 600 x 550mm .

2 small splices to parting beads required.

Top sash painted shut requires easing for decoration purposes.

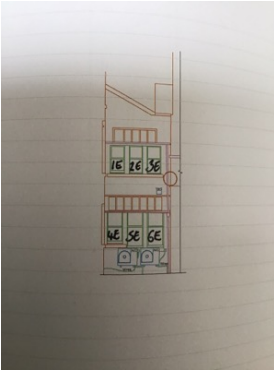
### WINDOW 4E

Cracked glass requires replacement @ 700 x 875 mm . ( frosted )

Top sash painted shut requires easing for decoration purposes.

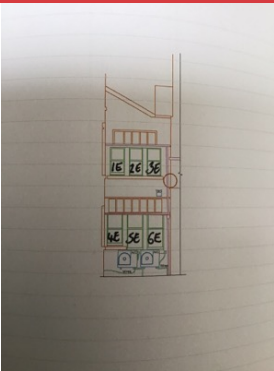
### WINDOW 5E

No repairs required.

Top sashes painted shut requires easing for decoration purposes.

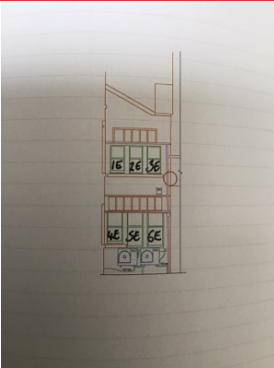
### WINDOW 6E

Small splices required to both parting beads .

Top sash painted shut requires easing for decoration purposes.

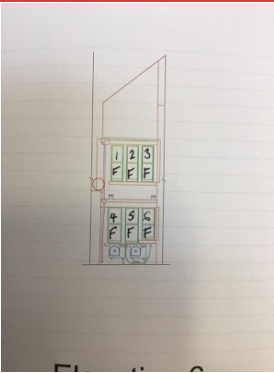
### WINDOW 1F

Top sash painted shut requires easing for decoration purposes.

Sash cords missing

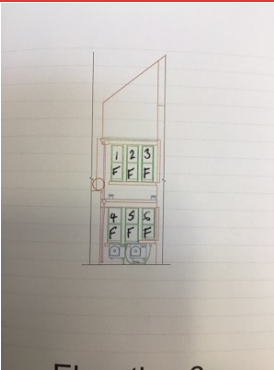
### WINDOW 2F

Top sash painted shut requires easing for decoration purposes.

Sash cords missing .

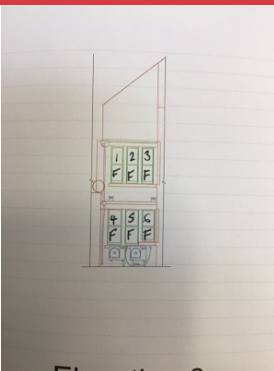
### WINDOW 3F

Top sash painted shut requires easing for decoration purposes.

Sash cords are missing .

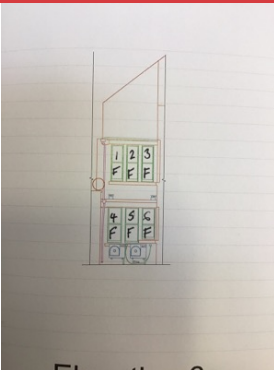
### WINDOW 4F

No repairs required.

Top sash painted shut requires easing for decoration purposes.

Sash cord missing .

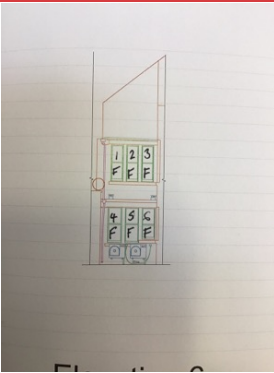
### **WINDOW 5F**

No repairs required.

Top sash painted shut requires easing for decoration purposes.

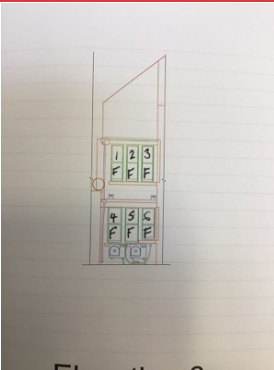
### **WINDOW 6F**

No repairs required.

Sash cord missing.

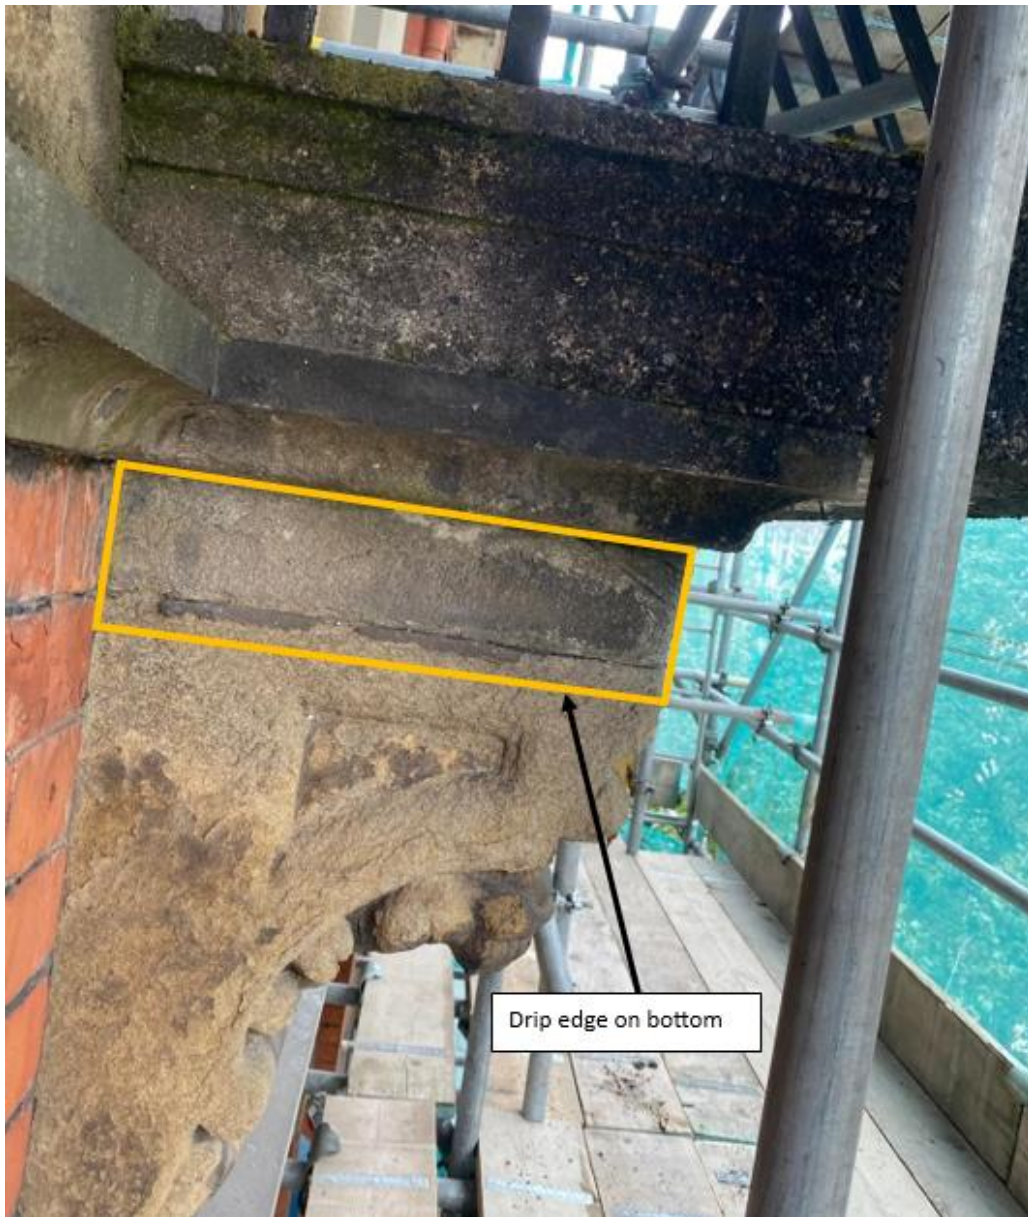
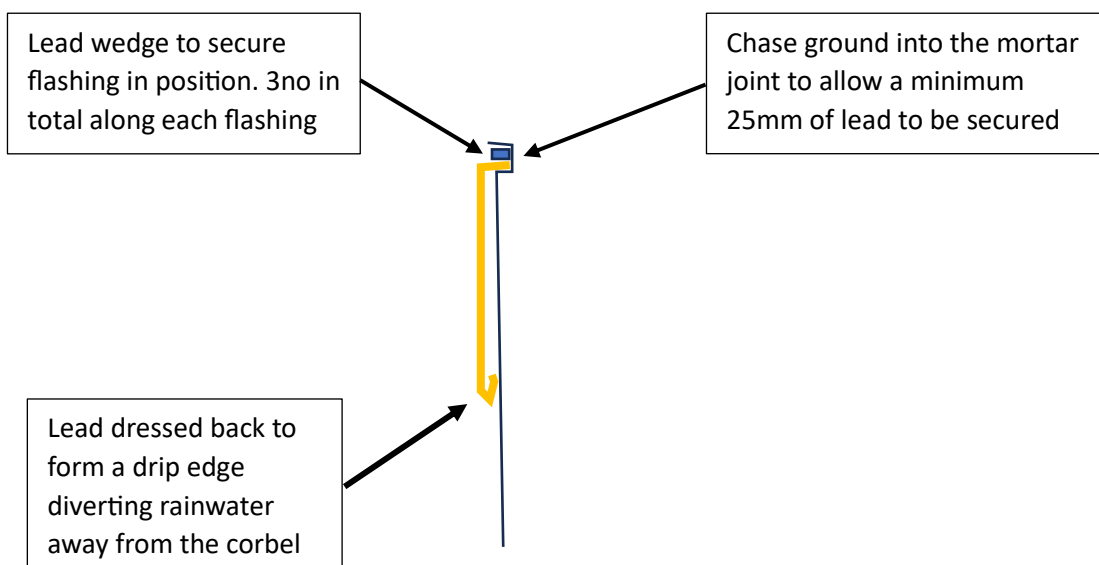
- Item 6. Lead flashing to balcony

Stone to underside of balcony to front elevation is being eroded by water run off from balcony surface. In order to protect stonework, allow to install lead flashing drip detail.

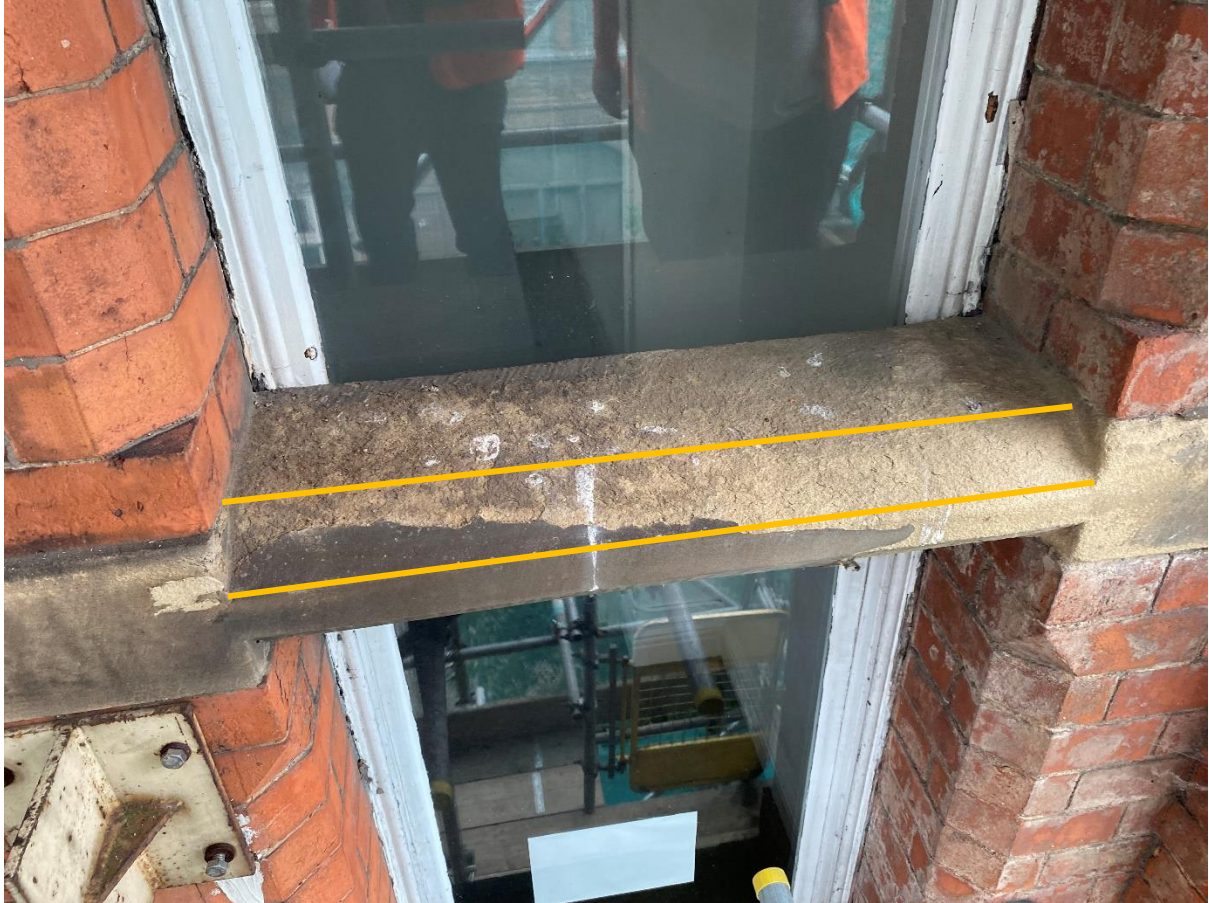
- Item 7. Stone repairs

Stone sills are eroded in places and require repair to ensure water is discharged away from the building.

- Stone is to be de-frassed and cleaned back to a good quality substrate
- Straight edges will be built up with a repair mortar and worked by hand with a trowel
- Once the lower straight edge has been established, the next one up will be re-established to ensure water can run off the sills and away from the building in the future
- Colour to be agreed with the CA before repairs take place
