# Chetham's School of Music, Manchester

## Results of Architectural Paint Research

31/01/2024

| Nature of Project | Architectural Paint Research to selected interior facets within the fire damaged music hall. |

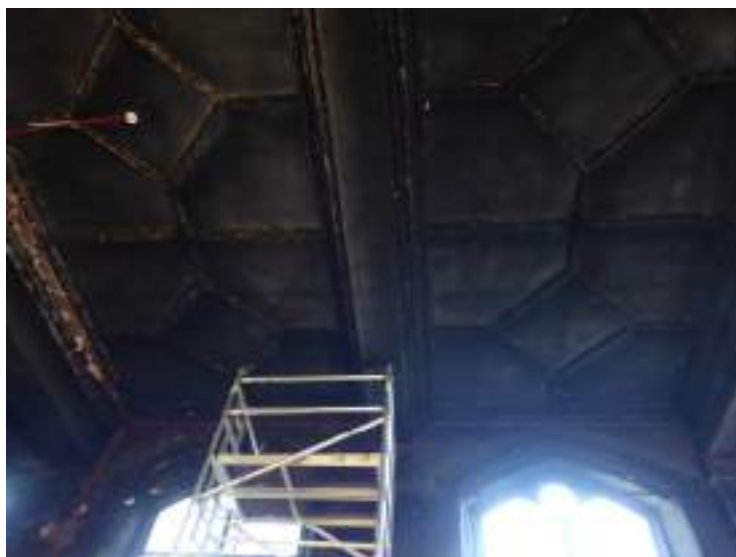
*Figure 13: The blackened ceiling to the west side of Whiteley Hall.*

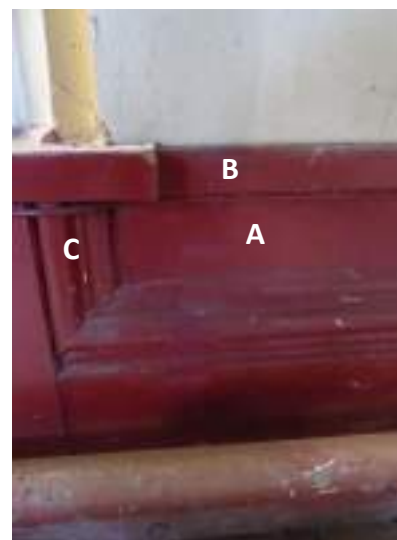
- Later timber baton
- Section of wall plaster incorporated into skirting section.
- Lower section of timber skirting – possibly with the upper portion a later addition.

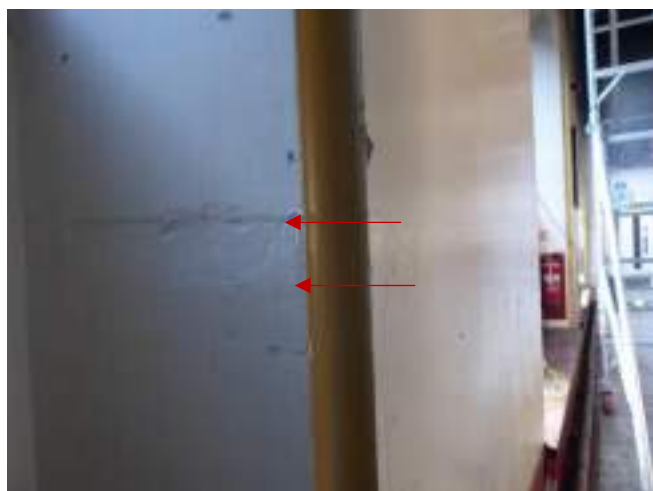
*Figure 15: west elevation window reveal showing an apparent break in the underlying paint films.*

Such gaps were not easy to photograph but have been shown from one of the window recesses to the east elevation in Figure 15.

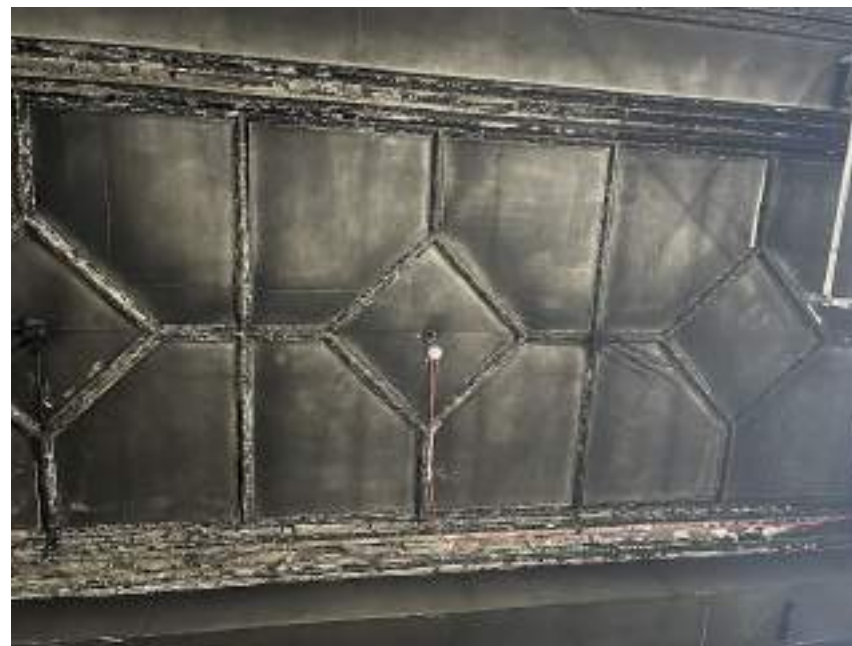
*Figure 16: detail of the fire damaged ceiling taken on the day of sampling.*

A number of areas contained failing paint films and all areas of flaking paint should be removed prior to redecoration. Whilst every effort should be made to retain paint archaeology suitable preparation is required to ensure appropriate bonding of the paint films, especially given the elevated nature of the facets and any future access limitations.

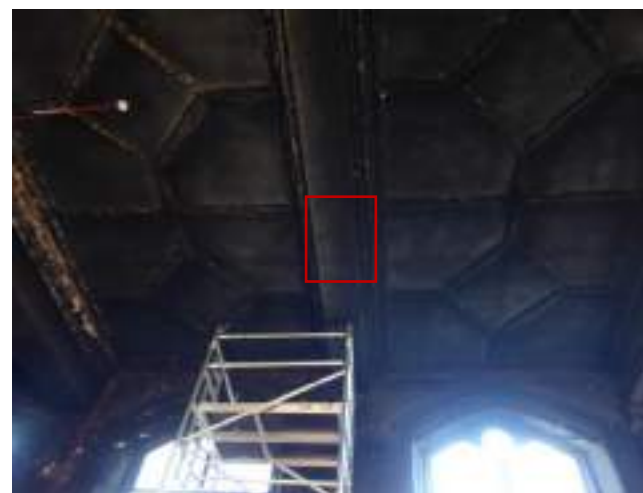
This modification is noted in the architect's report however a use of a wire mesh was outlined in the architects reports but was not identified in the ceiling panel inspected by the conservator to the west side of the room (Figure 18).

*Figure 18: section of ceiling showing suspected area of additional plaster skim.*

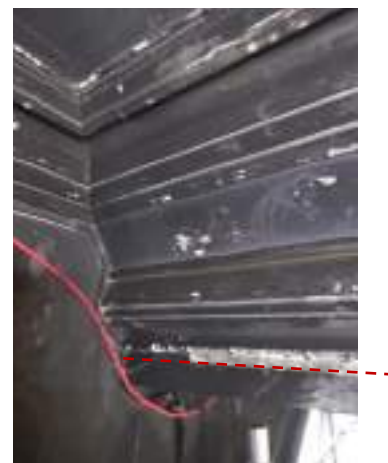
Underside of beam casing that appears to have had an additional coat of gypsum-based plaster.

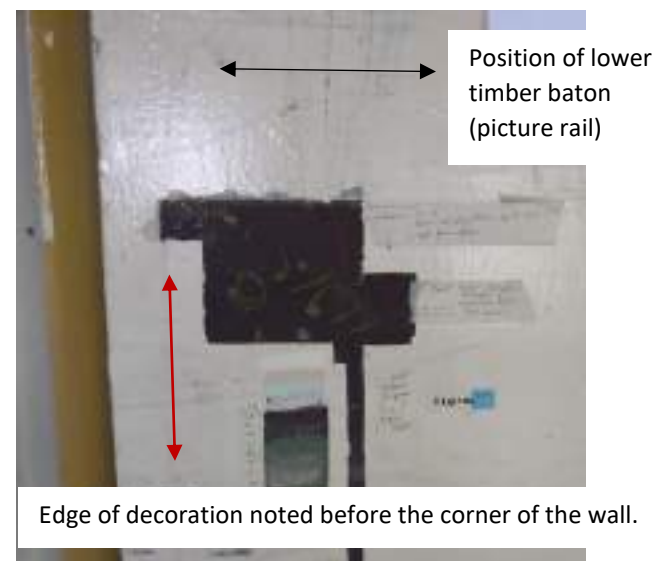
We then see the introduction of a dark red applied to the lower walls with some indication of the use of yellow to the upper section of the walls. The dark red colour was primarily applied to the lower wall from the skirting up to the first timber baton / picture rail. Whilst there appears to be two schemes of red there is an indication that the second scheme seen in the cross sections was a secondary layer applied to the first scheme to create the effect of a grain in the brush stroke. This was evident as a vertical "grain" up to just below the timber baton with a broad horizontal "grain" just below it. There is also evidence to the west wall of a gap at the corner of the wall into the window recess (see Figure 26). Details of what this might have been has not been identified and did not appear to continue above the height of the lower picture rail.

*Figure 26: area of exposed decoration to the west wall.*

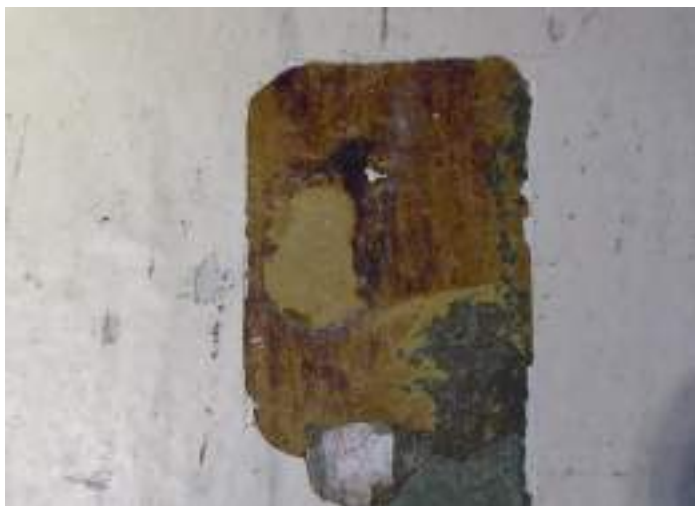
The dark red colour scheme was painted out with a strong yellow colour prior to the introduction of modern pastel paint schemes. There is evidence in the samples taken from the east wall, and seen in uncovering of the paint layers, that this was also painted over with a varnish or similar oil-based film. This has not been analysed in detail though does react to ultraviolet light and appears tacky when exposed, the film has also discoloured and now appears quite brown. It is likely that this is an organic oil-based varnish coating perhaps applied both as a protective and decorative finish to the lower wall (Figure 27).

*Figure 27: image of exposed yellow scheme with darkened coating applied over.*

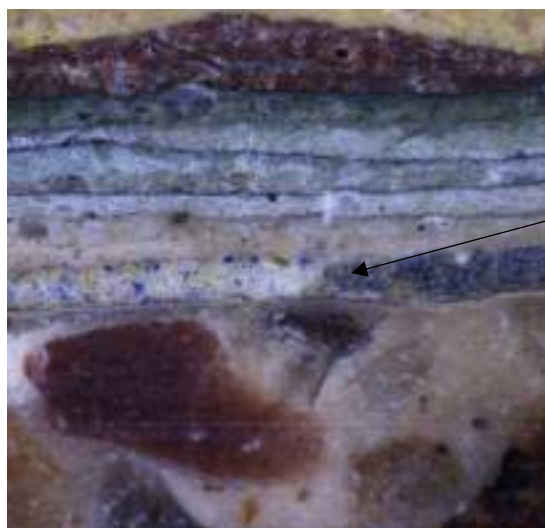
The earliest scheme seen to the walls is a dull grey colour semi-opaque distemper. The paint film has discoloured perhaps as a result of the impact of gas lighting and the reaction of the pigments with sulphur & carbon produced by the gas lighting. Electric lighting was not installed in the school until 1905 so this would be plausible.

Note colour change  
(darkening) within  
paint film.

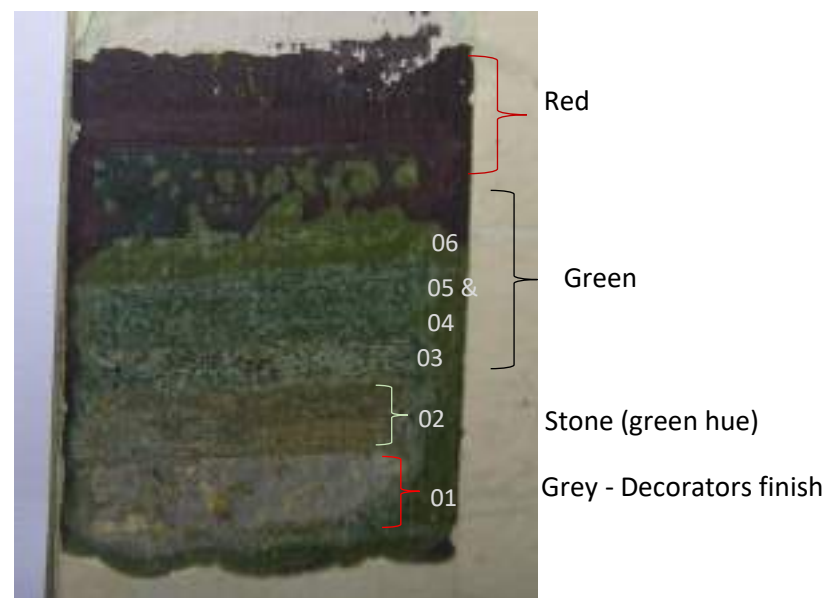
*Figure 30: image of exposed schemes of decoration applied to the wall (corresponding to sample 06)*

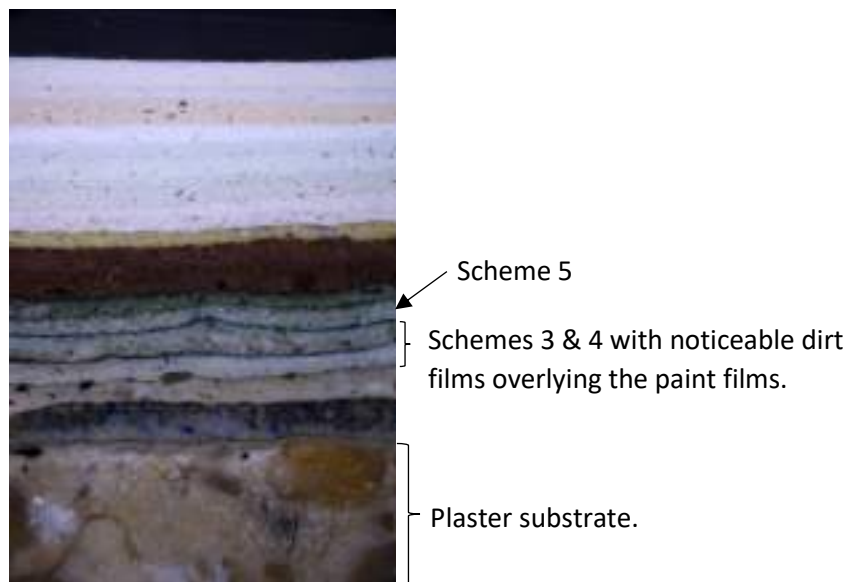
*Figure 33: Wall sample (06 at 200x mag) showing reduction in dirt films from scheme 5 onwards.*

There is a noted reduction in the dirt films seen over schemes three and four than seen to scheme five. This may suggest that this scheme was applied after the introduction of electric lighting in 1905. Though it can also indicate that redecoration occurred earlier in the maintenance schedule so there was a shorter period of time for dirt deposits to settle onto the paint films.

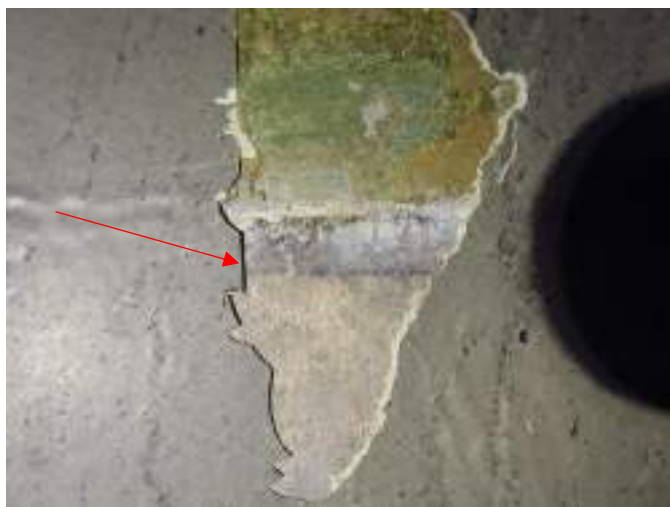
However limited investigation during the return visit of an upper area of the wall, accessible from the staircase to the mezzanine seating, suggests that any colour variation up the wall was limited. It was also noted a pencil line appears to survive for the marking up of the placement of the timber batons / picture rails as indicated in the image below from the east wall.

*Figure 36: detail of upper wall paint exposure where pencil lines are seen in the void where a timber baton has been removed.*

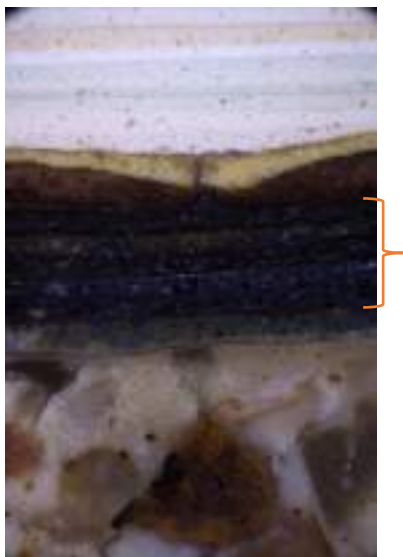
**Sample 06 (200x mag) - Pb**

The earliest paint films were found to contain lead which is toxic. Where paint removal is to be undertaken, methods should ensure safe working practice. Therefore, dry removal should be avoided to prevent the creation of air-borne, lead-containing dust, unless suitable extraction with a HEPA filter can be in place. The use of a heat gun should also not be used without the operative wearing suitable PPE and appropriate Hot Works permits in place. Any waste material from the use of paint strippers should be disposed of according to lead contaminated waste regulations.
