**111 DEANS\_GATE M3 2BQ - photographic audit in support of LBC application**

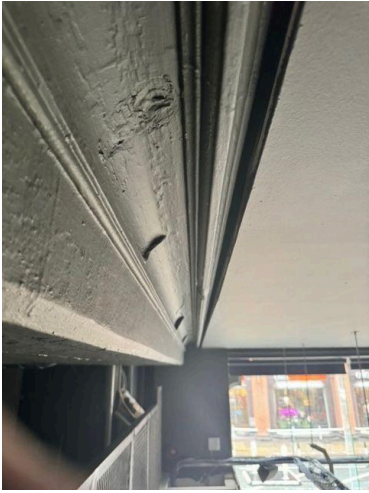
| <p>1 - Detail of RHS original cornice abutting recent plasterboard ceiling</p> | <p>2 - Existing high level mesh panels to be retained - cornice / plasterboard ceiling abutment to RHS</p> |

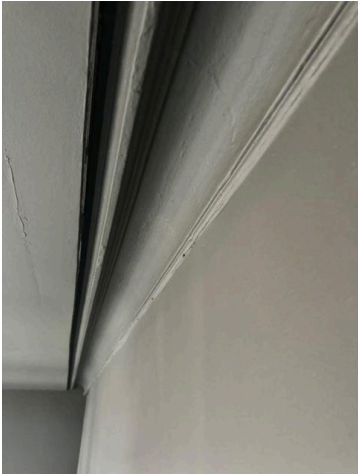
| <p>2 - Detail of rear wall original cornice abutting recent plasterboard ceiling</p> | <p>4 - existing fixings into non-original plasterboard ceiling</p> |

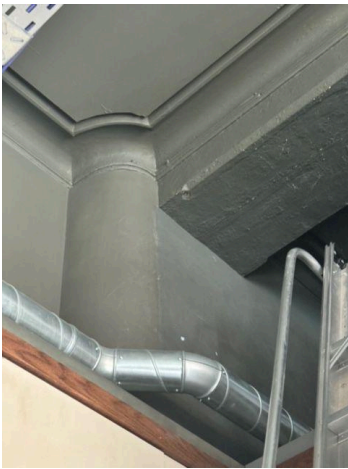
| <p>5 - NE corner high level curved column above recent boxing out</p> | <p>6 - NE corner showing original cornice and recent plasterboard infill - note edge of exposed plasterboard</p> |

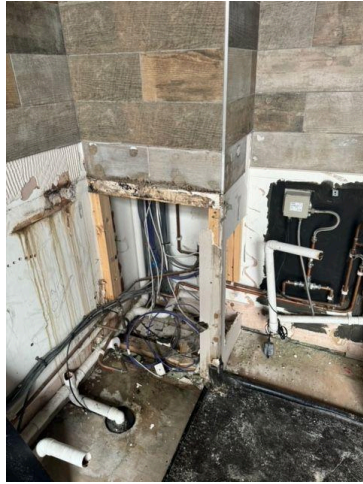
7 - Non- original boxing out to be removed

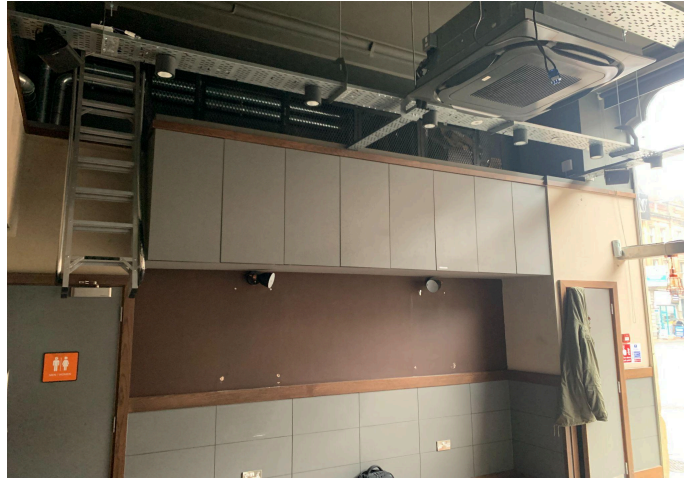
8 - non-original high level joinery / wall lining to be removed

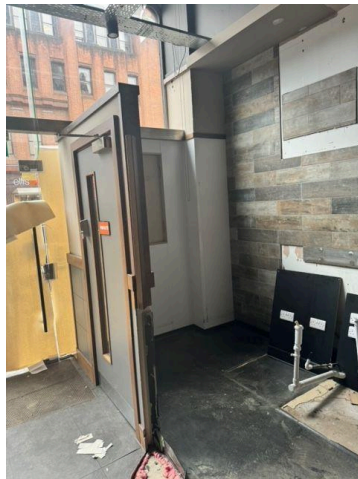
9 - free standing / non original door frame / partition to be removed

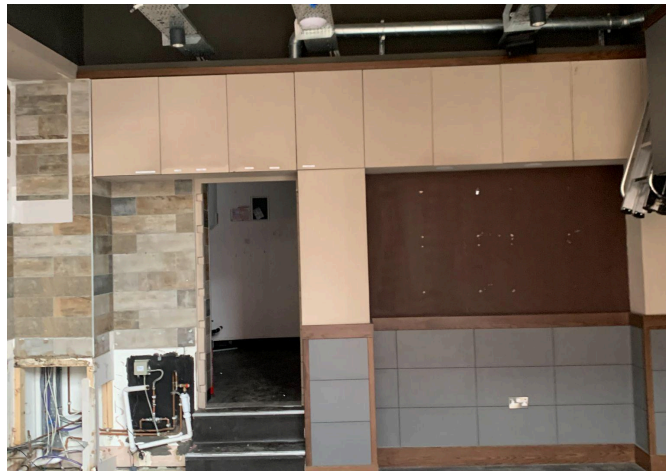
10 - non original high level joinery and column to rear wall / wall lining to be removed

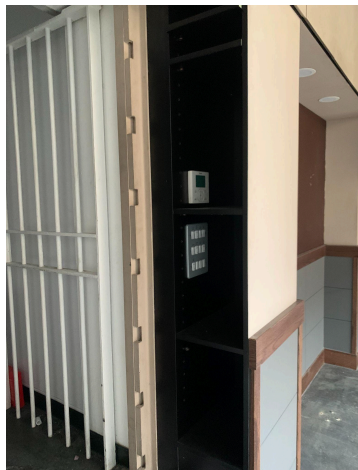
11 - non original column and wall lining to be removed -vault gate to be retained

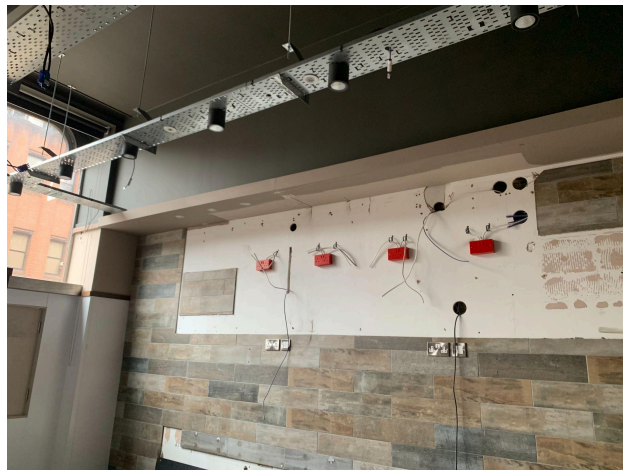
12 - non-original high level bulkhead to be removed; note white wall lining behind tiling is to be retained (non-original)
