Doc Ref: **2951-BCL-00-XX-RP-S-0001**

**Cardinal Partnership Ltd**  
**Leestone Road**  
**Sharston Industrial Estate**  
**M22 4RB**

**Cardinal Partnership**  
**Harling Road**  
**Wythenshawe**  
**M22 4UZ**

**Structural Inspection Report**

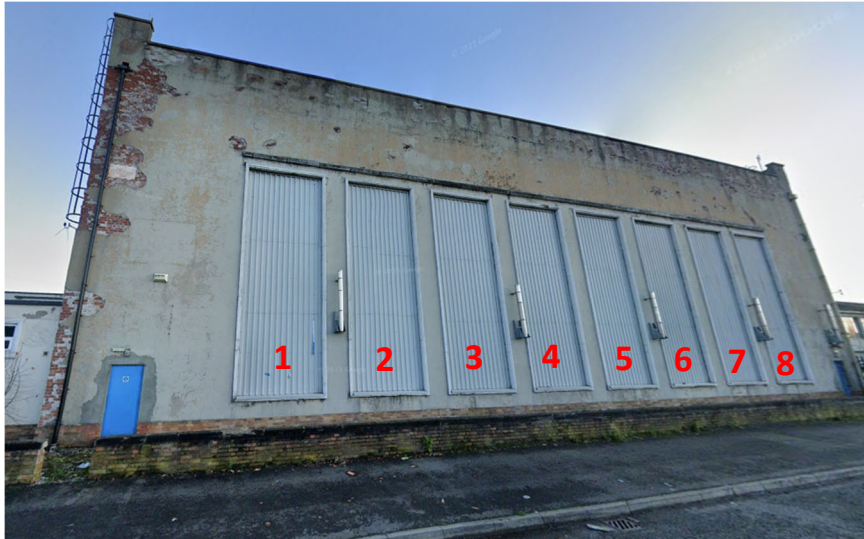
- 4.1.1 The north-west elevation was a large rendered masonry elevation with 8 No large windows, parapet and rainwater hoppers and downpipes at each end of the elevation (Photo 2).

Photo 2. North-west elevation

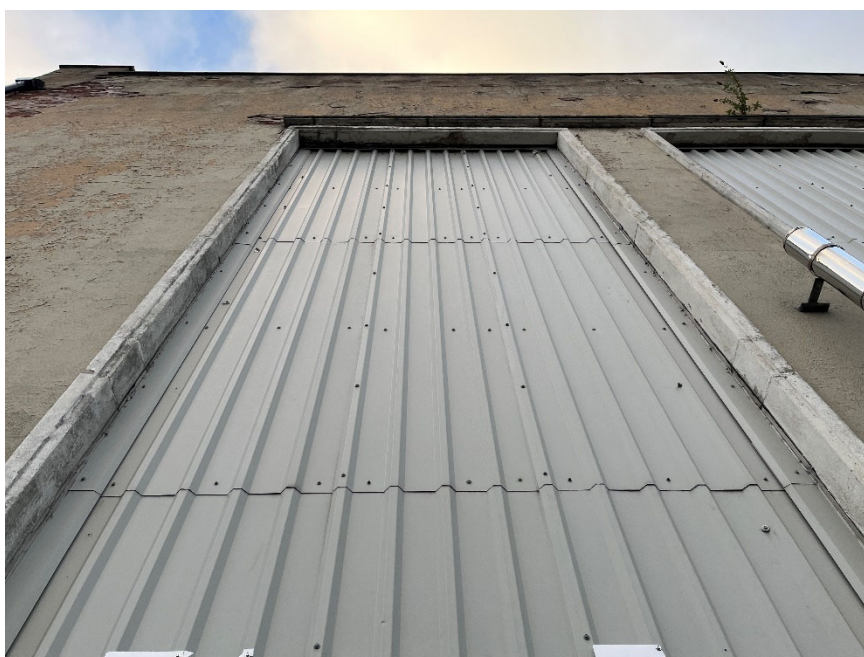
Photo 3. Typical window detail with profiled surround and head

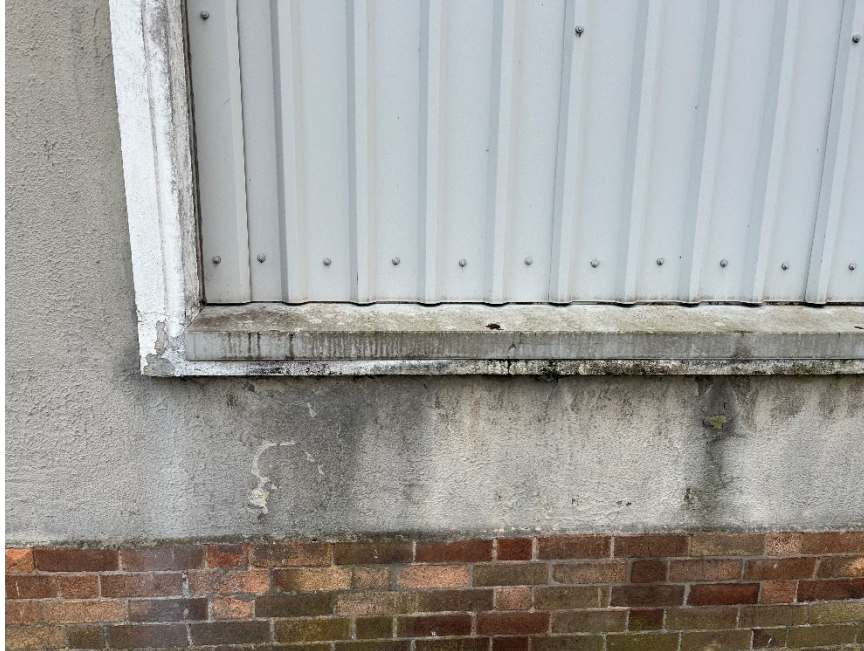
- 4.1.4 Each window had been infilled with profile metal cladding and a pressed-metal cill flashing over the original cill section, meaning it was not possible to inspect the cill element (Photo 4).

Photo 4. Typical window cill with pressed-metal flashing

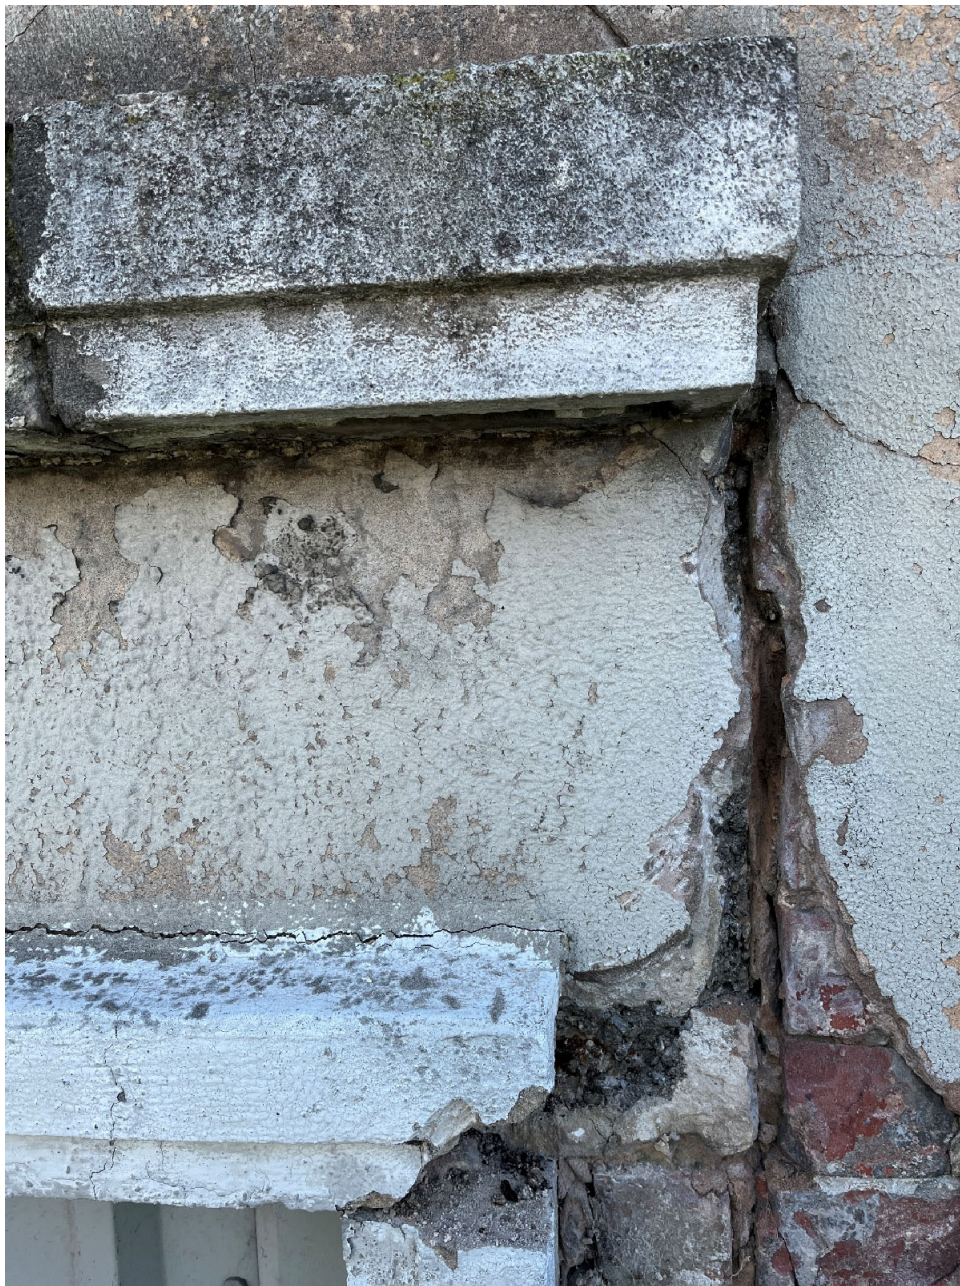
- 4.1.7 At the top right-hand corner of window 8, there was loose material around the window surround and the end of the concrete lintel and so this location was used to remove loose material to inspect and understand the core of the structure (Photo 5). The structure consisted of a 420mm deep concrete lintel with 100mm bearing on to the masonry wall at the window reveal. Above the lintel was a 140mm deep projecting stone band in segments that ran continuously above all 8 windows. The head of the window surround was integral with the concrete lintel and there was cracking between the projecting window surround and the concrete lintel. The window jambs were segmental and in separate pieces to the window head and lintel.

Photo 5. Top right-hand corner of window 8 showing structural arrangement

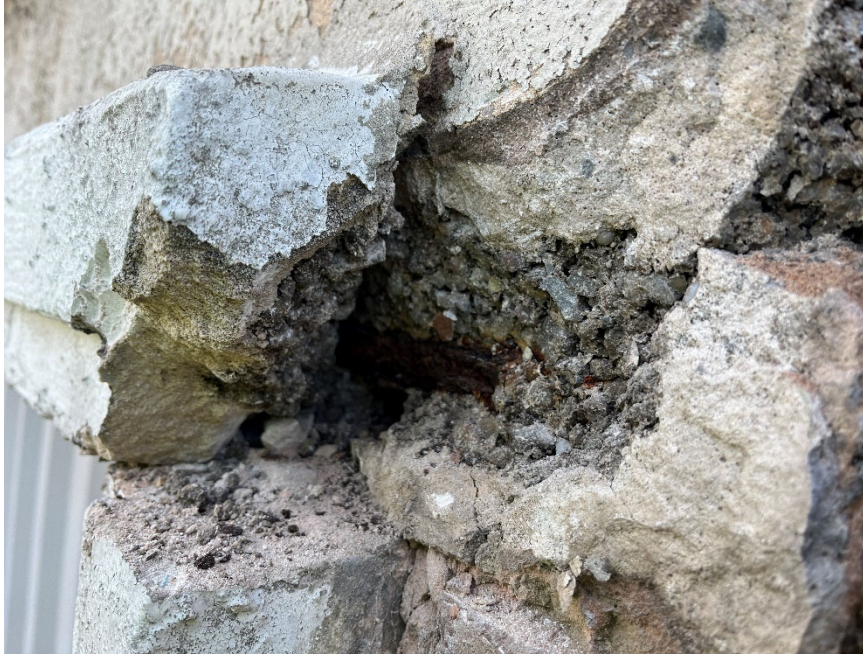
- 4.1.8 Closer inspection of the window head revealed the lintel and window head to be a single element of cast-stone construction with 30-40mm cast stone surface finish and aggregate concrete core (Photo 6). A single reinforcing bar was visible within the concrete core and was visibly corroded. There was no reinforcement present within the projecting window surround and no clear evidence of any links within the lintel.

Photo 6. Integral window head and lintel

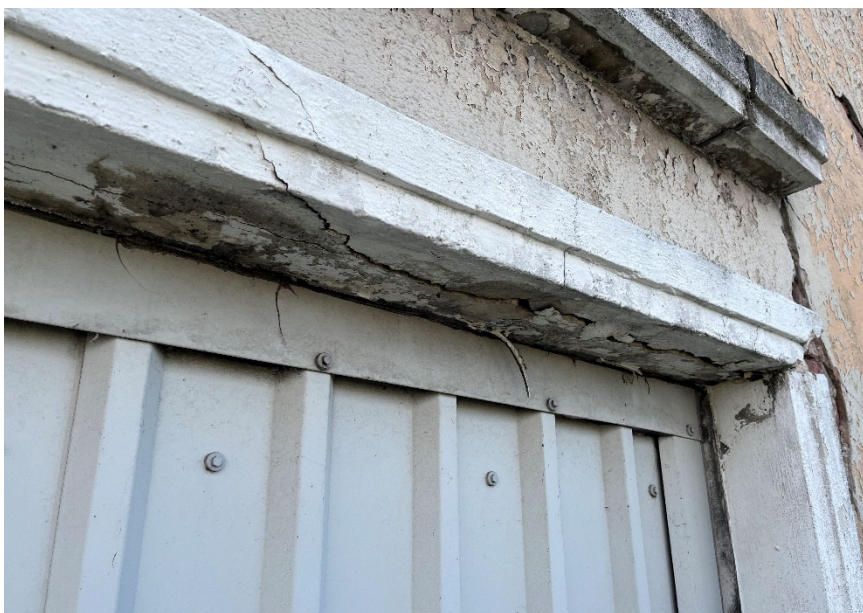
- 4.1.9 Inspection of the lintel from below showed there to be a continuous longitudinal crack at the junction between the deep concrete lintel and the projecting window surround profile (Photo 7). This location coincided with the corner reinforcing bar within the lintel.

Photo 7. Longitudinal crack to soffit of concrete lintel

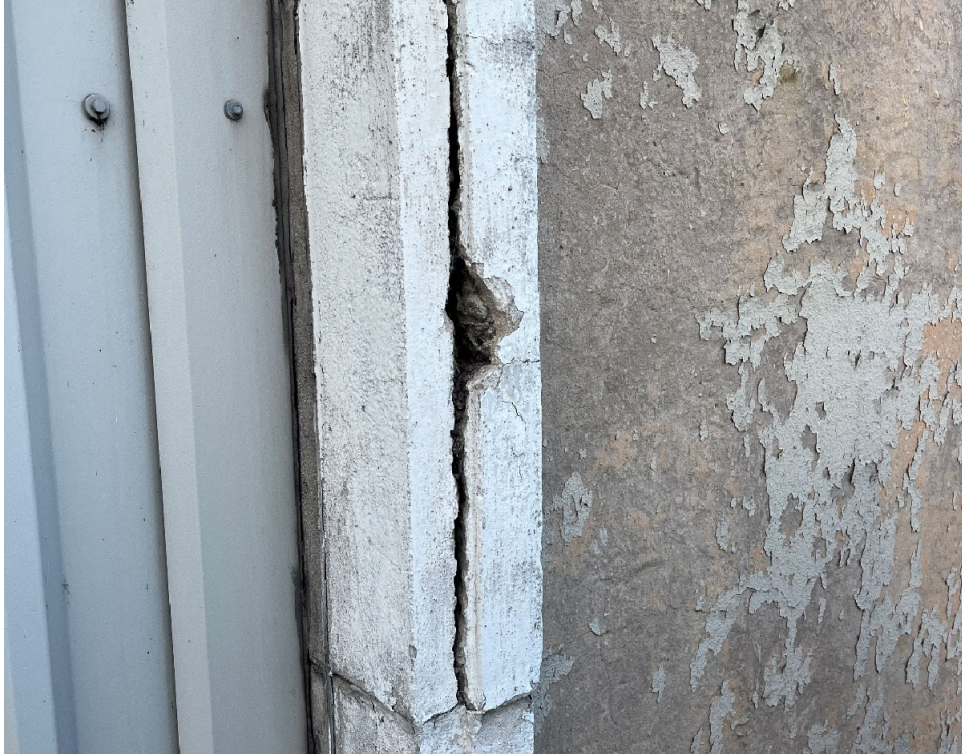
4.1.10 One of the right-hand window jamb sections of window 8 also showed signs of spalling (Photo 8), and closer inspection of this section revealed the same cast stone construction with aggregate concrete core (Photo 9). The connection between the window jamb sections nor between the window jamb and masonry wall could not be determined without removal of a section of the jamb.

Photo 8. Spalling window jamb to right-hand side of window 8

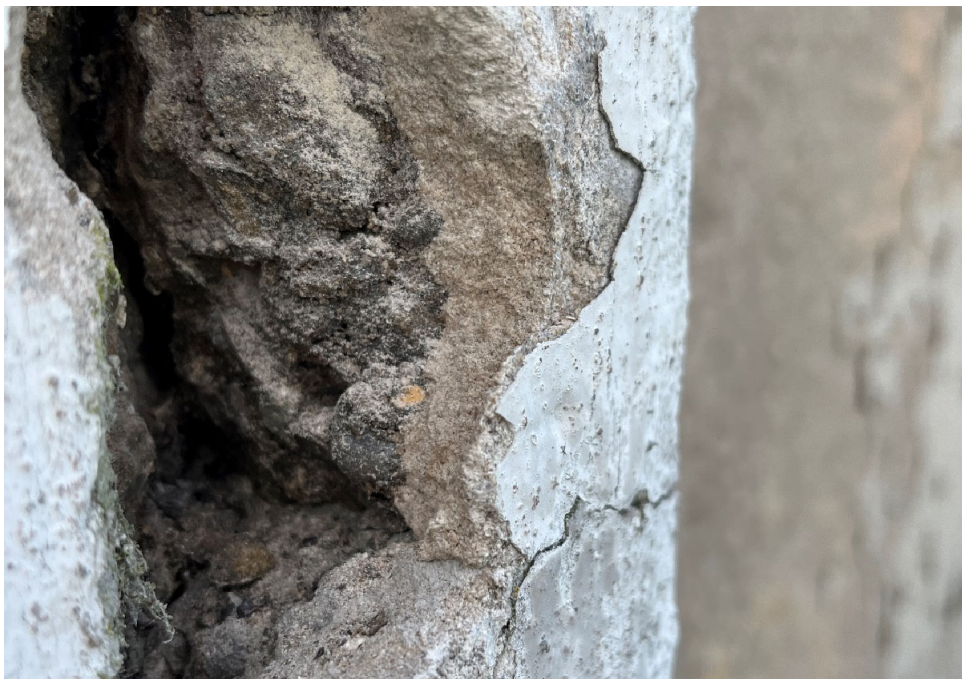
Photo 9. Cast stone window jamb section

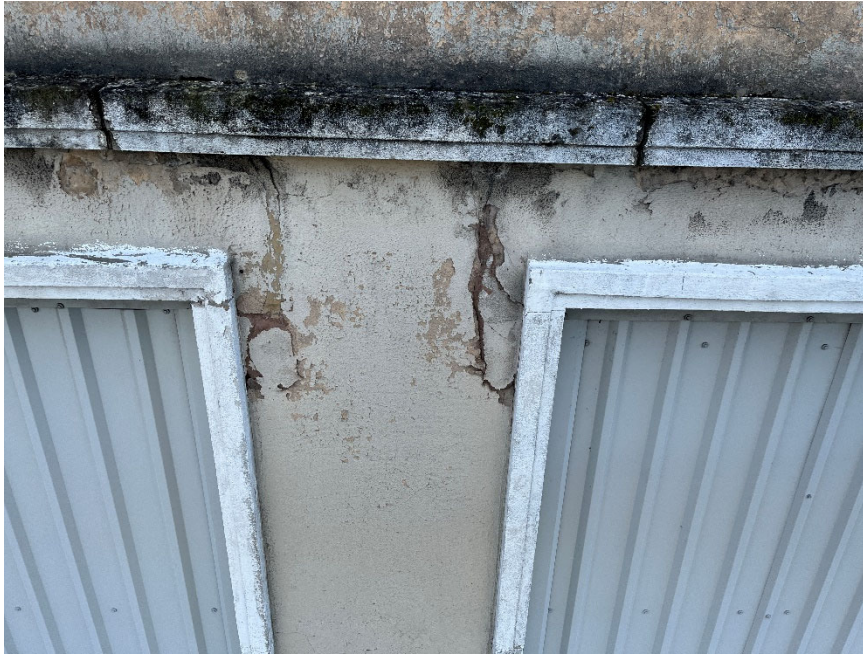
- 4.1.11 Between windows 7 and 8, the extent of spalling was less severe, however there was visible cracking and spalling of the render at the interface between the end of the concrete lintel and the supporting masonry wall (Photo 10).

Photo 10. Cracking and spalling between windows 7 and 8

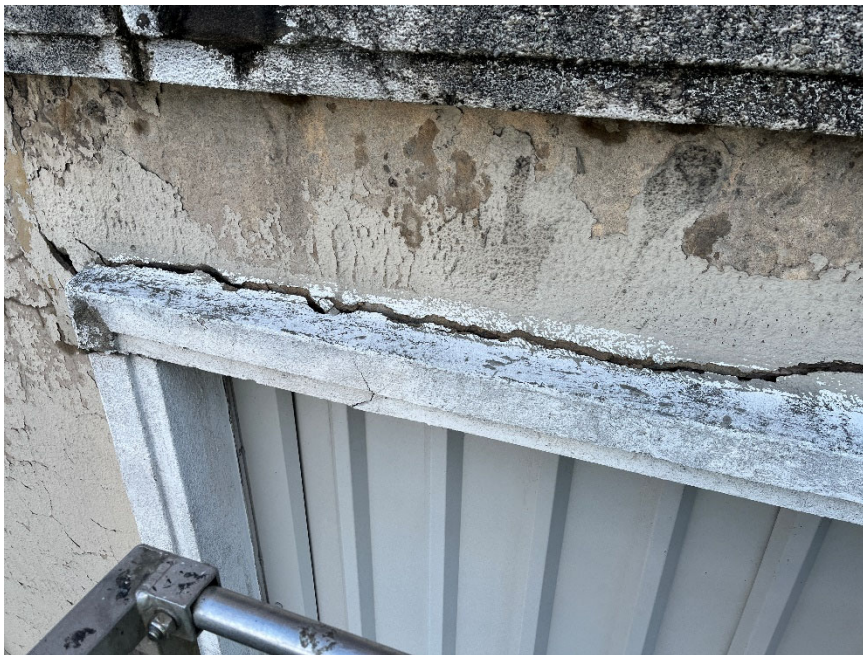
- 4.1.12 The left-hand side of window 7 was in a similar condition to the right-hand side of window 8, with cracking between the concrete lintel and the projecting window surround (Photo 11). It appeared there were inherent defects in the form of construction of the lintels and window surrounds, though the severity of the corrosion and thus the extent of cracking and spalling varied at each location.

Photo 11. Cracking to left-hand side of window 7

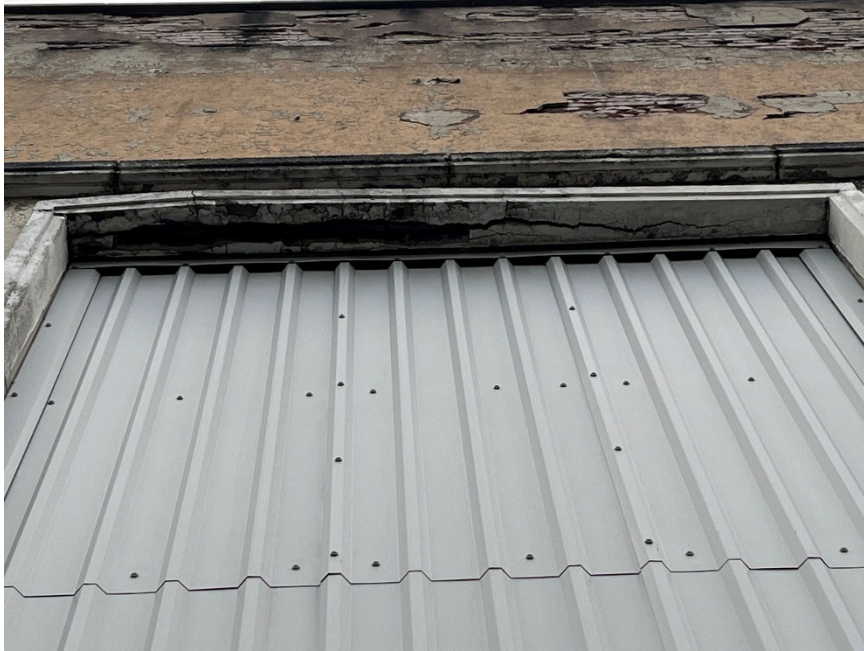
- 4.1.13 The head of window 6 was the most severely affected of the 8 No windows, with clear daylight present between the concrete lintel and the projecting window surround, and large sections being at imminent risk of falling from the building (Photo 12).

Photo 12. Head of window 6 with severe spalling and risk of debris falling

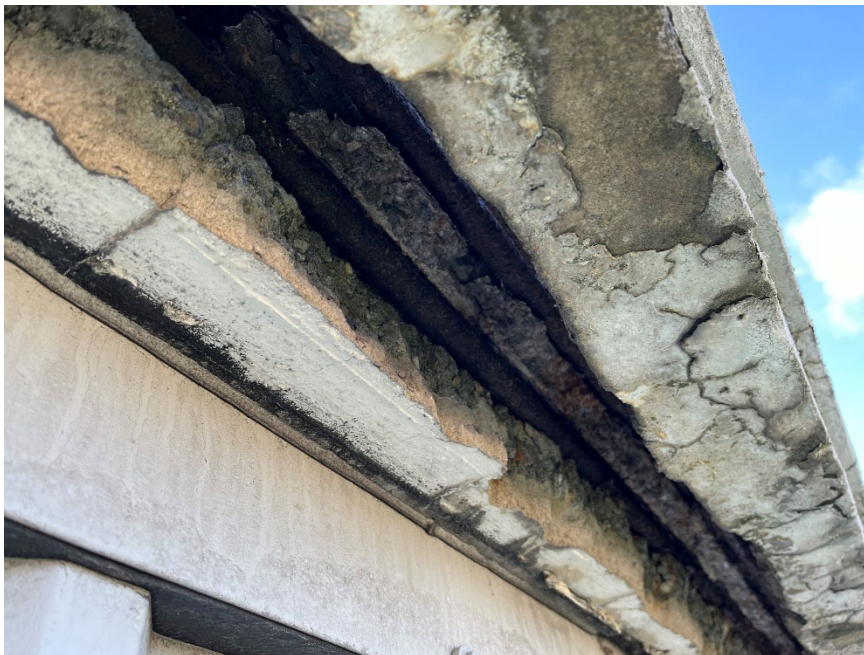
- 4.1.14 Two bottom reinforcing bars were visible at the head of window 6, with the outside bar being in the same location as seen at window 8 (Photo 13). The long lengths of reinforcing bar visible confirmed there to be no link reinforcement in the lintel and no reinforcement between the lintel and window surround profile.

Photo 13. Reinforcing bars visible to underside of window 6 lintel

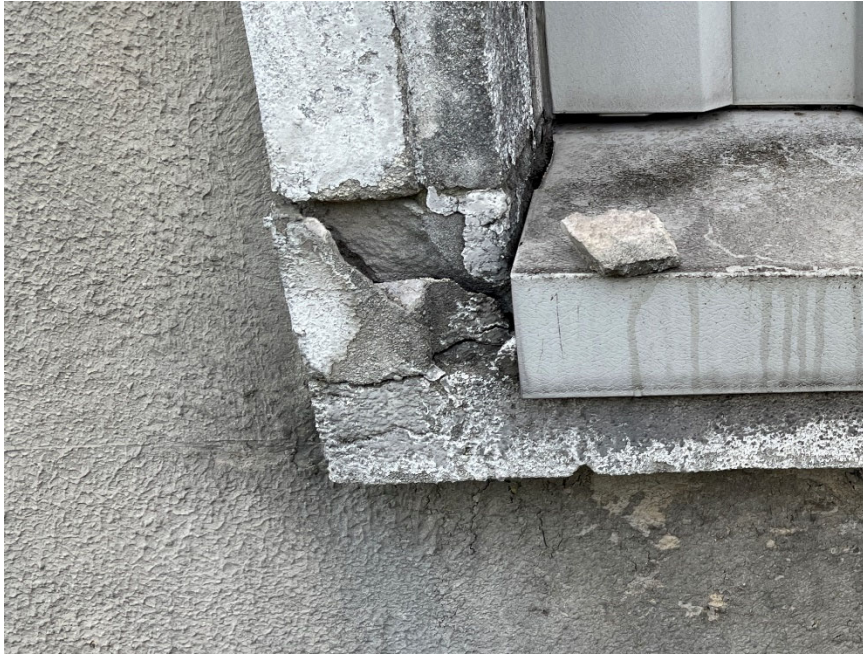
- 4.1.15 Window 5 was in a similar condition to the other windows, with continuous longitudinal cracks visible above and below the projecting window head section. In addition, there was spalling at the bottom left-hand corner of the window surround (Photo 14).

Photo 14. Spalling to bottom left-hand corner of window 6 surround

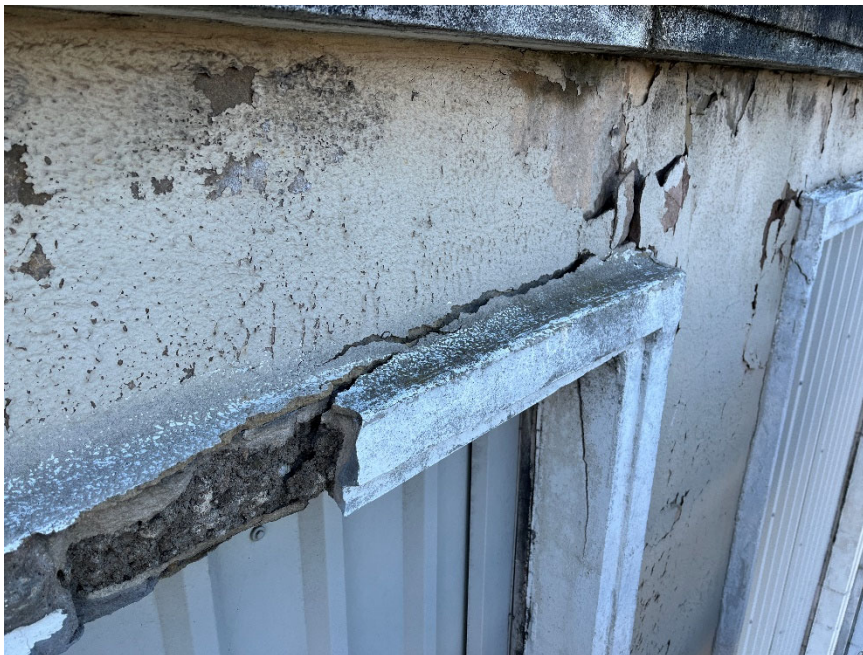
- 4.1.16 A large section had already fallen from the building at the head of window 4 (Photo 15) and there was a large open joint at the interface between the lintel and the head of the right-hand window surround.

Photo 15. Large section fallen from the lintel of window 4

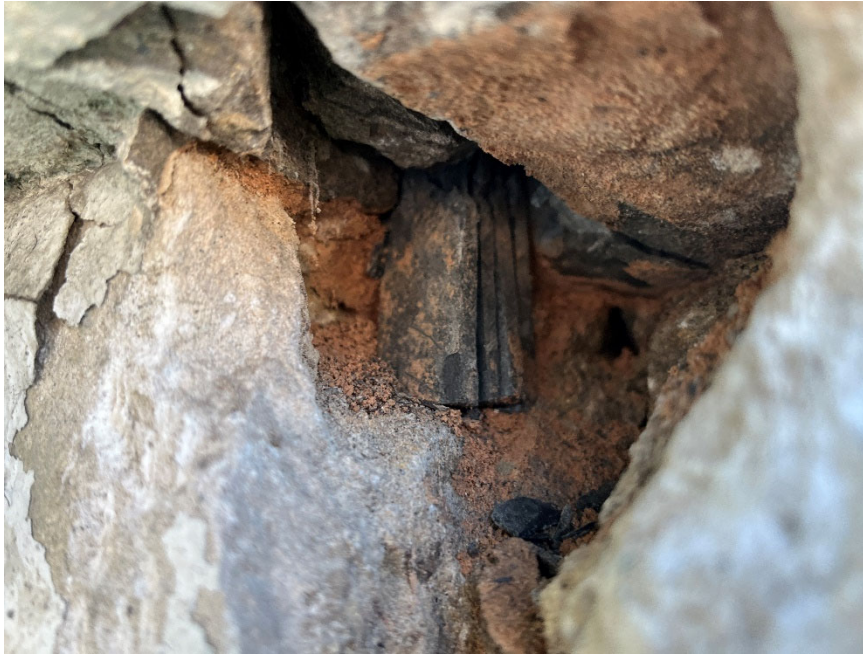
- 4.1.17 Investigation of the open joint at the head of the window surround revealed there to be slate pins between the adjacent cast stone sections (Photo 16). There was no other evidence of any connection between adjacent units, for example dowels, straps or other reinforcement.

Photo 16. Slate pins between adjacent window surround panels

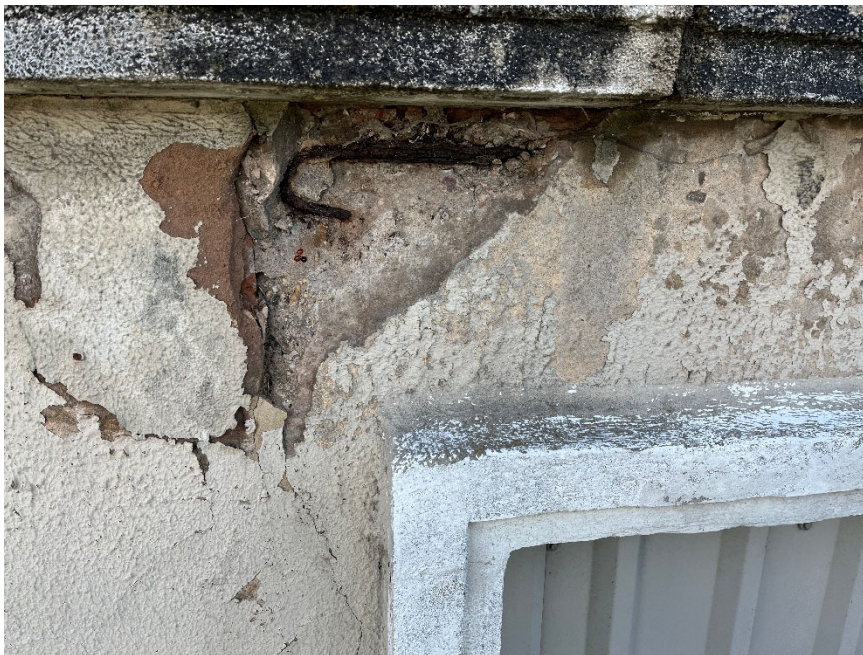
- 4.1.18 Window 3 was in a relatively good condition, with limited longitudinal cracking, however the front face of the lintel had spalled at the left-hand support and revealed the hooked end of the lintel top reinforcing bar (Photo 17).

Photo 17. Hooked end of reinforcing bar visible to window 3 head

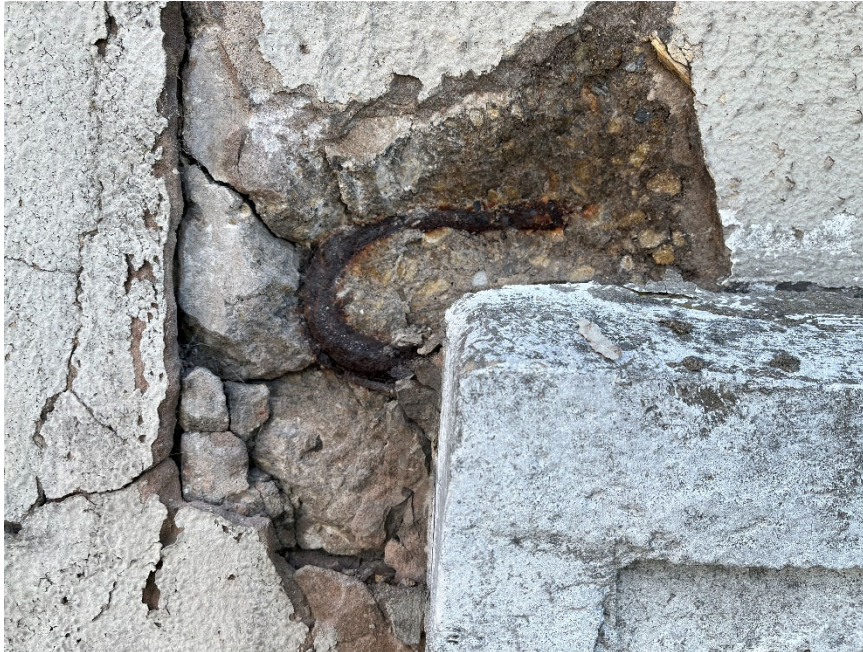
4.1.20 Window 1 had longitudinal cracking similar to seen on other windows, and the bottom reinforcing bar was visible and confirmed a similar hooked end to the top reinforcing bars (Photo 18).

Photo 18. Exposed bottom reinforcing bar to left-hand side of window 1 lintel

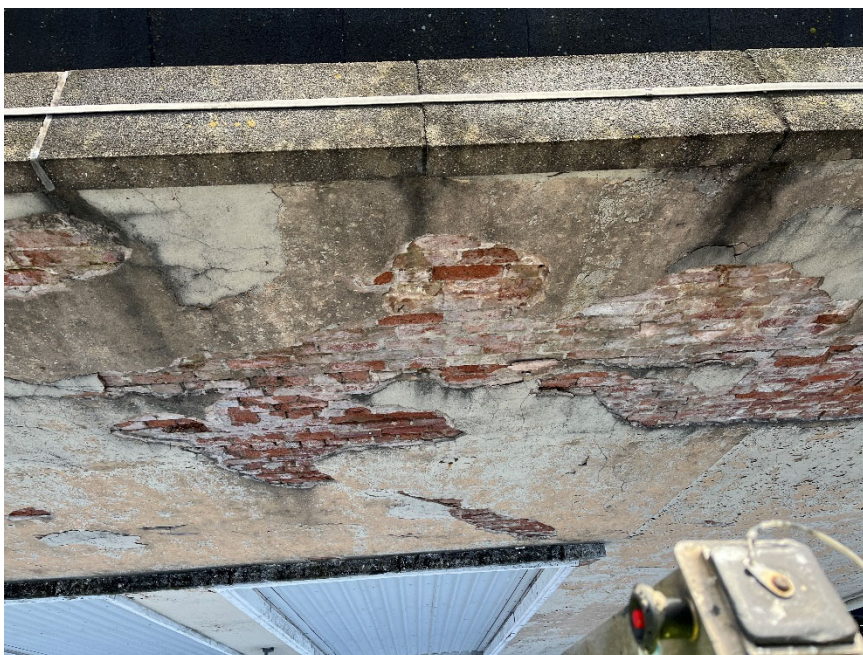
4.1.21 The parapet was inspected at high level and there was significant delamination or loss of the render coating to the majority of the parapet extent (Photo 19). The render below parapet level also showed widespread evidence of delamination, decay and missing sections.

Photo 19. Delamination of render coating to parapet

- 5.14 The external render coating was in a poor condition throughout and had delaminated from the underlying brickwork, particularly at parapet level where large sections of render were at risk of falling from the building. The poor condition of the render is not of an immediate structural concern, however is a health & safety risk and its repair would assist in limiting the extent of water entering the core of the wall and the associated increased risk of further reinforcement corrosion in the medium to long term.

- 6.6 The render to the full north-west elevation is in poor condition and there are large sections at risk of falling from the building. The replacement of the render is not considered to be a structural item and requires architectural input as well as agreement to replace the render, material selection and methodology followed by a listed building consent application.

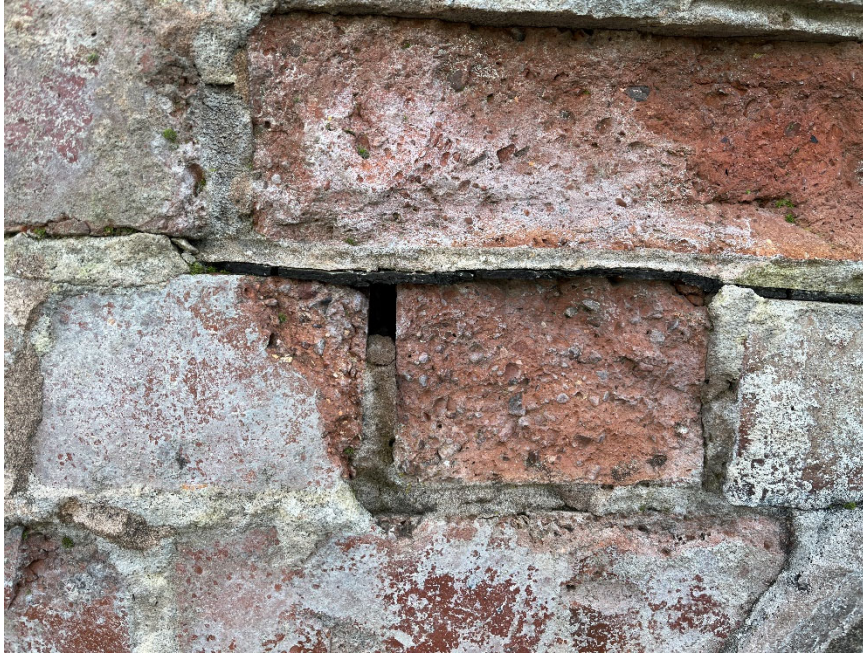
4.1.22 A bitumen DPM ran longitudinally at roughly the level of the roof structure to the far side of the parapet, and was visibly decayed, with longitudinal cracking visible in the render/masonry (Photo 20).

Photo 20. Decayed bitumen DPM to parapet wall

parapet wall would be recommended as part of any proposed remedial works, to remove the potential for movement of the wall above this level and cracking in any new render coating.

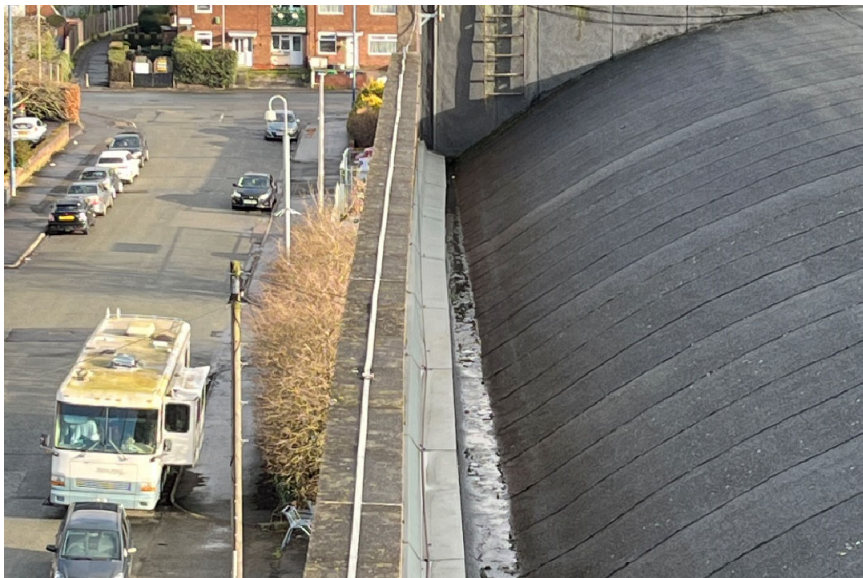
4.1.23 The alignment of the parapet was viewed from above and found there to be a reasonable external bow at around the window 3/4 position (Photo 21). The inside face of the parapet had been tanked and there was a pressed metal flashing above the parapet gutter.

Photo 21. External bow of parapet wall visible from above

- 5.15 The parapet wall was in a reasonable structural condition though there was visible evidence of outward movement above window 3 and 4. A measured verticality survey of the wall from window head level up to top of parapet by a building surveyor would be recommended to understand the magnitude of the outward movement. Replacement of the decayed DPM course at the base of the
-

- 6.7 The parapet wall was generally in a reasonable structural condition however it is recommended that a measured verticality survey be carried out by a surveyor to understand the magnitude of the outward incline, as well as replacement of the decayed bitumen at the bottom of the parapet masonry.

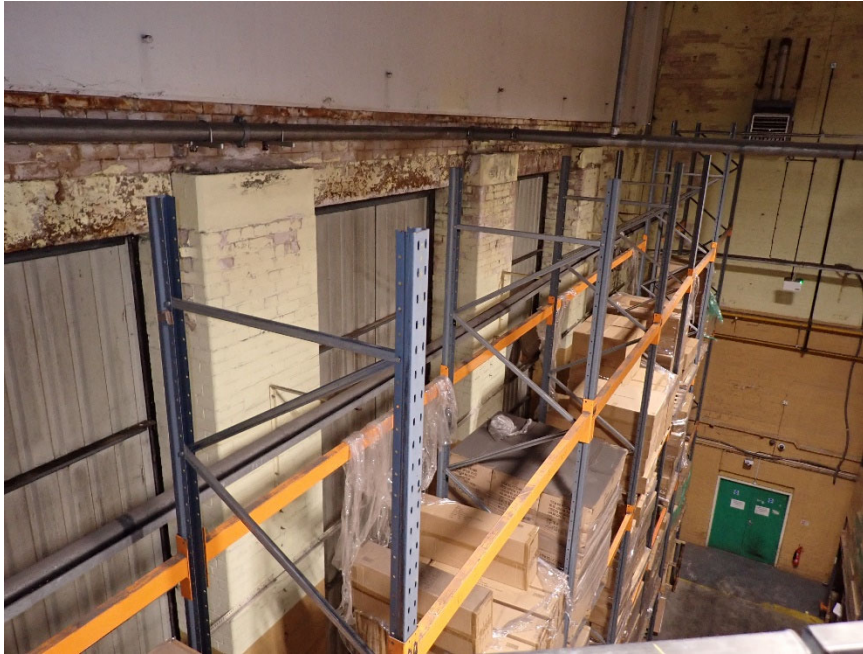
- 4.2.1 Internally there was high-bay racking present alongside the north-west elevation. All storage was removed from the top shelf to allow visual inspection from the aisle (Photo 22).

Photo 22. High-bay racking to internal face of north-west elevation

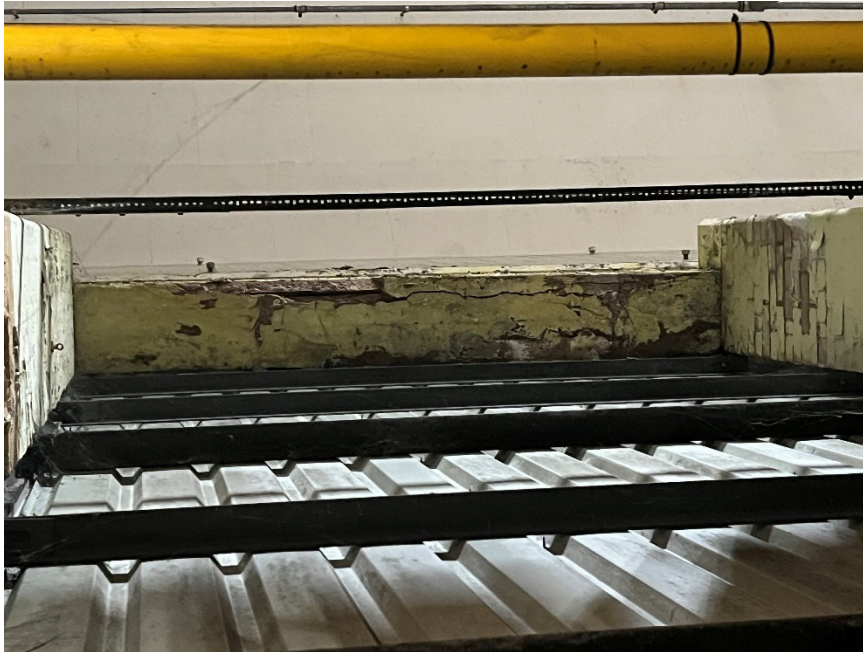
- 4.2.4 Each lintel was inspected from ground-floor level looking up, and face-on at high level. The underside of the concrete lintel to window 8 showed there to be longitudinal cracking to the inside face, where the corner reinforcing bar was visible and the concrete had spalled along part of the lintel length (Photo 23).

Photo 23. Underside of internal lintel to window 8

- 6.3 For the internal lintels it is recommended that any loose material is removed, the exposed reinforcing bars cleaned and painted with a suitable protection system and then a concrete repair carried out using a concrete repair mortar such as Fosroc Renderoc. Works are required to the internal lintel above window 8 and is also recommended where minor cracking is present above windows 5 and 3.

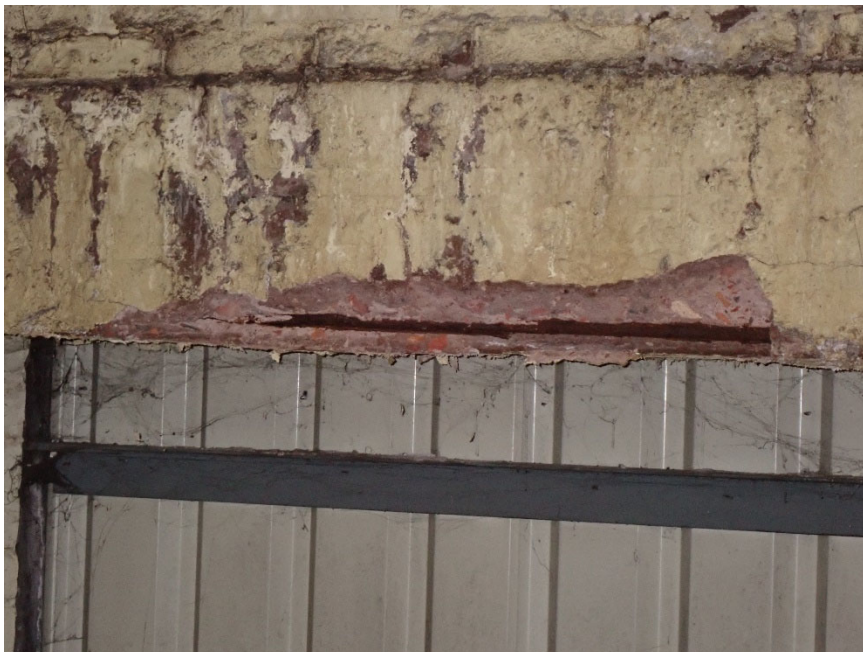
- 4.2.5 The same lintel viewed at high-level showed the concrete to be of more traditional reinforced concrete with brick aggregate (Photo 24). A large section of lintel had spalled and there was minor corrosion of the underlying corner reinforcing bar. No link reinforcement was present.

Photo 24. Spalling of internal face of window 8 internal lintel

- 5.3 The internal lintels were generally found to be in a reasonably sound condition with limited evidence of structural defects. Three internal lintels had been affected by minor corrosion of the embedded reinforcing bar to the internal corner, and concrete had spalled and fallen from the window 8 lintel.

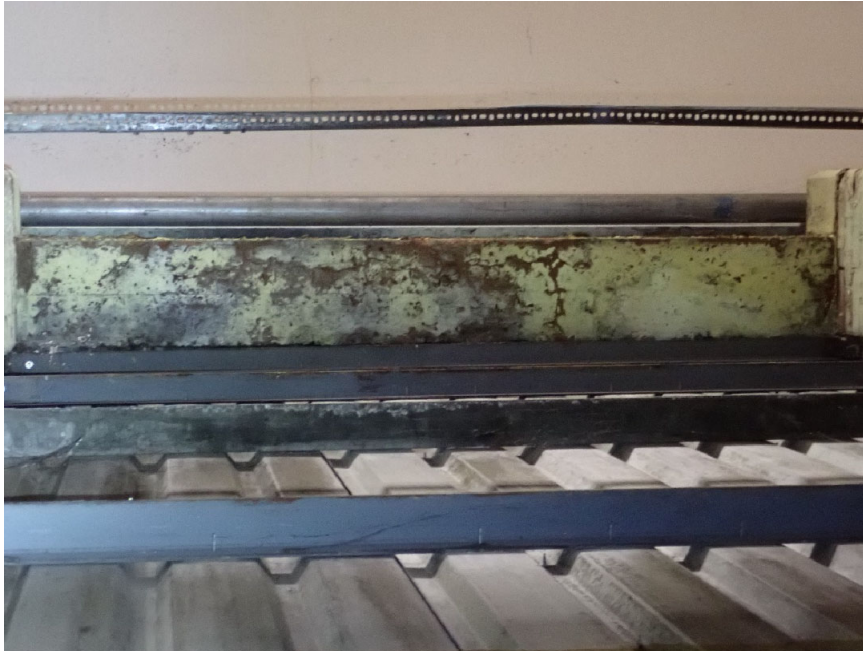
- 4.2.6 The remaining internal lintels were free from concrete spalling, however there was minor longitudinal cracking to the soffit of the window 5 (Photo 25) and window 3 lintels.

Photo 25. Minor longitudinal cracking to soffit of window 5 internal lintel
