Client:  
**Beech Holdings**

Project:  
**PICCADILLY WAREHOUSE  
Bloom Street**

Sheet Name:  
**First Floor\_Heritage Plan\_Planning**

| Drawing No. | <b>24006-HFR-BS-01-DR-A-9051</b> | Rev. | <b>P01</b> |

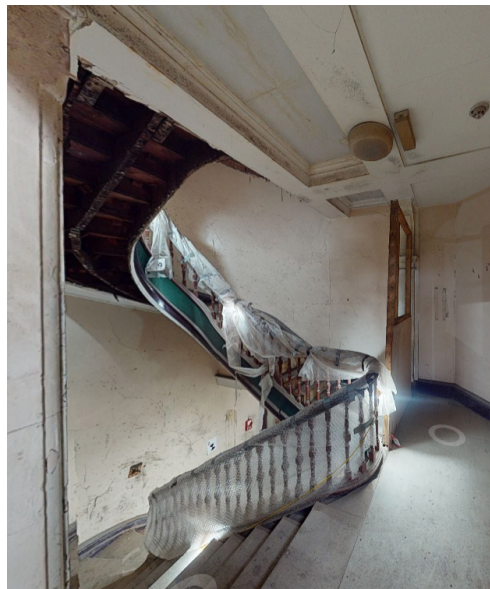
M1

To be repaired and repainted.  
**Reinforcement structure:** to be as discreet as possible, ideally concealed within flight.  
**Lath&plaster ceiling:** currently demolished. Proposed to be reinstated once new structure is complete.  
**Balustrade:** Appox. 150mm below Building Regulation. Proposal to fix additional handrail 900mm above steps as per regulation. New intervention to be clearly identifiable.

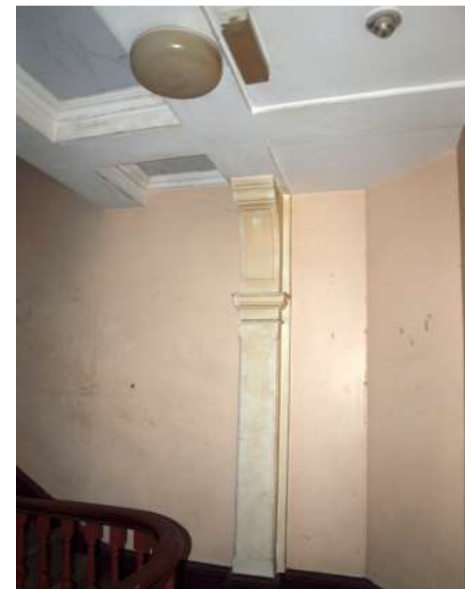
M2 - M3

Cracks to be repaired. To be repainted.

To be retained and repaired where required.

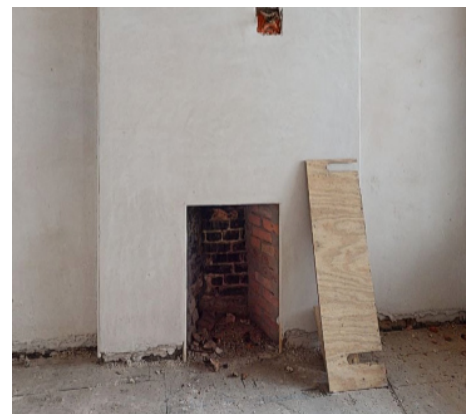
## FIREPLACE

To be refurbished and retained as a feature.  
Top to be blocked off.  
Work has been carried on site, however further investigations on the new plaster is required to confirm that works have been carried at a satisfactory standard.  
Contractor to confirm.

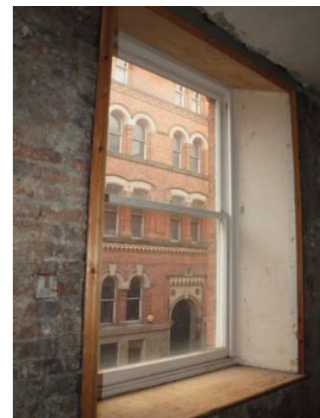
## TIMBER SURROUNDING

**ALL RICHMOND ST. ELEVATION.**  
Currently missing from site.  
To be rebuilt if **Heritage Consultan** assess historical value of missing frames.  
Current brickwork jamb repaired and in good condition and can be left exposed.
