# Arboricultural Appraisal Report

## Subsidence Damage Investigation at:

6 Scarsdale Road  
Manchester  
M14 5PS

| REPORT DATE: | 15/03/2024 |

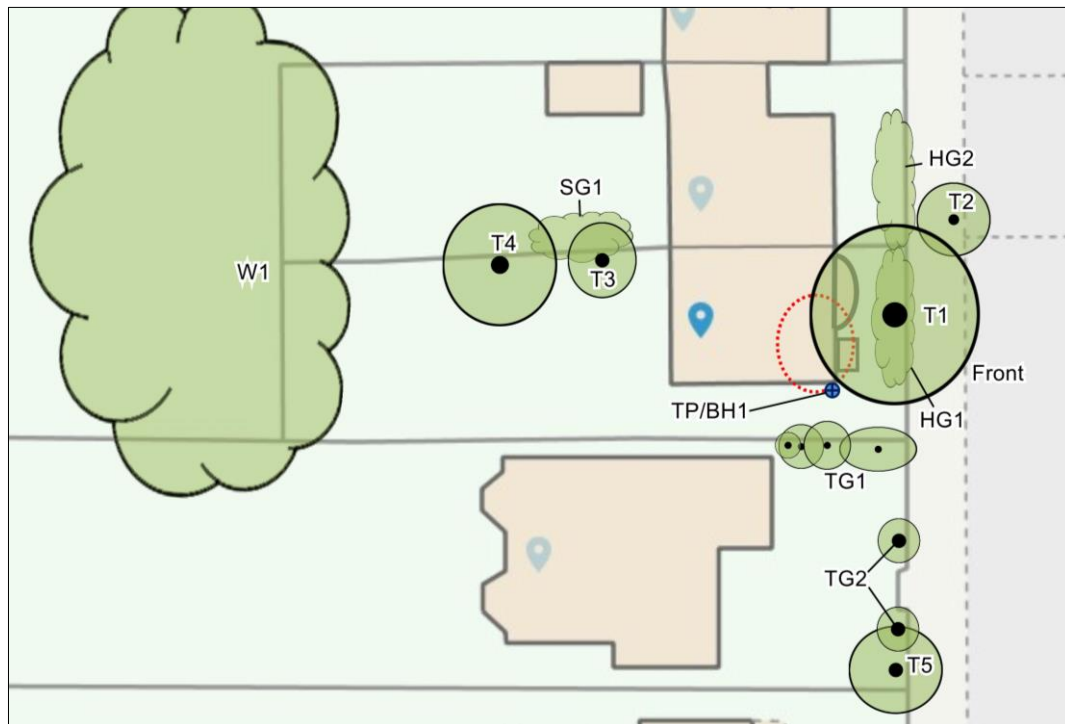
## Site Plan

Samples recovered from TP/BH1 have been positively identified (using anatomical analysis) as *Fagus*, *Prunus* and *Acer*, the origin of which will be T1, HG1 and the associated elements of TG1 confirming their influence on the soils below the foundations.

Approximate areas of damage
