# Investigative Works Findings

35 King Street

March 2024

**Mark Pinney**  
ASSOCIATES

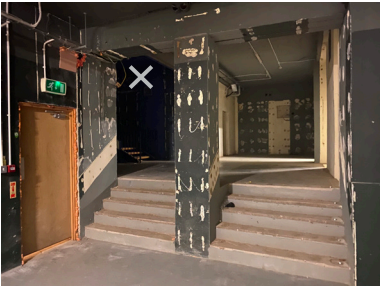
| TAG | CATEGORY | LOCATION | PURPOSE AND EXPECTATION | METHOD | FINDINGS |
|---|---|---|---|---|---|
| B1 | Opening into the ceiling above | Basement staircase area<br> | To understand how the floor has been filled.<br><br>We are expecting to find either concrete or steel deck. | Firstly a 10mm hole will be drilled in the ceiling to ascertain the build up. If the build up cannot be ascertained from the hole then a 300x300mm section of the ceiling will be carefully removed to reveal the construction above and closed up after investigation.<br><br>Opening to be located in the centre above the stairs. | Non-original concrete deck found. |

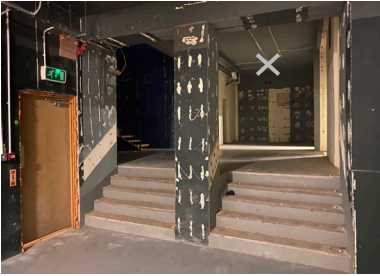
| TAG | CATEGORY | LOCATION | PURPOSE AND EXPECTATION | METHOD | FINDINGS |
|---|---|---|---|---|---|
| C1 | Opening into the ceiling above | B.02<br> | To understand ground level floor build up.<br><br>We are expecting to find a concrete deck. | Firstly a 10mm hole will be drilled in the ceiling to ascertain the build up. If the build up cannot be ascertained from the hole then a 300x300mm section of the ceiling will be carefully removed to reveal the construction above and closed up after investigation.<br><br>Opening to be located in the centre of the retail area. | Non-original concrete deck found. |

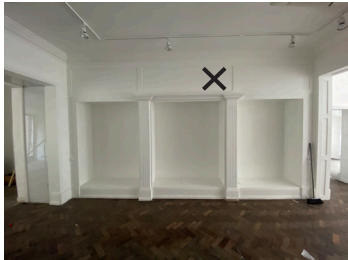
| TAG | CATEGORY | LOCATION | PURPOSE AND EXPECTATION | METHOD | FINDINGS |
|---|---|---|---|---|---|
| D1 | Opening into the wall | G.03<br> | Determine whether the wall is made of brick and examine the condition of the brick.<br><br>We are expecting to find a brick wall or stud wall. | Firstly a 10mm hole will be drilled in the wall to ascertain the wall build up. If the build up cannot be ascertained from the hole then a 300x300mm section of the plasterboard/panelling will be carefully removed to reveal the wall construction behind and closed up after investigation. | Non-original wall lining to brick wall found. |

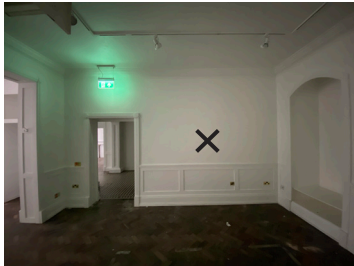
| TAG | CATEGORY | LOCATION | PURPOSE AND EXPECTATION | METHOD | FINDINGS |
|---|---|---|---|---|---|
| D2 | Opening into the wall | G.04<br> | Determine whether the wall is made of brick and examine the condition of the brick.<br><br>We are expecting to find a brick wall or stud wall. | Firstly a 10mm hole will be drilled in the wall to ascertain the wall build up. If the build up cannot be ascertained from the hole then a 300x300mm section of the plasterboard/panelling will be carefully removed to reveal the wall construction behind and closed up after investigation. | Non-original wall lining to brick wall found. |

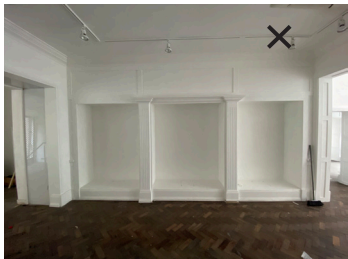
| TAG | CATEGORY | LOCATION | PURPOSE AND EXPECTATION | METHOD | FINDINGS |
|---|---|---|---|---|---|
| E1 | Opening into the ceiling above | G.03<br> | To understand if there is any steelwork or lintels in this area and to find out if services can run horizontally within the ceiling void.<br><br>We are expecting to find a concrete beam. | First we would use the existing ceiling hatch for our investigation. If the existing hatch isn't sufficient for the investigation, we would then drill a 10mm hole. If the build up cannot be ascertained from the hole, then we would open up a 300mmx300mm hole for visual structural survey that would be closed up after the investigation. Opening located in the corner at the south east end of the room. | Non-original plasterboard ceiling suspended under concrete slab found. |

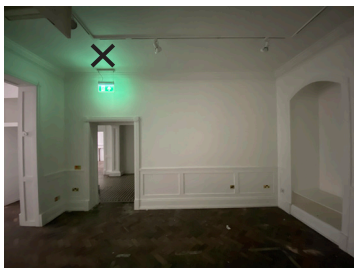
| TAG | CATEGORY | LOCATION | PURPOSE AND EXPECTATION | METHOD | FINDINGS |
|---|---|---|---|---|---|
| E2 | Opening into the ceiling above | G.04<br> | To understand if there is any steelwork or lintels in this area and to find out if services can run horizontally within the ceiling void.<br><br>We are expecting to find a concrete beam. | First we would use the existing ceiling hatch for our investigation. If the existing hatch isn't sufficient for the investigation, we would then drill a 10mm hole. If the build up cannot be ascertained from the hole, then we would open up a 300mmx300mm hole for visual structural survey that would be closed up after the investigation. Opening located in the corner at the south west end of the room. | Non-original plasterboard ceiling suspended under concrete slab found. |

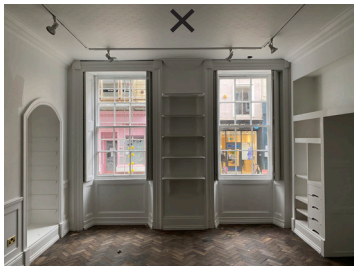
| TAG | CATEGORY | LOCATION | PURPOSE AND EXPECTATION | METHOD | FINDINGS |
|---|---|---|---|---|---|
| C4 | Opening into the ceiling above | G.05<br> | To understand the build up of the floor above.<br><br>We are expecting to find a concrete deck. | Firstly a 10mm hole will be drilled in the ceiling to ascertain the build up. If the build up cannot be ascertained from the hole then a 300x300mm section of the ceiling will be carefully removed to reveal the construction above and closed up after investigation.<br><br>Opening located in the centre of the room. | Non-original plasterboard ceiling suspended under concrete slab found. |
