# report

structural engineering

WATCHES OF SWITZERLAND

17 - 21 ST ANNS SQUARE

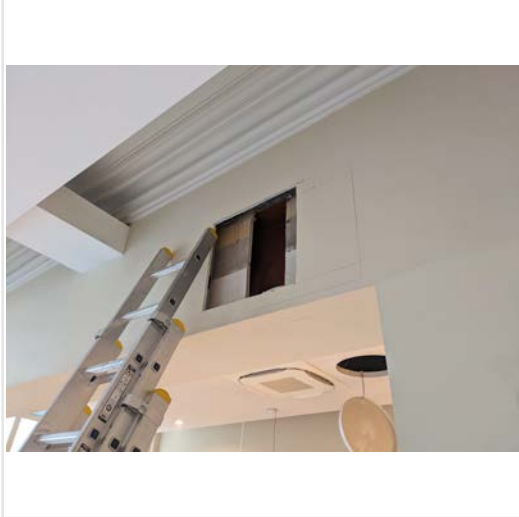
Location A2 (reference drawing 1920/S/520)

Steel beam found, providing support to the first floor.

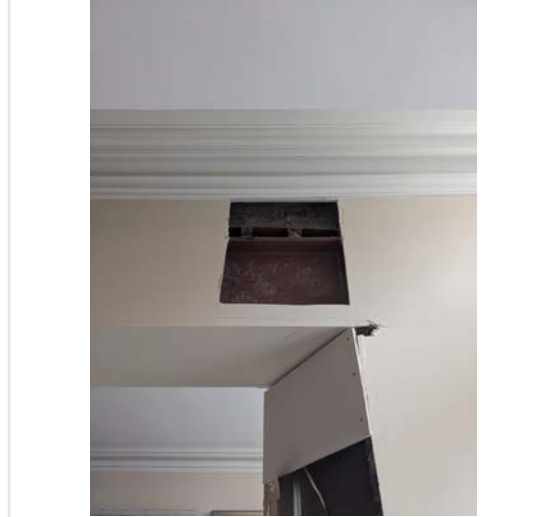
Location A3 (reference drawing 1920/S/520)

Pair of back to back steel beams found, providing support to the first floor.

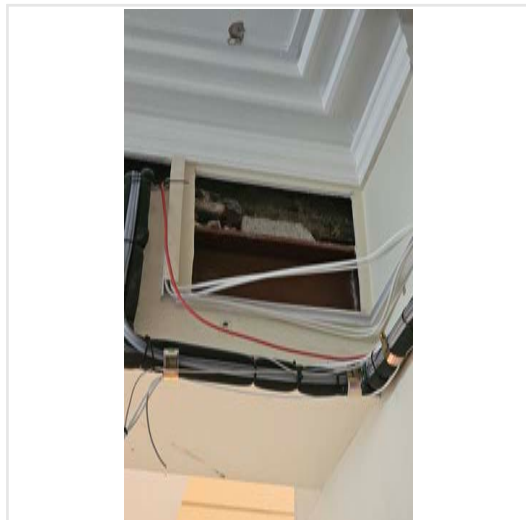
Location A4 (reference drawing 1920/S/520)

Pair of back to back steel beams found, providing support to the first floor. Findings consistent with location A3.

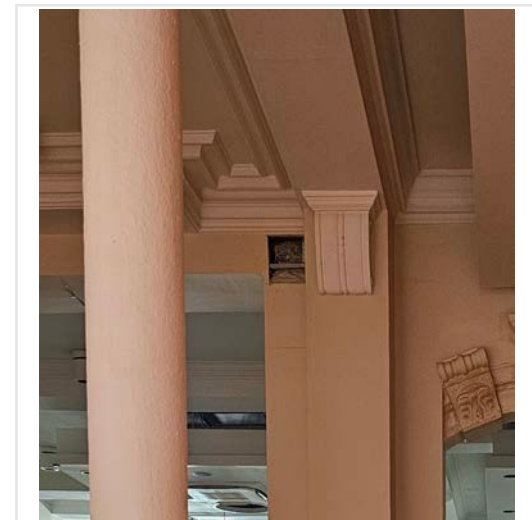
Location A5 (reference drawing 1920/S/520)

Beam found, providing support to the first floor.

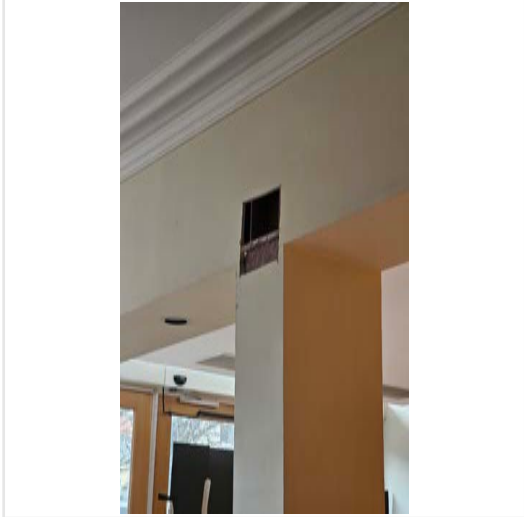
Location A6 (reference drawing 1920/S/520)

Steel column found within plasterboard boxing out, providing intermediate support to the back to back steel beams above.

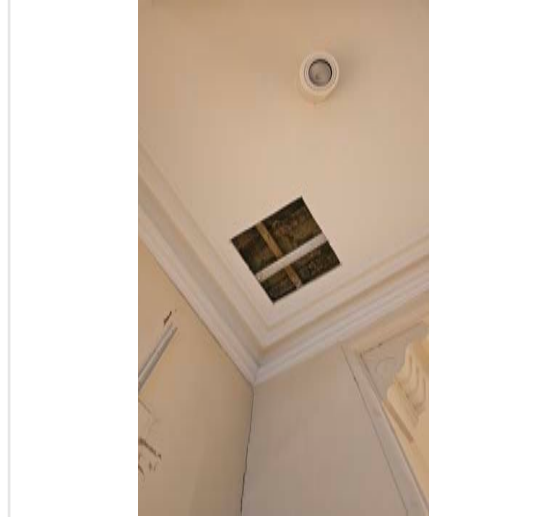
Location B1 (reference drawing 1920/S/520)

Timber floor found with soft insulation between floor joists. Non-original light gauge steel channels found to support the plasterboard ceiling.

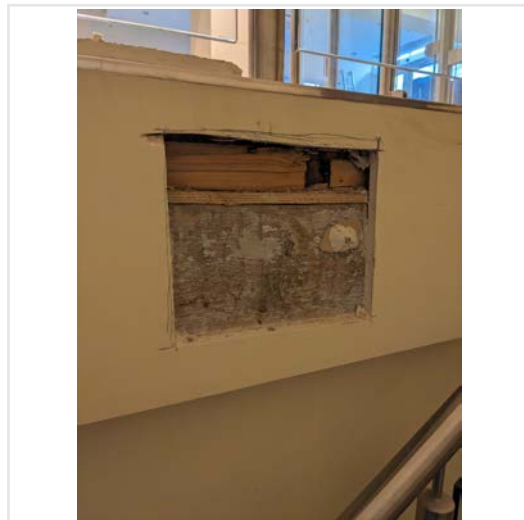
Location D1 (reference drawing 1920/S/520)

Timber beam found, to trim out the floor opening for the existing staircase.

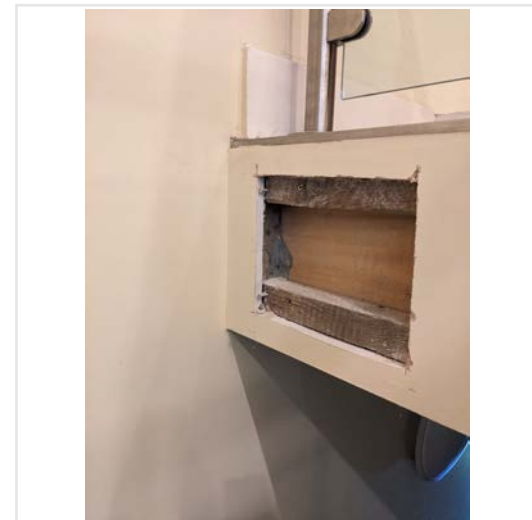
Location D2 (reference drawing 1920/S/520)

Non-original timber beam found, supported on a metal joist hanger at one end. Beam trims out the floor opening for the existing staircase.

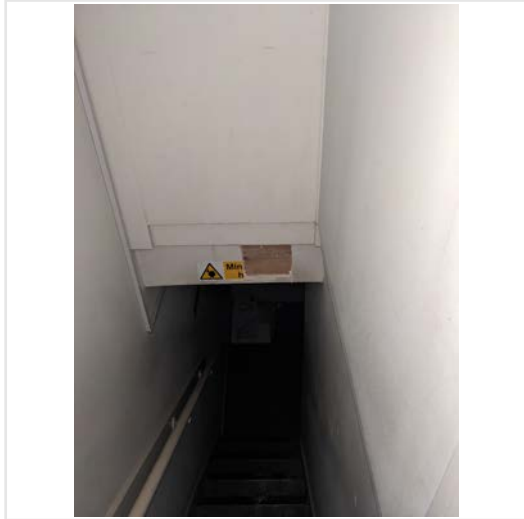
Location D3 (reference drawing 1920/S/520)

Non-original timber beam found, to trim out the floor opening for the existing staircase.

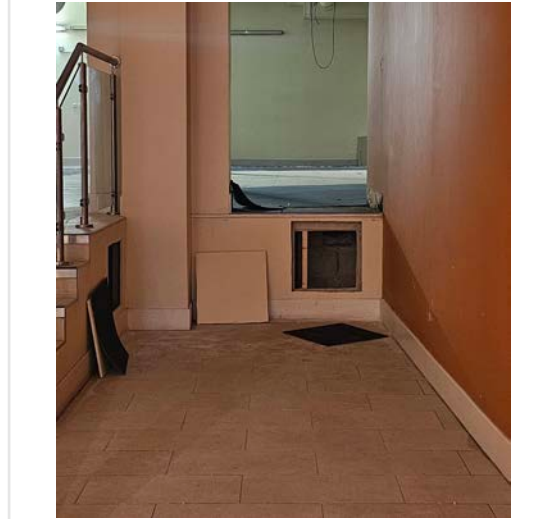
Location E1 (reference drawing 1920/S/520)

Non-original blockwork wall found. Large void between opening and wall.

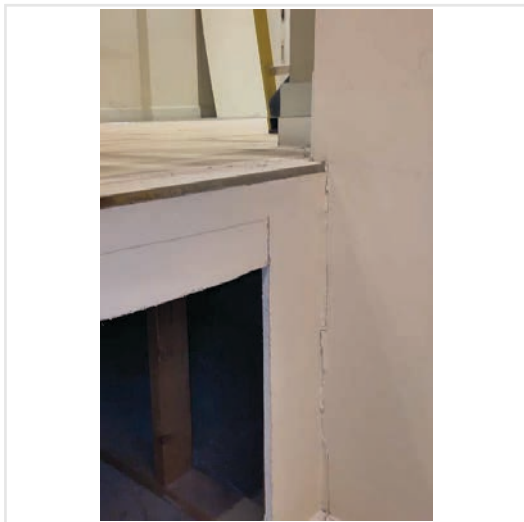
Location E2 (reference drawing 1920/S/520)

Timber joists found to support stair landing. Landing joists supported on timber stud dwarf walls.

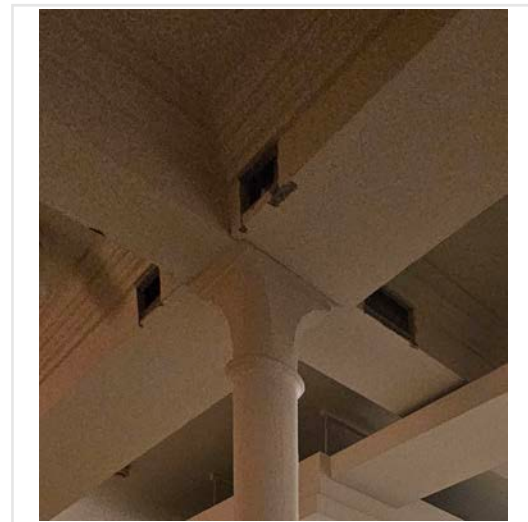
Locations F2, F3 and F4 (reference drawings 1920/S/520 and 1920/S/521)

Timber beams found, supported on original cast iron columns below through historic connections.

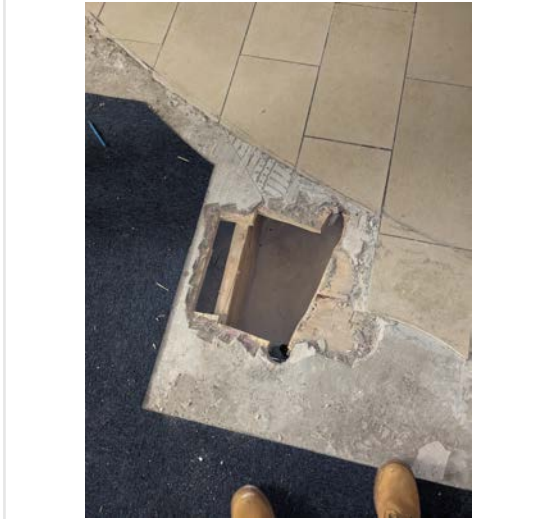
Location G1 (reference drawing 1920/S/521)

Non-original timber floor found.

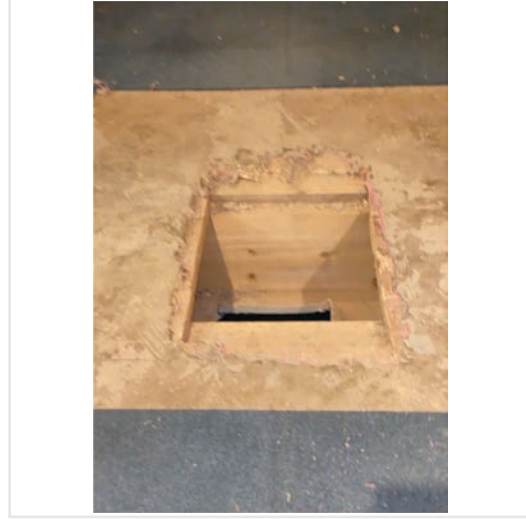
Location H2 (reference drawing 1920/S/521)

Non-original timber floor found, non-original reinforced concrete slab located below timber floor.

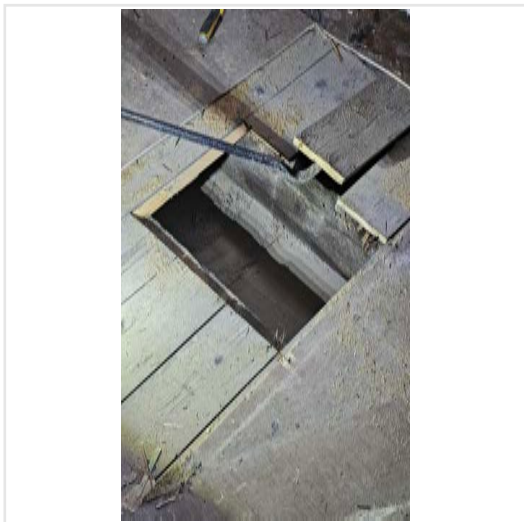
Location H3 (reference drawing 1920/S/521)

Timber floor found, appearance and condition of the joists suggest they may be original.

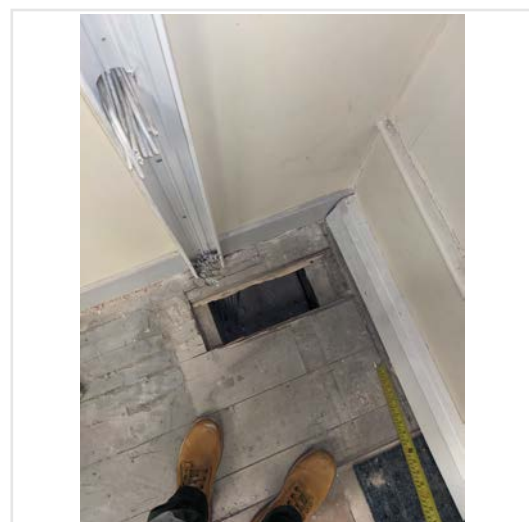
Location H7 (reference drawing 1920/S/521)

Timber floor found, appearance and condition of the floor joists suggest they may be original.

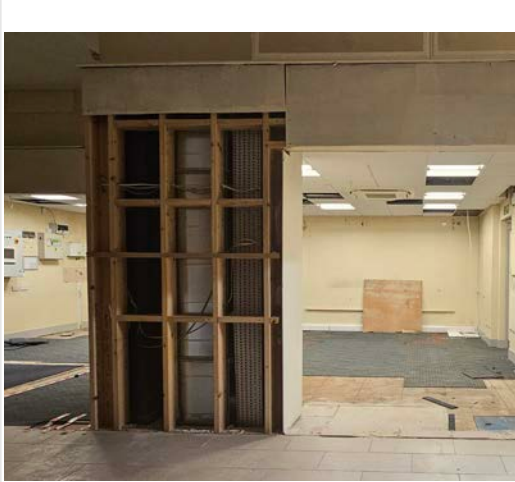
Location I2 (reference drawing 1920/S/520)

Non-original timber stud wall found, concealing modern ductwork and cabling.

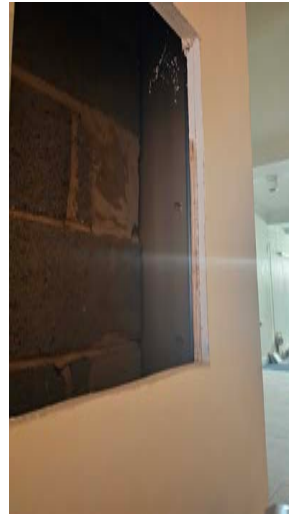
Location I3 (reference drawing 1920/S/521)

Blockwork wall located behind the plasterboard. Void present between plasterboard and face of the blockwork.

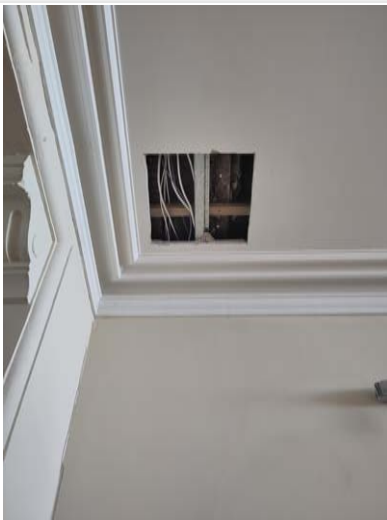
Location J1 (reference drawing 1920/S/521)

Timber floor above found. Non-original light gauge steel channels found to support the plasterboard ceiling.

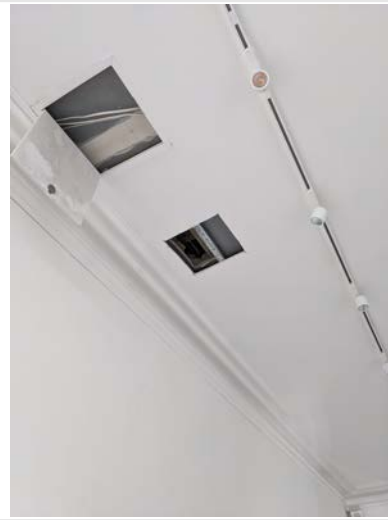
Location J2 (reference drawing 1920/S/521)

Timber floor above found. Non-original light gauge steel channels found to support the plasterboard ceiling.

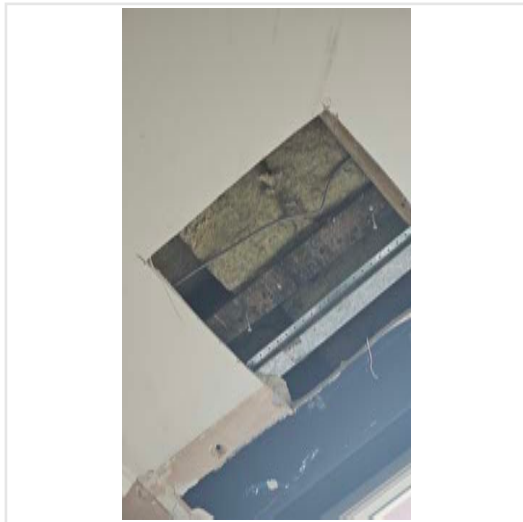
Location M1 (reference drawing 1920/S/521)

Timber floor found with soft insulation between floor joists. Non-original light gauge steel channels found to support the plasterboard ceiling.

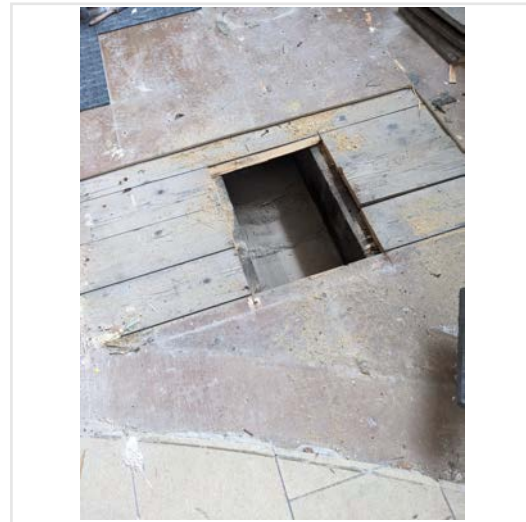
Location N2 (reference drawing 1920/S/522)

Timber floor found, appearance and condition suggest it may be original.

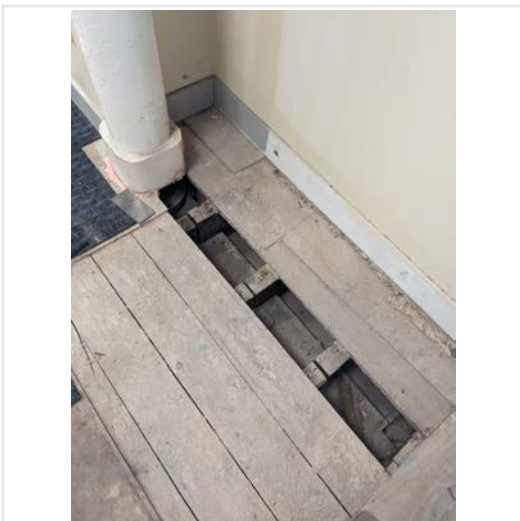
Location N4 (reference drawing 1920/S/522)

Timber floor found, appearance and condition suggest it may be original.

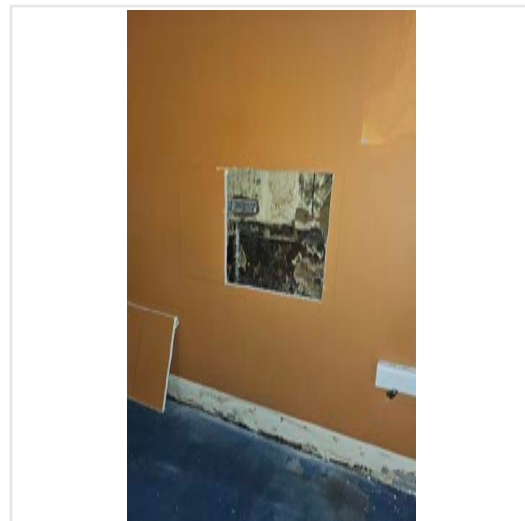
Location O1 (reference drawing 1920/S/522)

Masonry wall found, presence of damp and mould suggests historic water ingress in this location.

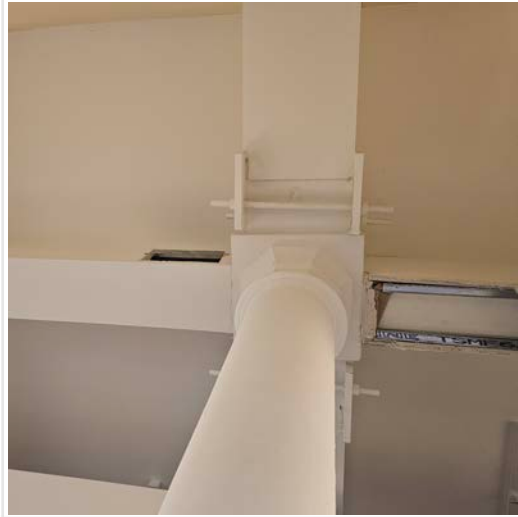
Locations A1 & A3 (reference drawing 1920/S/519)

Non-original steel beams found in both openings.  
Non-original light gauge steel channels used to support plasterboard finish.

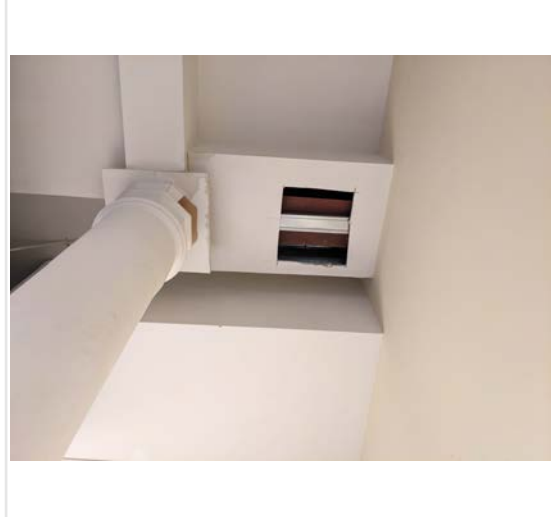
Location A5 (reference drawing 1920/S/519)

Non-original steel beam found. Non-original light gauge steel channels used to support plasterboard finish.

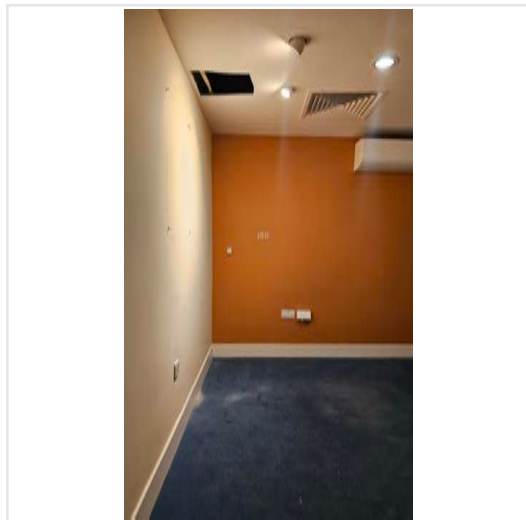
Location B1 (reference drawing 1920/S/519)

Large void found above ceiling, edge of concrete slab visible from within the ceiling void.

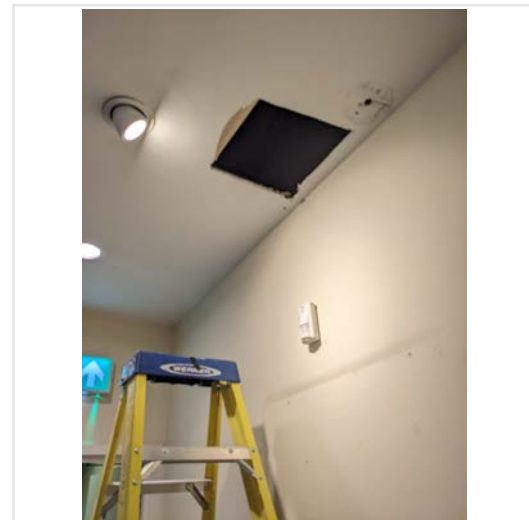
Location B2 (reference drawing 1920/S/519)

Large void found above ceiling, containing services and a dropped ceiling support system.

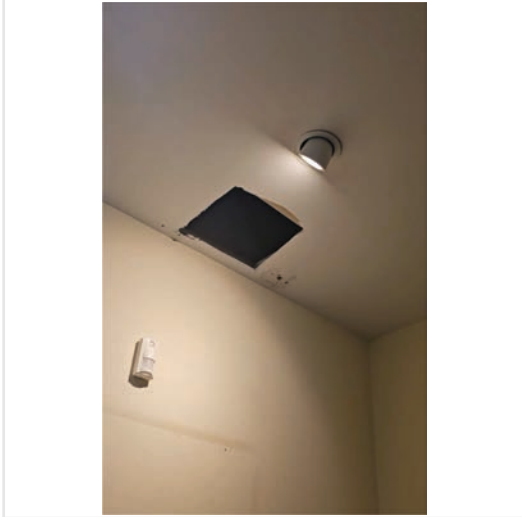
Location B3 (reference drawing 1920/S/519)

Large void found above ceiling, containing services and a dropped ceiling support system.

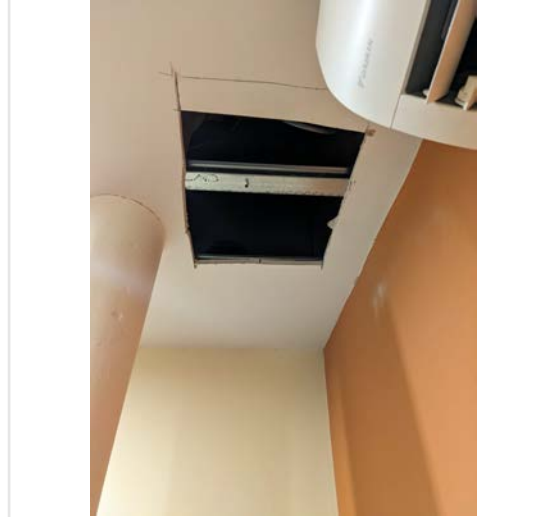
Location B5 (reference drawing 1920/S/519)

Large void found above ceiling, containing services and a dropped ceiling support system.

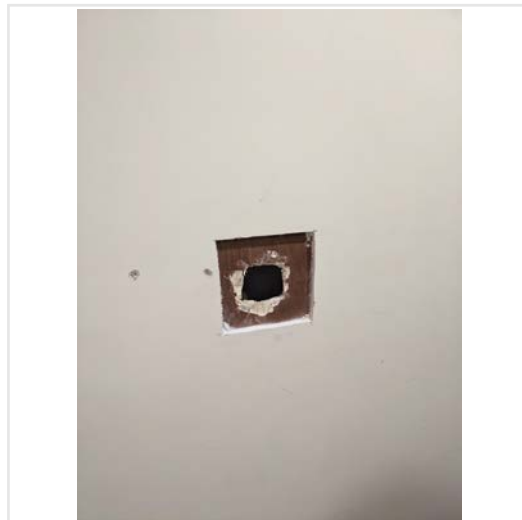
Location C2 (reference drawing 1920/S/519)

Non-original timber stud wall found.

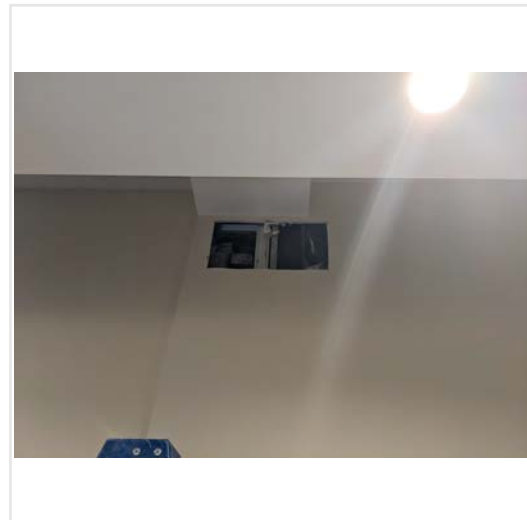
Location D1 (reference drawing 1920/S/519)

Non-original vertical steel channel, acting as a supporting column, found. Channel assumed to support incoming downstand beam above.

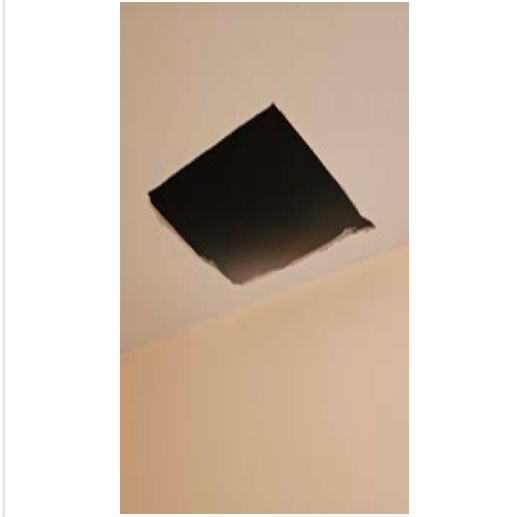
Location D2 (reference drawing 1920/S/519)

Large void found above ceiling, edge of concrete slab visible from within the ceiling void.
