# **Arboricultural Impact Assessment and Method Statement Victoria Point**

**Final report**

Prepared by LUC

April 2024

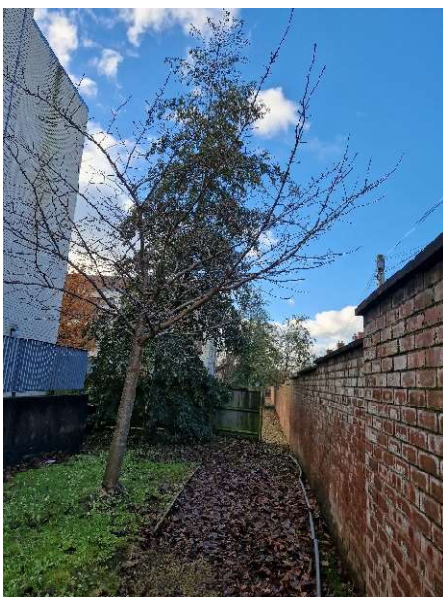
**Figure 2.2: photo showing trees T74 Alder and T75 Cherry**

**2.7** A number of Alder trees are spread throughout the site with many along the northern boundary in close proximity to the buildings. Due to their positions the long-term retention of these trees is reduced.

| Ref. | Species | Height | Stem Diameter (mm) | Crown Spread | Crown Clearance (m) | Life Stage | Rem. Contrib. | Physiological Condition | Structural Condition | Comments | Recommendations | Retention Category | RPA Area |
|---|---|---|---|---|---|---|---|---|---|---|---|---|---|
| T074 | Alder<br>( <i>Alnus sp.</i> ) | 12 | 270 | N:3<br>E:3<br>S:3<br>W:3 | 0 | Semi Mature | 40+ Years | Good | Fair | Damage from stake to stem. Soil level raised around base. Alder beetle present. Exposed roots. Canopy touching ground. | Remove to facilitate the development | B1 | 32 |

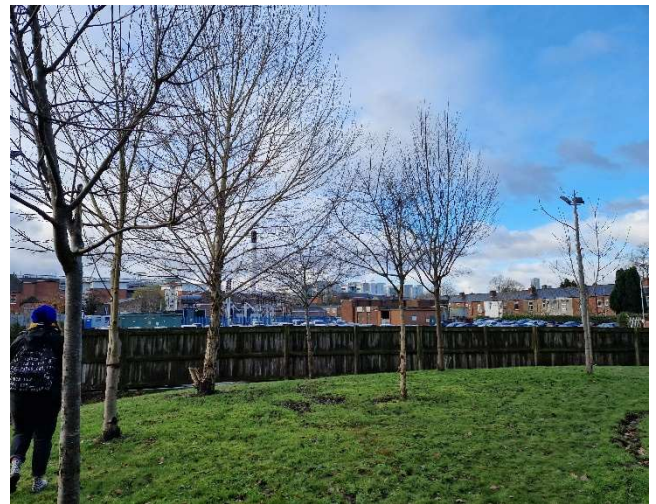
**Figure 2.3: Photo showing trees T031 to T035**

**2.8** Trees to the western side of the block 4 provide an attractive area of planted trees and open space. Although many are categorised as category C in this area due to their size or condition, they all have a value as a group feature.

| Ref. | Species | Height | Stem Diameter (mm) | Crown Spread | Crown Clearance (m) | Life Stage | Rem. Contrib. | Physiological Condition | Structural Condition | Comments | Recommendations | Retention Category | RPA Area |
|---|---|---|---|---|---|---|---|---|---|---|---|---|---|
| T031 | Norway Maple<br>( <i>Acer platanoides</i> ) | 5 | 100 | N:2<br>E:2<br>S:2<br>W:2 | 2 | Semi Mature | 20+ Years | Fair | Poor | Damage to stem from tree tie caused wound and constriction. | Remove to facilitate the development | C1 | 5 |

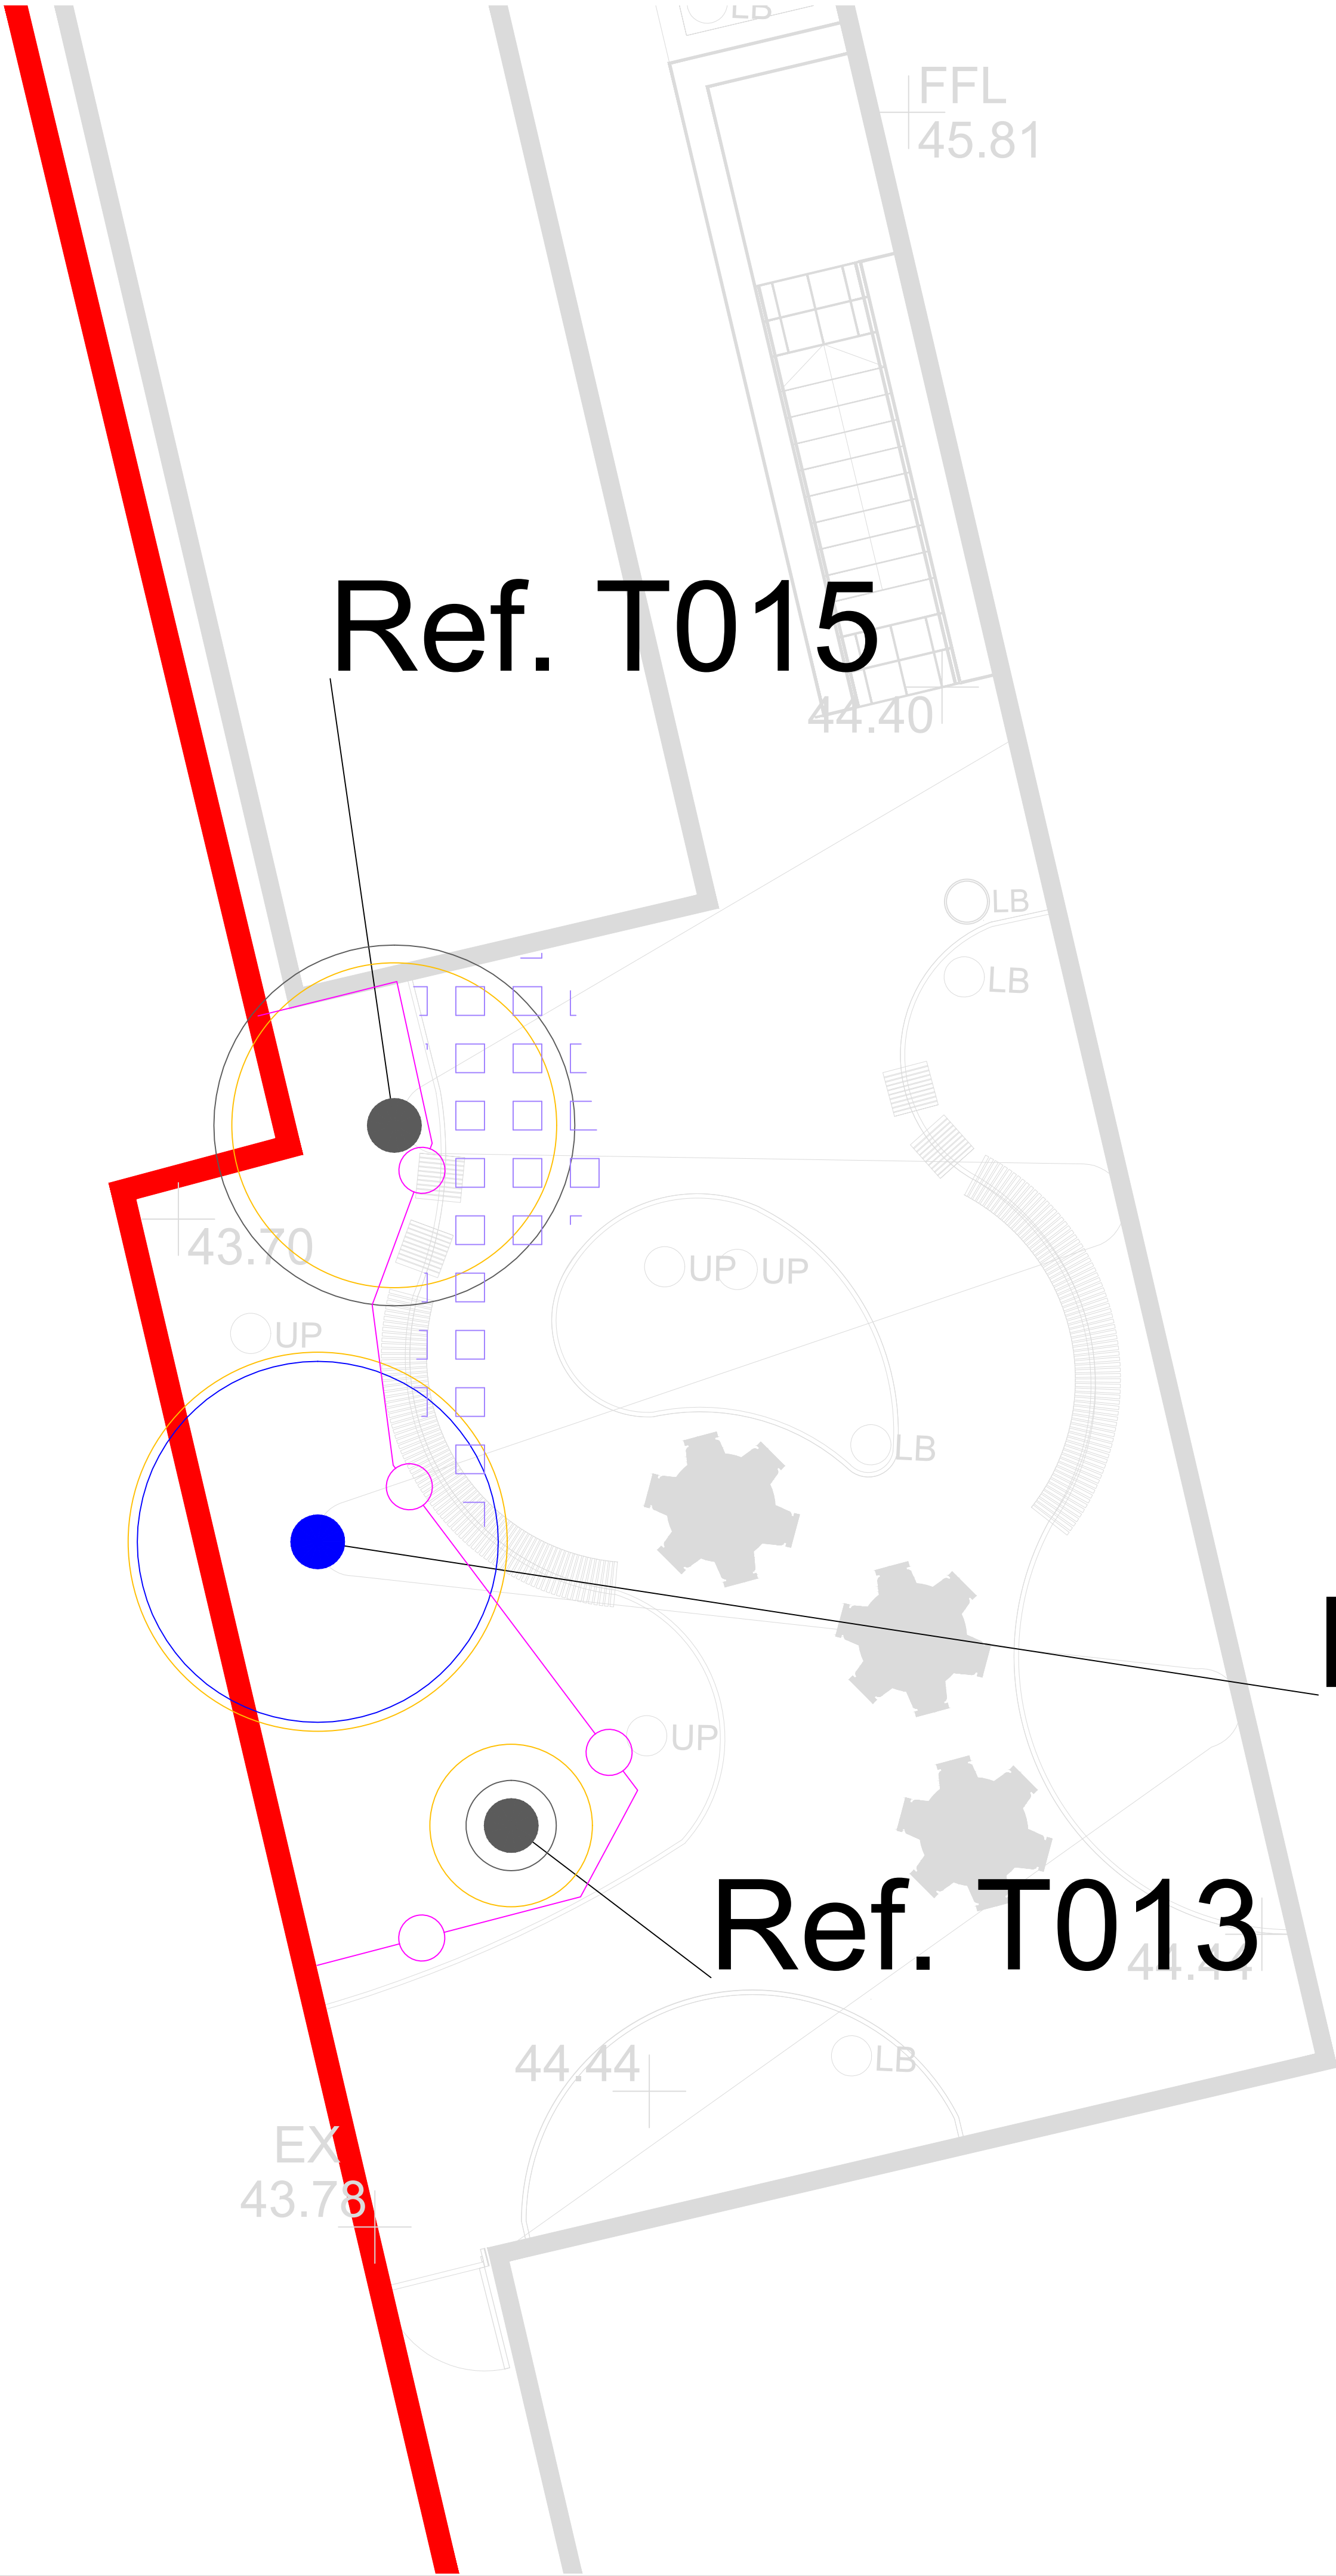
The construction of the new footpath within the trees T014 -T015 will incur into the RPA of these trees and therefore require a special construction method that will be required to be followed as found below.

- A. A vegetation scrape to a maximum depth of 50mm may be undertaken by flat toothed bucket. No vehicle or plant will enter the unprotected area.
- B. Leveling layer of washed sharp sand (no salt or fines) may be laid as required to a maximum depth of 50mm. A geotextile membrane will be laid across the whole area of new footpath
- C. The cellular confinement system will be laid in line with the manufactures instructions.
- D. The top finishing surface will be required to be porous.
- E. The new surface will then be tied into adjacent surface levels.
