## 86 Cross Street, Manchester

15155-BKP-V1-XX-RP-S-001

Existing Building Condition Report

For  
Individual Restaurants

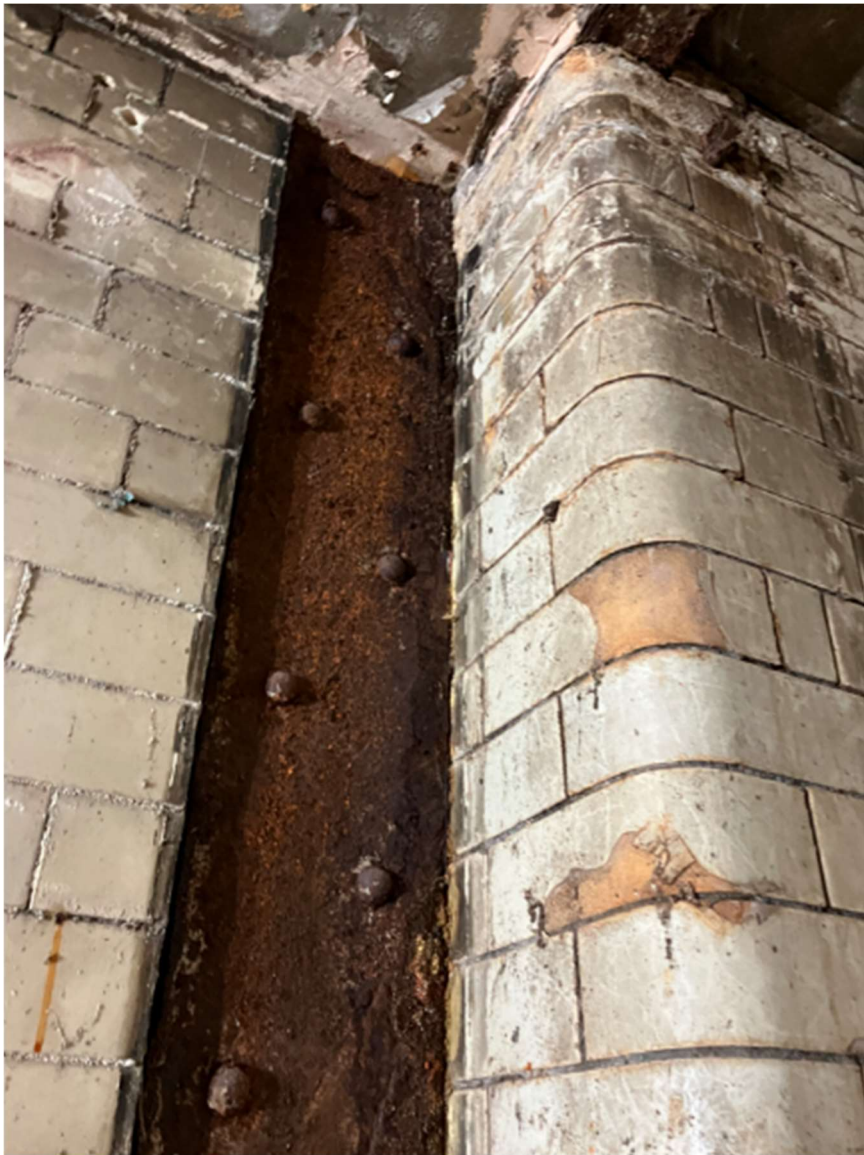
- Masonry walls generally witnessed to be in good condition with no significant signs of deterioration of bricks or distortion / bulging of walls. Some minor water staining witnessed in some areas (notably in the vicinity of historically infilled pavement smoke vents – refer to notes below) and pointing of masonry walls / paint finish in some areas showing signs of minor deterioration.
- Existing basement level door witnessed to north elevation of building with access into adjacent property basement area
- Embedded steel column members were witnessed within external basement walls and some significant rusting of steelwork / spalling of steel surfacing noted

*Figure 7 – Embedded Steel Column Showing Signs of Rusting*

- Embedded basement level columns to be locally exposed where significant rusting of steelwork noted within basement area; concealed faces of embedded columns to be exposed for further inspection and possible repairs

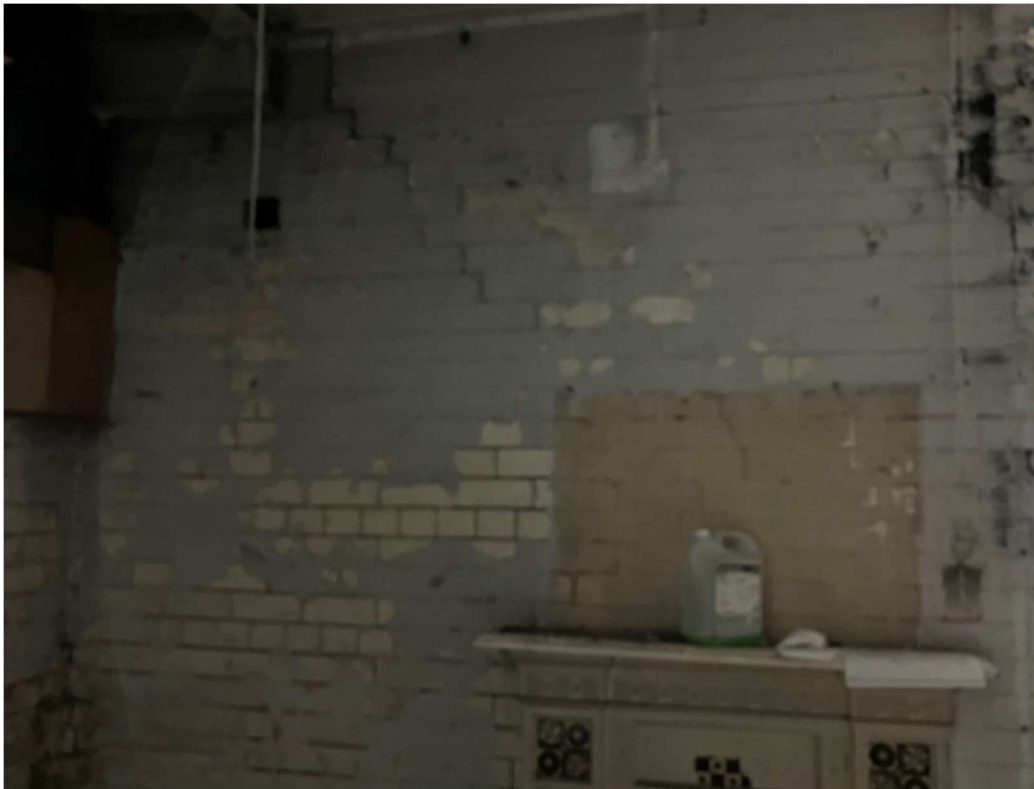
- Existing brickwork chimney structure showing signs of historic cracking above fire place (diagonal crack pattern appearing to originate from existing steel beam bearing onto wall).

*Figure 8 – Masonry Cracking to Existing Chimney Structure*

- Basement level masonry staining to be cleaned (including removal of loose paint finish) and localised repointing recommended
- Basement level chimney structure showing signs of cracking to be repaired; consisting of clearing any loose debris from cracked joints and localised repointing
- Existing basement manholes to receive new double-sealed covers
- Existing steelwork showing signs of minor surface corrosion to be cleaned to remove signs of minor rusting and repainted
- Cracked / loose masonry to ground floor cills to be repaired
- Loose plasterboard panelling to rear elevation to be removed / replaced as necessary

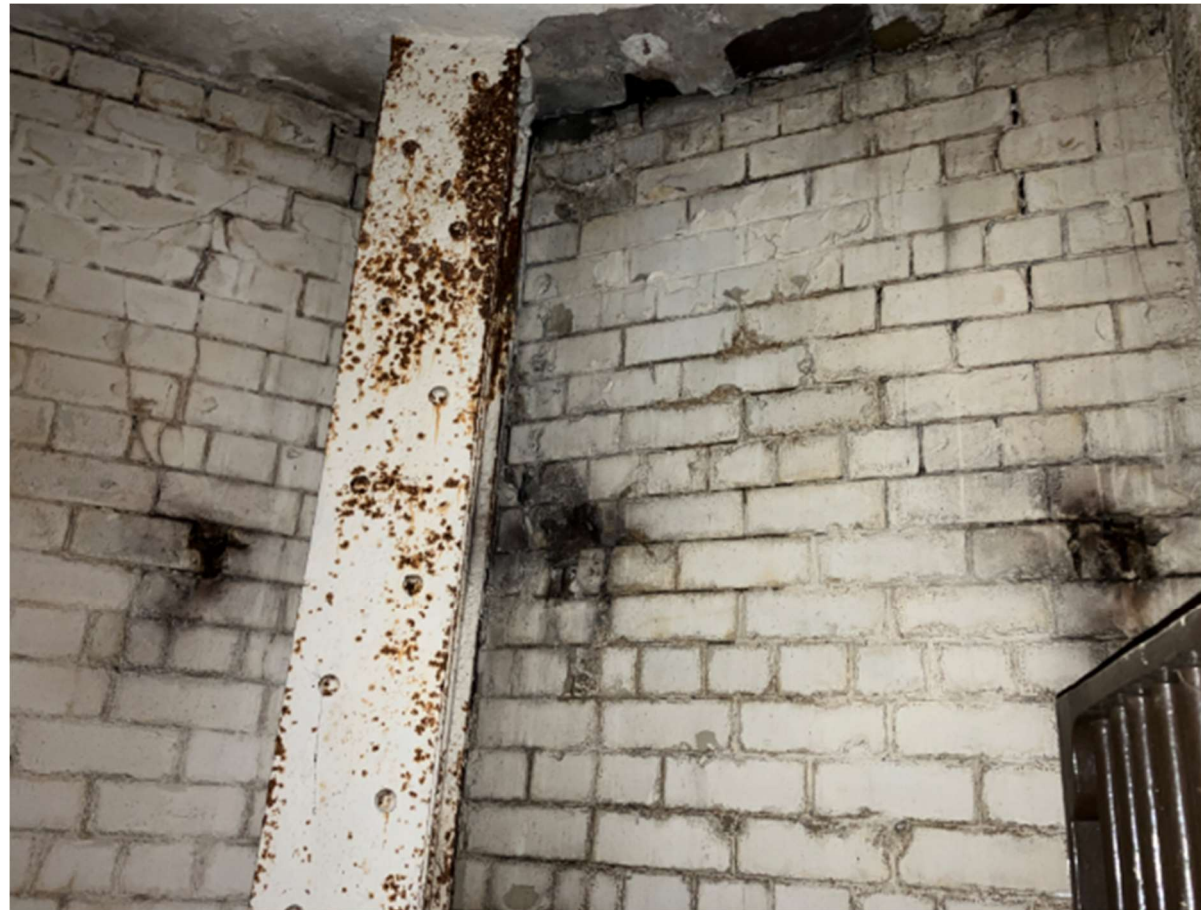
- A number of further steel column support members were witnessed at basement level installed in close proximity to basement walls. These column members appear to be in reasonable condition, with some surface rusting visible.

*Figure 9 – Steel Support Column Showing Signs of Surface Rusting*

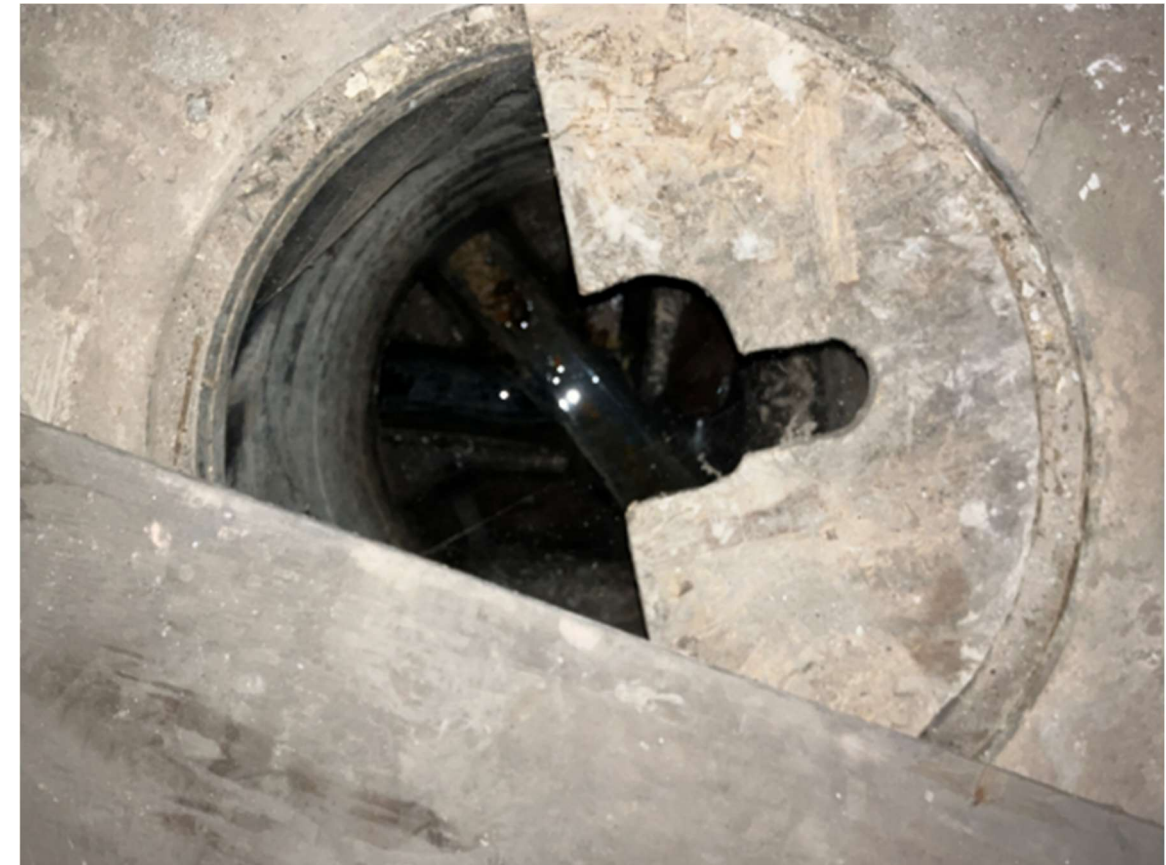
*Figure 10 – Existing Uncovered Manhole Chamber*

- Basement slab contains 2No. existing steel manhole covers, assumed to provide access to building drainage system. Covers were sealed and not accessed during BKP inspection
- A third manhole access point was witnessed on site, notably with no manhole cover (temporarily covered with ply sheeting at the time of inspection). Existing drainage system was witnessed within this approximately 720mm deep chamber

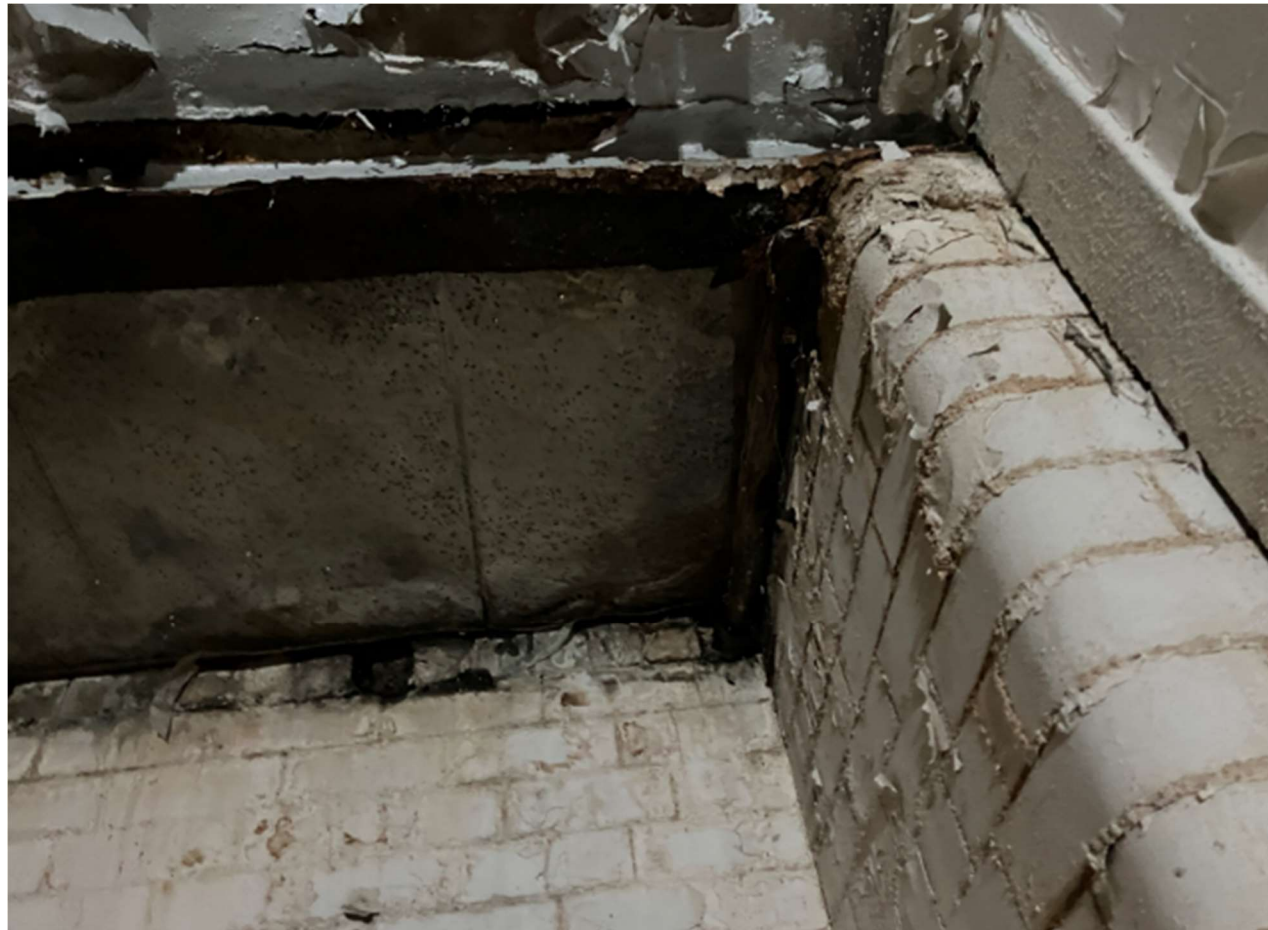
- Historical pavement level smoke vents appear to have been present within the basement in 3No. locations (1No. location onto Cross Street and 2No. locations onto John Dalton Street, with related basement wall recesses taken out under pavements). Original smoke vent covers have been removed and replaced with concrete slabs (assumed to be nominally reinforced and cast into webs of steelwork support members in these locations, with pavement finishes installed over). It is noted that steelwork supports in these 3No. areas are all showing signs of significant deterioration and rusting / spalling of visible surfaces was noted. It is assumed that there is no waterproofing measures currently present above vent infill slabs and surface water is able to infiltrate through pavement finishes, resulting in significant corrosion of steel supports in these areas.

*Figure 13 – View on Former Pavement Smoke Vent Showing Slab Infill and Corroded Steel Support Member*

Based on BKPL non-intrusive investigation works, structural defects have been identified in the location of historic pavement smoke vents; original smoke vents appear to have been removed and infilled with relatively recent concrete slab, however significant corrosion of adjacent steelwork floor support members was identified on site.

Cause of this significant corrosion is likely due to lack of any formal waterproofing measures above the recently installed concrete slab / below pavement finishes above, resulting in water ingress during wet weather. Corrosion in this location is likely made further exacerbated by the presence of de-icing salts within surface water runoff at pavement level.

Given the extent of corrosion witnessed on site, existing members are to be replaced as follows;

- Existing corroded steelwork member to be carefully removed, including cutting out of adjacent filler joist / concrete infill
- Exposed ends of filler joist secondary steelwork members to be cut back to allow removal of corroded beams; ends of secondary members to be further reviewed on site and any corroded beam ends to be cut back to unaffected steel

- Existing basement wall bearings to be further reviewed and any damaged masonry removed and replaced
- New steelwork support member with welded steel bottom plate to be installed, to provide support to cut edges of existing filler joist / concrete infill floors

- New beam to be encased in concrete to provide support to existing low-level masonry cill above
- Temporary propping to be removed

It is further recommended that consideration is given to improvement of waterproofing local to historical pavement smoke vents, to prevent further water ingress and potential issues in the future. It is anticipated that waterproofing details would be developed by suitable waterproofing specialist, however these may involve removal of paving slab finishes directly over former smoke vents, installation of suitable waterproofing DPM membrane (or similar) to prevent future water ingress and reinstallation of paved finishes. All works within the existing pavement area subject to consultation with Manchester City Council Highways. Details of proposed repair works to former pavement smoke vents are included in Appendix D of this report.

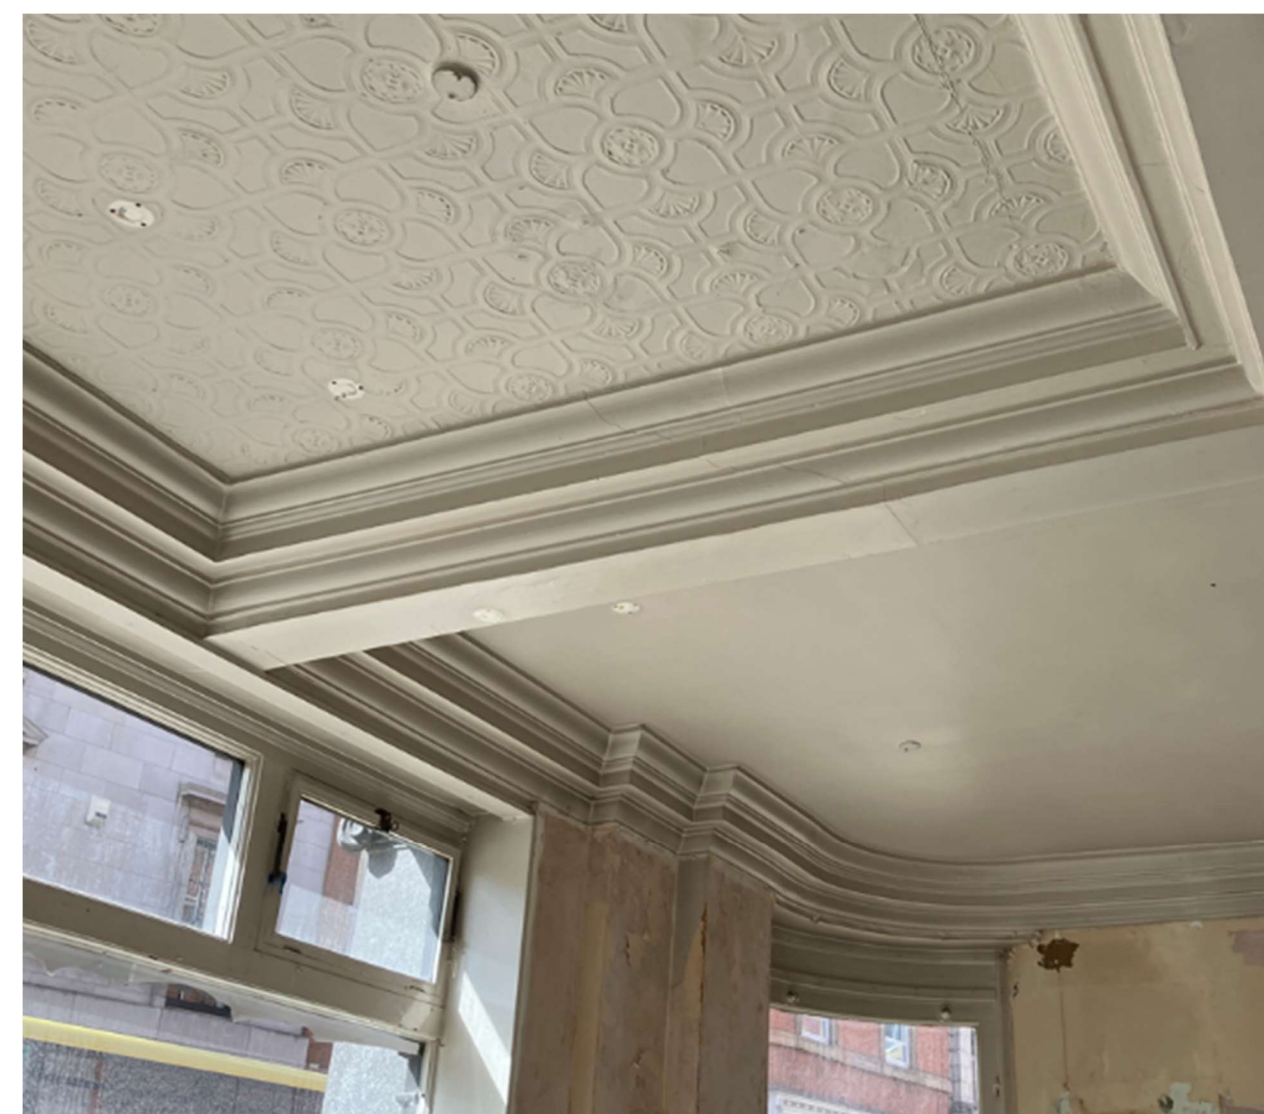
- Decorative ceiling generally witnessed in good condition, with the exception of some minor cracking of ceiling / coving witnessed to ceiling adjacent to John Dalton Street elevation. Cracking appears to be superficial only

*Figure 16 – Superficial Cracking Witnessed to Existing Ceiling / Coving*

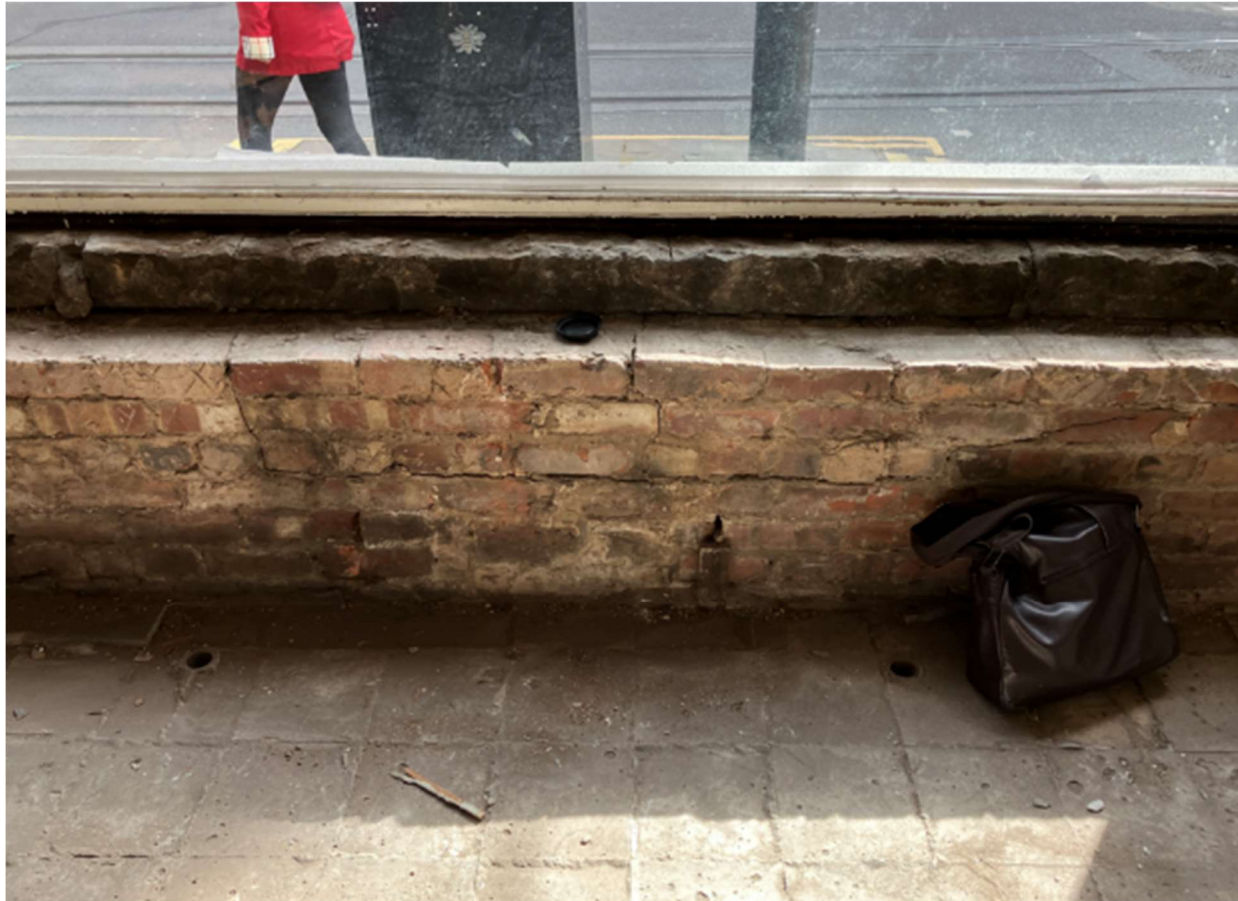
- Masonry cills to Cross Street elevation were noted include slight deteriorated of internal masonry leaf in some locations; including some cracking of brickwork joints, local loose bricks, etc.

*Figure 17 – Loose Masonry / Cracking to Brickwork Cills to Cross Street Elevation*

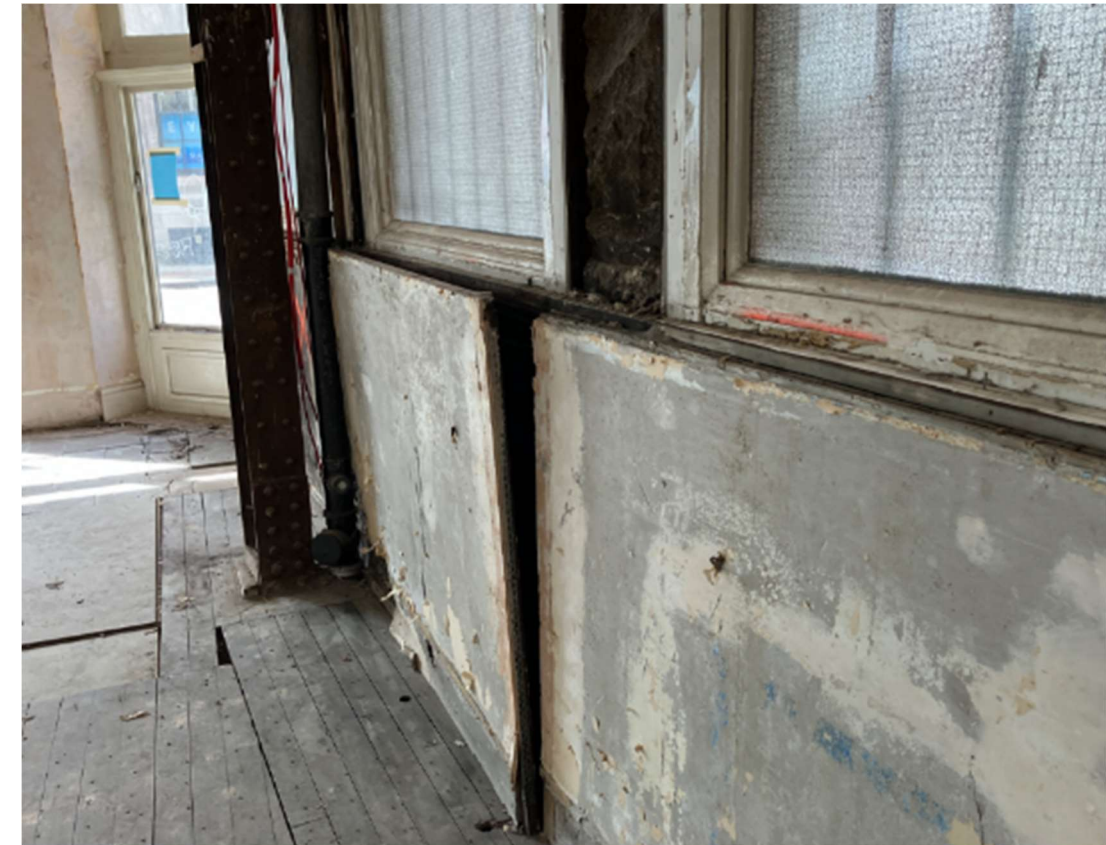
- Plaster board panels have been included to interface face of rear elevation (covering low-level window openings to rear elevation onto Four Yards). Panels were noted as loose in some locations and showing signs of some minor cracking

*Figure 18 – Loose Plasterboard Panelling to Rear Elevation*

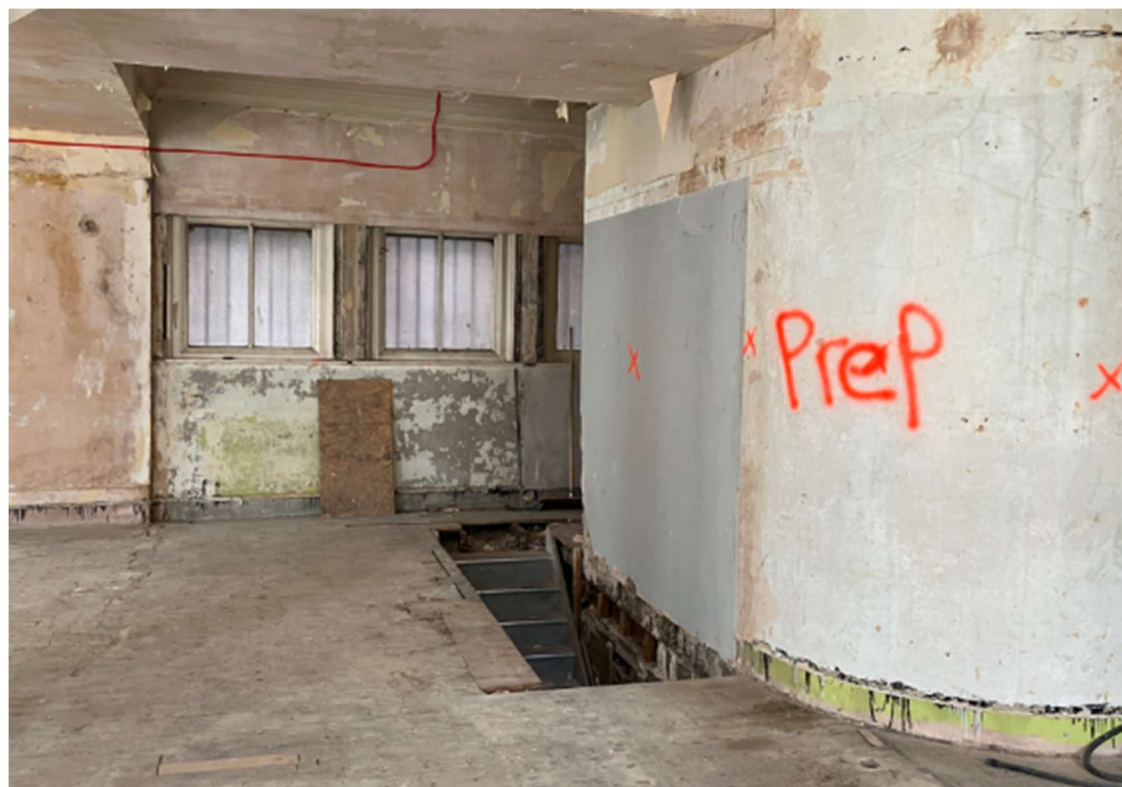
- Curved masonry wall noted in close proximity to existing basement access stair; it is noted that this curved section of masonry appears to have been constructed off the ground floor filler joist floor

*Figure 19 – Curved Masonry Wall Adjacent to Basement Access Stair*

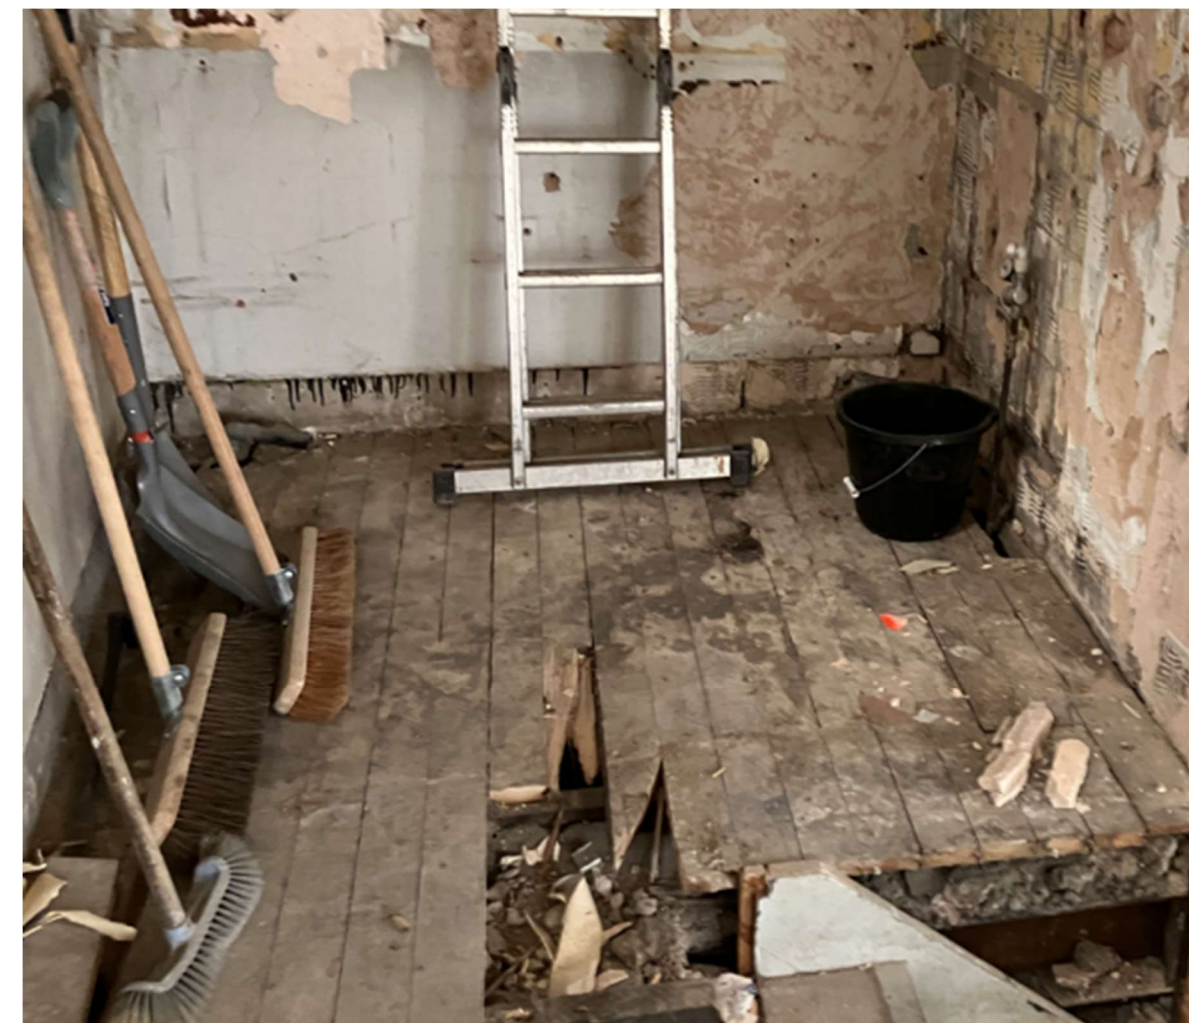
*Figure 20 – Damaged Floor Board Finishes to Top of Basement Access Stair*

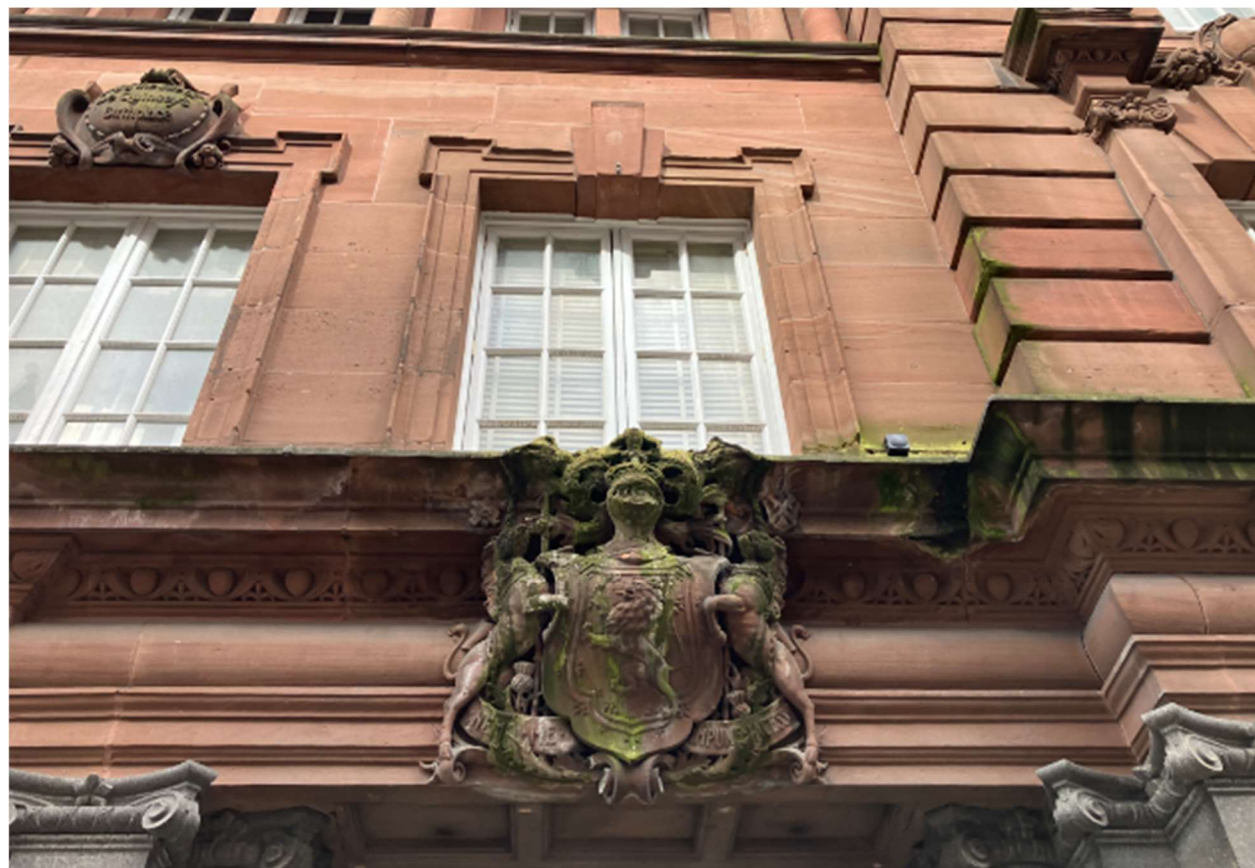
*Figure 23 – Minor Moss Staining to Stonework*
