# WHITELEY HALL, MILLGATE BUILDING, CHETHAM'S SCHOOL OF MUSIC, LONG MILLGATE, MANCHESTER

## Archaeological Watching Brief

Report No. 2024-04  
(Project Code: MA 854)

Client: Chetham's School of Music

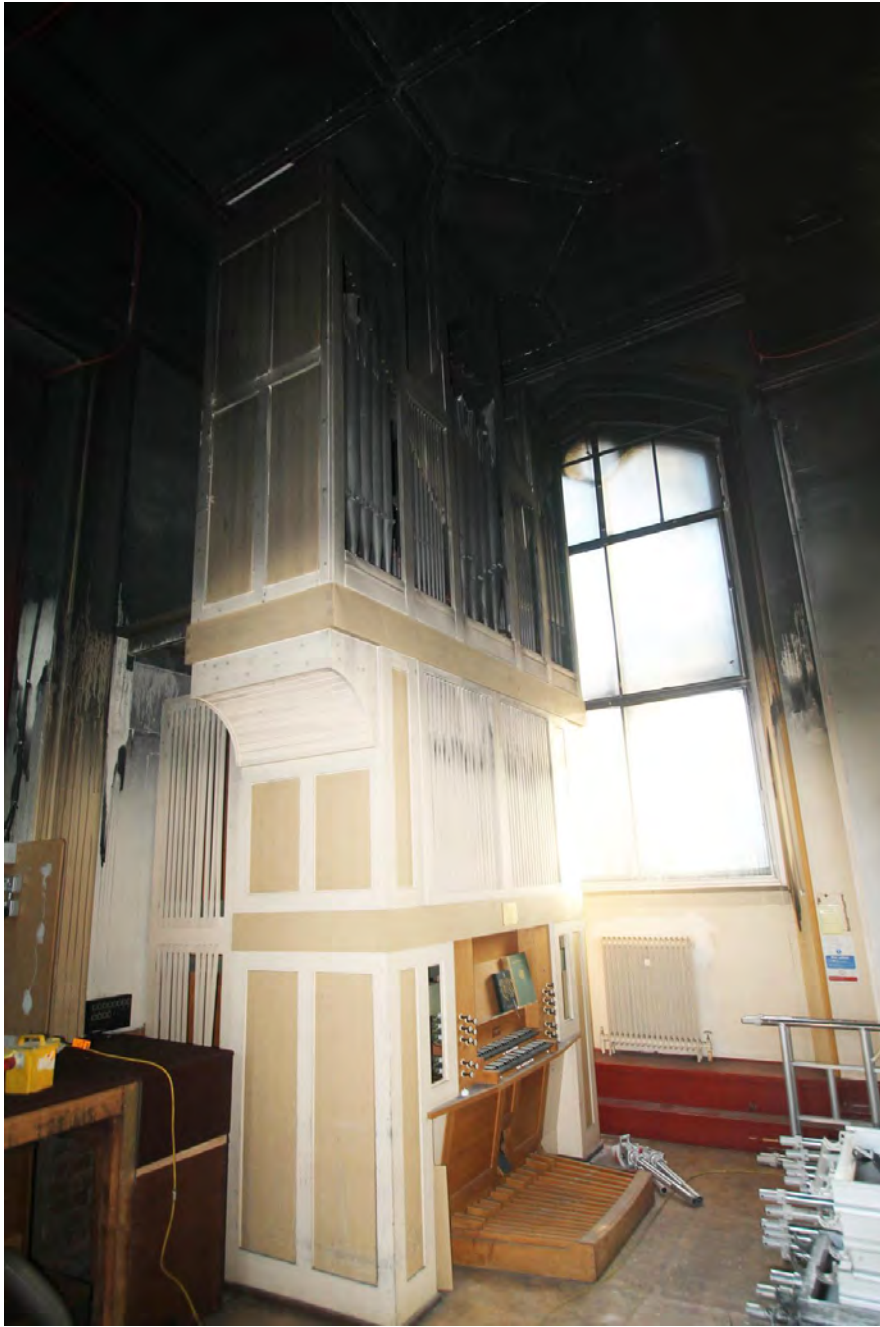
Plate 1. Fire damaged organ, viewed from west.

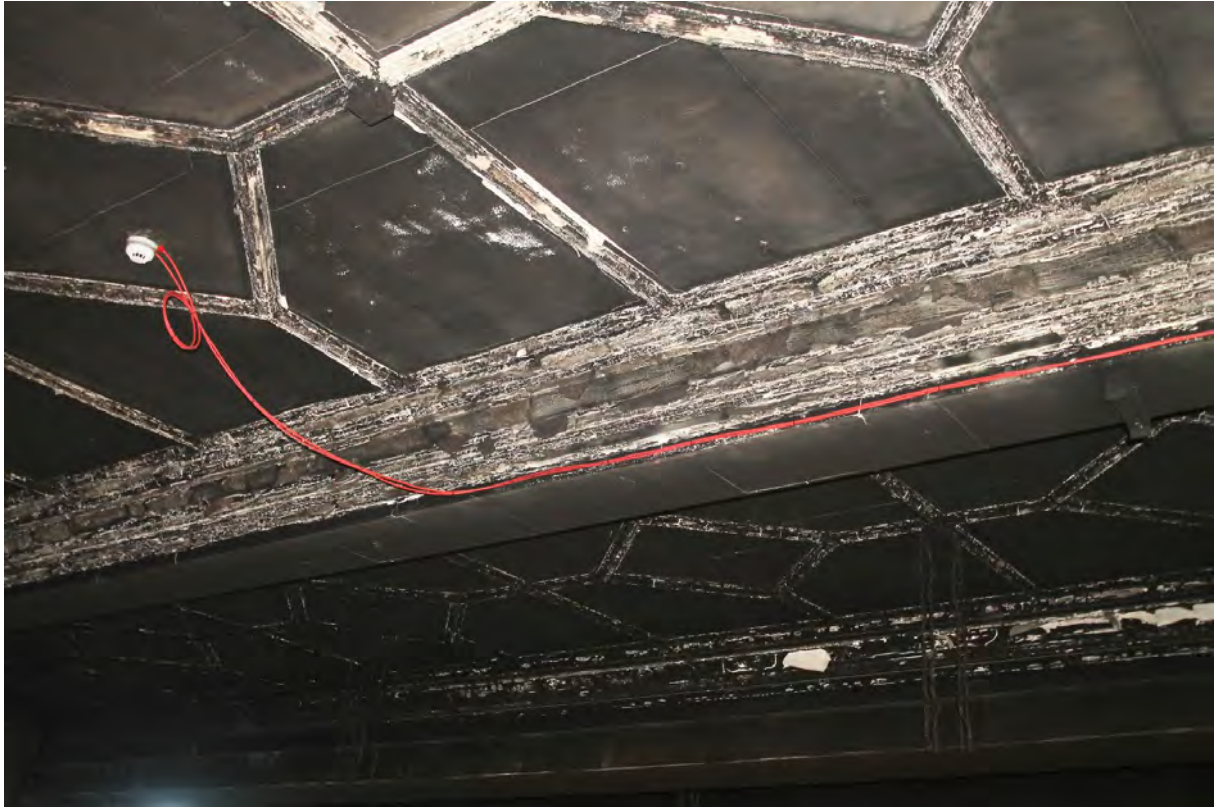
Plate 36. Fire and smoke damaged ceiling, bay 1, viewed from south.

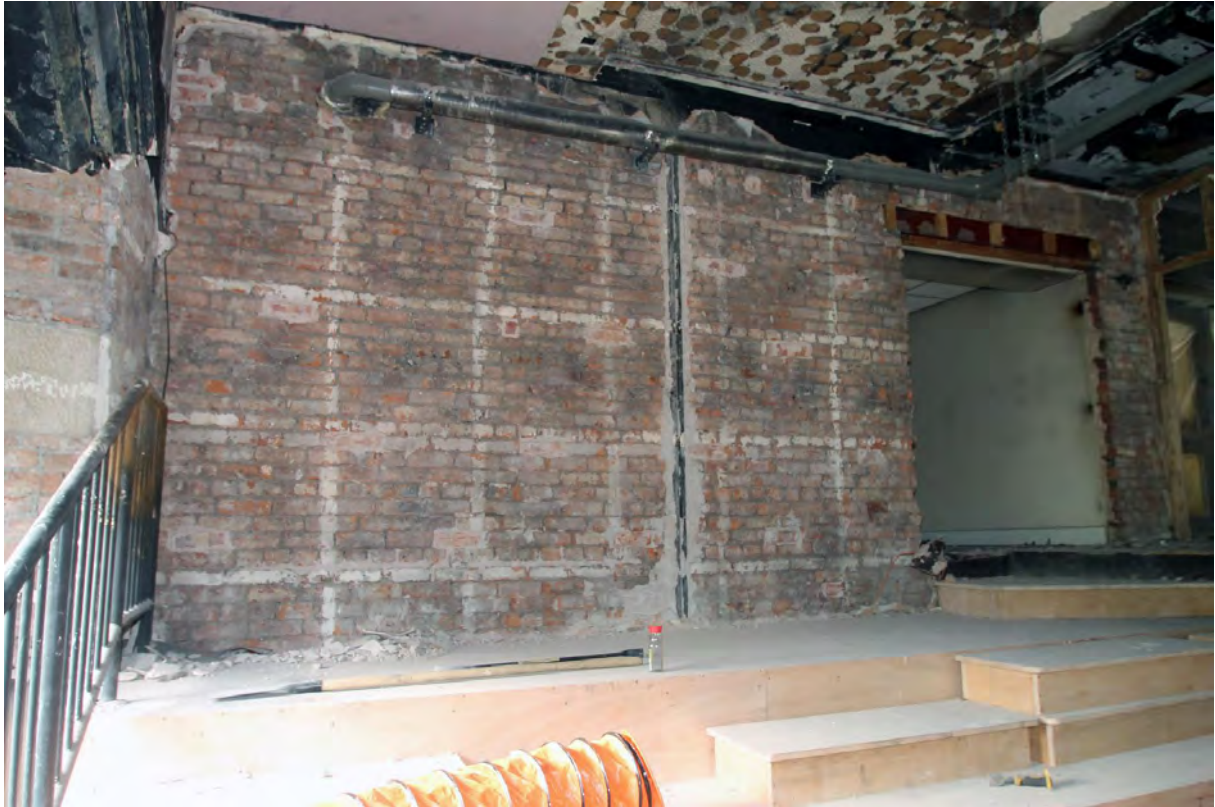
The south wall of the balcony in bay 1 was also stripped of its dry lining, which comprised modern plasterboard panels, mounted upon timber battens, which were fixed into the brickwork. The bricks were identical to those of the east and west elevations. A modern timber partition had controlled access through the probable original central doorway; but just to the south of this was a larger, inserted doorway, beneath an inserted steel lintel. This doorway had provided access into the toilets here, and into the main staircase.

Plate 47. South wall of balcony, following removal of dry lining, viewed from north.

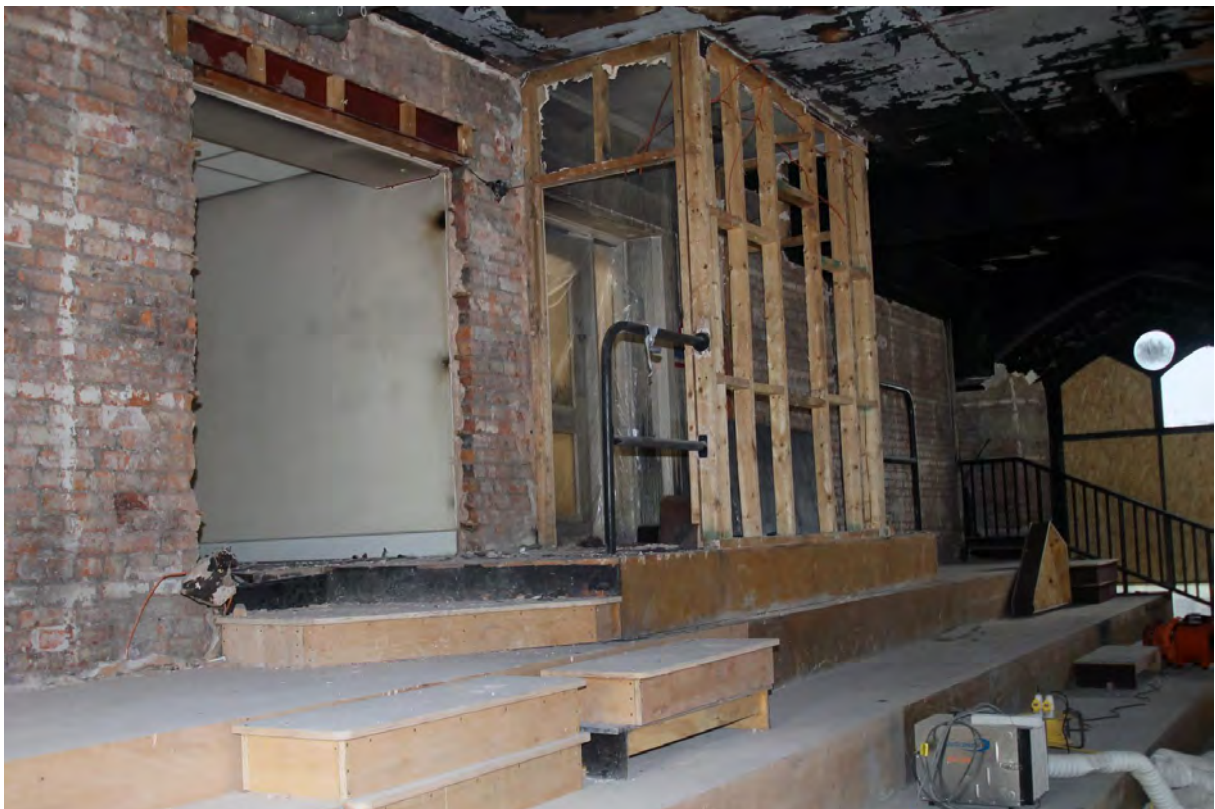
Plate 48. South wall of balcony, viewed from north-east, showing inserted doorway.

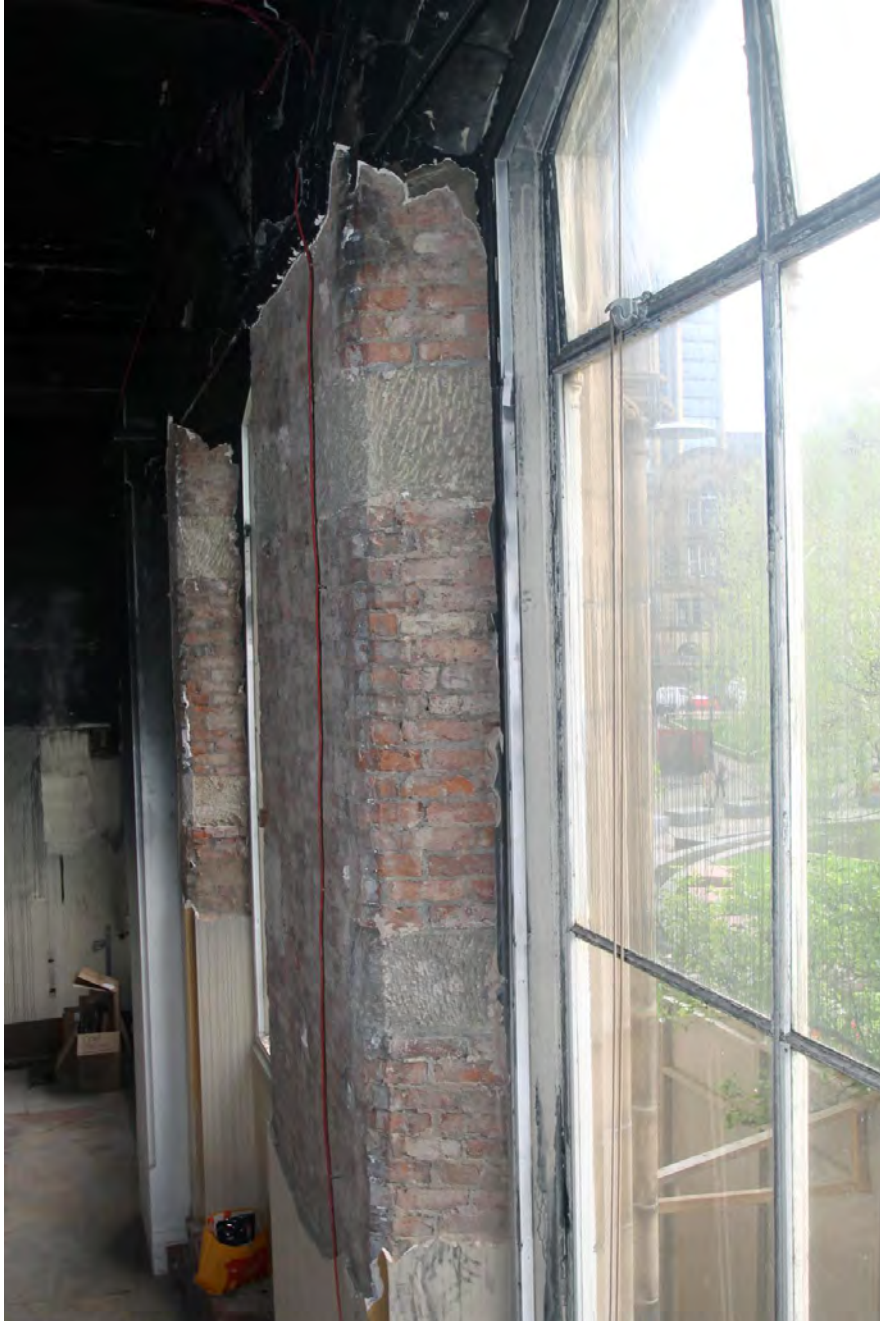
The internal walls were partly stripped of fire damaged plaster, towards the ceiling. The west and east walls were constructed of machine-made brickwork, laid in an English Garden Wall (EGW) bond of three stretcher courses to each header course. The bricks measured 230mm in length by 75mm in thickness. Natural illumination within each of the five bays was provided by large opposing windows, each of two-centred arches, of the pointed segmental type. The arches and architraves were decoratively enhanced by plasterwork mouldings. Removal of plasterwork revealed that each window reveal contained pairs of substantial gritstone blocks, each 330mm deep, within the upper and lower parts. It is suggested that these blocks provided structural ties linking through between the external gritstone window surrounds, and the internal brickwork elevations. It also seems likely that these gritstone blocks were utilised for affixing of the heavy timber frames of the windows.

Plate 49. Window aperture, east elevation, bay 1, following plaster removal.

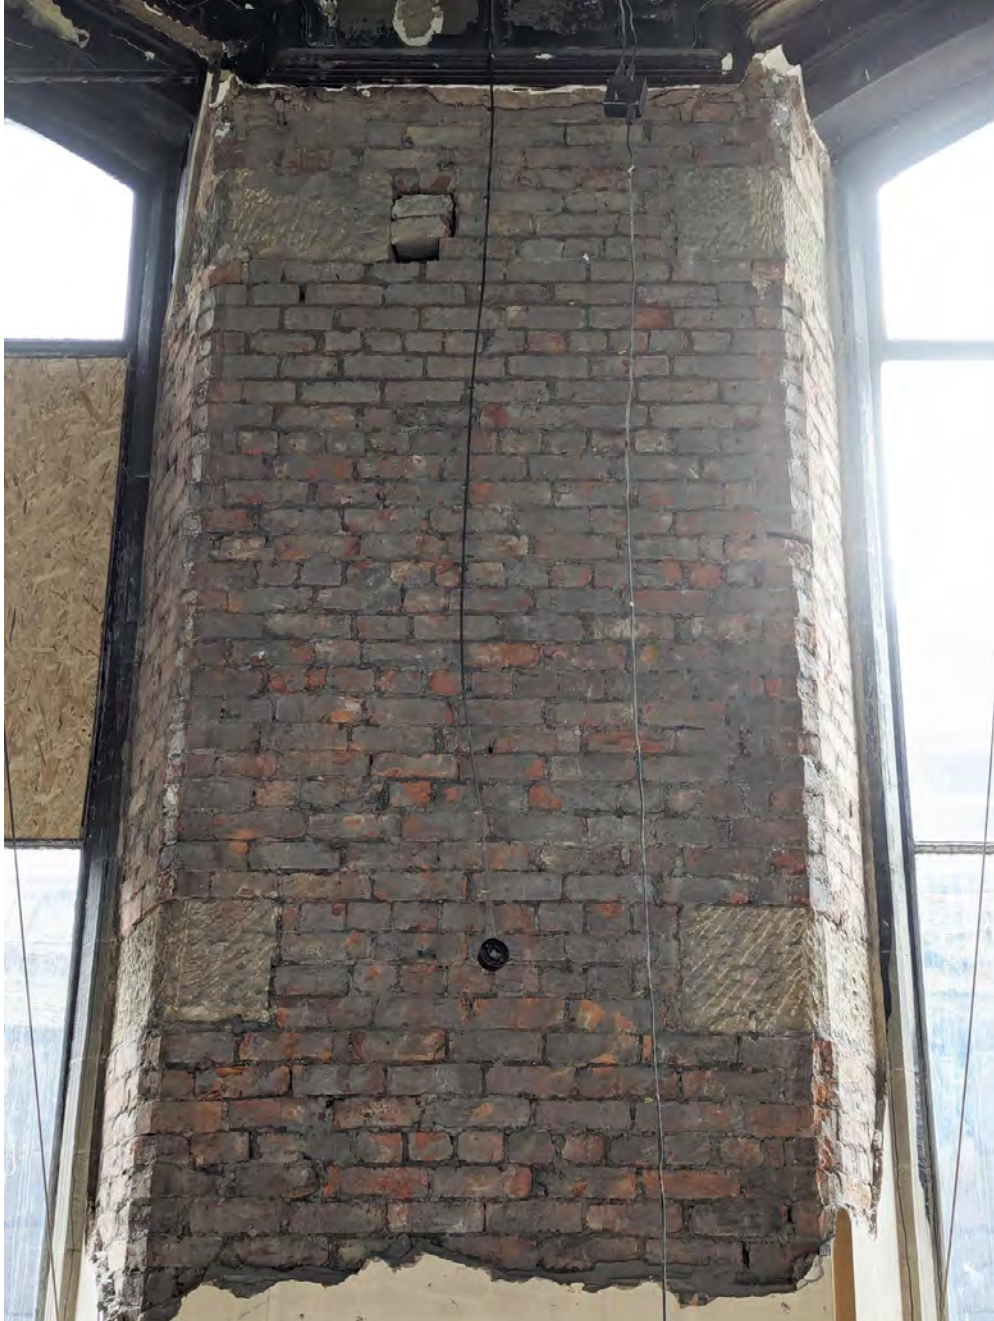
Plate 50. East elevation, between bays 2 and 3, following plaster removal.

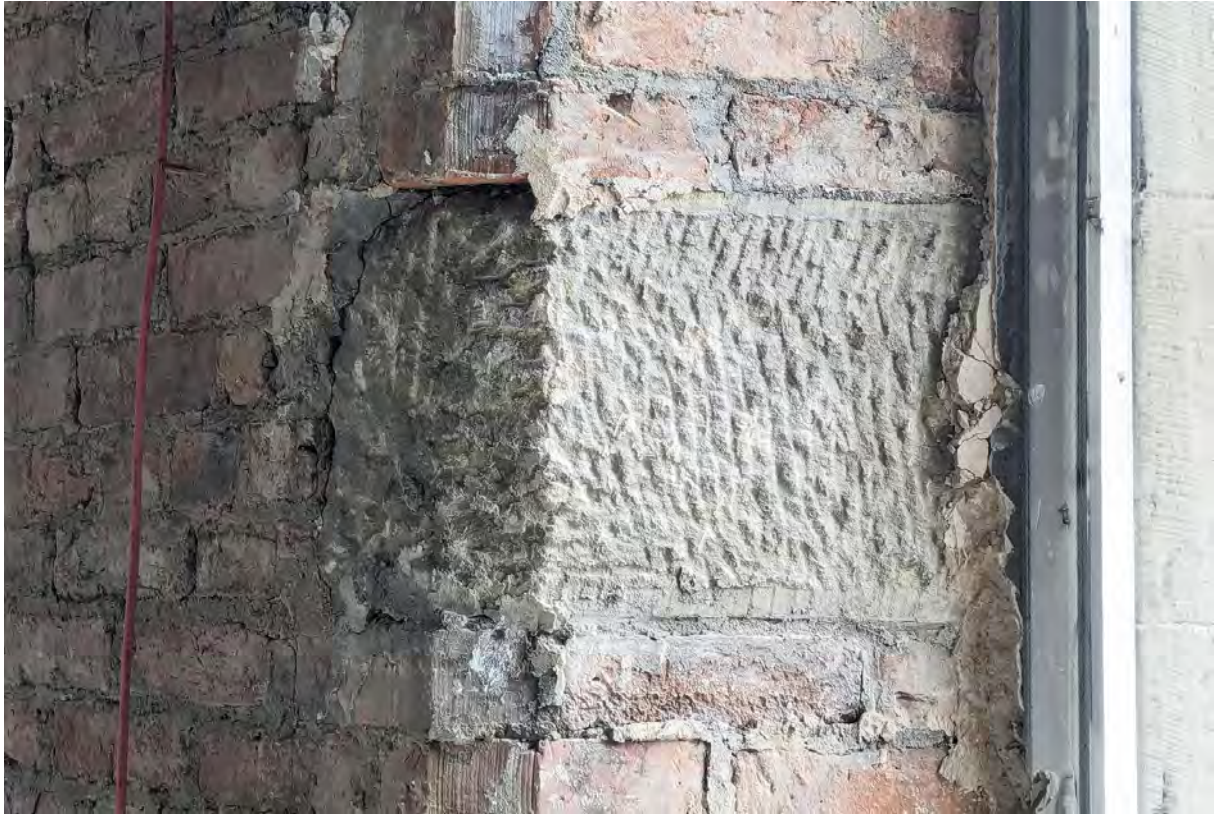
Plate 51. Gritstone block in south window reveal, west elevation, bay 2.

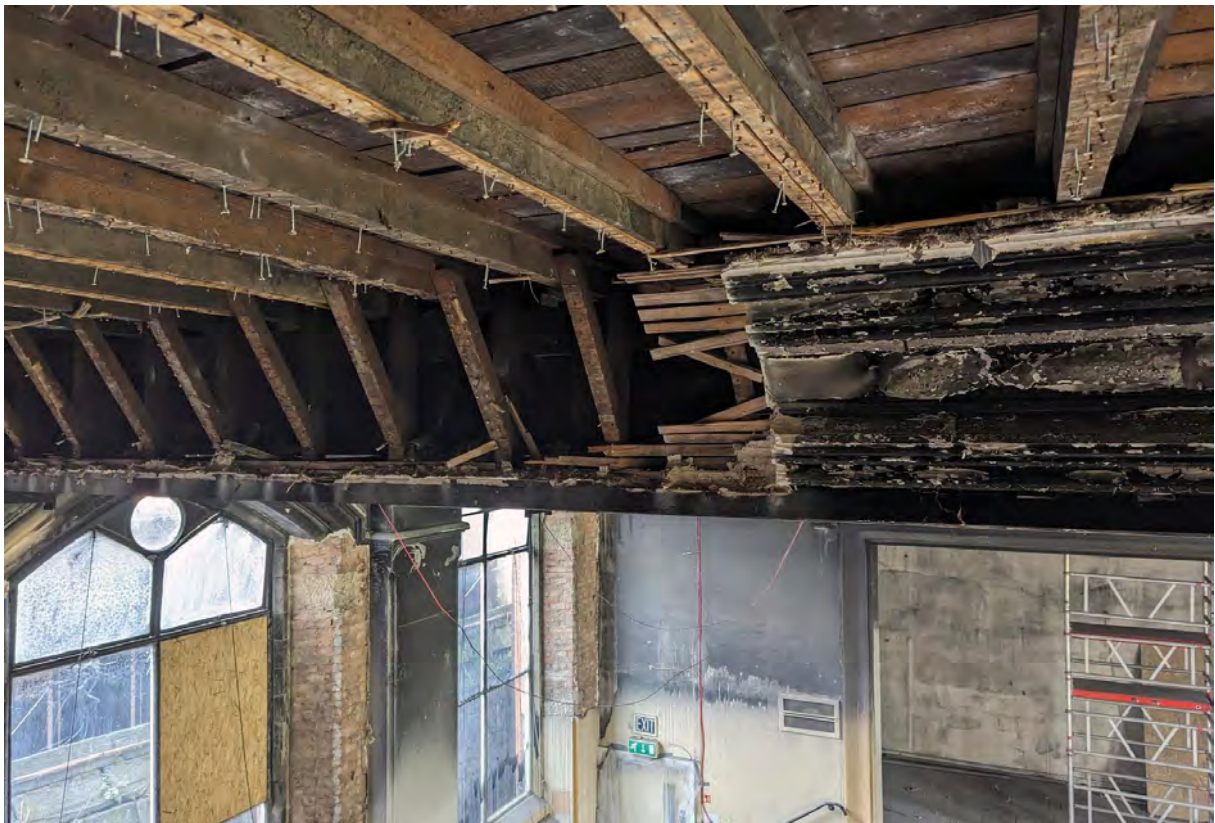
The wrought iron beams were ‘boxed in’ by hanging vertical timbers off the floor joists noted above, and these hangers were then linked beneath the beam soffits by horizontal timber bearers. Angled timber rakers (Plates 55 & 56) were then affixed from the vertical timbers, onto the floor joists over. This assemblage of timber was then used to form a covering of ‘lathe & plaster’, onto which the whole of the ornamental plasterwork was ‘keyed’ (Plates 52 & 53).

Plate 52. Beam with lathe & plaster being removed, between bays 2 & 3, viewed from south.

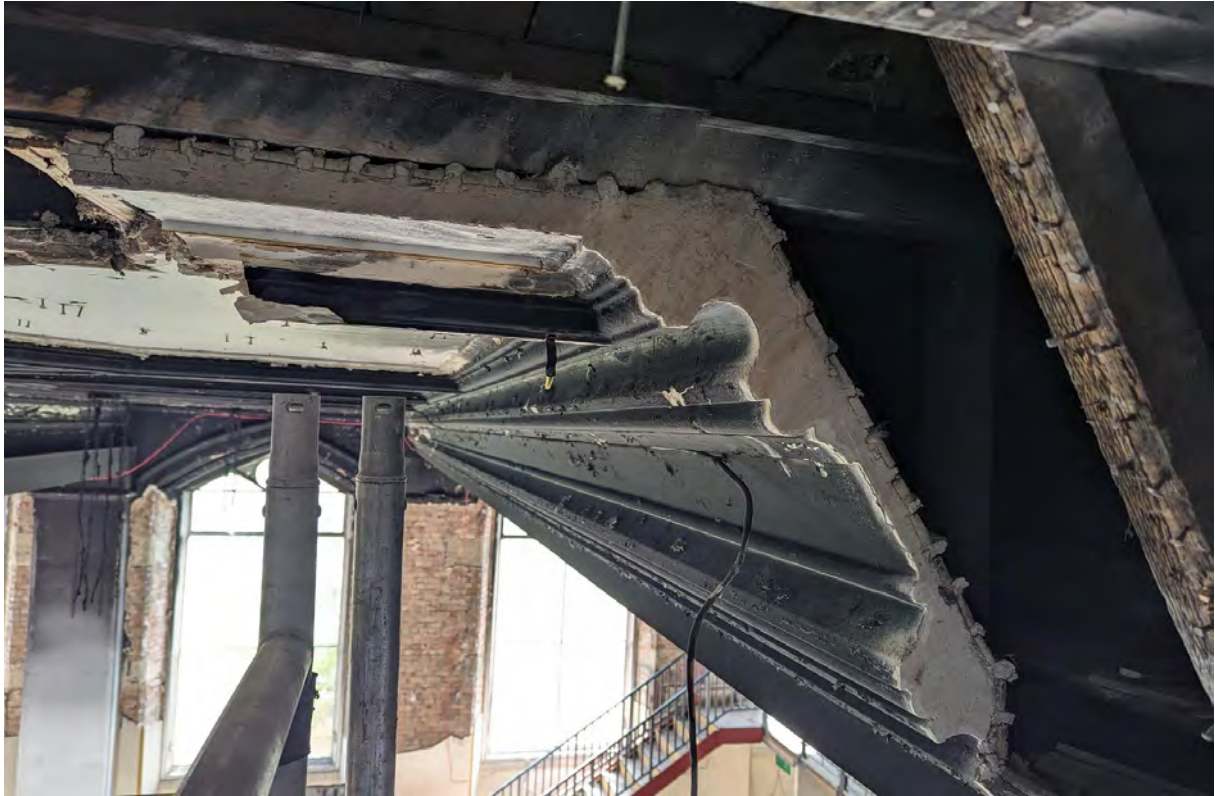
Plate 53. Cut section of plasterwork ceiling, bay 3, south side, viewed from east.

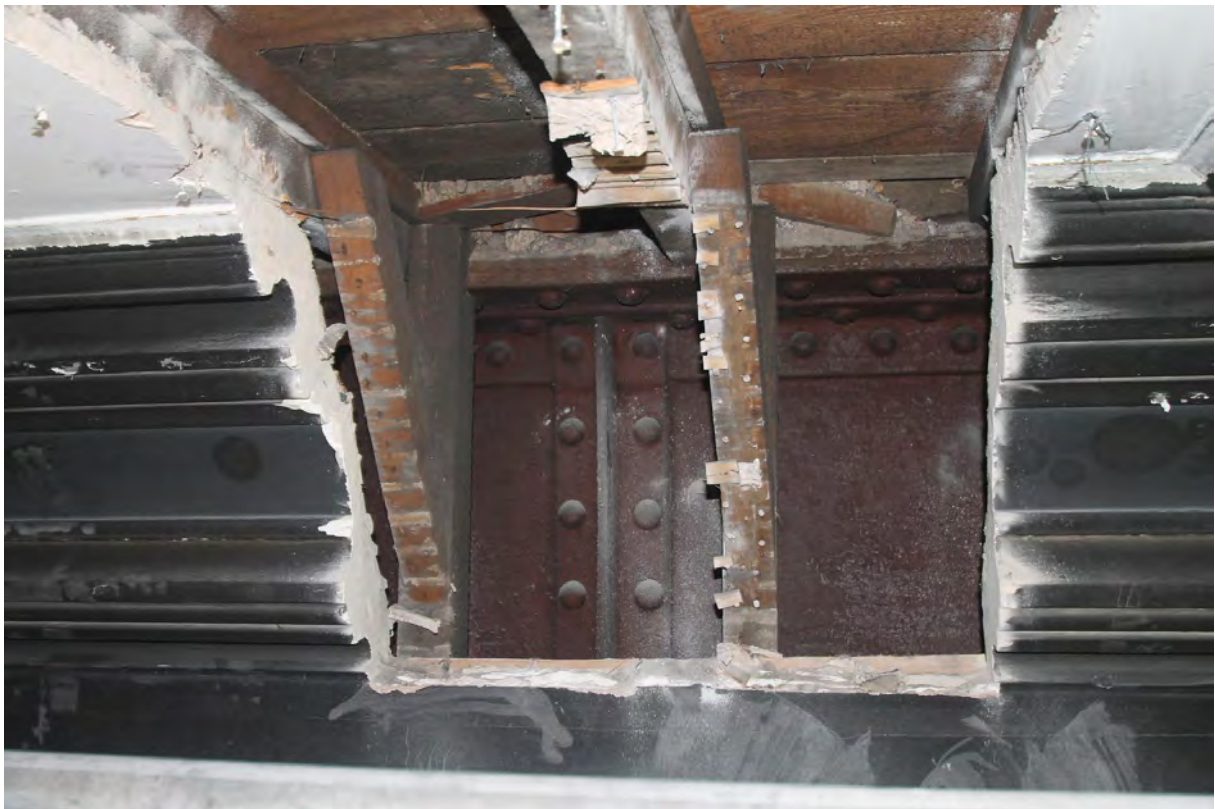
At unknown lateral intervals, vertical wrought iron stiffening plates had been rivetted to the webs (Plate 54), to obviate any buckling, and one pair of such plates had been affixed in a cross arrangement (Plate 55), possibly indicating the beam midpoint. The far ends of these beams were not visible, although it is most likely that they were bearing upon large gritstone blocks seated into the east and west walls.

Plate 54. Plasterwork cut away to reveal wrought-iron beam, bay 3, viewed from north.

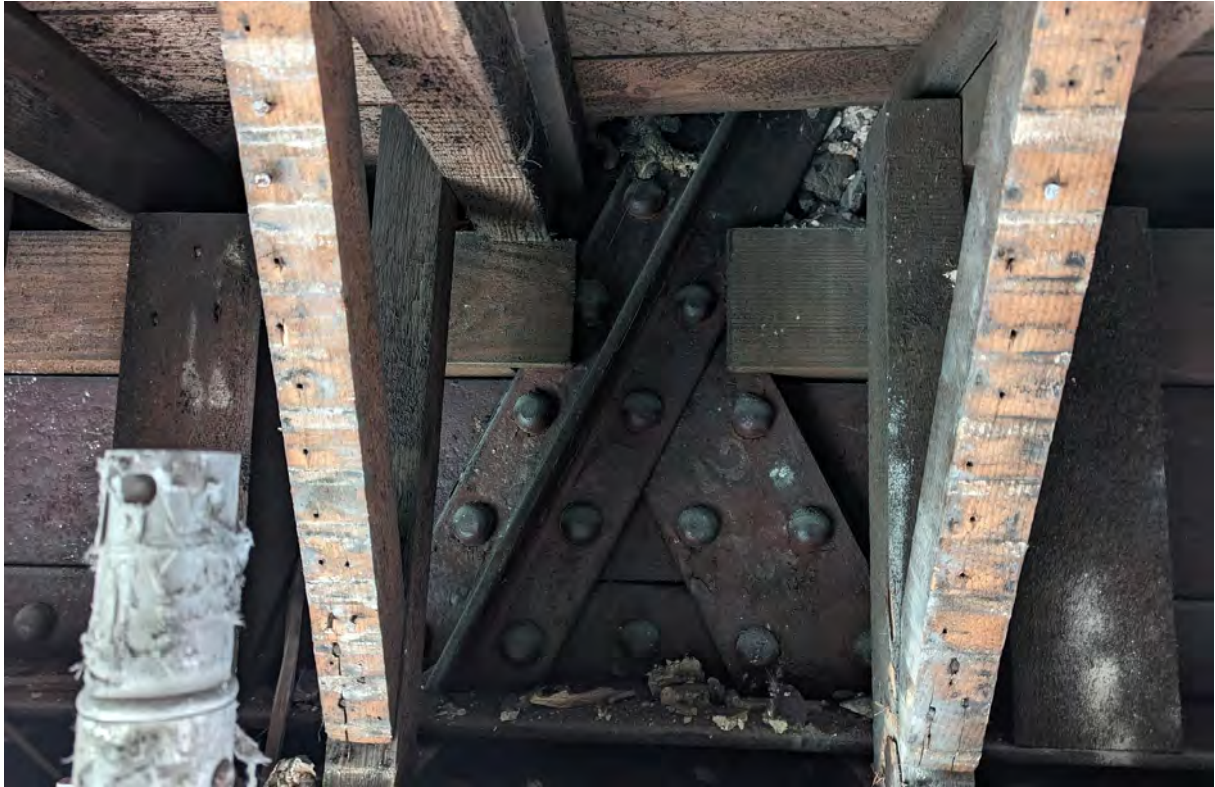
Plate 55. Wrought iron beam, bay 4, with diagonal braces, viewed from north.

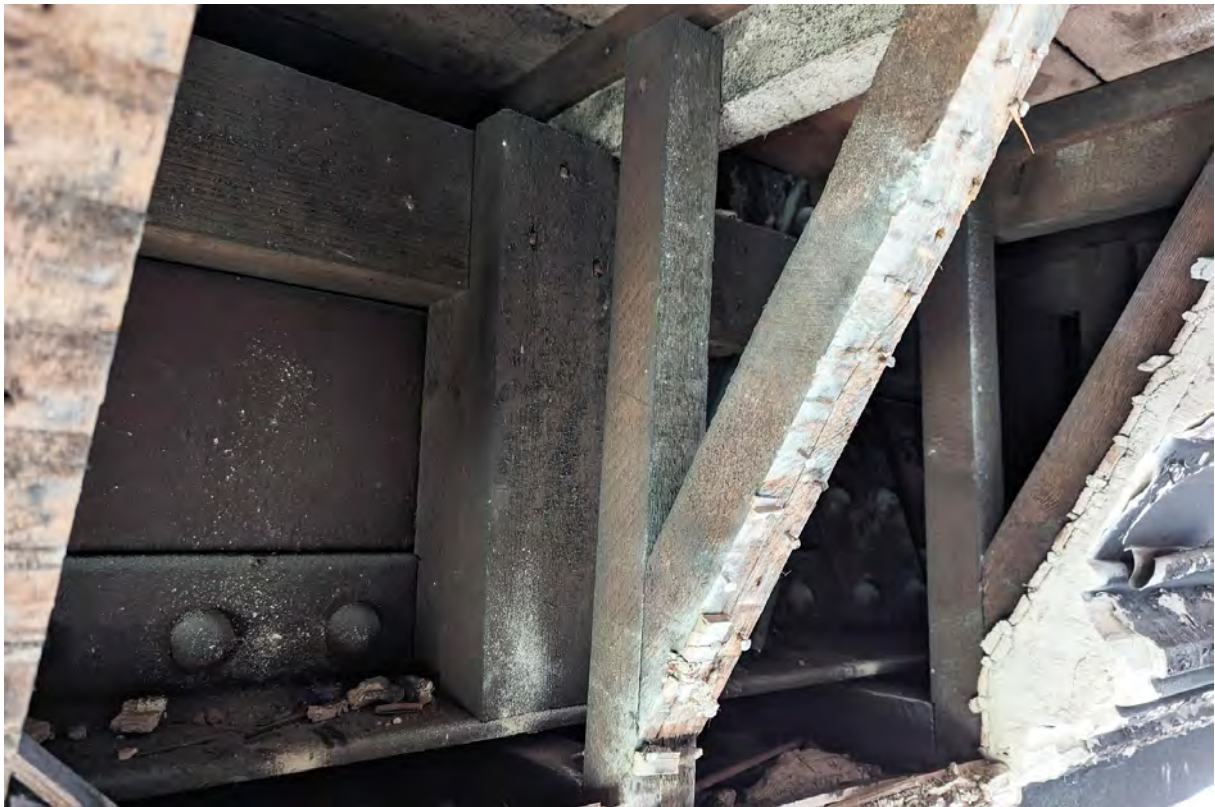
Plate 56. Wrought iron beam, bay 2, viewed from north-east, showing timber formwork.

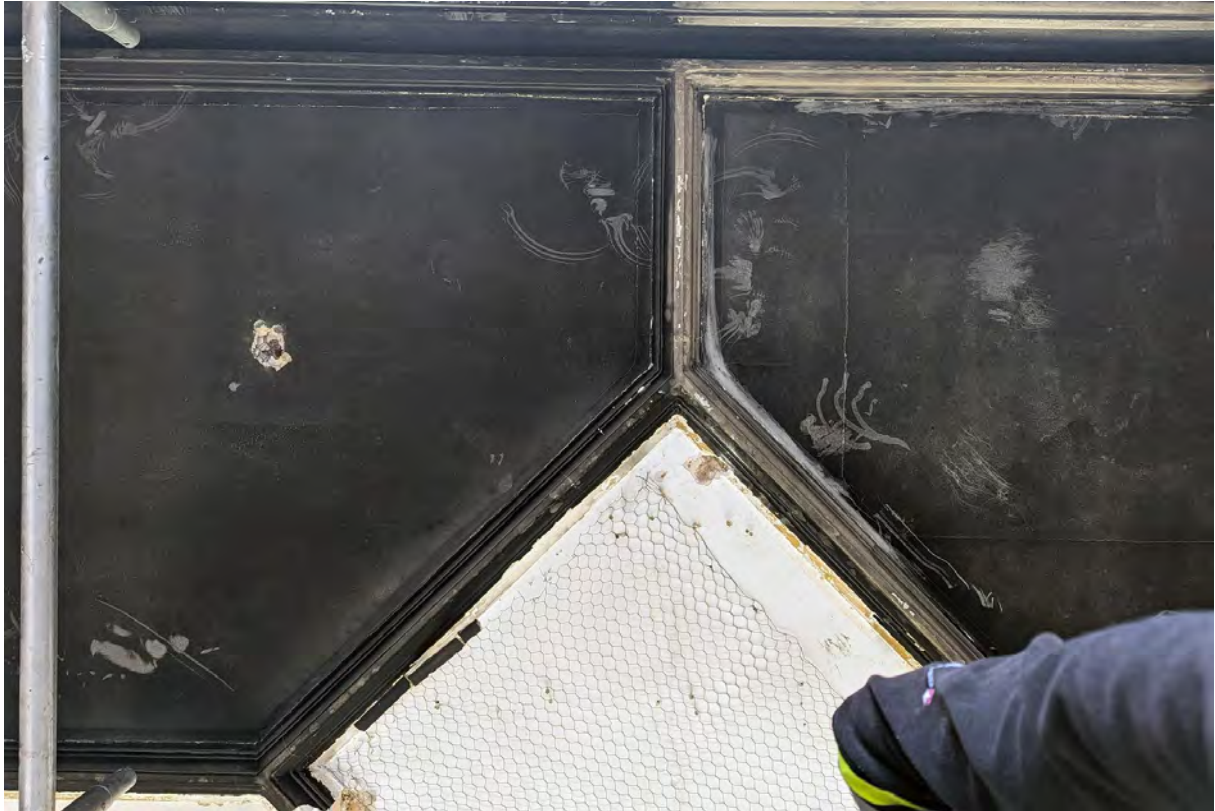
Plate 57. Intact plasterwork ceiling panels, bay 2, west side. Viewed from below.

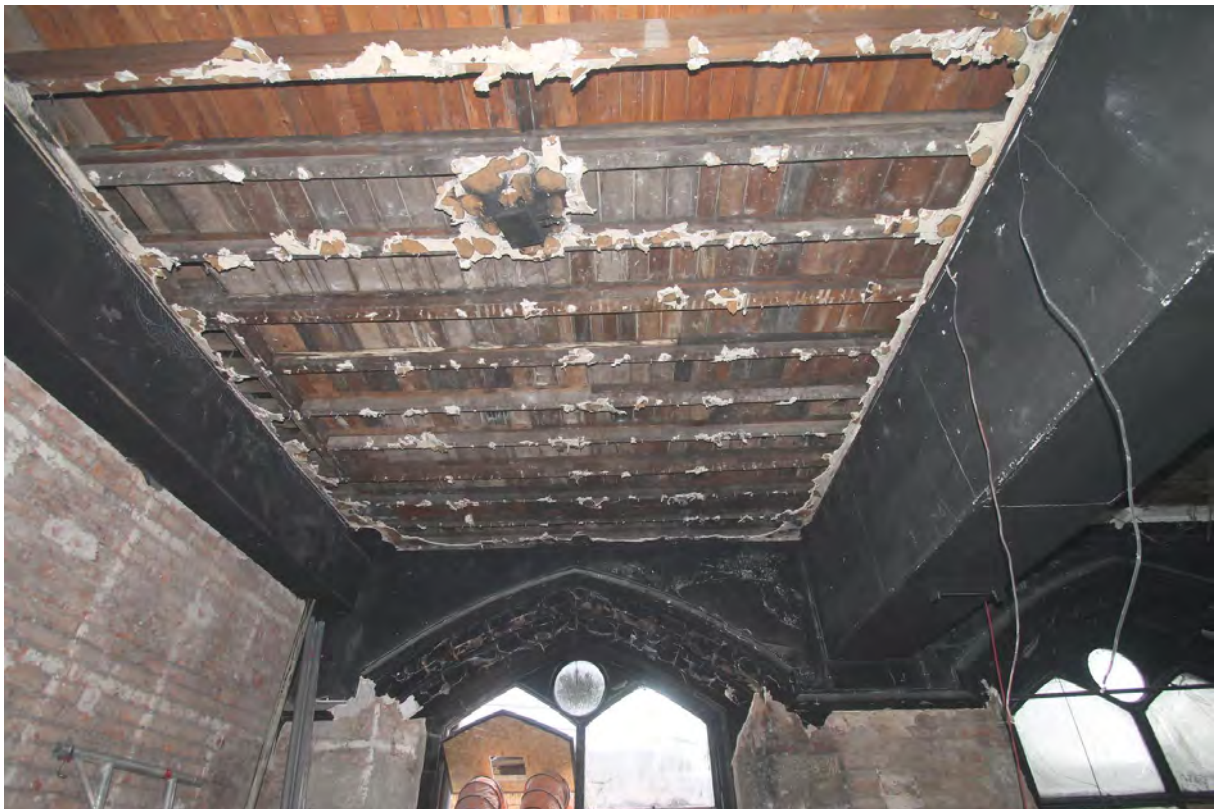
Plate 58. Bay 1, following removal of later plasterboard ceiling, viewed from east.

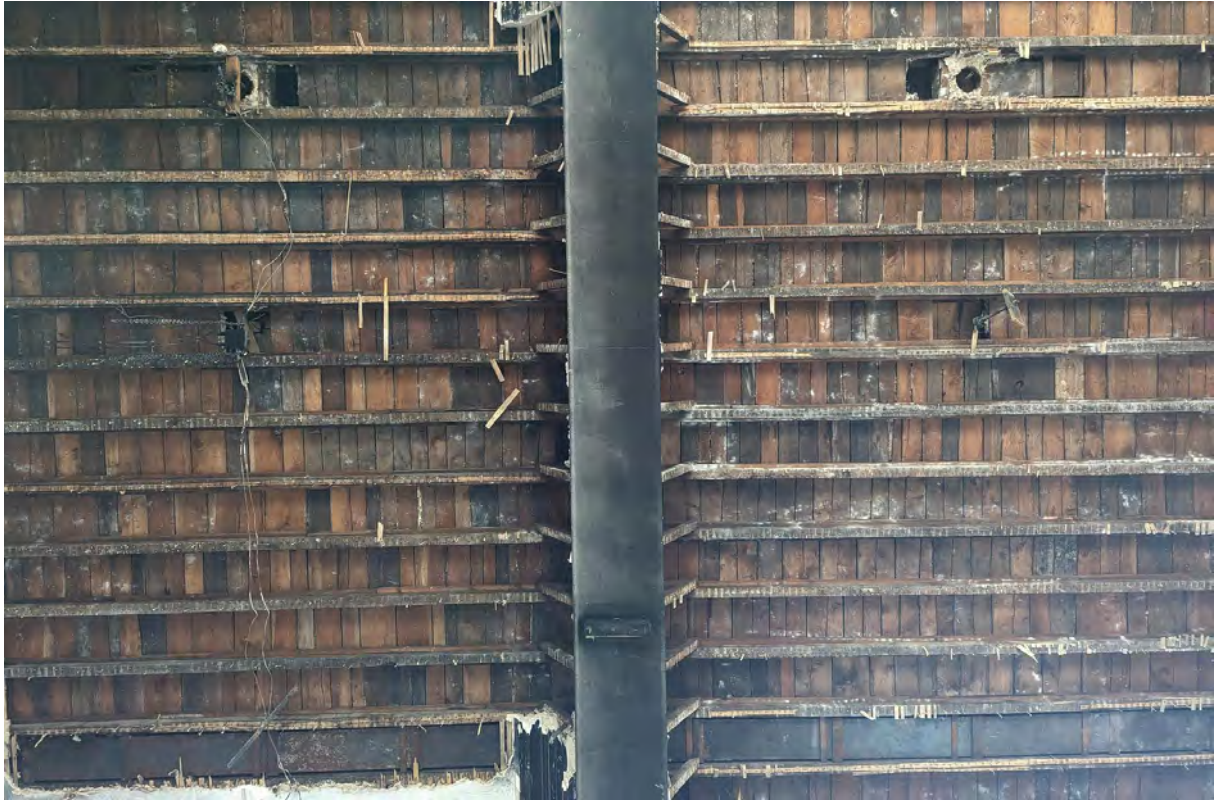
Plate 59. Ceiling of bays 2 and 3, following removal of plasterwork. Viewed from below.

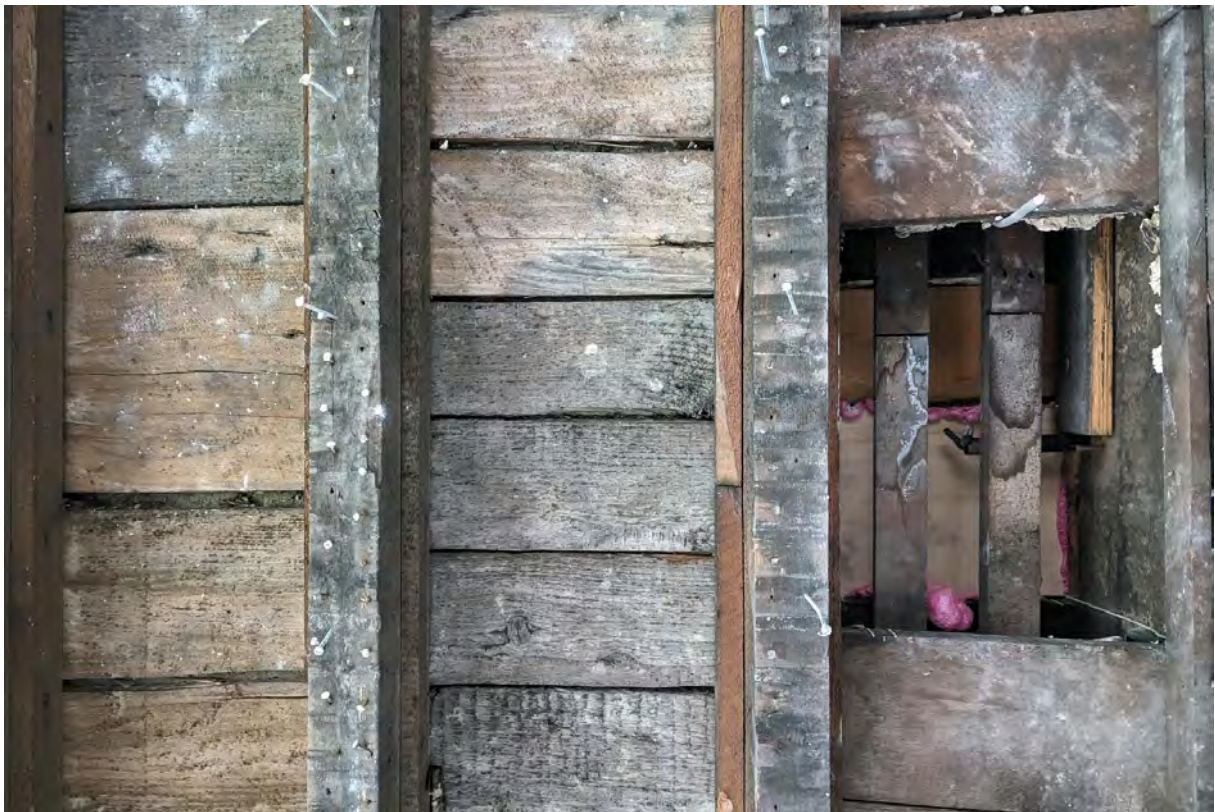
The wrought iron beams were used as a support for the plasterwork ceiling, and for the timber floor over. Firstly, north-south timber floor joists were laid over the upper flanges, at 340mm centres. Battens were attached to the sides of these joists, and upon the battens, spanning between the joists, were affixed short sections of timber planks (see photo inset, Figure 3). A layer of plaster was applied over these plank sections, and this may have formed a soundproofing element beneath the overlying timber floor (Plate 59). At one location, these plank sections were removed, exposing the timber floor over, and the latter appeared to have been replaced or repaired, with modern foam extruding between the timber boards (Plate 60).

Plate 60. Ceiling of bay 2, following removal of plasterwork. Floor over seen through gap.
