Simon Harrison  
Watson Construction Ltd

Date: 21<sup>st</sup> July 2023  
LKC Reference: LKC 23 1327\_Gas Risk Assessment

**RE: Former Manchester College Moston Campus - Ground Gas Risk Assessment**

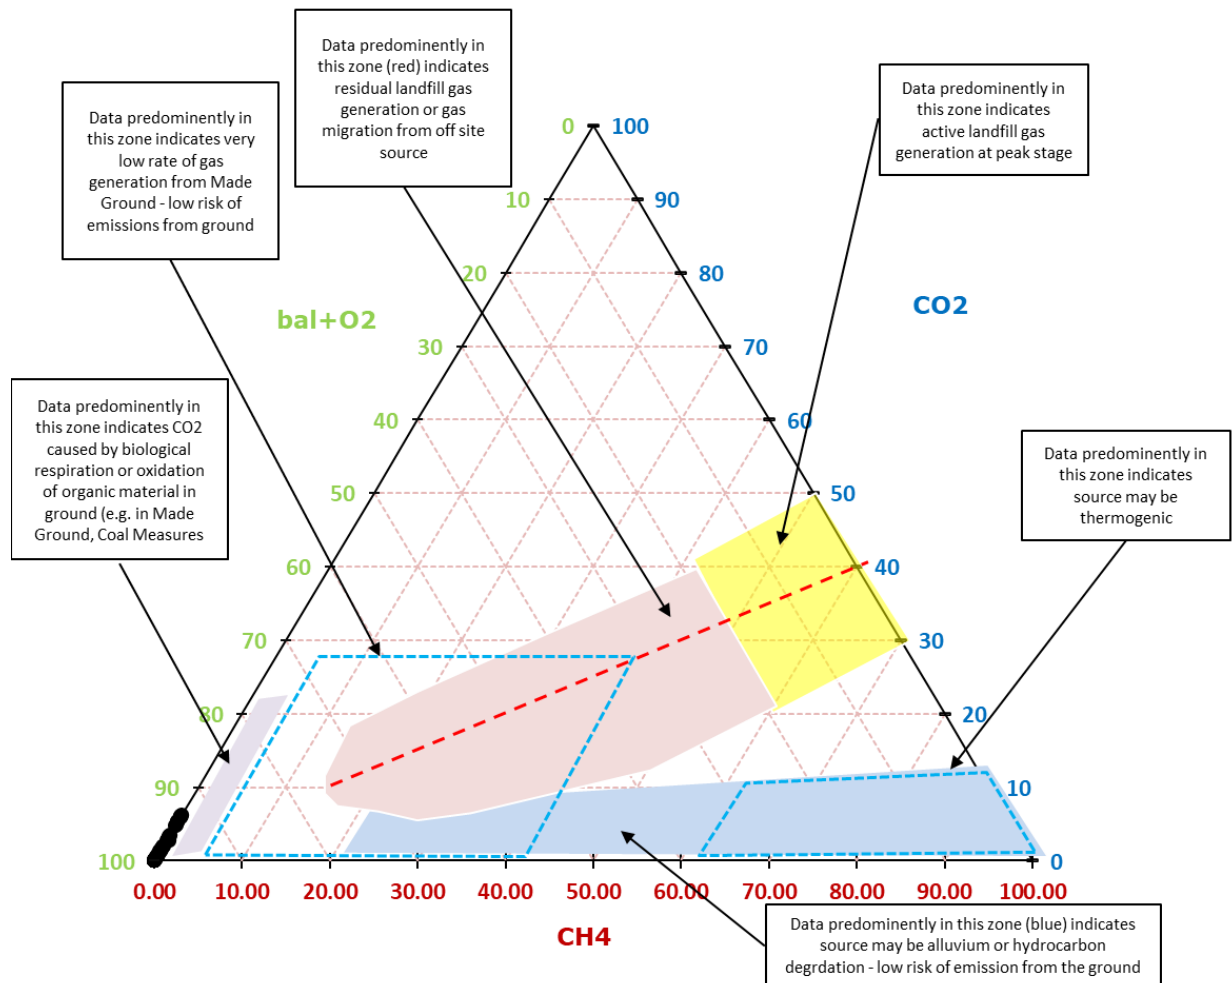
Plate 3-1: Ternary Plot Showing Curtins Gas Monitoring Data.

The Curtins gas data (plotted above) falls within the area of the ternary plot which is indicative of microbial respiration or oxidation of organic material. This indicates the CO<sub>2</sub> is likely to be from microbial degradation of organic material in the soil.

Wilson *et al* goes on to say “*where gas monitoring results plot within the zone shown...for microbial respiration there is no requirement to increase the Characteristic Situation simply because CO<sub>2</sub> concentrations exceed 5%*”

to made ground or bentonite. Microbial action chemical oxidation processes may have both contributed to the observed CO<sub>2</sub> concentrations.

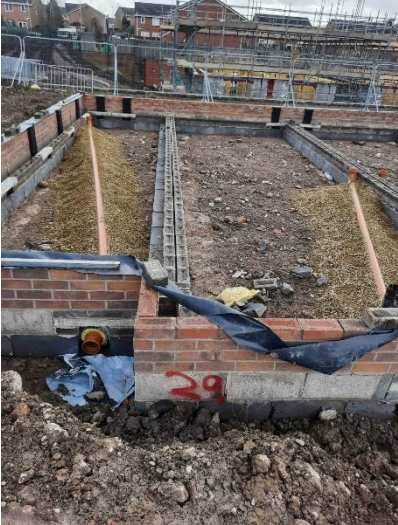
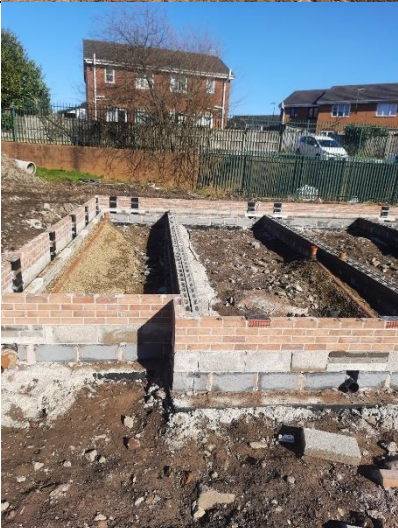
Furthermore, it is understood that the buildings incorporate a ventilated sub-floor void (Photographic evidence in Appendix C) CL:AIRE Research Bulletin 17<sup>6</sup> states:

The build phase of the development incorporates a ventilated sub-floor void which is likely to provide more than sufficient gas protection for the site setting. Evidence of this is provided in Appendix C.

| | | <p>Evidence of subfloor void</p> |
| | | <p>Evidence of subfloor void</p> |

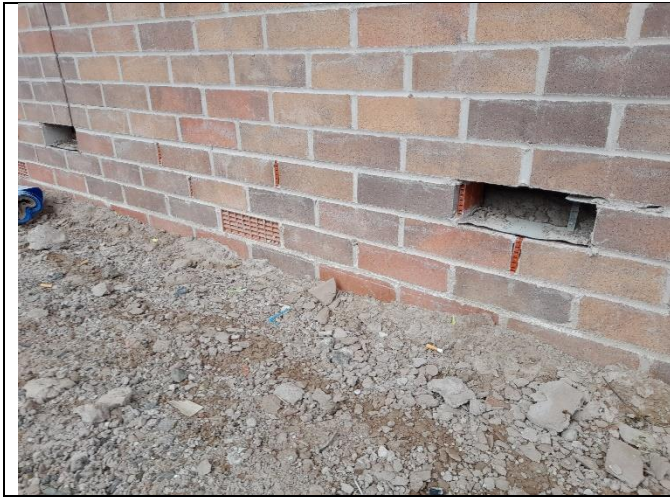
Evidence of airbricks.
