**Appendix: Photographs**

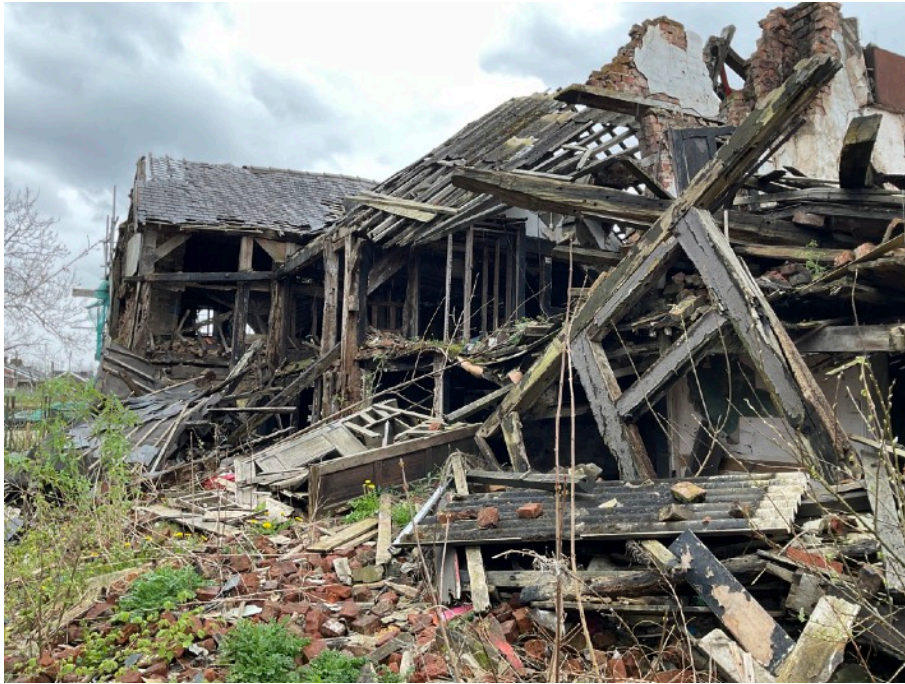
The rear is in a state of collapse.

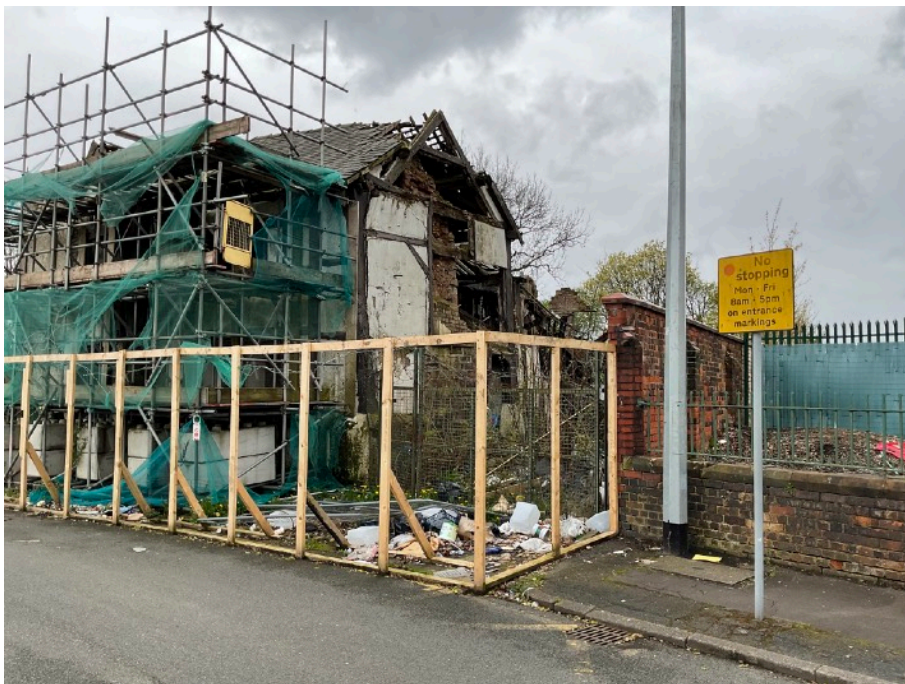
North gable. Panels are detaching.

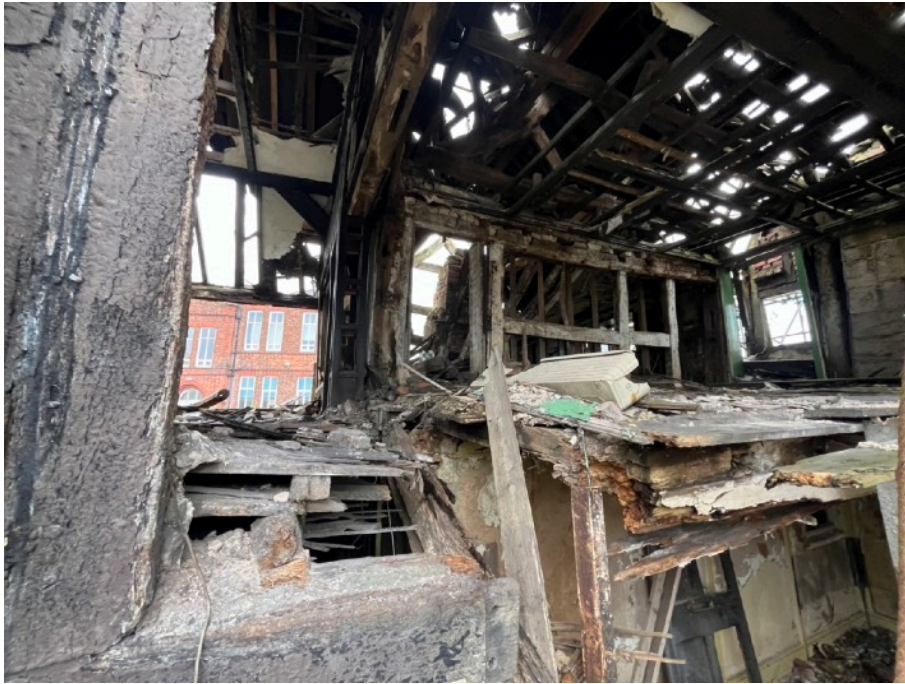
The timber frame is evident within the west wing.

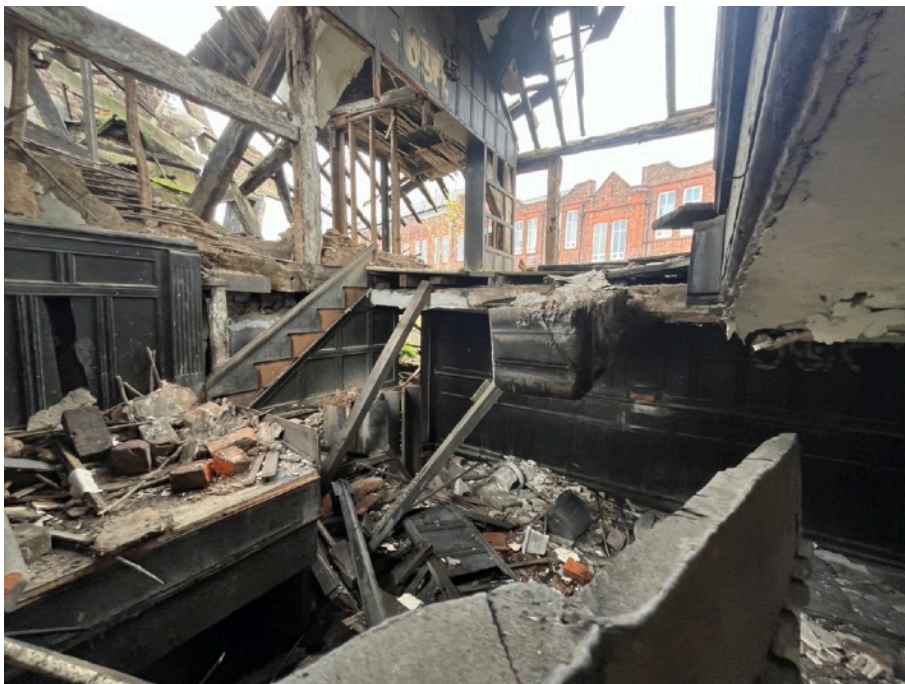
Much of the framing has been lost in the main body of the house.
