## Consultant Advice Note

Job Number: 14794  
Project Title: Manchester Art Gallery, Consultant Advice Note  
Doc Ref: 14794-BKP-14-ZZ-TN-S-0003  
Purpose of Note: Highlight structural failures that require remediation

Date: 13 May 2024

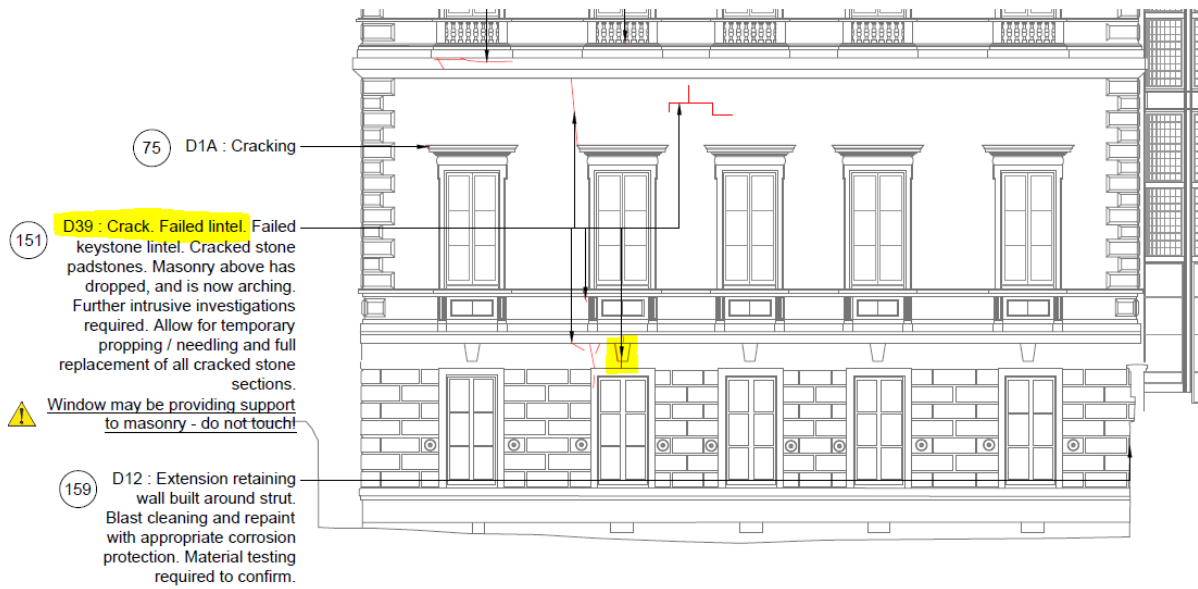
Figure 1 - Part Elevation to show location of lintel.

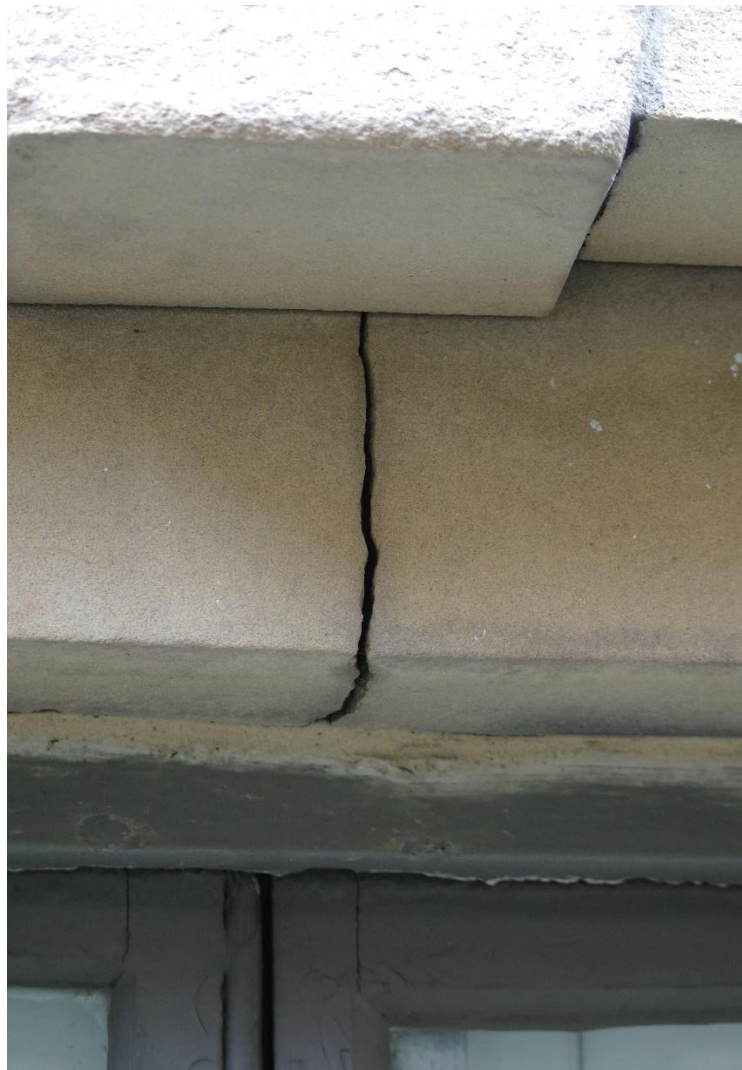
Figure 2 - Failed, cracked lintel – likely supported by the window frame

The lintel has a wide crack (5mm) through the centre, and a shear crack to the left-hand bearing. The lintel has dropped, and is likely now supported by the window frame. It appears to be historical, however, it has resulted in the keystone above slipping, and the likely cause for the masonry above to have settled.

The lintel presents a risk to any works around the window, as this is highly likely to be supporting the lintel.

The lintels need to be replaced, which will require Temporary propping, both internally and externally. The keystone lintels will require to be taken down and reset in the correct position. A detailed method statement for reinstatement will need to be developed in tandem with a conservation masonry specialist.

In the meantime, we strongly recommend that temporary props are installed to the window heads to prevent any further movement and relieve any load on the window frames.

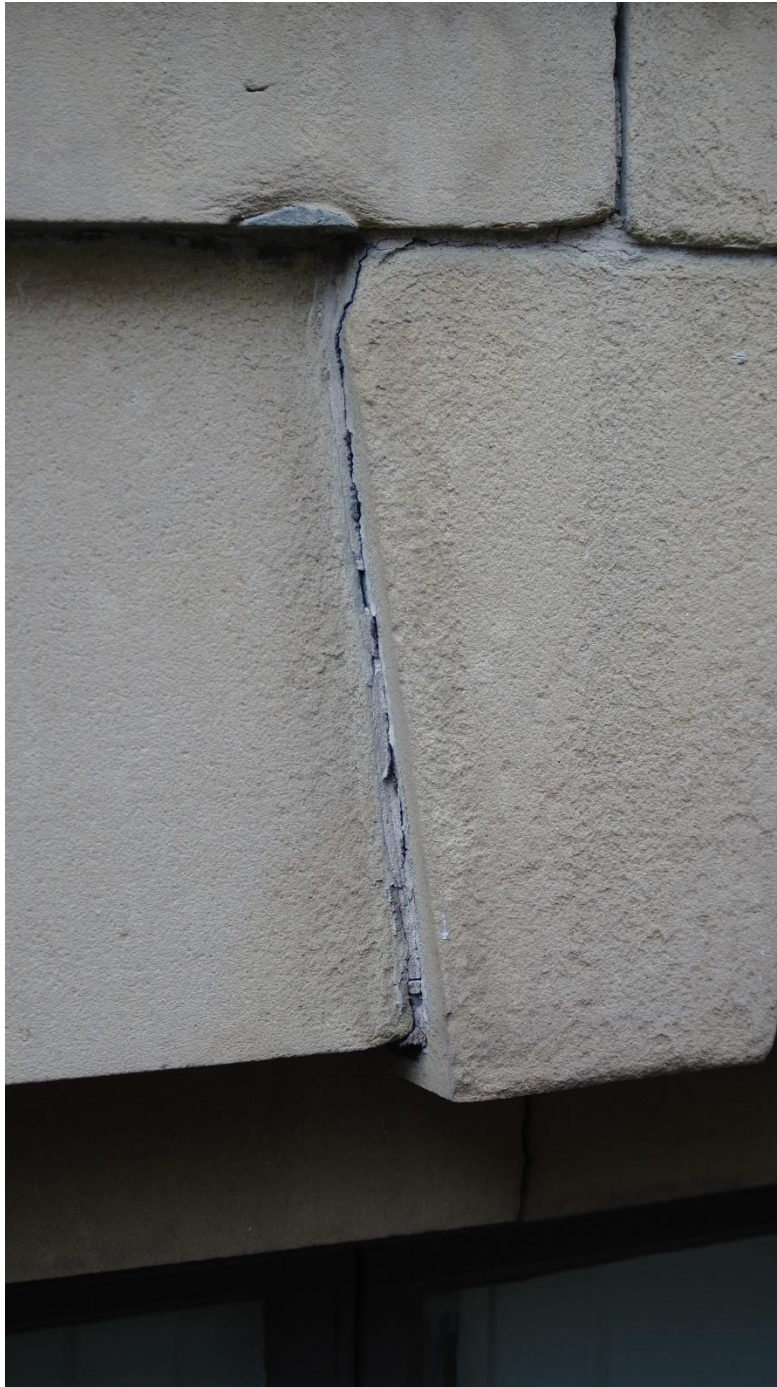
*Figure 3 - Joint slippage around the keystone*

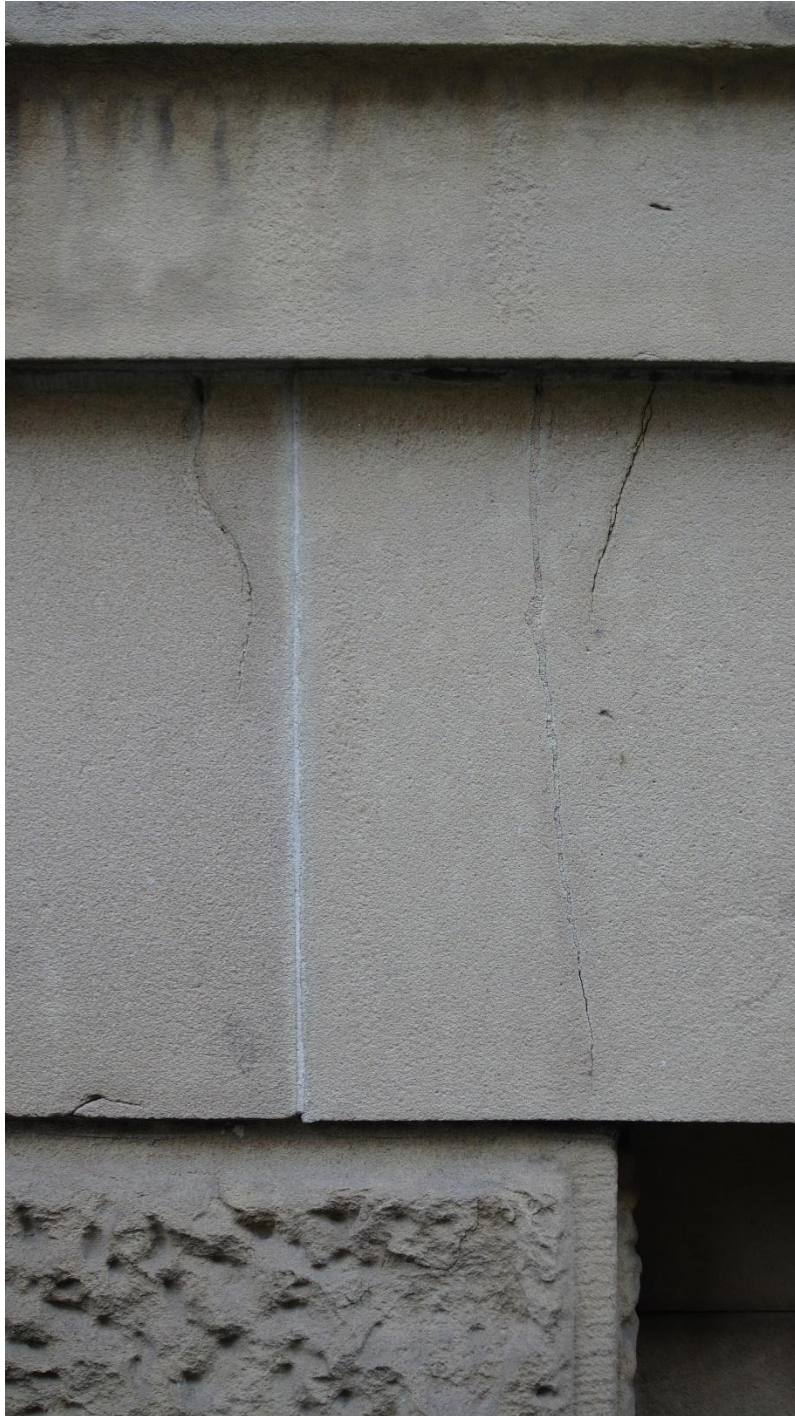
*Figure 4 - Shear crack at left hand bearing of lintel, previously infilled with mortar*

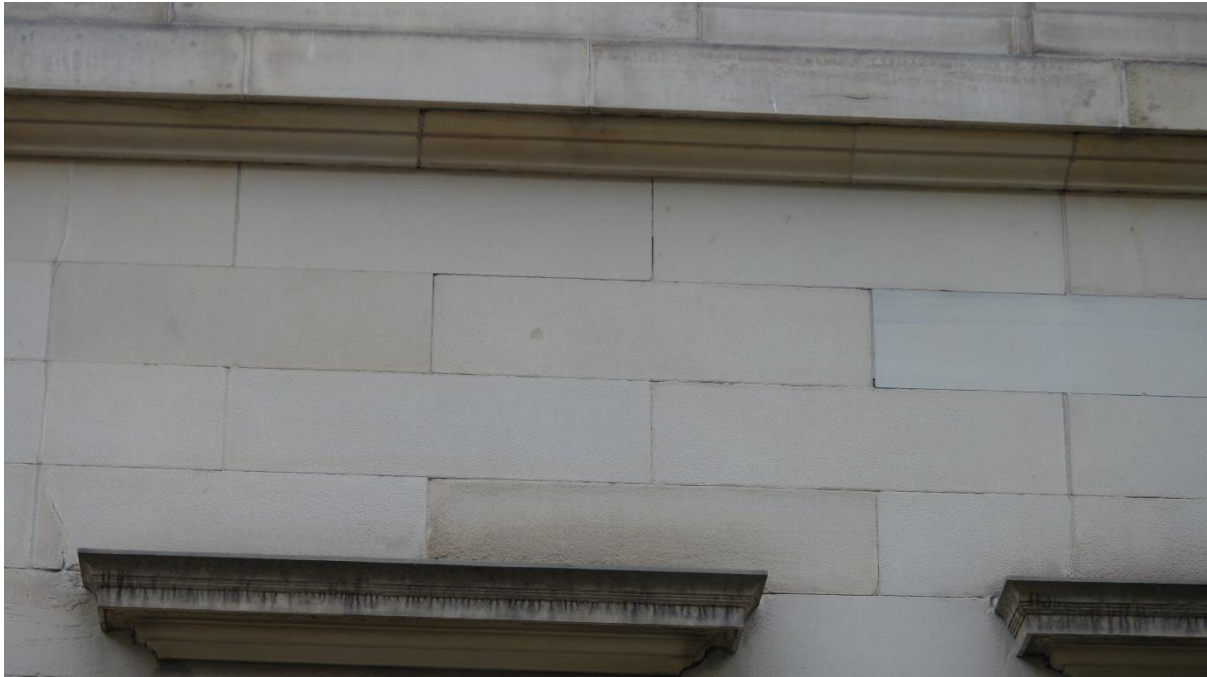
*Figure 5 - Bed joint cracking over the window above, where the masonry has settled.*

Due to the position of the windows above, the whole panel has dropped, and the masonry panel above the first floor windows is now arching, resulting in the crack pattern observed in the bed and perpend joints.

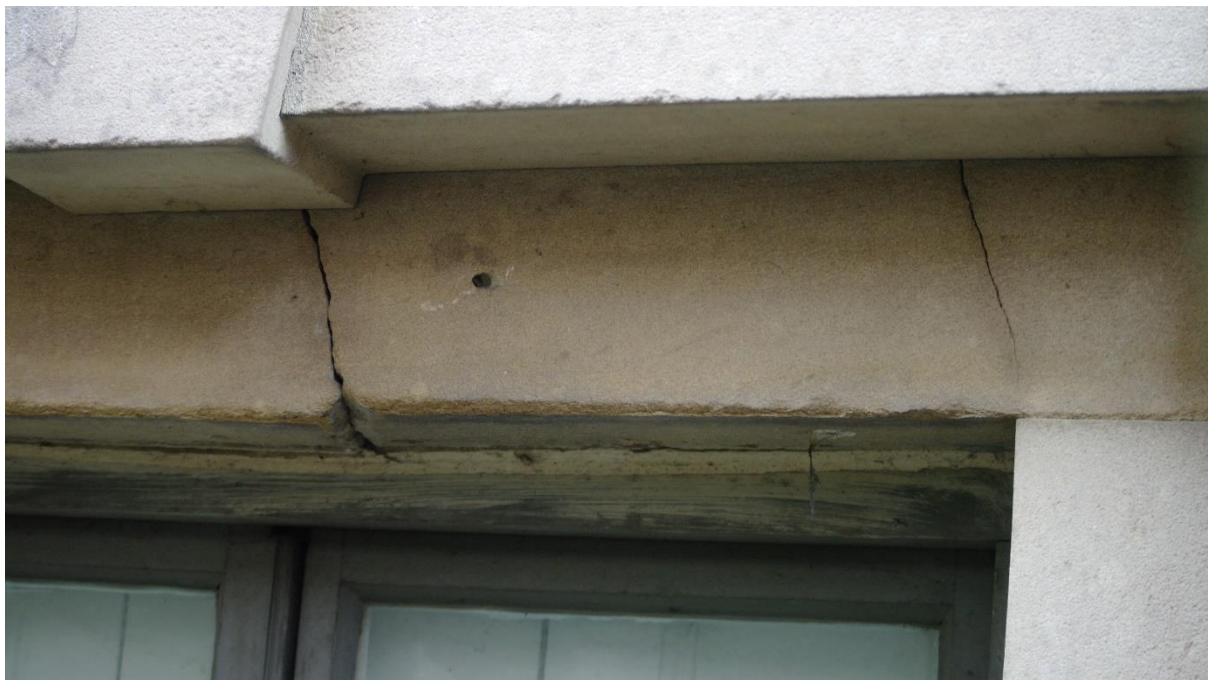
Figure 7 - Failed Lintel, offset crack. Additional flexural crack at bearing.

The lintel has a crack (3mm) diagonally across the centre, with a flexural crack to the right-hand bearing. The lintel has visibly dropped due to the diagonal nature of the crack, and is likely now supported by the window frame. It appears to be historical, however, it has resulted in the keystone above slipping, and the likely cause for the masonry above to have settled.

The lintel presents a risk to any works around the window, as this is highly likely to be supporting the lintel.

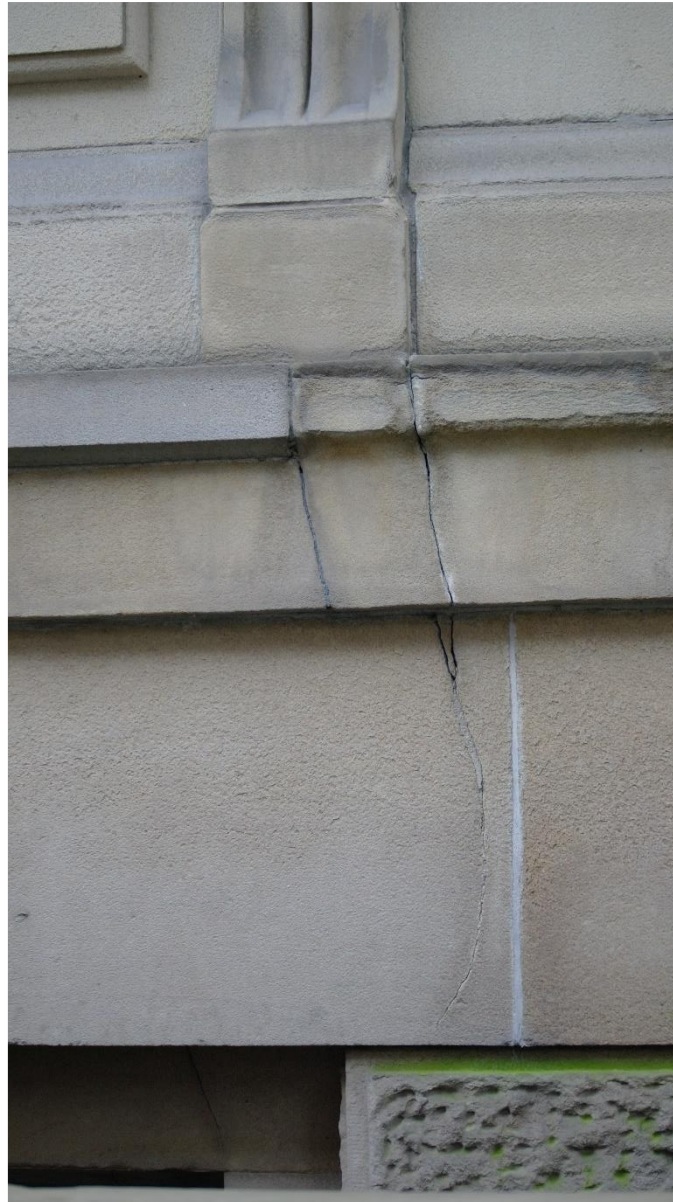
*Figure 8 - Shear crack at bearing of voussoir of keystone lintel.*
