Upper Ground Floor - Heritage Plan.  
1 : 50

Project:  
**PICCADILLY WAREHOUSE  
Mindel House**

Sheet Name:  
**Upper Ground Floor\_Heritage  
Plan\_Planning**

Drawing No: **24006-HFR-MH-UG-DR-A-9050** Rev. **P01**  
Drawn By: **SR** Scale: **1 : 50 @ A1**  
Created: **07.05.24**

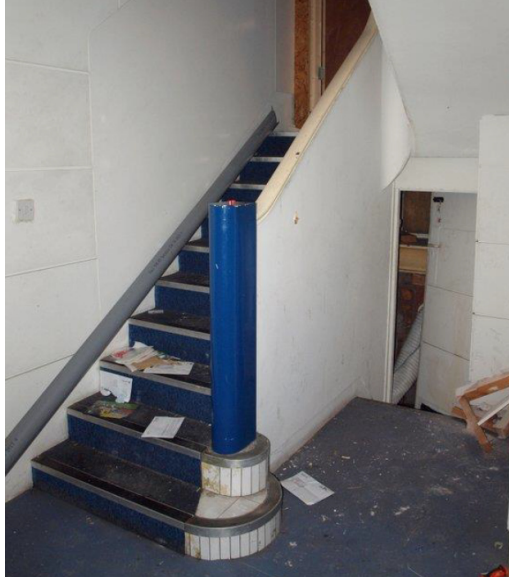
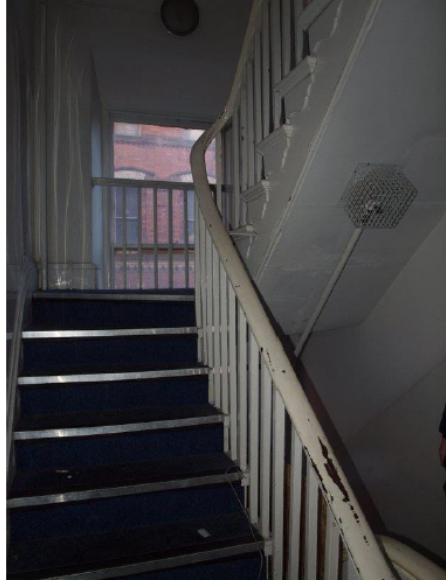
## MAIN STAIRCASE

**MAIN STAIRCASE**  
To be repaired and repainted.  
Lath&plaster ceiling: currently partially demolished. Proposed to be reinstated once all works are completed.  
Balustrade: Appox. 150mm below Building Regulation. Proposal to fix additional handrail 900mm above steps as per regulation. New intervention to be clearly identifiable.

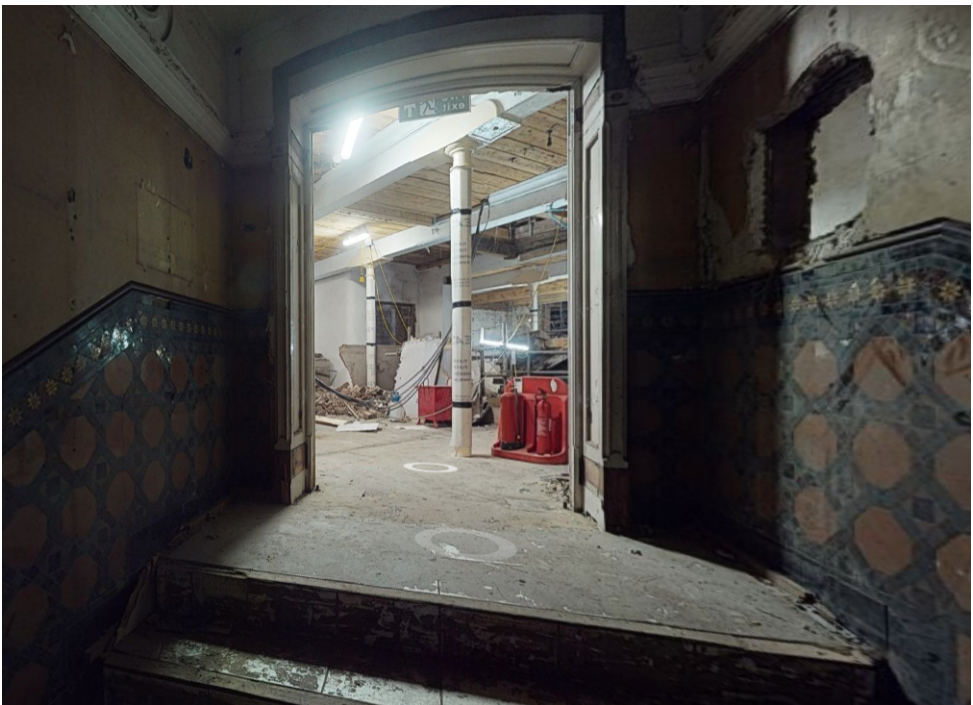
## ENTRANCE + LOBBY

To be retained and repaired. Tiles still in place might need localised repairing. Wall to be buff colour to match existing.

Cracks to be repaired. To be repainted in white.

Full refurbishment including:

To be repaired, sanded and repainted.  
Ironmongery to be upgraded. Design and colour to match existing.

To be retained and repaired where required.  
New door to fit arch above.
