**Project Name:** Amspec Limited - Lower Campfield - LSO0373827 - merged  
**Project Status:** Complete  
**Project Date:** 27/06/2024  
**Lanes Division:** Manchester

As requested, we have recently carried out a drainage CCTV survey at the site location and our full and detailed findings are contained in the attached CCTV report which you can review at your leisure.

Section 2: Cracks, deposits coarse 10%, deposits fine 10%  
Section 3: Deposits fine 10-20%, hole in drain, joint displaced medium  
Section 4: Deposits fine 10%, deposits coarse 10%  
Section 5: Deposits fine 10-20%, deposits coarse 10%  
Section 6: Deposits coarse 10-20%  
Section 7: Deposits fine 10-20%, cracks, deposits hard 30%  
Section 8: Deposits fine 10%  
Section 10: Deposits fine 10%  
Section 11: Deposits fine 10-40%  
Section 12: Deposits hard 10%, deposits fine 10-20%  
Section 13: Deposits fine 10%, deposits hard 30%  
Section 14: Deposits fine 10-50%, deposits hard 10%  
Section 15: Crack longitudinal  
Section 16: Fracture longitudinal  
Section 17: Settled deposits 10%  
Section 18: Settled deposits 10%  
Section 19: Settled deposits up to 30%  
Section 20: Settled deposits 10% and crack circumferen

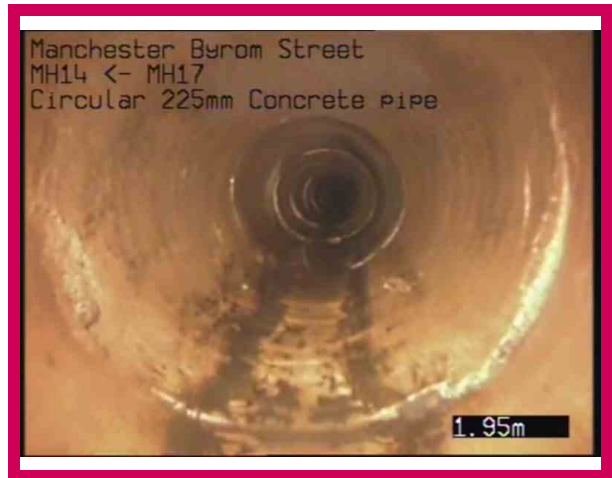
2, 00:00:16, 1.95 m  
Surface damage, spalling from 8 o'clock to 9 o'clock

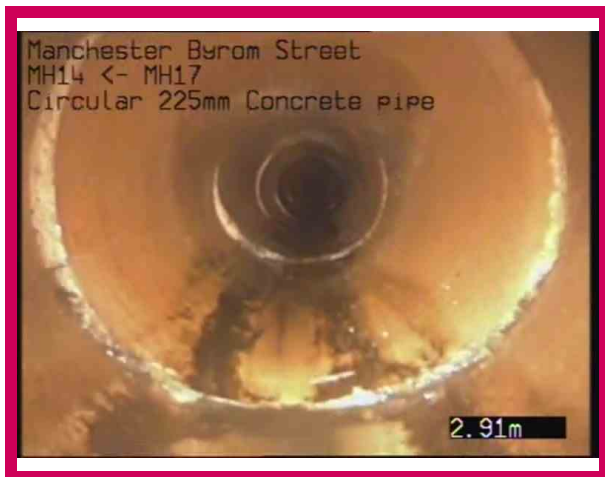
3, 00:00:23, 2.91 m  
Crack, longitudinal at joint at 8 o'clock

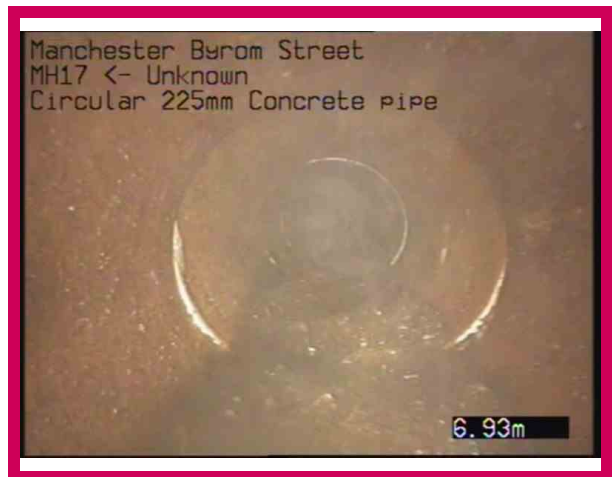
3, 00:00:33, 5.95 m  
Settled deposits, fine, 10% cross-sectional area loss

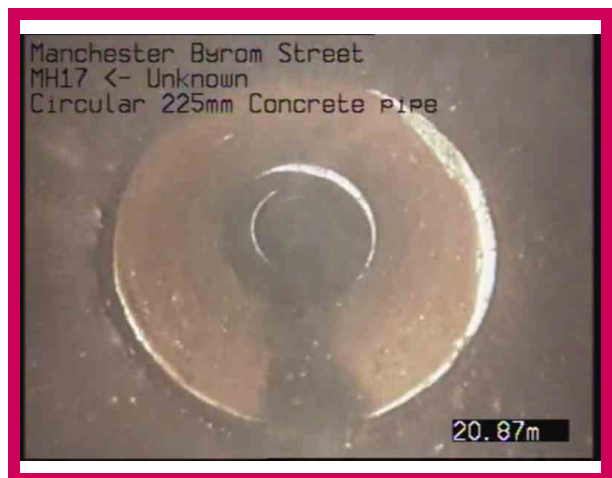
5, 00:00:47, 11.14 m  
Settled deposits, fine, 15% cross-sectional area loss, start

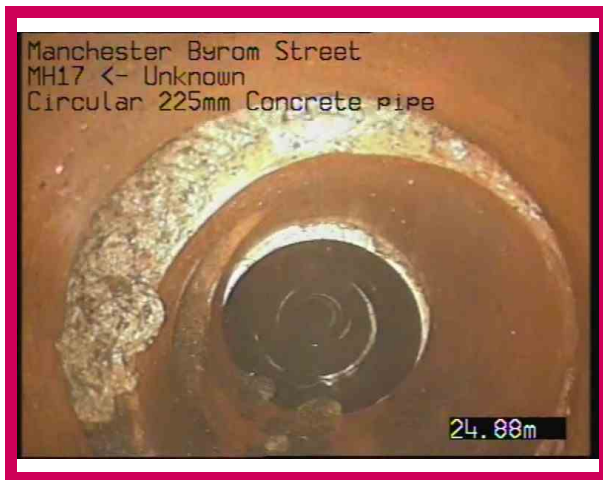
7, 00:02:00, 24.81 m  
Joint displaced, medium

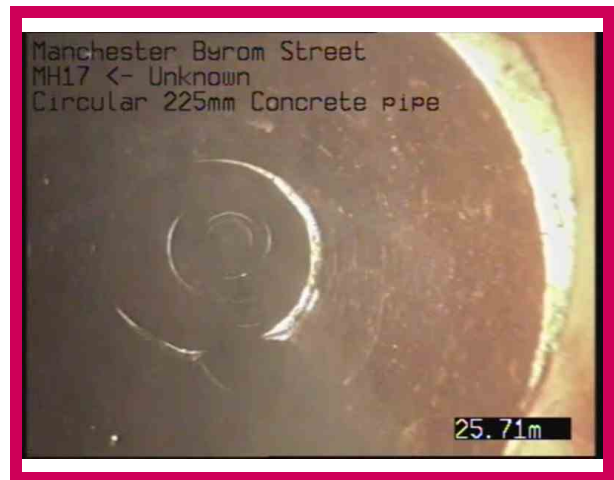
8, 00:02:10, 25.52 m  
Joint displaced, medium

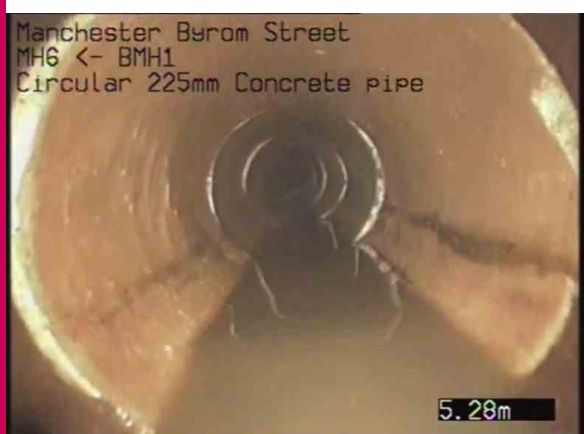
5, 00:00:20, 5.28 m  
Surface damage, spalling from 2 o'clock to 3 o'clock

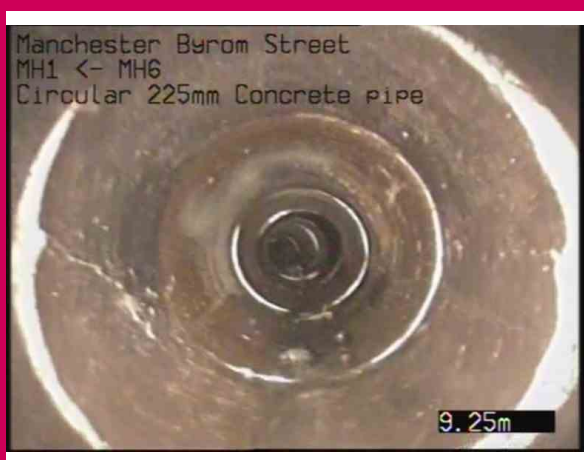
4, 00:00:45, 9.25 m  
Crack, longitudinal at joint at 9 o'clock

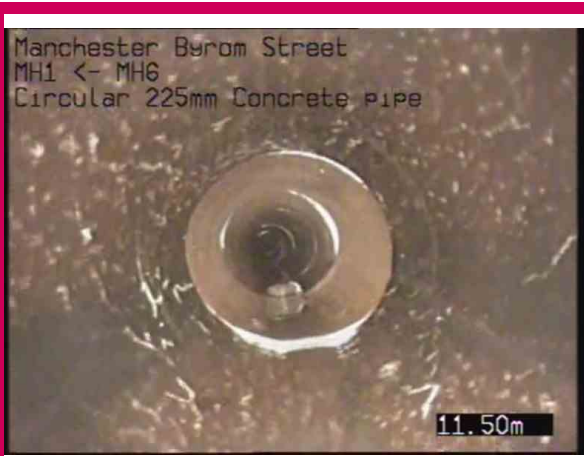
7, 00:00:52, 11.50 m  
Cracks, multiple from 12 o'clock to 2 o'clock

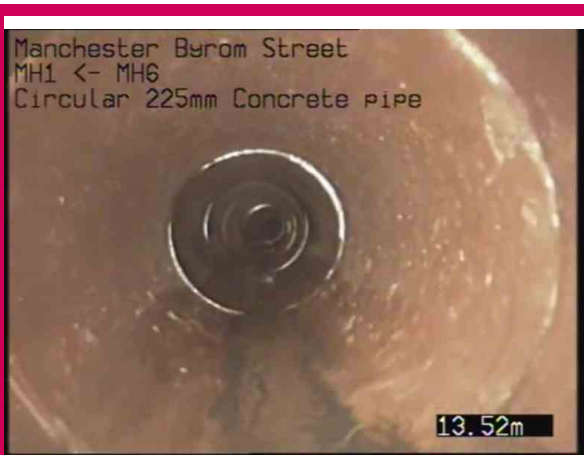
9, 00:01:03, 13.52 m  
Surface damage, spalling at 2 o'clock

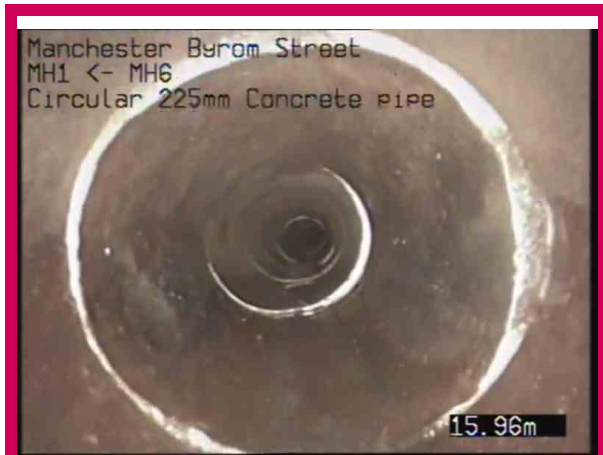
10, 00:01:16, 15.96 m  
Surface damage, spalling from 2 o'clock to 4 o'clock

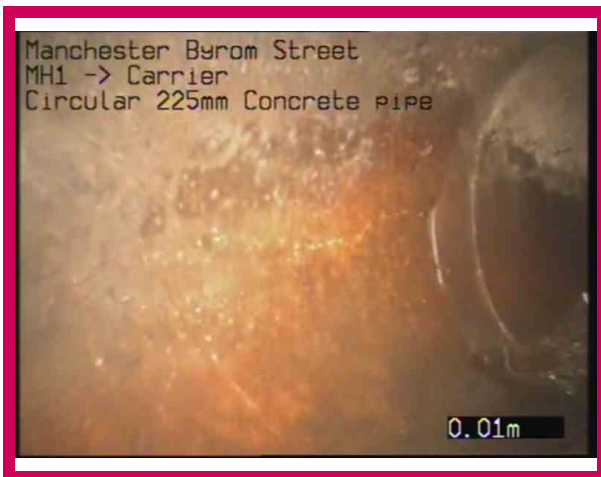
3, 00:00:07, 0.01 m  
Crack, longitudinal at joint at 9 o'clock

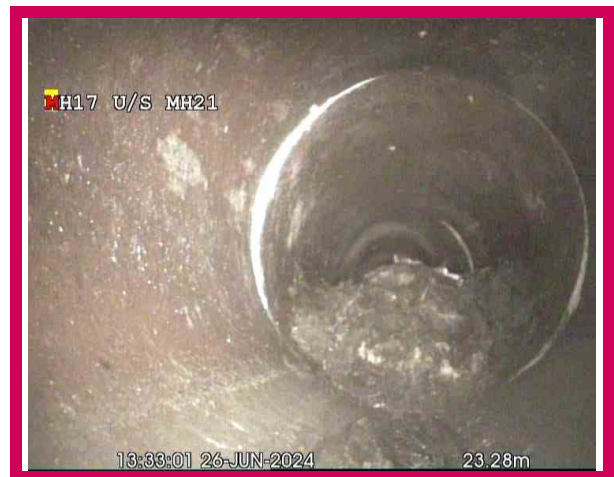
4, 00:02:23, 23.28 m  
Settled deposits, hard or compacted, 30% cross-sectional area loss

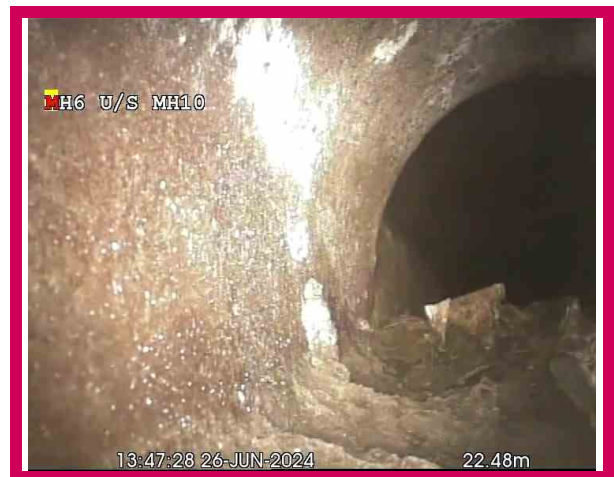
3, 00:01:03, 11.86 m  
Settled deposits, fine, 50% cross-sectional area loss

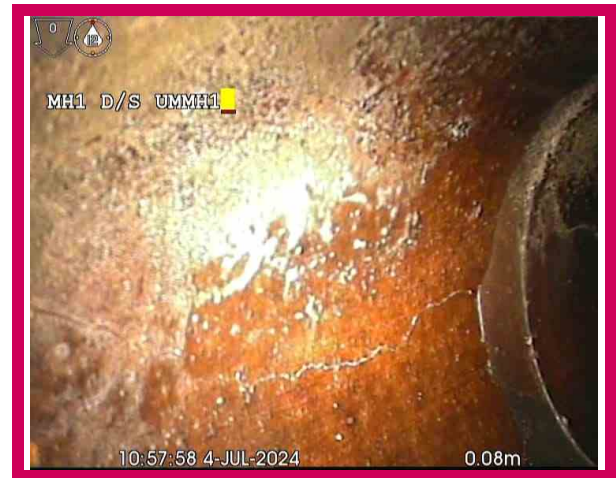
2, 00:00:05, 0.04 m  
Crack, longitudinal at joint at 9 o'clock

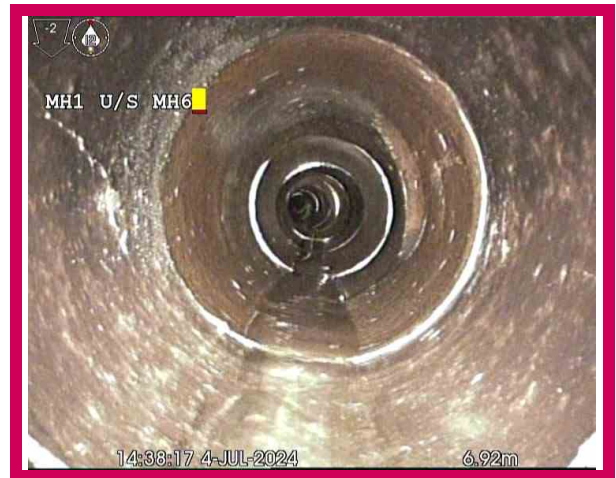
2, 00:00:47, 6.92 m  
Fracture, longitudinal at 9 o'clock
