HOUGH HALL  
MOSTON

## STRUCTURAL CONDITION REPORT

Project No 2204-03  
August 2022  
Rev: P02  
HHM-REN-00-XX-RP-S-00001

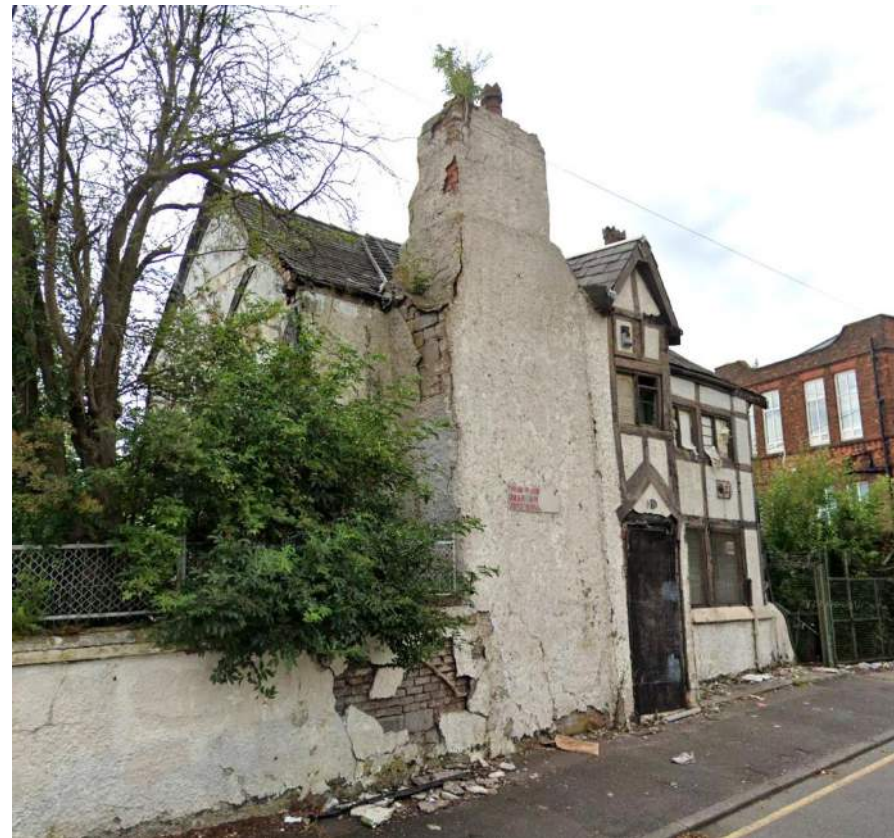
**Figure 1.2 – East elevation, c.2019** (Image © Google)

Figure 1.2 shows a recent view from Hough Hall Road, illustrating the condition of the building.

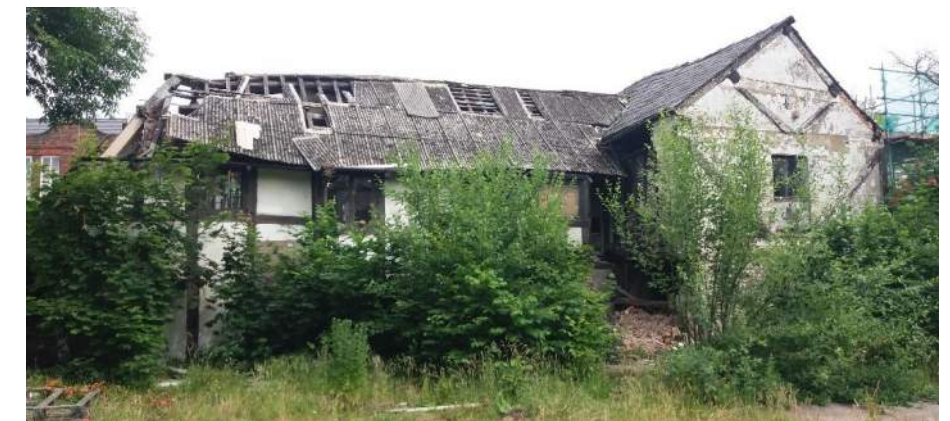
Figure 2.2 – South elevation, general view

- Timber framing of the main range, up to the point of collapse, is largely intact though the condition could not be determined. The material of the infill panels between timber members could not be determined.

- All walls are somewhat bowed and out of plumb, though this is not unexpected for a building of this type and age.
- At ground and first floor levels, the side (west) wall of the crosswing, adjacent to the wall noted in point #4 below, has collapsed, revealing the stud wall finished with lath and plaster beyond. From the remaining portions, a lack of tying between the portions of brick walls at ground to first floor level is apparent (the timber corner post is present from first floor to eaves). The brick walls in this area are likely a later replacement for original timber posts and studding. These brick walls are visible in the photo from circa 1849 shown in Appendix 'A'.

- The ends of the eaves beams, purlins and ridge beam of the crosswing roof project from the gable wall. These appear to be deteriorated and would require local rectification or full replacement of the member, depending on the extent and severity of deterioration.
- Some historic casement windows and a historic timber door are in situ on the Main Range.
- Multiple items of mature vegetation are growing immediately adjacent to the building, and it is likely that the root systems have penetrated the building fabric.

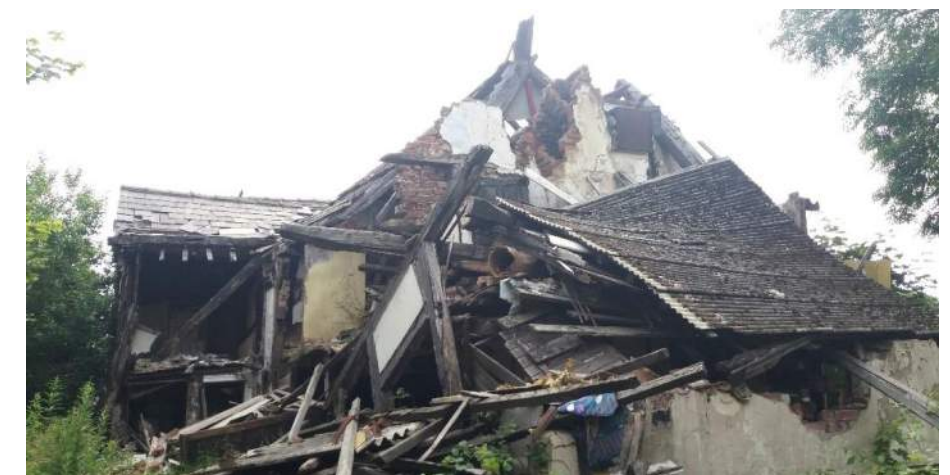
Figure 2.3 – West elevation

- The west elevation is almost entirely collapsed, with only portions of the brick wall at ground floor level remaining.
- Although not visible, it is anticipated that the timber framing members which formed the western end of the main range are still present on site, beneath the collapse. It is recommended that when material is being cleared from site, all historic timber members are set aside for assessment by a specialist.

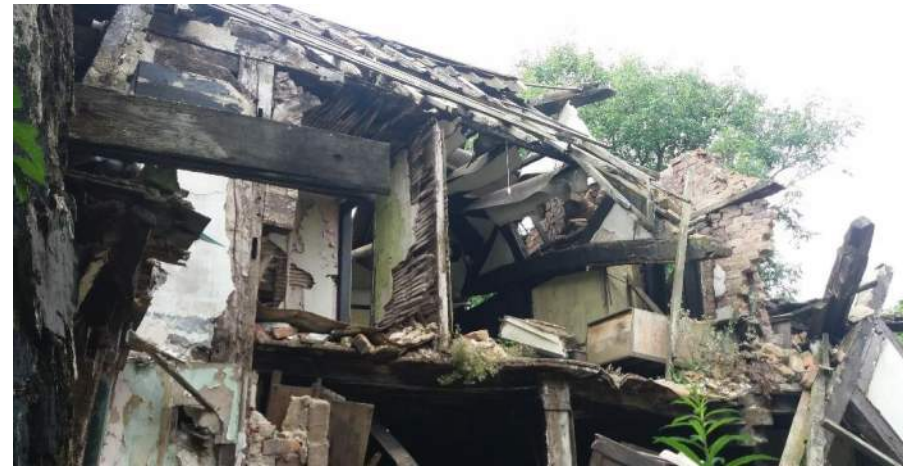
Figure 2.4 – North elevation of main range

3. As above, the west side of the projection from the main range does not have an external wall due to formerly being part on an internal space.
4. The timber framing of the gable of the projection from the main range appears to be intact, though the condition of the timbers could not be assessed, and the material of the infill panels could not be determined. At eaves level, a kingpost roof truss is visible.

6. The timber framing of the crosswing gable appears to be intact, though the condition of the timbers could not be assessed, and the material of the infill panels could not be determined.

9. At eaves level of the crosswing gable, a roof truss of modified queen post type (similar in form to that noted in point #2 above) is visible, though some infill panels have been lost.

10. A ventilation grille is visible in the plinth course of the crosswing, indicating a subfloor void below ground floor.
11. Multiple items of mature vegetation are growing immediately adjacent to the building, and it is likely that the root systems have penetrated the building fabric.

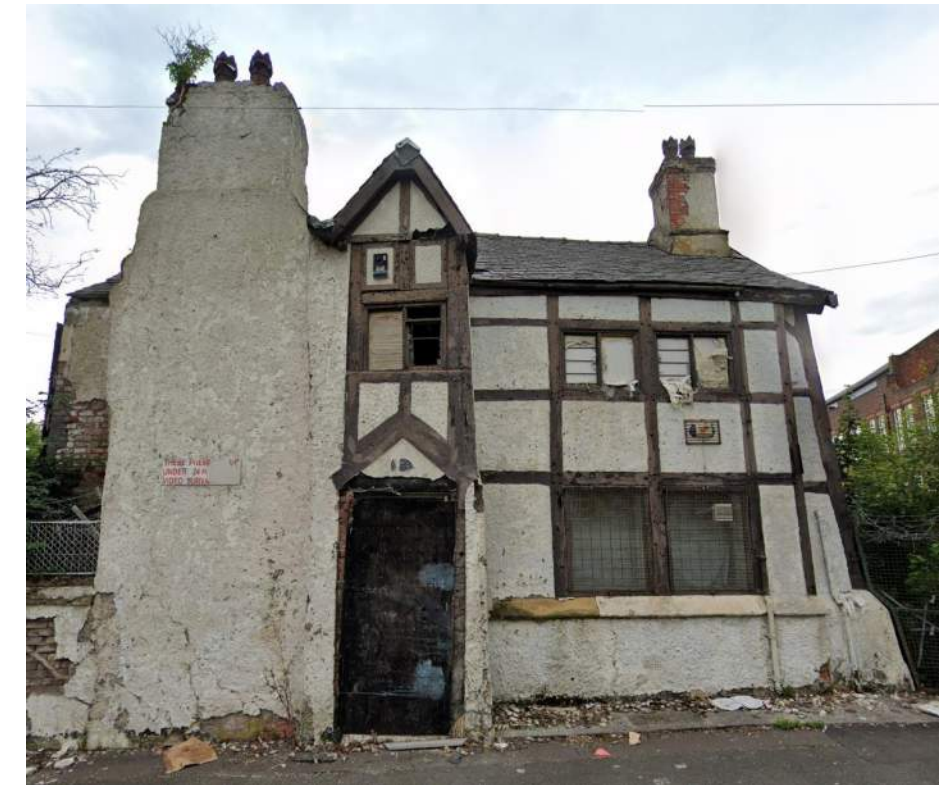
Figure 2.5 – East elevation, c.2019 (Image © Google)

1. The infill panels between timber framing members and all stone / brick masonry walls on the east elevation appear to be covered with a cement-based render, largely obscuring the materials behind.
2. The render appears loose and has been lost in some places. Vegetation is visible.
3. The timber framing appears to be largely intact, though the condition of the timbers is unknown.
4. Some timber elements are suffering from decay; however, the extent is unknown.
5. The walls at ground to first floor adjacent to the door opening onto Hough Hall Road are of brick; likely having replaced timber posts.
6. Some items of vegetation are growing from the brickwork / stonework of the walls and chimneys.
7. A ventilation grille is visible in the plinth course, indicating a subfloor void below ground floor.

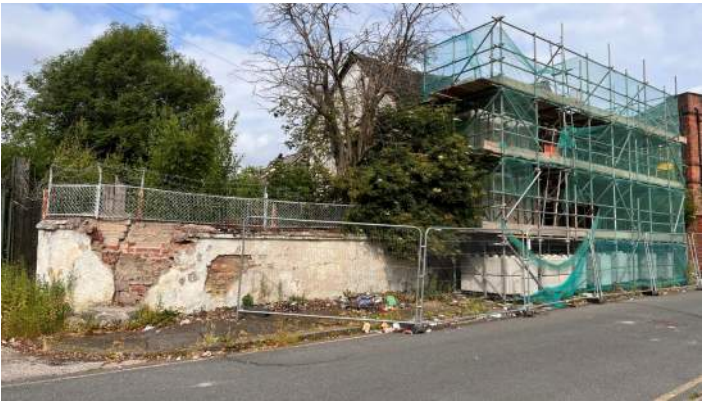
02: EAST ELEVATION WITH SCAFFOLD PROPPING IN PLACE. MOUNTING BLOCK IS AT THE LEFT OF FRAME.

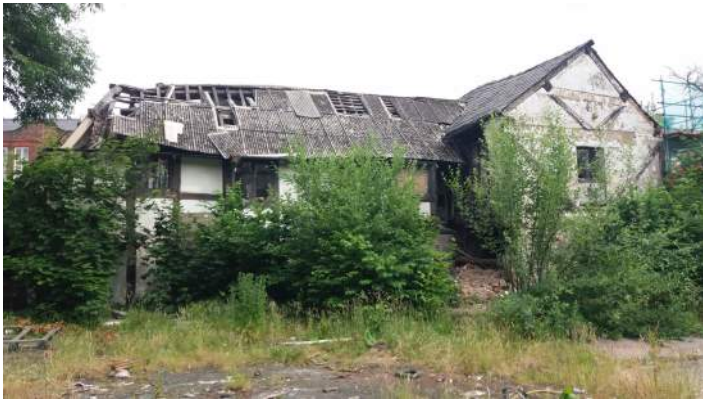
03: SOUTH ELEVATION. GENERAL VIEW. COLLAPSED PORTION OF MAIN RANGE IS AT THE LEFT OF FRAME.

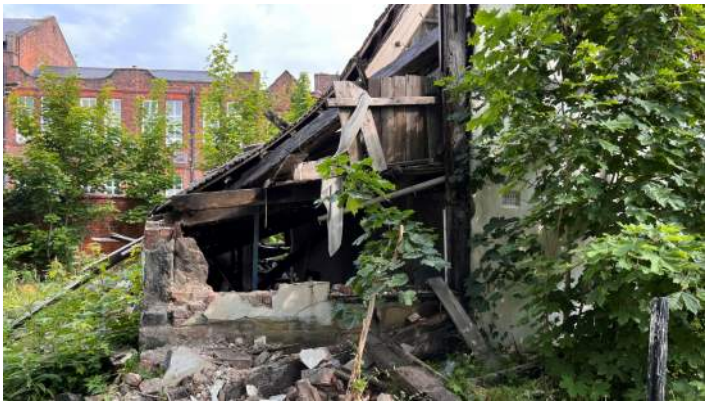
04: SOUTH ELEVATION. WEST END OF MAIN RANGE. ROOF AND FIRST FLOOR ALMOST TOTALLY COLLAPSED.

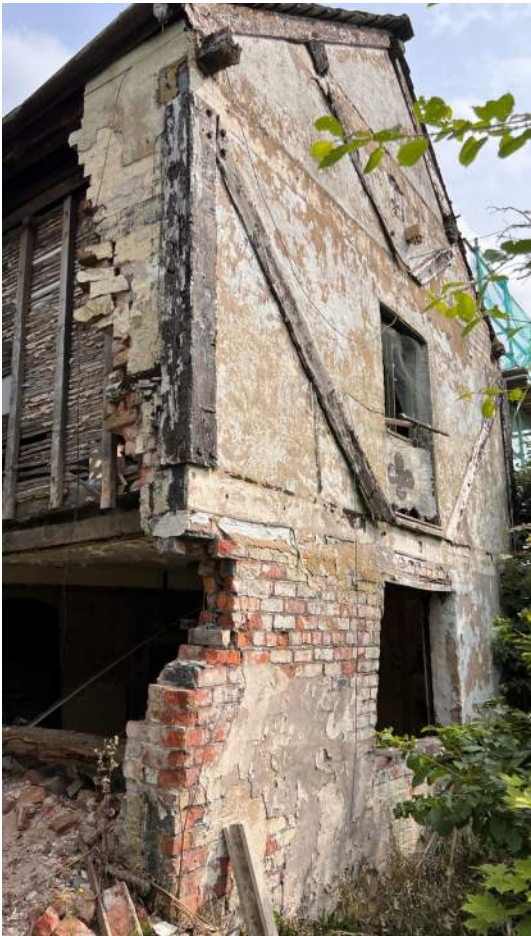
05: SOUTH ELEVATION. GABLE WALL OF CROSSWING. BRICK WALL AT GROUND FLOOR LEVEL IS SIGNIFICANTLY OUT OF PLUMB. NOTE GIRDING RAIL, WITH TENON FOR NOW-REMOVED CORNER POST.

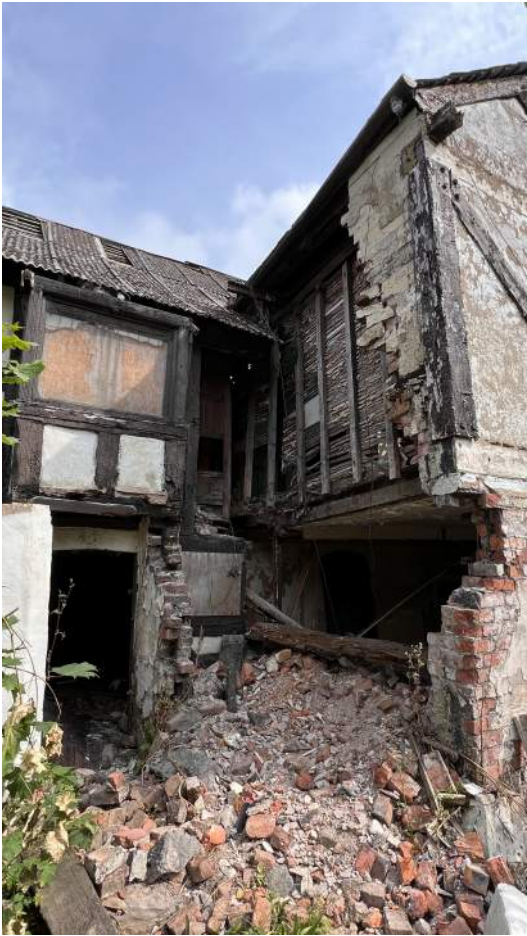
06: SOUTH ELEVATION. REAR WALL OF CROSSWING AT JUNCTION WITH MAIN RANGE. NOTE STUD WALL WITH LATH AND PLASTER AT LEVEL 01.

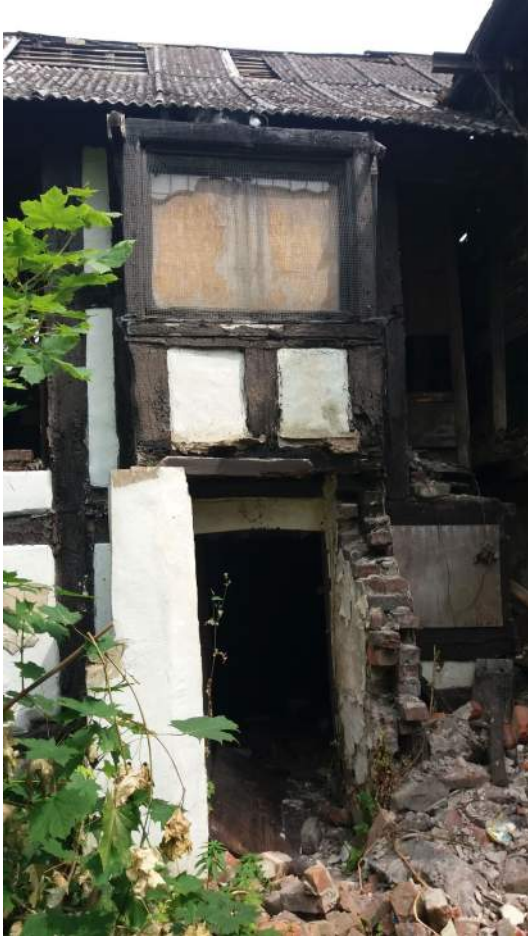
08: SOUTH ELEVATION. ENTRANCE INTO BUILDING AND BAY WINDOW ABOVE. EVIDENCE OF A PORCH, NOW REMOVED.

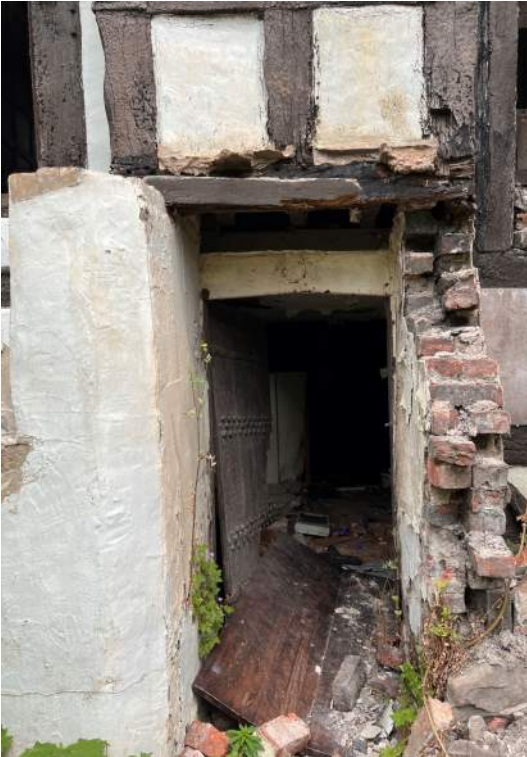
09: SOUTH ELEVATION. REMNANT WALLS OF A PORCH, NOW REMOVED. TIMBER DOOR IS IN SITU.

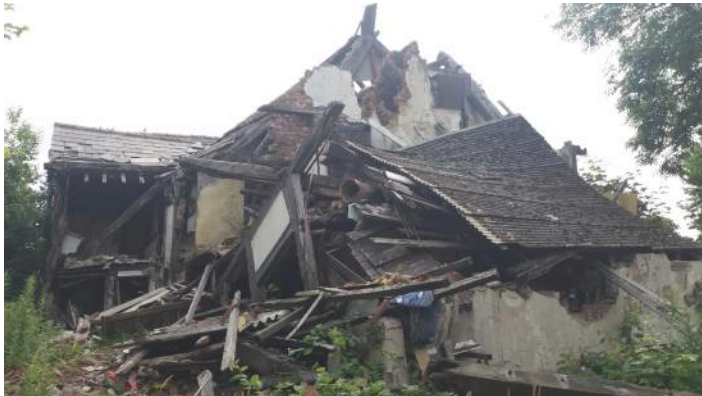
10: WEST ELEVATION. GENERAL VIEW. EXTENSIVE COLLAPSE AT THE WESTERN END OF THE MAIN RANGE.

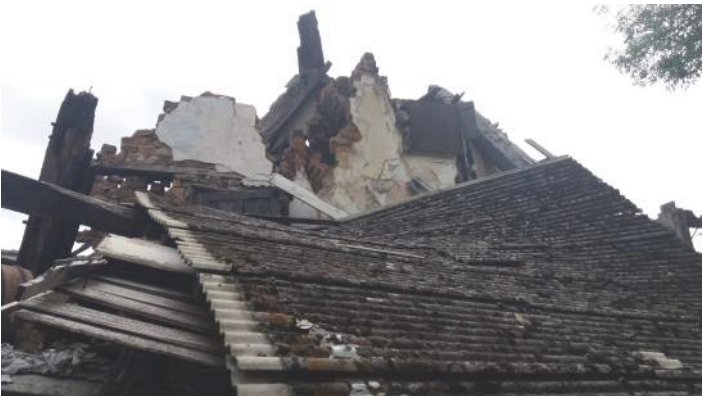
11: WEST ELEVATION. EXTENSIVE COLLAPSE; NOTE INTERNAL BRICK WALL AND CHIMNEY.

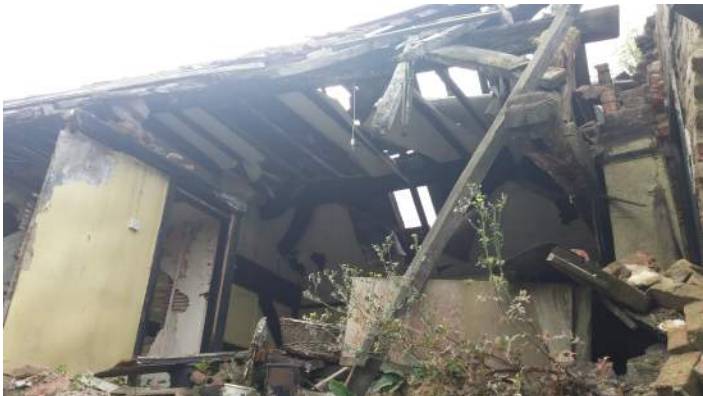
6. **Room F6.** The floor structure of room F6 is sagging excessively, due to failure caused by the removal of a timber column at ground floor level, presumably during the emergency demolition works. However, the primary structural elements of the floor remain in situ. The post and / or wall at first floor level which would have supported the roof truss have also been removed, causing the roof structure to fail due to lack of vertical support. However, the timber roof truss is still in situ. The western wall of room F6, built of brick and integral with the chimney, has largely collapsed.

12: NORTH ELEVATION. CENTRAL BAY OF MAIN RANGE, ADJACENT TO DEMOLISHED PORTION OF BUILDING. LOOKING INTO ROOM F6. UNSUPPORTED ROOF STRUCTURE.

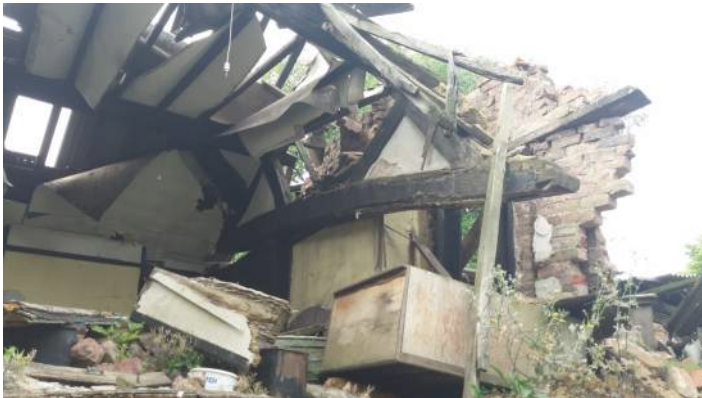
13: NORTH ELEVATION. CENTRAL BAY OF MAIN RANGE, ADJACENT TO DEMOLISHED PORTION OF BUILDING. UNSUPPORTED ROOF STRUCTURE. TIMBER ROOF TRUSS APPEARS LARGELY INTACT. FIRST FLOOR IS IN SITU.

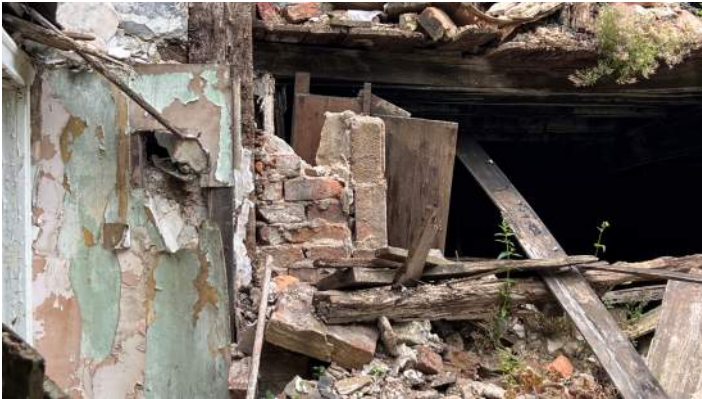
14: NORTH ELEVATION. CENTRAL BAY OF MAIN RANGE. REMNANT WALL AND STONEWORK ADJACENT TO DEMOLISHED PORTION OF BUILDING. FIRST FLOOR IS IN SITU.

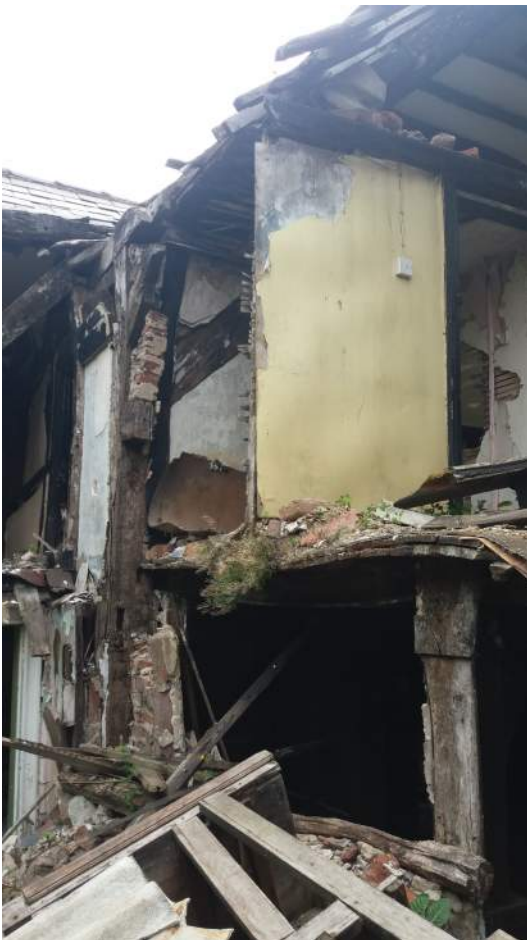
15: NORTH ELEVATION. CENTRAL BAY OF MAIN RANGE. FIRST FLOOR AND ROOF ARE IN SITU. NOTE TIMBER COLUMNS AND PRIMARY BEAM SUPPORTING FIRST FLOOR.

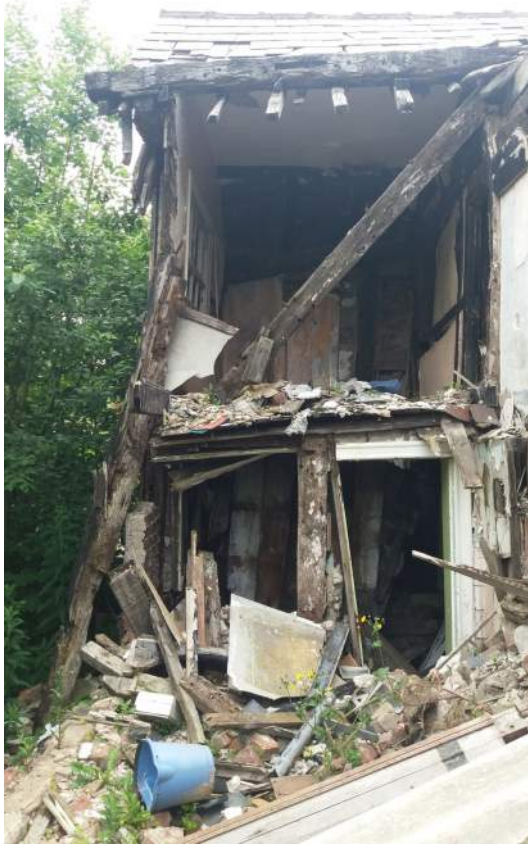
16: NORTH ELEVATION. SIDE OF PROJECTION FROM MAIN RANGE, ADJACENT TO DEMOLISHED PORTION OF BUILDING. FIRST FLOOR AND ROOF ARE LARGELY INTACT; CORNER POST OF PROJECTION HAS BEEN REMOVED.

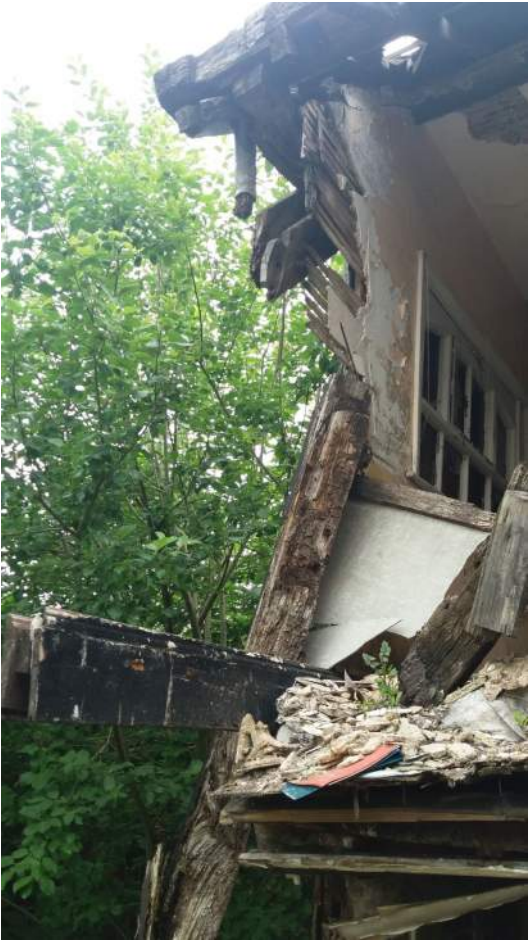
17: NORTH ELEVATION. CORNER OF PROJECTION FROM MAIN RANGE. CORNER POST HAS BEEN REMOVED.

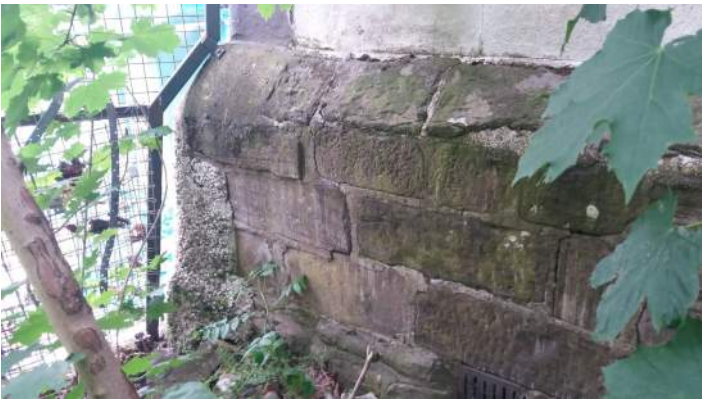
19: NORTH ELEVATION, CROSSWING. STONE PLINTH COURSE AT GROUND LEVEL WITH LATER CEMENT-BASED POINTING AND RENDER.

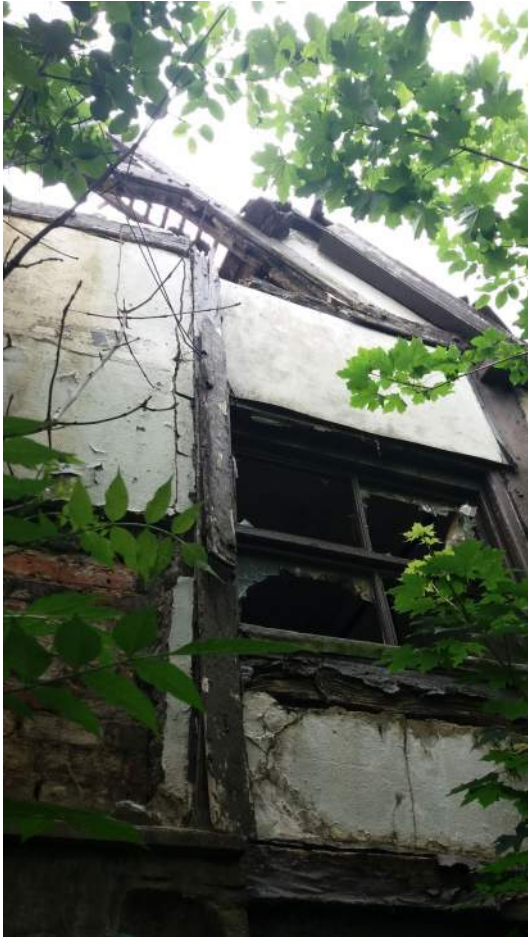
21: NORTH ELEVATION. GABLE OF CROSSWING. ROOF STRUCTURE BEYOND IS NO LONGER PRESENT.

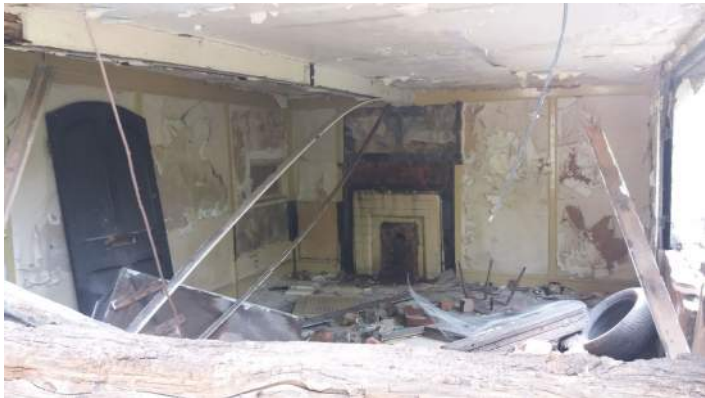
23: ROOM G1.

1. **Room G1.** The floor structure appears to be intact, though this could not be verified due to the presence of rubble and other detritus. The form and condition of the floor could not be verified. A wall running east-west divides this room from the rest of the ground floor. The construction of the wall is not clear, but it appears to be a partition only, i.e., non-structural. A primary timber beam at ceiling level is boxed out; the condition could not be assessed.

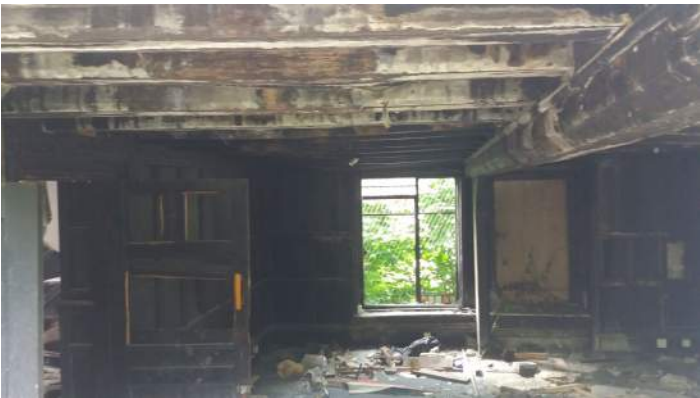
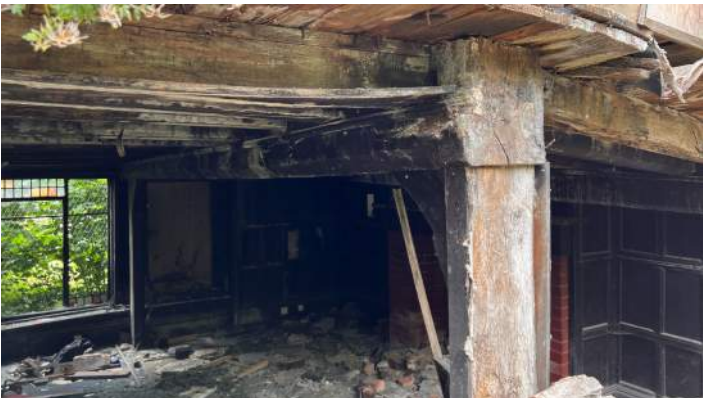
5. **Room G5.** As noted in previous sections, the external wall of room G5 is no longer present, due to emergency demolition of the adjacent portion of the building, and subsequent further collapse. The floor structure appears to be intact, though the condition could not be assessed. The primary timber elements, although showing signs of long-term water ingress, appear to be in reasonable condition though this could not be verified. However, one structural column (on the north side of the room) has been removed, leading to failure of the floor structure above. The remaining timber column (also on the north side of the room) carrying a primary timber beam has a relatively small section and little or no positive connection to the beam above, making this connection susceptible to failure if subjected to any significant force.

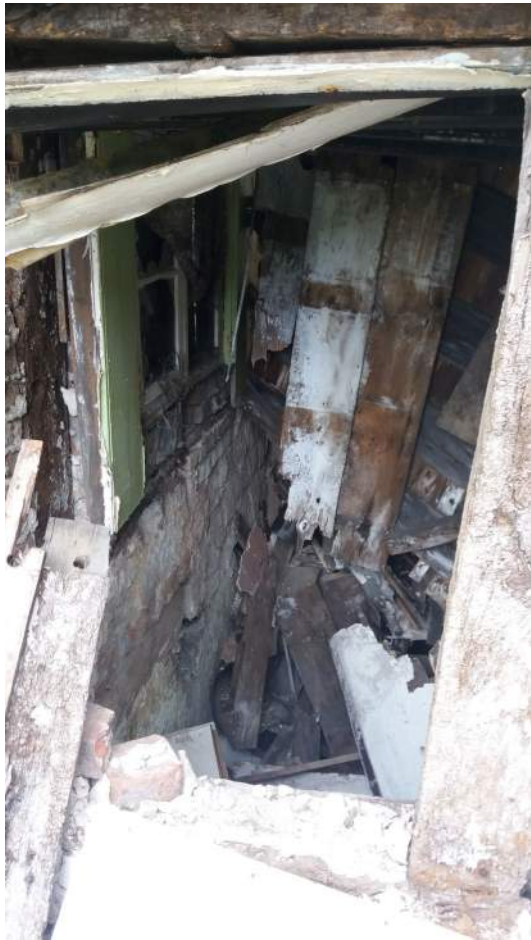
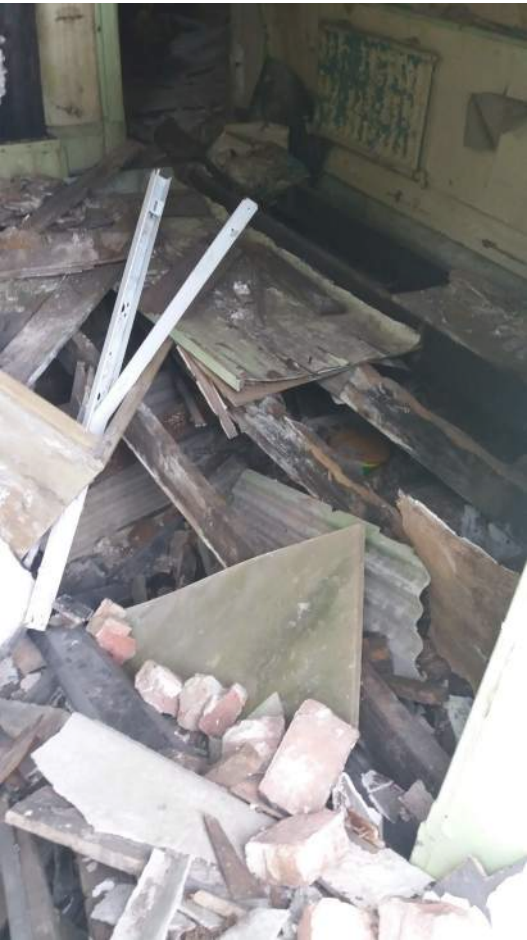
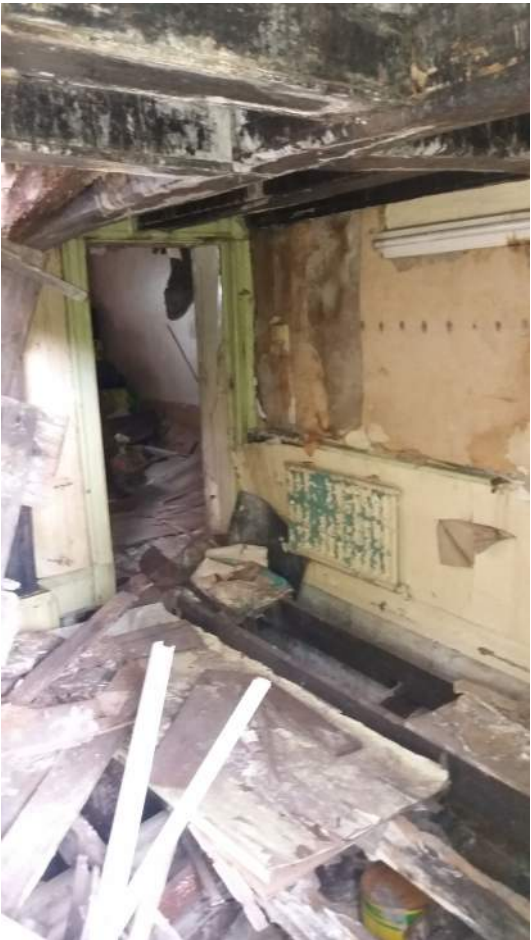
2. **Room G2.** Room could not be accessed. No observations possible.
3. **Room G3.** The floor structure has collapsed into the subfloor void below. The primary timber beams at ceiling level show signs of long-term water ingress however their condition appears to be reasonably good. Part of the floor covering at Level 1 above has fallen through.

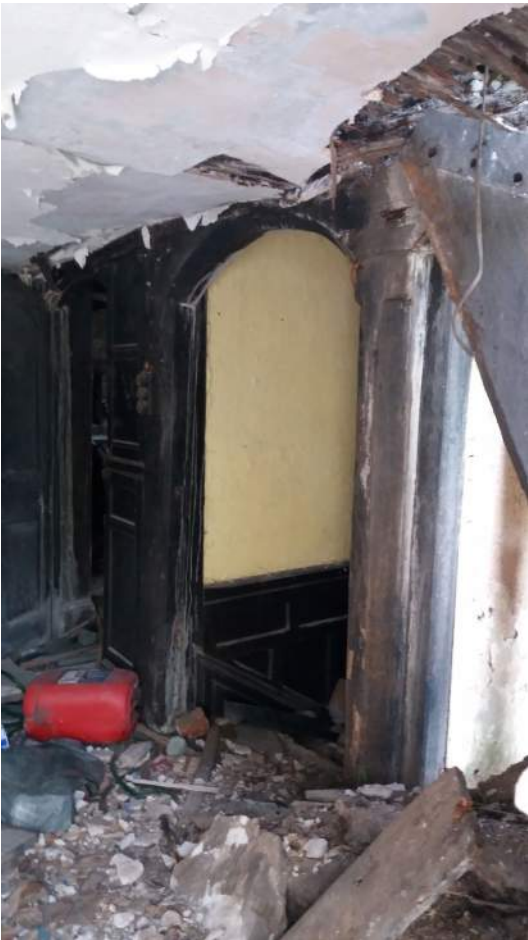
4. **Room G4.** Very limited observation possible. The ceiling has largely collapsed into the room. The primary timber elements visible appear to be in reasonable condition, though this could not be verified.

29: ROOM G4. SMALL STAIRCASE DOWN TO ROOM G1.

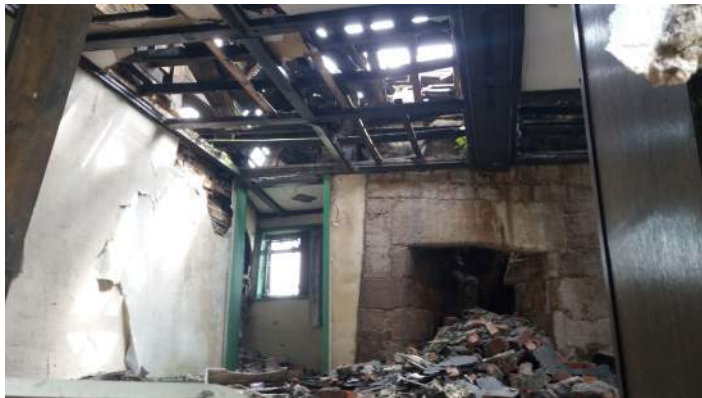
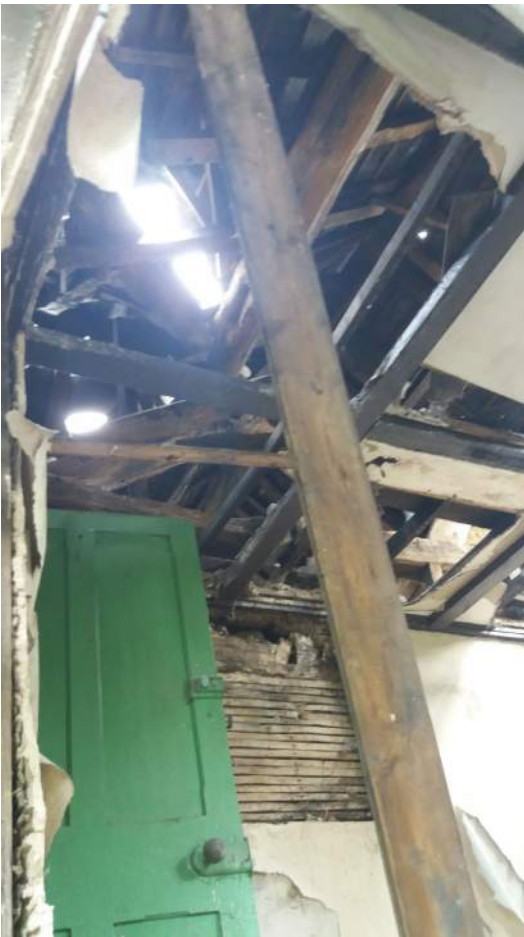
1. **Room F1.** The floor structure appears to be intact, though this could not be verified. The stone fireplace does not exhibit any obvious cracking. The primary structure of the roof above appears to be intact, though the roof coverings, and rafters have collapsed onto the ceiling, causing it to fail. The room is therefore open to the elements and accordingly, it is likely that the primary timber members will have suffered some deterioration. The partition wall separating this room from room F2 appears to be partially of timber stud with lath and plaster, and partially of brick.

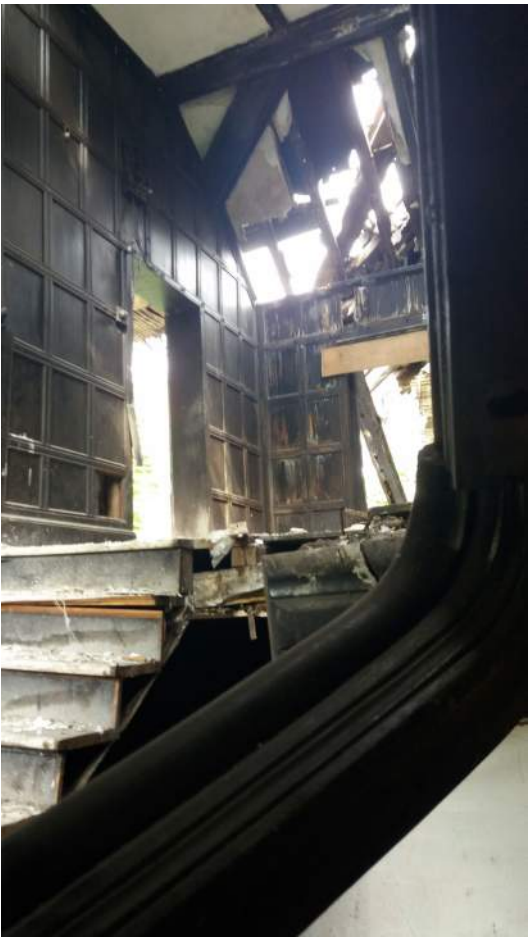
4. **Room F4.** The floor of room F4, along with the staircase it supports, appears to have partially failed. The walls and primary roof members above appear to be largely intact, though the wall on the north side of the room shows obvious signs of extensive water damage due to being exposed to the elements.

33: ROOM F4. MAIN STAIRWAY WITHIN THE BUILDING.

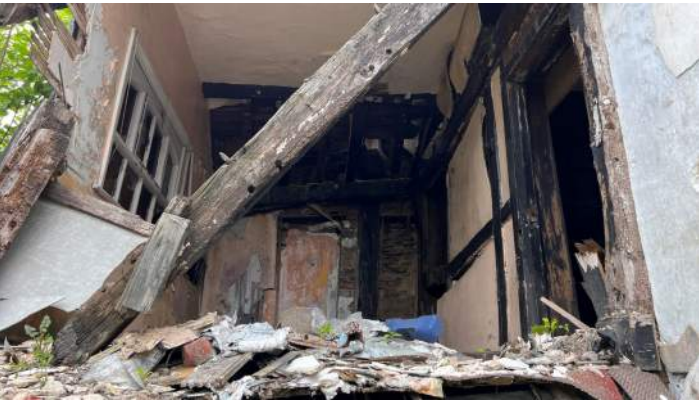
35: ROOM F3.

2. **Room F2.** Room could not be accessed. No observations possible.
3. **Room F3.** The emergency demolition works to the adjacent portion of the building have removed one wall of this room, leaving it open to the elements. The floor of the room has failed locally due to the removal of the corner post and part of the adjacent wall at ground floor, presumably during the emergency demolition works. However, the extant floor, wall and roof structures appear largely intact.
