| Site name: A&H Construction - Lowry Park,<br>Grimshaw Lane, Manchester. | | Units/ plots checked: : Unit 6 core area line outs | | | |
| Inspection by: Dan Squire | | Weather: 7°C Wet | | | |

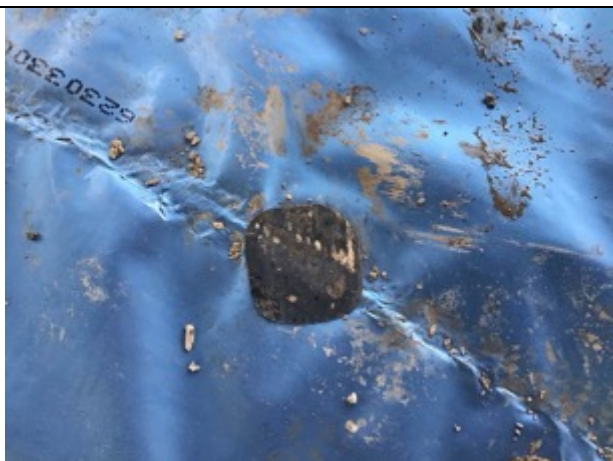
SAGM patch repair

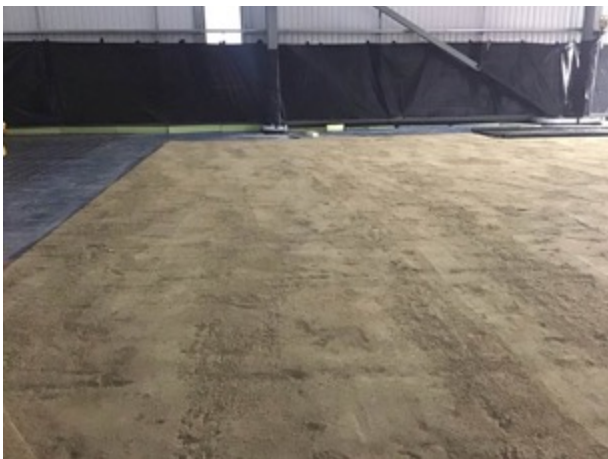
Sealed SAGM patch repairs

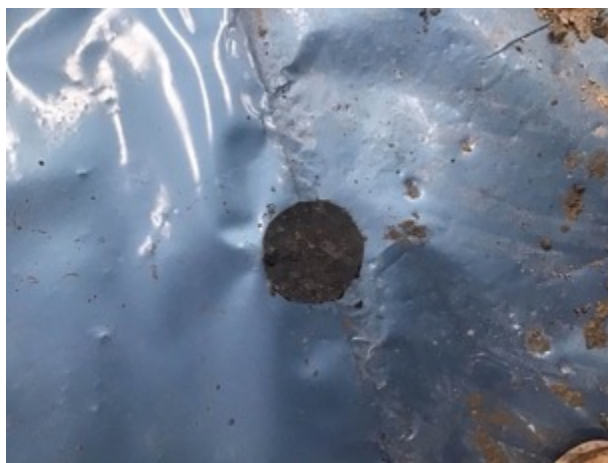
Sealed SAGM patch repair during the installation

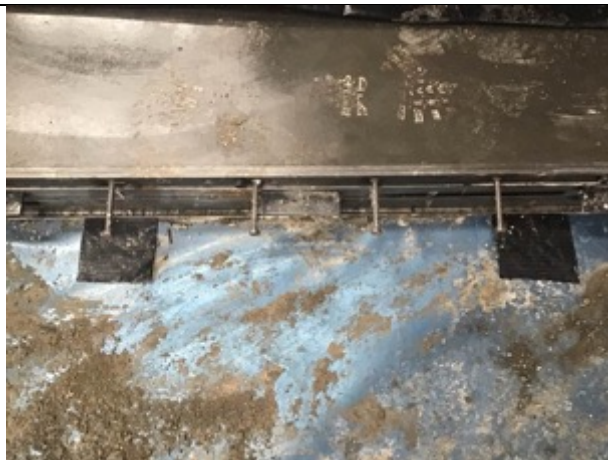
Sealed SAGM pin hole repairs

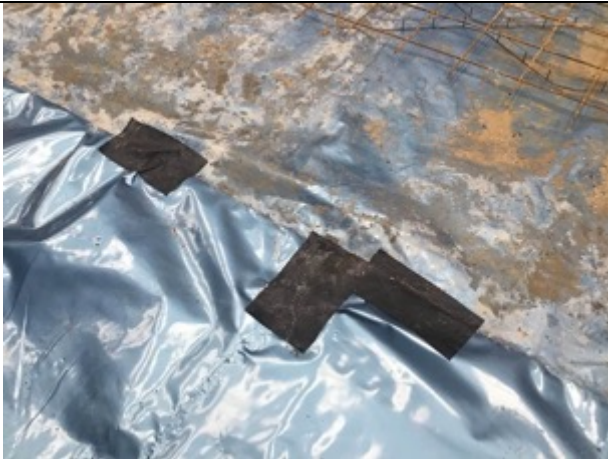
Sealed SAGM defect patch repairs

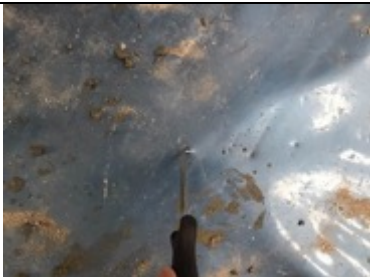
Recorded defect

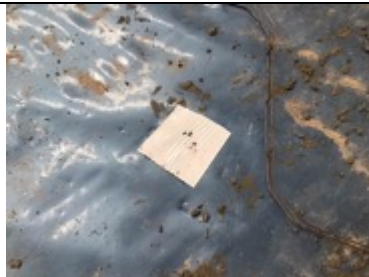
Defect sealed using SAGM and  
heat applied

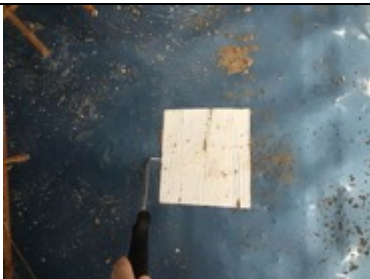
Sealed patch repair using SAGM  
and heat applied

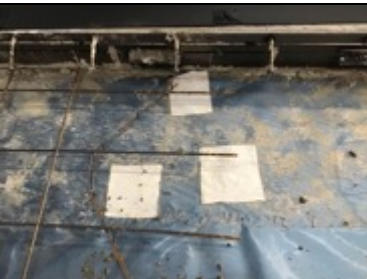
Sealed pin hole repair patches  
using SAGM and heat applied

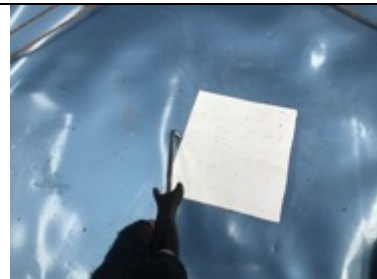
Sealed patch repair to recorded  
defect using SAGM and heat  
applied

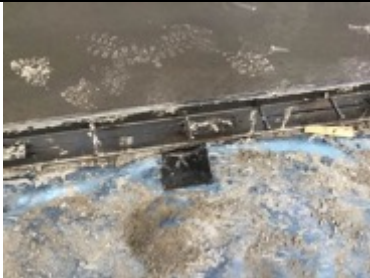
Sealed shuttering pin patch repair using SAGM and heat applied

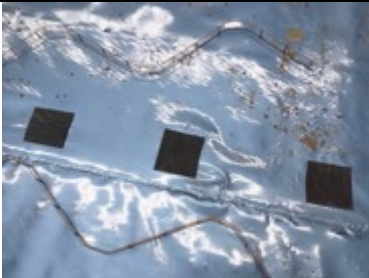
Recorded defects sealed using SAGM patch repairs and heat applied

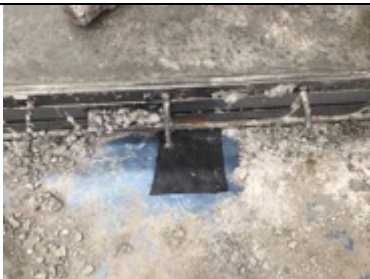
Sealed shuttering pin patch repair using SAGM and heat applied

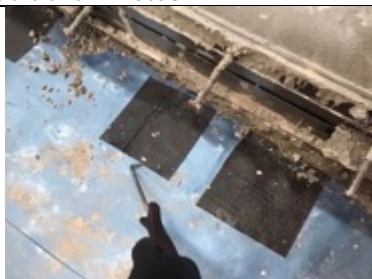
Sealed shuttering pin patch repair using SAGM and heat applied

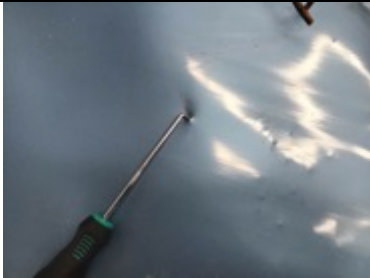
Recorded defect

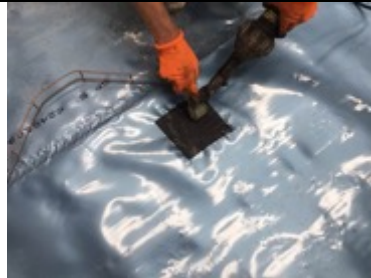
Recorded defect sealed using  
SAGM and heat applied

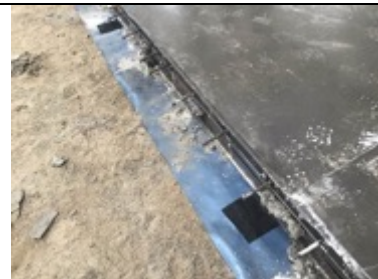
Pin patch repairs made using SAGM and heat applied

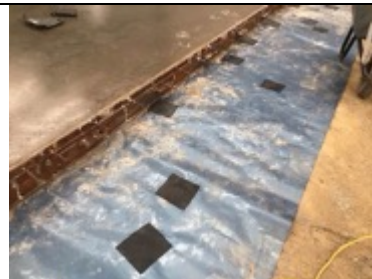
Armoured joint pin hole patch  
repairs made using SAGM and  
heat applied
