Our Ref: 1826-01  
20<sup>th</sup> February 2024  
Client:  
Greg Cawley  
Senior Project Manager  
AtkinsRéalis  
The Exchange, 3 New York Street  
Manchester  
M1 4HN

## Poland Street Zone – Ancoats Green – Boundary Wall Inspection Summary Report

Civic Engineers Mark-Up - 1826-01-SK- 1000 - PL - Sht 1  
Non-Intrusive Condition Survey To Boundary Wall  
Ancoats Green - Manchester  
PSL Date - Feb 2024

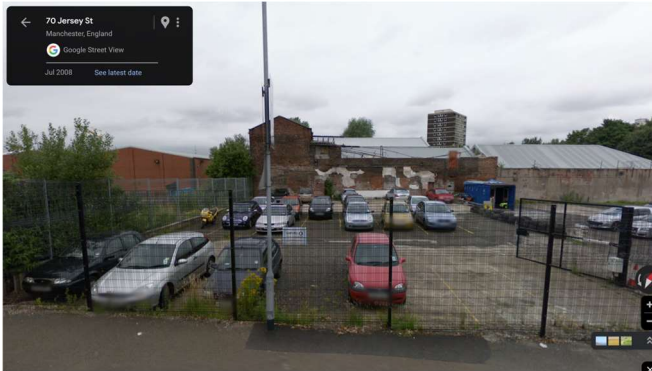
Figure 2 – Google maps image capture – Jul 2008

An additional review of google maps image capture history, documents that between Jul 2008 and Sept 2012 a warehouse building, constructed in solid brickwork was demolished at the site, and it appears probable that the boundary wall is the remnants of the demolished building indicated in figure 2.

It's assumed that the boundary wall will have had an adequate head restraint, via the connection to the roof structure prior to the demolition works which in effect converted the wall into a freestanding wall – i.e. a wall with no head restraint.

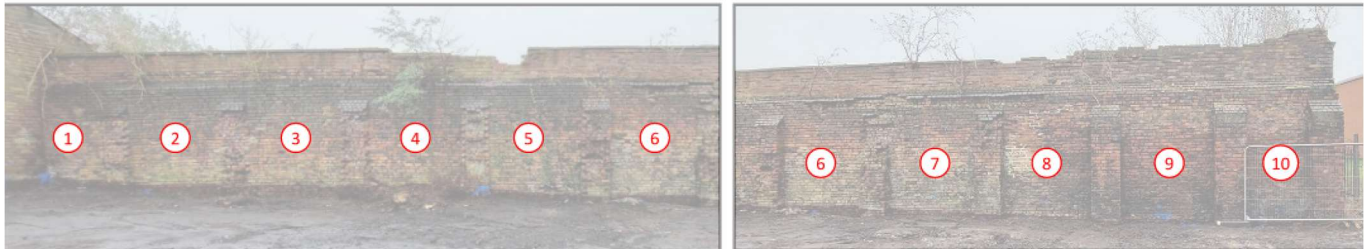
*Figure 4 – Photograph of wall denoted with panel references.*

This section of the report documents the areas of defect and deterioration observed during the site inspection. To manage the documentation of the survey the wall has been subdivided into panels and denoted as per figure 4.

Significant areas of mortar deterioration were observed in each of the wall panel 1 to 9, and generally the severity of issue increased in extent and depth of mortar loss towards the northeastern side of the wall.

Surface spalling of the brickwork was evident in most areas of the wall and again was generally more severe to the northeastern side of the wall. Although typically spalling of the wall will only presents cosmetic issues, as the severity increases so too does the likelihood of structural issues arising due to the deteriorating condition.

The wall has large areas of vegetation growth within the mortar bed, and in some instances, this has resulting in larger planting taking effect in the wall, (see panels 4, 6, 7 and 8) Where the large planting has occurred it is evident that structural issues have arisen immediately adjacent due to the resulting adverse stresses within the wall.

A partial collapse of the wall has occurred in panels 4, 5, 8 and 10, and this is accompanied by adjacent structural cracking and loosening of the brickwork panel, further weakening the masonry construction increasing the likelihood of further collapse.

A section of stretcher courses, (3No.) have locally broken away from panels 6 to 8 revealing the inner snapped header coursing. Adjacent to this section of wall further failure of the neighbouring brickwork can be seen such as loosened and missing brick sections, this results in local weakening of the masonry construction and increasing the likelihood of further local collapse.

As discussed above structural cracking has occurred in panel 3, 4, 5, 6, 7 & 8. The more obvious structural cracking has occurred in the top section of the wall where the wall thickness appears to

reduce to 1 brick thick. The primary cause of the structural cracking is assumed to be associated with the vegetation discussed in section 3.1, and cracking observed appears to be affecting the plumbness of these sections of the wall and can be seen to be leading to potential for further local collapse of the wall, as the wall further deteriorates or whilst subjected to periods of inclement weather.

The ad-hoc removal of the support pier thickenings to the masonry walls has occurred in panels 1 to 8, it is not clear from inspecting whether this has been done intentionally during the building demolition or is a result of deterioration either prior to the demolition works or subsequently during the ensuing period since the completion of the demolition works.

The impact of removing the pier is to significantly reduce the lateral stability of the wall and therefore it is not obvious why this would be done intentionally and is assumed that this is a structural deterioration of the wall, reducing the capacity of the wall to withstand periods of high wind loading.

Taking account of the above conclusions, the following is proposed as potential mitigation options for dealing with the existing boundary wall. Option 2 and 3 will be subject to completion of a visual inspection to the rear face of the boundary wall.

- Reduce the height of the wall (as a minimum to the top of the pier sections)
- Remove Vegetation
- Patch repair areas of Mortar Deterioration
- Replace sections of missing masonry.

- Reinstatement of intermediate additional lateral support via reconstruction of the masonry piers or incorporation of a steelwork support posts.
- Review of the existing foundation / and potential underpinning works

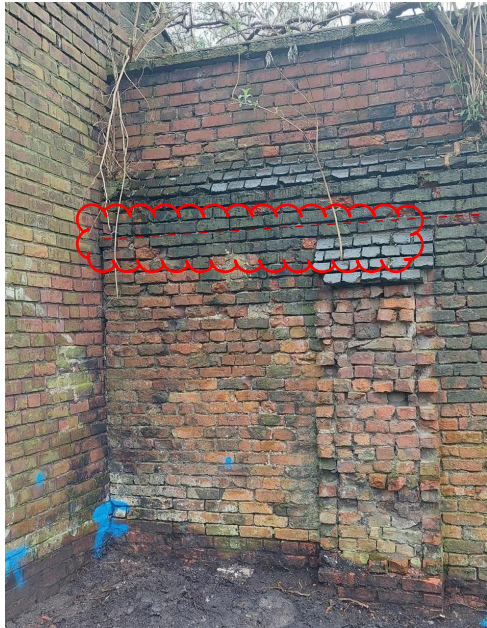
Panel 1: Wall Defect / Deterioration Checklist

| Description of Damage | Observed | Extent of Damage |
|---|---|---|
| Mortar Deterioration | ⚠ | 2 |
| Missing bricks | ⚠ | - |
| Loose Brickwork | ⚠ | 2 |
| Wall Settlement | ⚠ | 1 |
| Surface Spalling | ⚠ | 2 |
| Pier Support Removed | ⚠ | 3 |
| Vegetation | ⚠ | 2 |

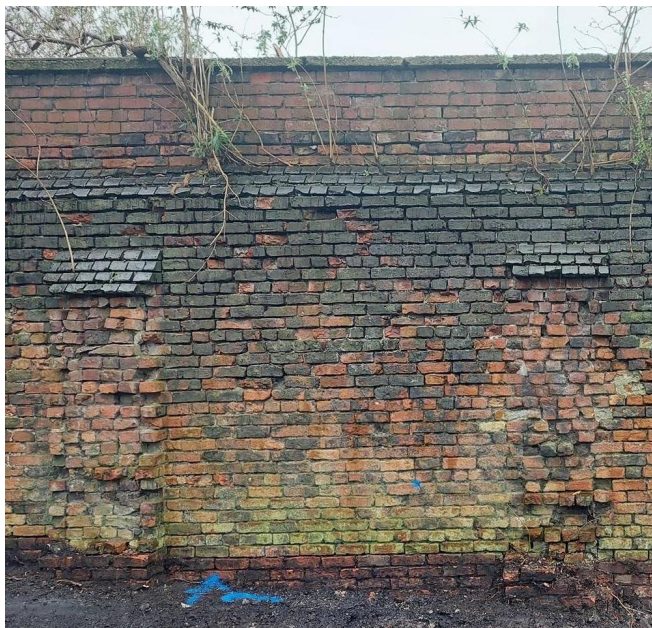
Panel 2: Wall Defect / Deterioration Checklist

| Description of Damage | Observed | Extent of Damage |
|---|---|---|
| Mortar Deterioration | ⚠ | 2 |
| Missing bricks | ⚠ | 2 |
| Loose Brickwork | ⚠ | 2 |
| Surface Spalling | ⚠ | 1 |
| Pier Support Removed | ⚠ | 3 |
| Vegetation | ⚠ | 2 |

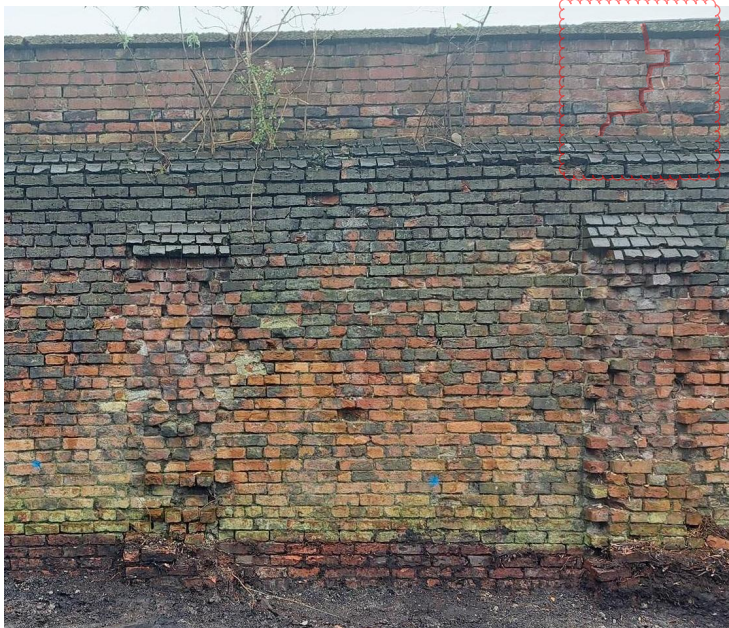
Panel 3: Wall Defect / Deterioration Checklist

| Description of Damage | Observed | Extent of Damage |
|---|---|---|
| Mortar Deterioration | ⚠ | 2 |
| Missing bricks | ⚠ | 2 |
| Loose Brickwork | ⚠ | 2 |
| Structural Cracking | ⚠ | 2 |
| Surface Spalling | ⚠ | 1 |
| Pier Support Removed | ⚠ | 3 |
| Vegetation | ⚠ | 2 |

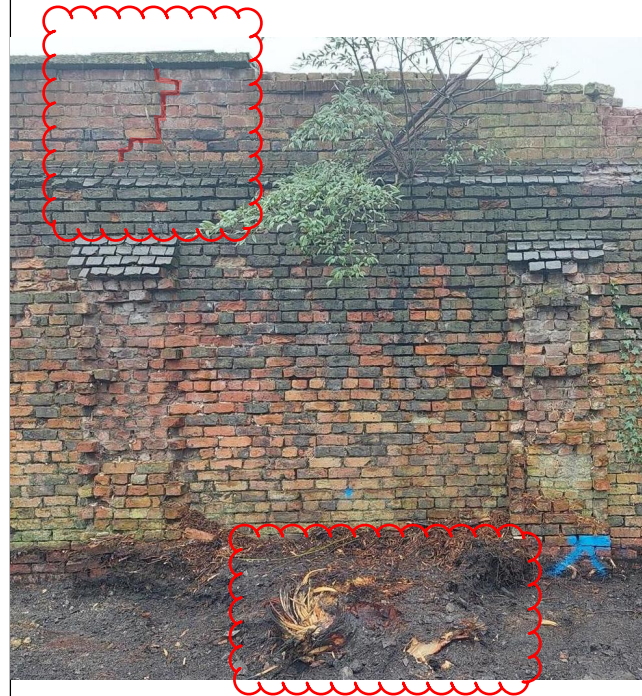
Panel 4: Wall Defect / Deterioration Checklist

| Description of Damage | Observed | Extent of Damage |
|---|---|---|
| Mortar Deterioration | ⚠ | 2 |
| Missing bricks | ⚠ | 2 |
| Local Wall Collapse | ⚠ | 3 |
| Loose Brickwork | ⚠ | 3 |
| Surface Spalling | ⚠ | 1 |
| Pier Support Removed | ⚠ | 3 |
| Vegetation | ⚠ | 3 |

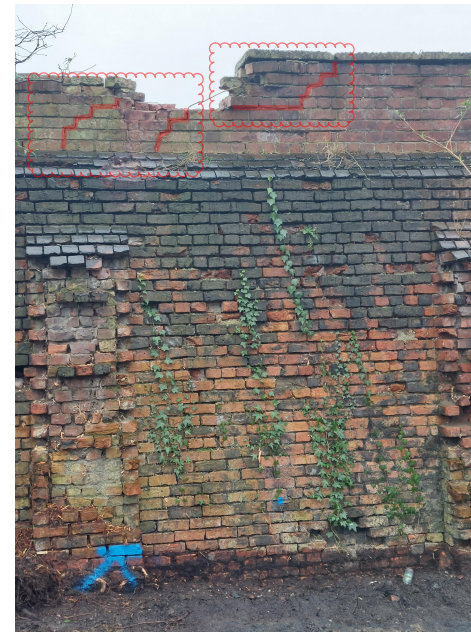
Panel 5: Wall Defect / Deterioration Checklist

| Description of Damage | Observed | Extent of Damage |
|---|---|---|
| Mortar Deterioration | ⚠ | 2 |
| Missing bricks | ⚠ | 2 |
| Local Wall Collapse | ⚠ | 3 |
| Loose Brickwork | ⚠ | 3 |
| Structural Cracking | ⚠ | 3 |
| Surface Spalling | ⚠ | 2 |
| Pier Support Removed | ⚠ | 3 |
| Vegetation | ⚠ | 1 |

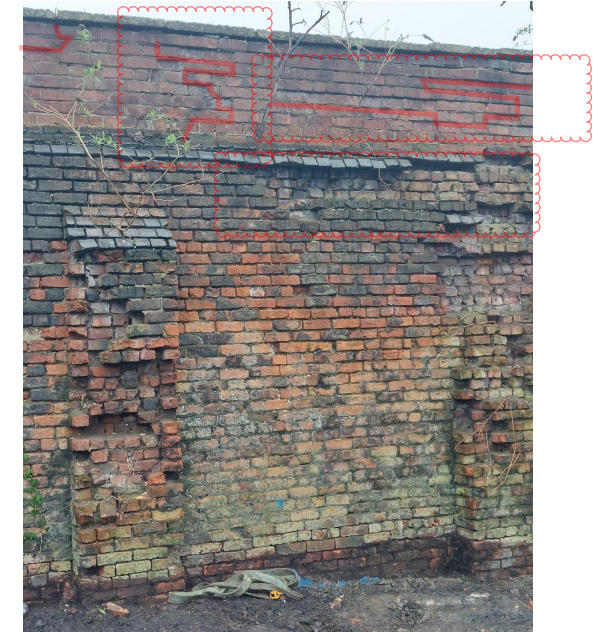
Panel 6: Wall Defect / Deterioration Checklist

| Description of Damage | Observed | Extent of Damage |
|---|---|---|
| Mortar Deterioration | ⚠ | 2 |
| Missing bricks | ⚠ | 3 |
| Local Wall Collapse | ⚠ | 3 |
| Loose Brickwork | ⚠ | 3 |
| Structural Cracking | ⚠ | 2 |
| Surface Spalling | ⚠ | 2 |
| Pier Support Removed | ⚠ | 3 |
| Vegetation | ⚠ | 2 |

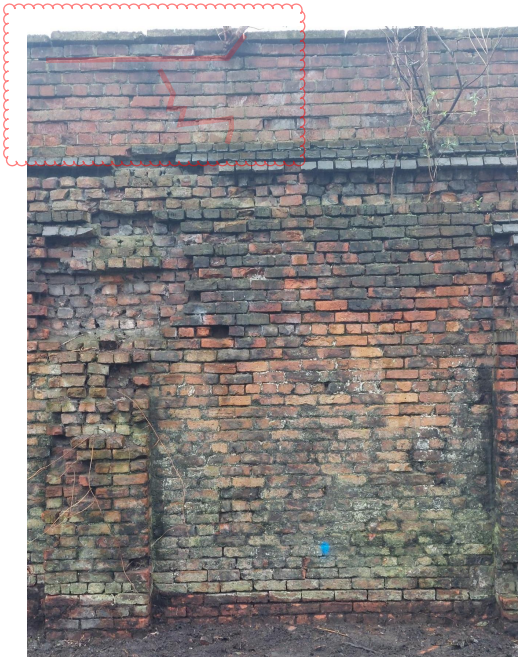
Panel 7: Wall Defect / Deterioration Checklist

| Description of Damage | Observed | Extent of Damage |
|---|---|---|
| Mortar Deterioration | ⚠ | 2 |
| Missing bricks | ⚠ | 3 |
| Local Wall Collapse | ⚠ | 3 |
| Loose Brickwork | ⚠ | 3 |
| Structural Cracking | ⚠ | 2 |
| Surface Spalling | ⚠ | 2 |
| Pier Support Removed | ⚠ | 3 |
| Vegetation | ⚠ | 3 |

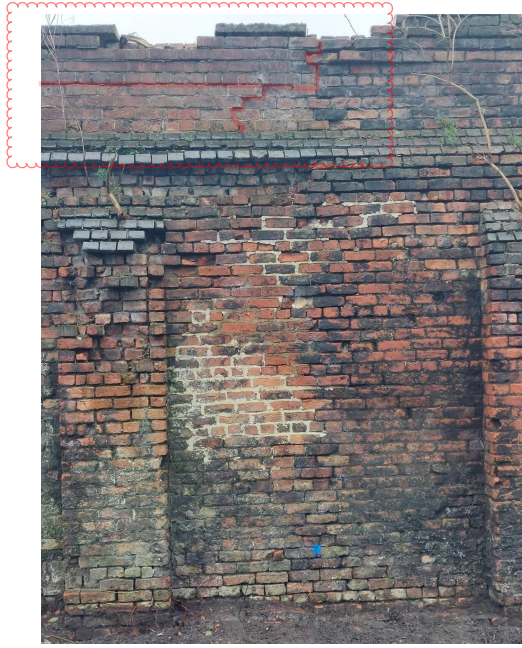
Panel 8: Wall Defect / Deterioration Checklist

| Description of Damage | Observed | Extent of Damage |
|---|---|---|
| Mortar Deterioration | ⚠ | 2 |
| Missing bricks | ⚠ | 3 |
| Local Wall Collapse | ⚠ | 3 |
| Loose Brickwork | ⚠ | 3 |
| Structural Cracking | ⚠ | 2 |
| Surface Spalling | ⚠ | 1 |
| Pier Support Removed | ⚠ | 3 |
| Vegetation | ⚠ | 2 |

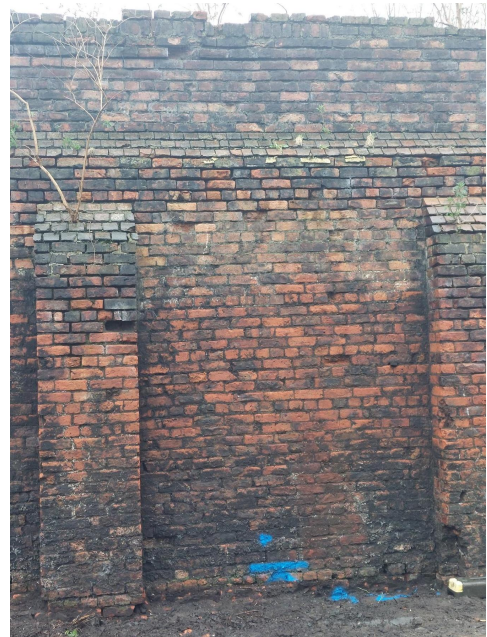
Panel 9: Wall Defect / Deterioration Checklist

| Description of Damage | Observed | Extent of Damage |
|---|---|---|
| Mortar Deterioration | ⚠ | 1 |
| Missing bricks | ⚠ | 1 |
| Local Wall Collapse | ⚠ | 1 |
| Loose Brickwork | ⚠ | 2 |
| Surface Spalling | ⚠ | 1 |
| Pier Support Removed | ⚠ | 1 |
| Vegetation | ⚠ | 1 |

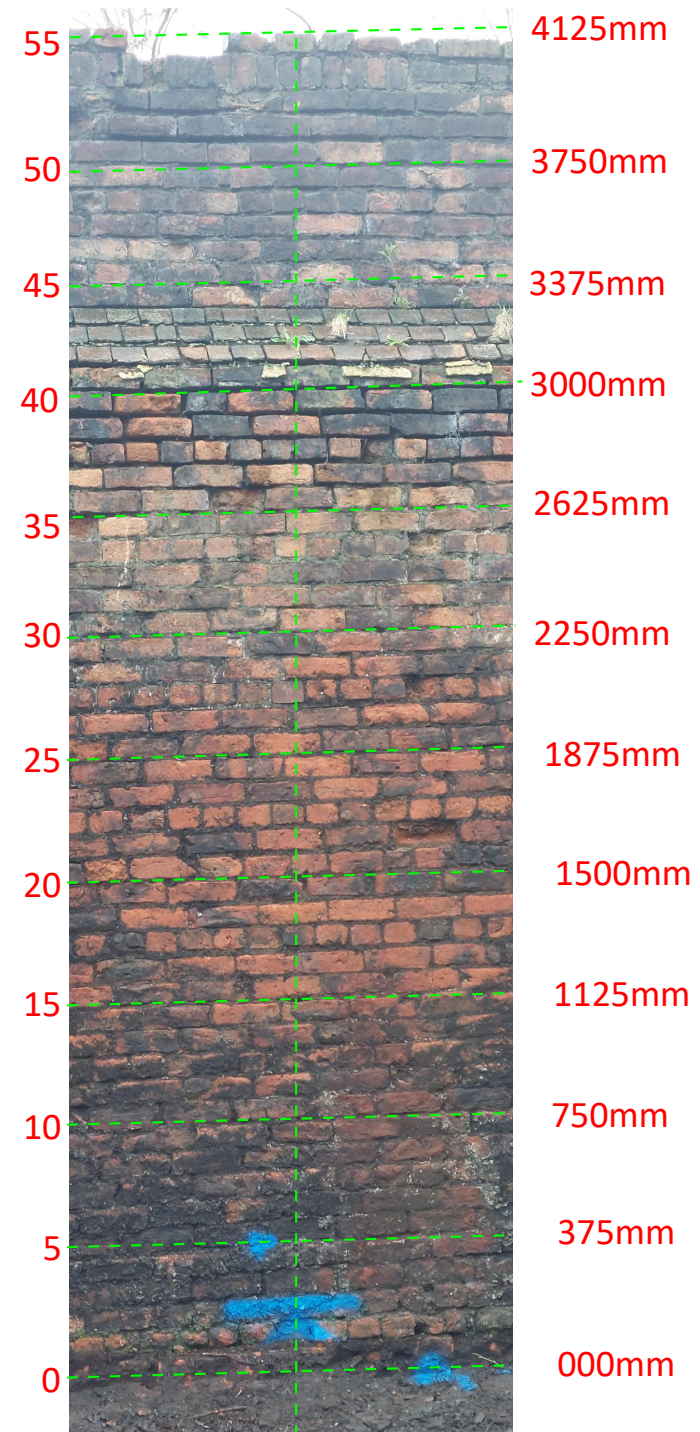
Wall Height Estimate

A further observation noted in the original photographs was the height of the wall which by simply counting of the brickwork course can be estimated to be approximately 4.10m high.

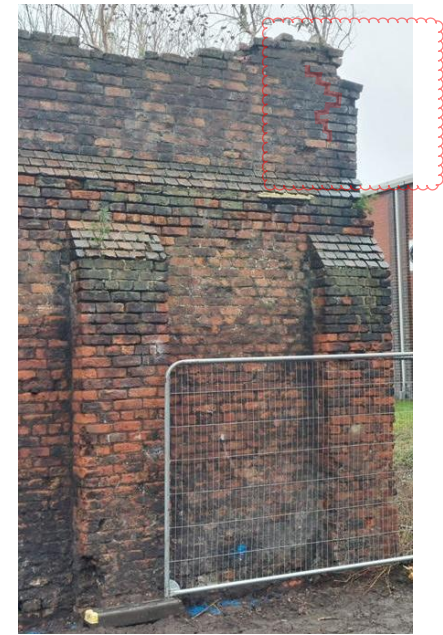
Panel 10: Wall Defect / Deterioration Checklist

| Description of Damage | Observed | Extent of Damage |
|---|---|---|
| Mortar Deterioration | ⚠ | 2 |
| Missing bricks | ⚠ | 3 |
| Local Wall Collapse | ⚠ | 3 |
| Loose Brickwork | ⚠ | 3 |
| Structural Cracking | ⚠ | 1 |
| Surface Spalling | ⚠ | 1 |
| Pier Support Removed | ⚠ | 1 |
| Vegetation | ⚠ | 2 |
