OUR TOWN HALL

Alteration to height of Chimney 26

Justification Statement

Document reference: OTH-PUR-TH-RF-RPT-A-0230

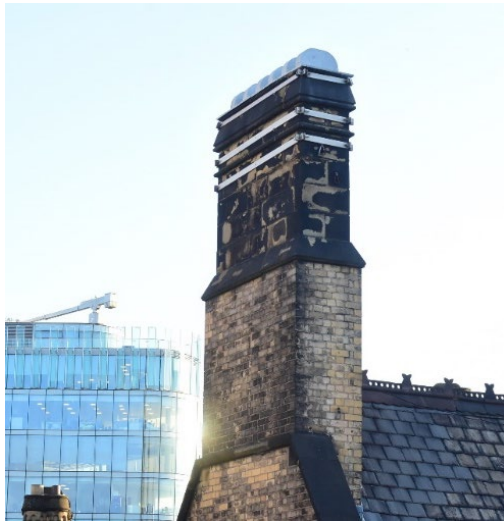
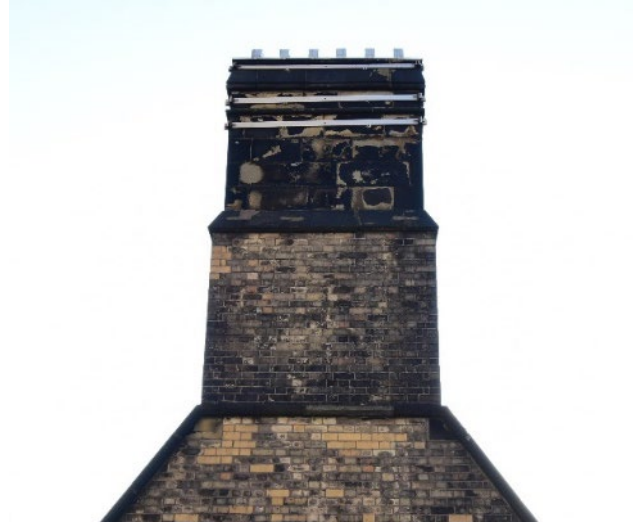
The chimney in question is the last of 35 chimneys to be restored and repaired. It is on the west elevation of the Great Hall and was in a severely damaged condition (refer to photos 1 and 2 below). The construction of this chimney was peculiar in that it was tall and slender as it only served a few offices each side of the adjacent light well, over the Bees Landing, but it had to be high to get the draught because of the surrounding structures. Consequently, it suffered from over saturation, and this caused the damage which had been a perennial maintenance problem, and is evident from the remedial strapping, zinc capping and significant and numerous stone erosion defects shown on the photographs (fig 1 and fig 2).

*fig 1 and fig 2 photos of existing condition prior to the project commencing in 2017*

This chimney, and its associated flues, had previously caused considerable water ingress and salt crystallisation issues in the stonework at the west end of the Great Hall which have now been carefully conserved internally during an earlier stage of the OTH project. However, the risk of recurrence of these defects will be greater the higher this chimney is in the reconstructed state, and particularly concerning is the risk to the completed work in the Great Hall if there is any further exposure of the masonry to the weather in its deconstructed state or during the reconstruction.

The bad condition of the stack necessitated partial demolition and reconstruction, incorporating considerable renewal of both brick and stone masonry. The scheme that gained consent (with conditions) in 2019, was to reconstruct the chimney to the same height it was originally built to.

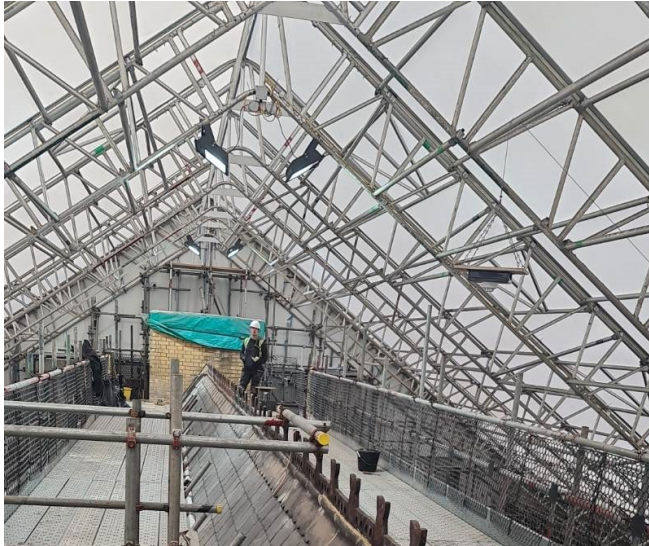
Photograph fig 3 below shows the chimney in its current deconstructed state, protected under the temporary enclosure over the re-slatted Great Hall roof but before any reconstruction or repair work to the chimney stack has commenced.

The consented full reinstatement proposal cannot be implemented under the existing temporary cover so, if it was pursued, it would mean having to expose the deconstructed and un-repaired remnant stack to the weather whilst the enclosure scaffolding is dismantled and the Bees landing rooflight is constructed, and the scaffold to reconstruct the chimney is erected and the reconstruction carried out. This scaffolding operation

and phase of the work described would take a significant period, and now that the cause of the defects in the Great Hall are fully understood, the additional resultant vulnerability is considered to be an unacceptable risk to the historic fabric and the conservation work that has already been completed. It is in this context that the design team proposed a revision to the reconstruction proposal which is the subject of this justification statement.

fig 3 current deconstructed state

The revised proposal is to reduce the height of the reinstated stack so that it can be reconstructed under the existing enclosure which will mitigate the additional risk to the historic fabric and highly significant heritage interiors beneath during the remaining construction stages but will also reduce the ongoing risk of water ingress of saturation in the future due to the reduction in the surface area of masonry exposed to the weather.

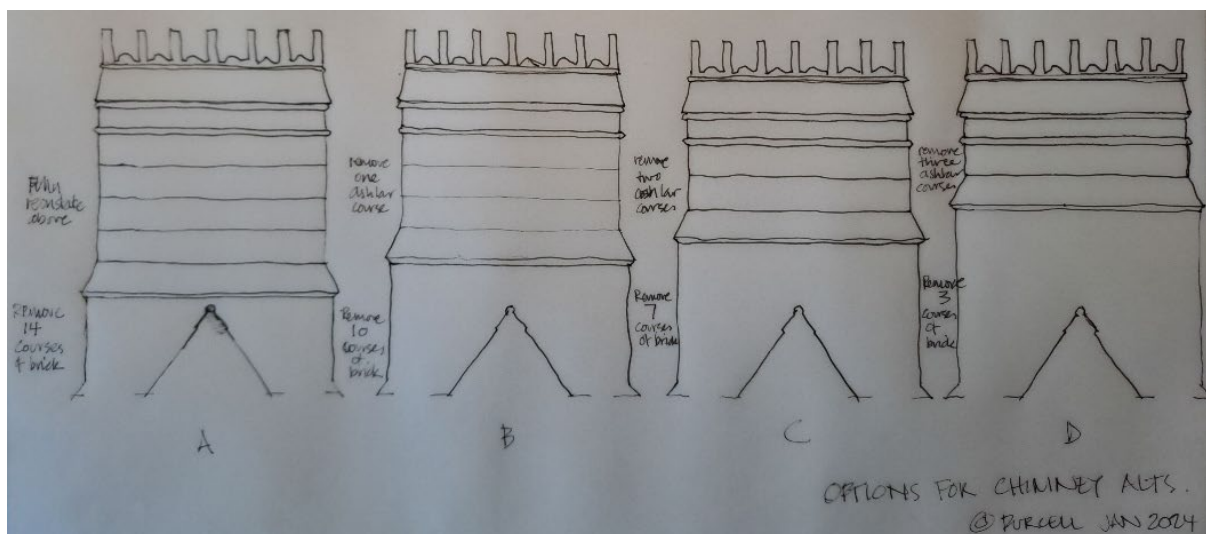
A number of options of achieving the reduction in height were put to the client and the LPA design and conservation manager as the illustration fig 4 below.

All the options proposed to reinstate all the moulded stone detailing to the cappings, string and plinth, as originally designed, and in consultation with the client and LPA there was a clear preference for option B which removed only one course of ashlar stonework and 10 courses of the brick below. This retained an appropriate proportion and spacing of features, and a practical distance above the ridge tiles of the Great Hall roof. The material arising from the alteration will be used for the repairs to this chimney of other features on the building within the project.

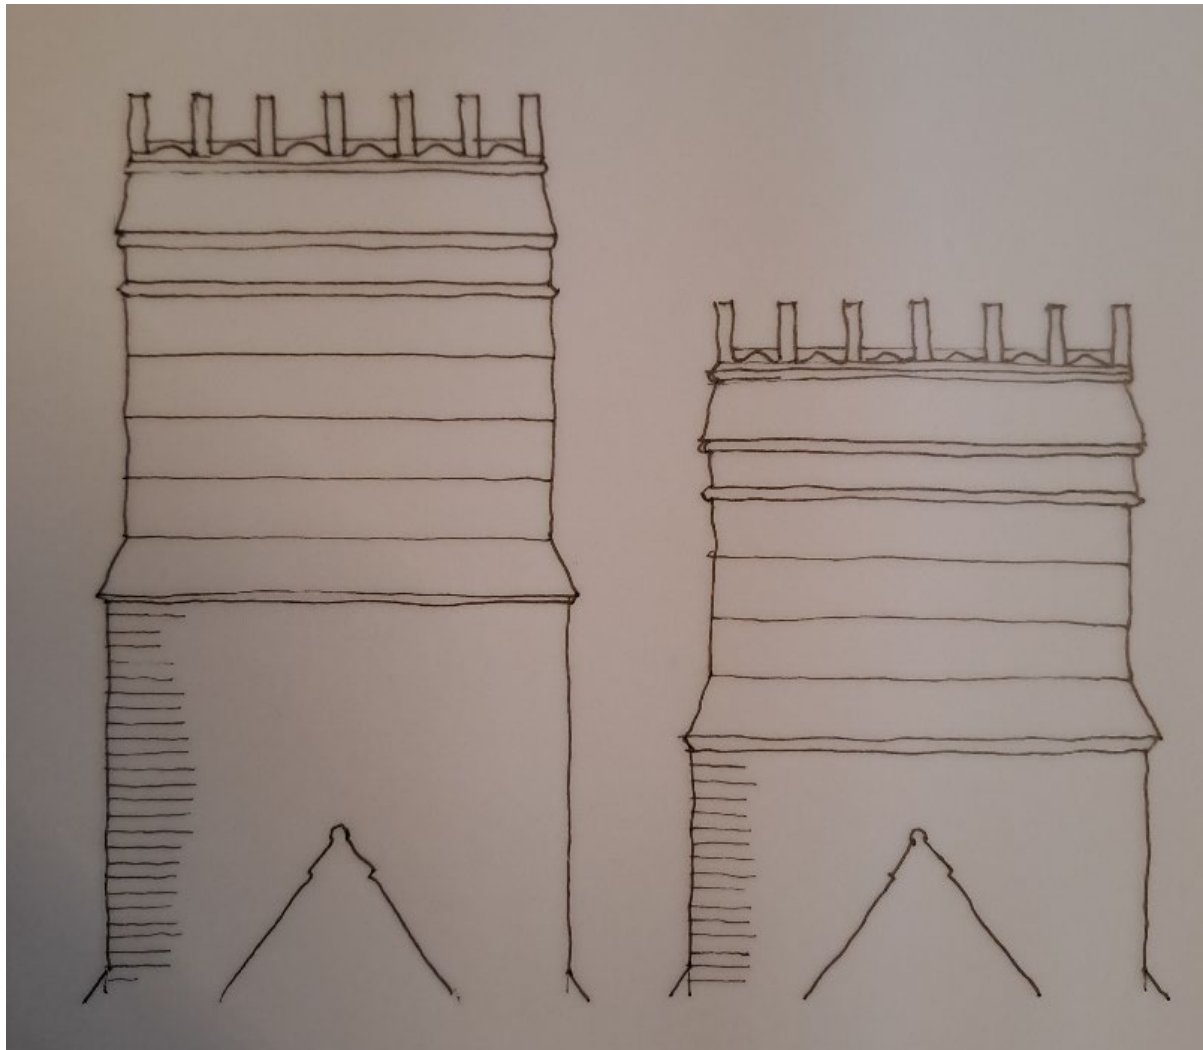
The sketch fig 5 below shows the comparison between the original design and the modified option B design

Original design on the left and modified design on the right.

The conclusion of this statement is that the modification of the design is minor and appropriate and the impact on the integrity of the original design is negligible compared to the significant mitigation of potential risk of damage to the historic fabric within the remaining construction stages and into the future.
