# TREE RISK ASSESSMENT SCHEDULE

**SURVEYOR:** Matthew Lally  
**DATE:** 23/02/2024  
**PROJECT ADDRESS:** 34 Lapwing Lane, West Didsbury, M20 2WR  
**PROJECT REF:** LTM1065.QTRA.01

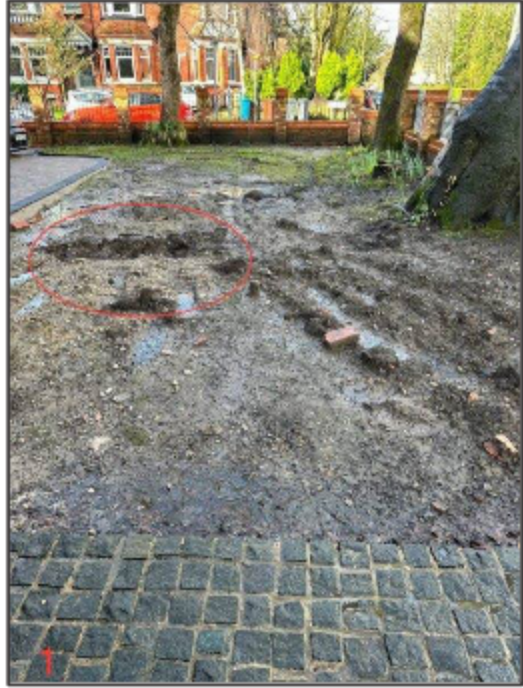
| Tree No. | T/G/W/H | Species | Height (m) | Age Class | Condition | Comments | Recommendations | Priority | Next Survey (months) | RISK ASSESSMENT OF | TARGET TYPE | MX TARGETS | TARGET | SIZE | POF | MASS % | ROH |
|---|---|---|---|---|---|---|---|---|---|---|---|---|---|---|---|---|---|
| 1 | T | Beech | 16 to 20 | M | B | A large and mature tree located at front of property, cavity present in main stem at 1.5m. Sounding hammer suggest cavity is large but there appears to be good levels of sound wood still present. Excavation and ground level changes in the root plate. Evidence of root severance. I have been informed that the excavation and root severance was undertaken due to emergency repair works by electricity north west. Codominant stems. Deadwood in crown. Vitality is within normal range. Structure of tree appears stable. | Crown lift to 5m over road and 3m over the internal and external paths, clear building by 3m. Remove deadwood. Monitor vitality. Monitor stem decay every 18 months | 3 | 18 | Stem failure at decay point | V | 1 | 2 | 1 | 6 | 100% | <1/1M |

Picture 1. T1-Beech located at front of the house. Excavation and root severance evident (red ellipse).

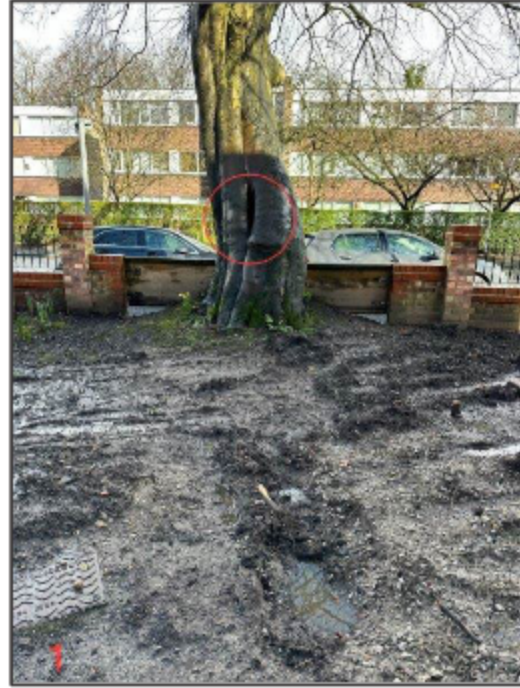
Picture 2. T1-Cavity present in main stem at 1.5m as indicated by red circle. Compaction is also evident in root plate.

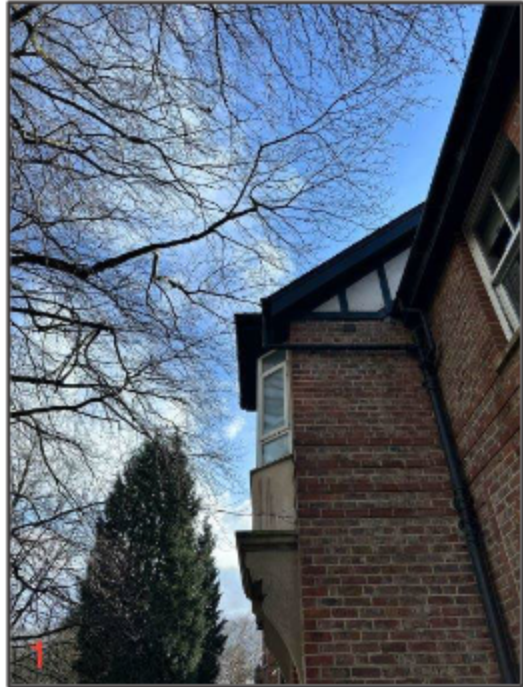
Picture 3. T1-Branches touching building.

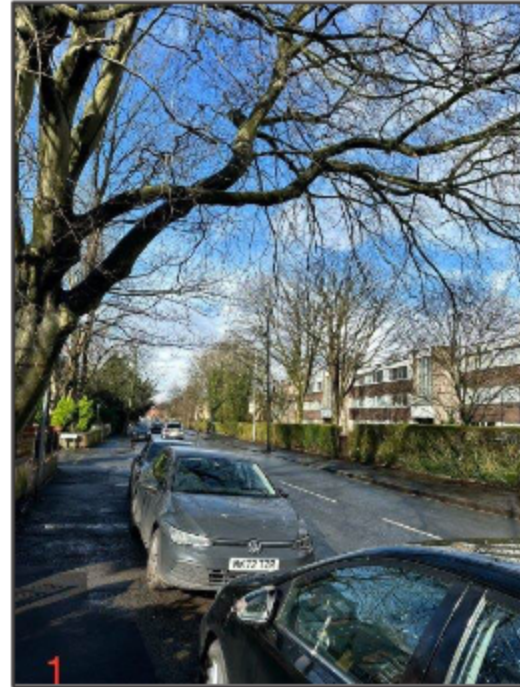
Picture 4. T1-Low branches over path and road.

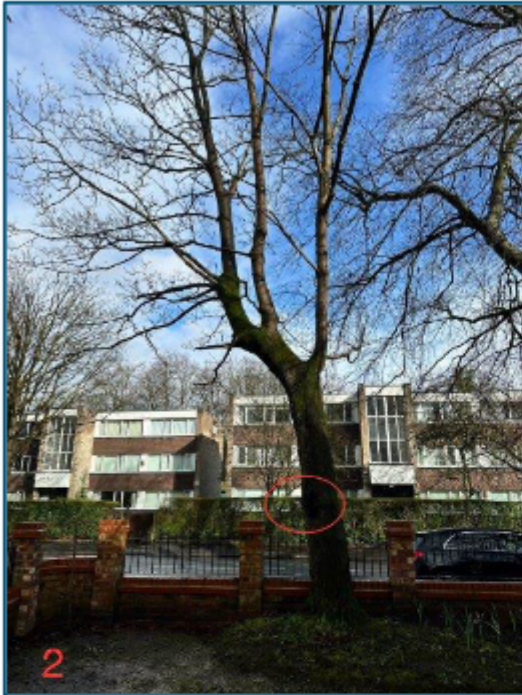
| Tree No. | T/G/W/H | Species | Height (m) | Age Class | Condition | Comments | Recommendations | Priority | Next Survey (months) | RISK ASSESSMENT OF | TARGET TYPE | MX TARGETS | TARGET | SIZE | POF | MASS % | ROH |
|---|---|---|---|---|---|---|---|---|---|---|---|---|---|---|---|---|---|
| 2 | T | Norway Maple | 11 to 15 | EM | B | Asymmetrical crown due to adjacent trees. Crossing stems. Codominant form. Minor stem canker but of little concern. Vitality is within normal range. Tree appears stable. Minor deadwood in crown. Evidence of excavation and compaction in root plate. | Consider removal of deadwood | 4 | 24 | Deadwood | H | 1 | 2 | 4 | 2 | 100% | 1/SOK |

**Picture 5.** T2-Norway maple with minor stem canker as indicated by red circle.

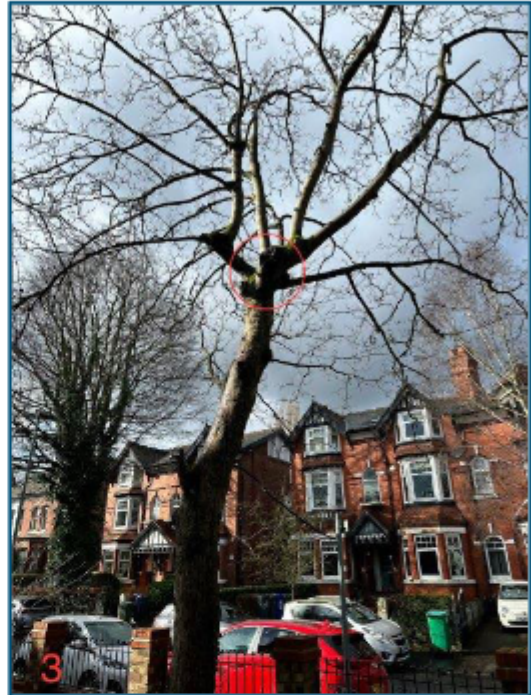
| Tree No. | T/G/W/H | Species | Height (m) | Age Class | Condition | Comments | Recommendations | Priority | Next Survey (months) | RISK ASSESSMENT OF | TARGET TYPE | MX TARGETS | TARGET | SIZE | POF | MASS % | ROH |
|---|---|---|---|---|---|---|---|---|---|---|---|---|---|---|---|---|---|
| 3 | T | Sycamore | 11 to 15 | EM | C | Asymmetrical crown due to adjacent trees. Historically topped at 6m with large regrowth stems. Decay evident in old pruning point at main stem break at 6m. Deadwood in crown. Vitality appears reduced. Multiple old pruning points on stem, partially occluded. Raised area of ground around base used as a planter has prevented an inspection of the tree base. Soil pressed against stem bark can cause suffocation of bark and cambium death. Evidence of excavation and compaction in root plate. | Remove deadwood. Remove soil from around base to original levels. Monitor vitality and decay at 6m every 18 months | 3 | 18 | Deadwood | H | 1 | 2 | 4 | 2 | 100% | 1/SOK |

**Picture 6.** T3-Sycamore with decay evident in old pruning point at main stem break at 6m (red circle). Vitality appears reduced and deadwood is present in crown.

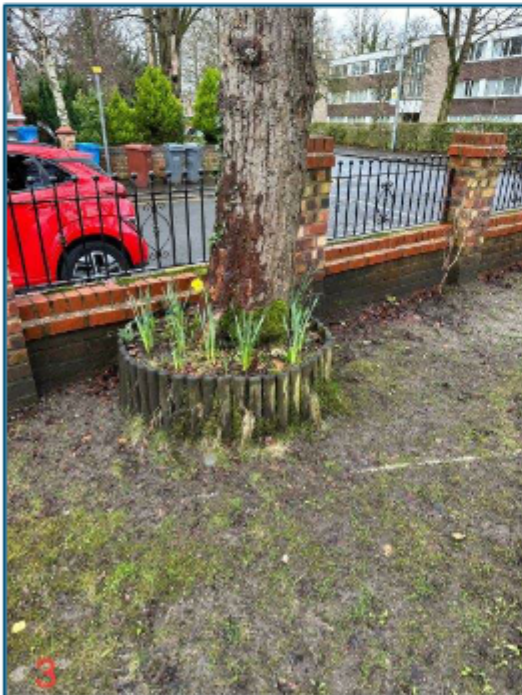
**Picture 7.** T3-Ground around stem base is raised into planter.
