# 117-119 Portland Street, Manchester

## Results of Architectural Paint Research

29/02/2024

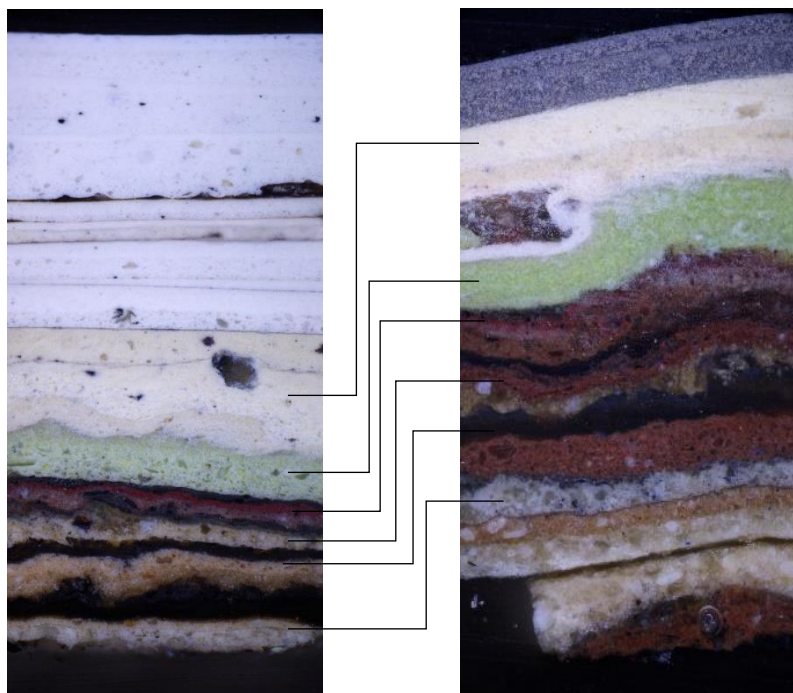
**Sample 10AB (200x mag) (left) taken from Portland Street elevation, interior window compared to sample 02, cast iron column. Surround showing correlation of earlier schemes.**

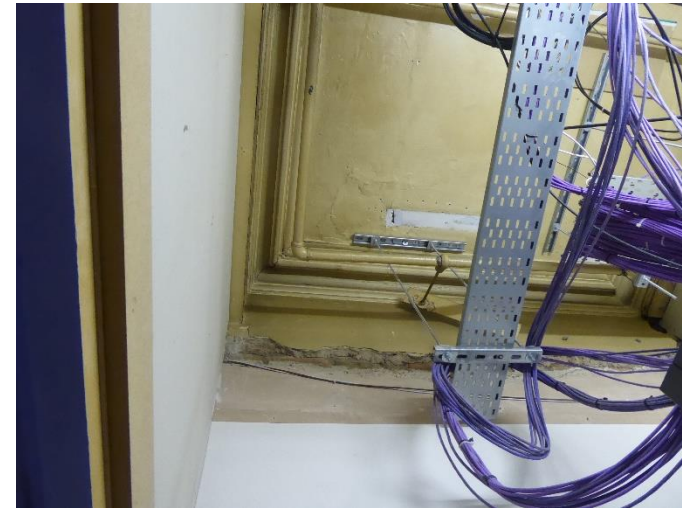
*Figure 12: section of surviving cornice and wall plaster within a services cupboard, level 1.*

The cutting away of the plaster would suggest that the walls have had an earlier plaster system removed and the walls recovered with modern plaster.

was noted that partial remains of the earlier plaster finishes survive (see Figure 12). This was not accessible for sampling but would be prudent to do so for building archaeology purposes prior to any alteration to the space.

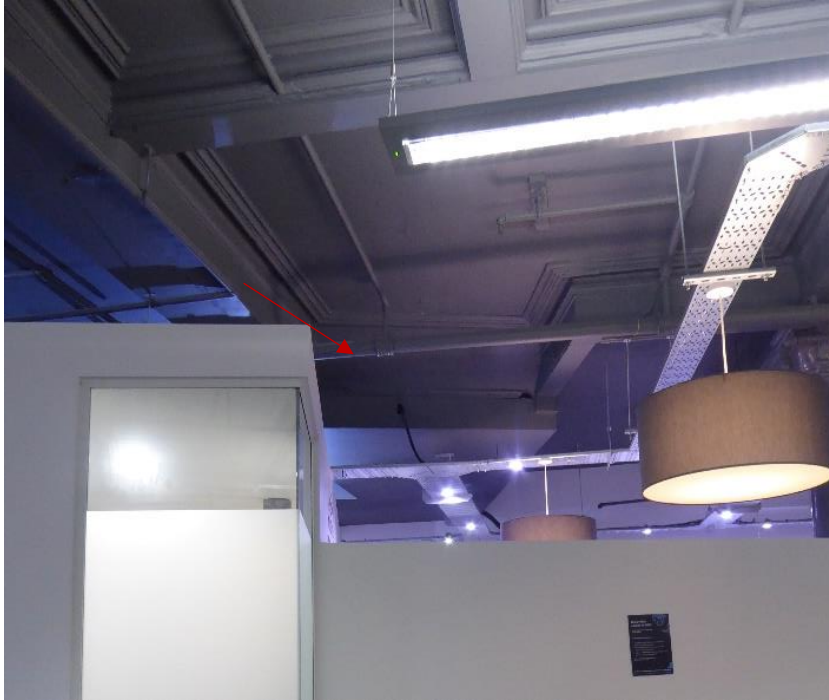
It is also possible that evidence relating to the location of an earlier staircase may survive. This is noted between the toilet facilities and the small kitchen area to the centre of the floor space. There is a natural line

of perimeter mouldings to the ceiling and an apparent drop in the level of ceiling, as though allowing for the rise of the staircase (Figure 13).

*Figure 13: possible evidence of the location of an earlier staircase to level 1.*

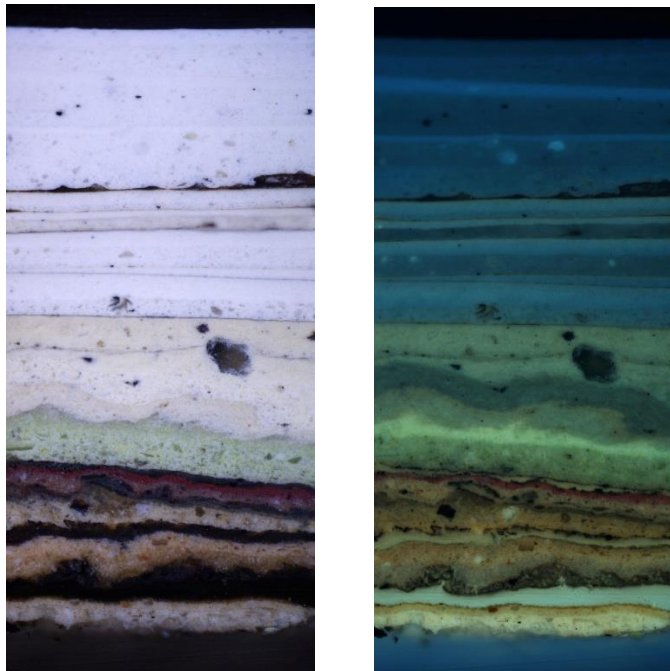
*Figure 15: sample 10 (taken at 200x magnification) shown in visible light (left) and ultraviolet light (right)*

Whilst no evidence of marbling was seen to the window samples there is comparable use of colour in the latter part of the earliest phase of decoration.

Scheme four in this sample is the strong red-pink colour applied over a pink undercoat seen as the sixth scheme in the samples taken from the columns. This suggests that there may be schemes missing or disruption to the schemes within the sample location and therefore a further scheme precedes this one. A significant dirt film is also noted in the varnish that has been applied over this scheme. Following additional archival research undertaken by Deloitte detail of the bomb damage to the area was revealed. Whilst the building that forms 113-119 Portland Street was not damaged during the raids on Manchester in December 1940 the building on the opposite side of the road was hit. This is likely to have resulted in significant detritus present in the atmosphere and whilst no significant build up of dirt layers are seen in the sample taken from the interior window finishes that may be attributed to this the disruption noted in this section of the sample, it may indicate losses associated with

Three schemes applied in a cream colour have then been applied which contain some evidence of dirt film suggesting these may preceded the 1956 Clean Air Act. The reaction to ultraviolet light would suggest these may be oil alkyd-based paints readily available after the Second World War. However, given the short period of time noted between the bomb damage to buildings to the opposite side of the road and the lack of dirt films in this phase of colour it is more likely this use of cream can be attributed to post war period of 1950s and early 1960s'

Later schemes of decoration have been applied in white synthetic resin-based paints with seven schemes noted the latter three are of a similar appearance and do not contain any evidence of dirt films beneath them. These paint films are well bound and would suggest a more regular programme of maintenance. It is understood that Bruntwood acquired the building in 2002 and the slight disruption in the paint films below these last three schemes of decoration would suggest that the upper three schemes are likely applied post 2002, though maintenance records for the current owner would clarify how many schemes of decoration have been applied since acquisition.

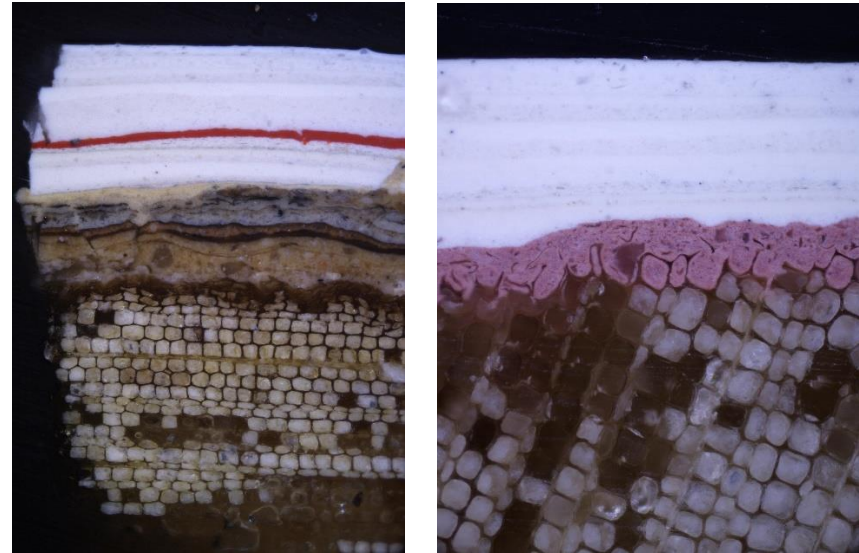
*Figure 16: sample 13 (left) and sample 15 (right) (taken at 200x magnification)*

Samples 12 and 13 from the rear elevation windows were comparable and also contained evidence of initial light brown colour schemes though there is less evidence of the varnish films noted here. The second scheme is also a darker brown colour (varnished) however this is where the comparable treatment stops with the rear windows then being painted with an off-white oil paint. This did not test positive for lead,, unlike the earliest brown colour schemes. The change to the use of white in these window frames may also be associated with the need to bounce more light into this space where inspection of fabric was undertaken in front of the large windows.

A cream colour is seen to the samples after the off-white decorative scheme followed by three further white colour schemes. A strong red colour is noted, applied over a white undercoat, prior to the last three schemes being applied in a bright white paint scheme.

By contrast sample 15 shown in Figure 16 contain a pink colour paint film as the earliest scheme followed by a five later bright white paint schemes. This indicates this is a replacement section of joinery to the window.

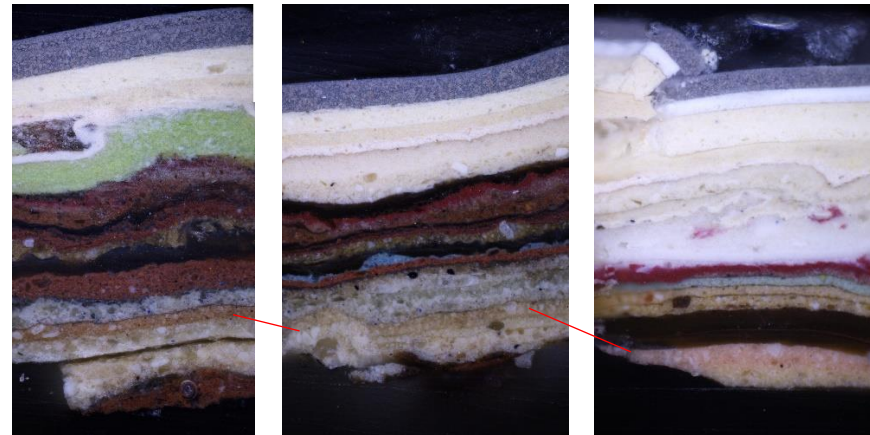
This scheme also appears to make use of a varnish film over the preparatory layer (sample 02) and further investigation would be required to understand the appearance of the scheme at this height. This scheme is missing from Sample 01 and sample 02 appears to have been finished with a warm blush colour which becomes lighter in sample 03 to

the upper height of the column. Sample 04 from the base of the capital is also painted in a warm blush colour (indicated by red line below).

*Figure 17: Sample 02 (left) 03 (centre) and 04 (right) showing correlation of scheme two.*

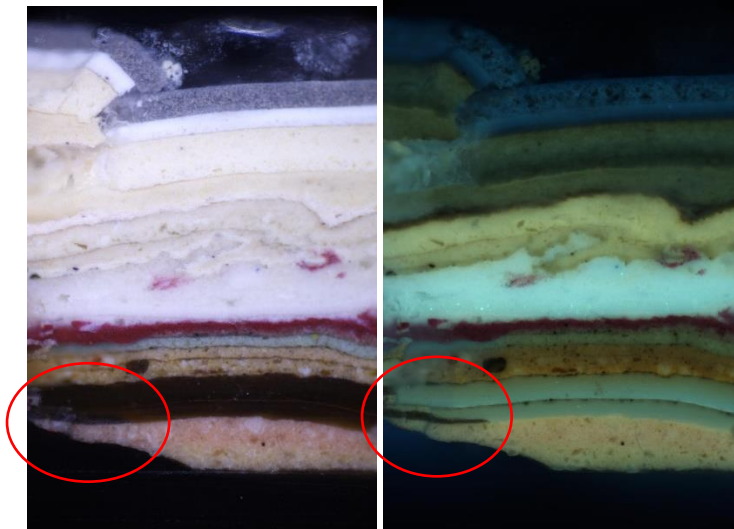
Sample 04 also contains a varnish film over the blush paint layer beneath which a secondary broken paint film is also noted under ultraviolet light this suggests a paint finish such as marbling was employed at scheme 02 (see Figure 18).

*Figure 18: Sample 04 (taken at 200x magnification in darkfield mode) in visible light (left) and ultraviolet light (right).*

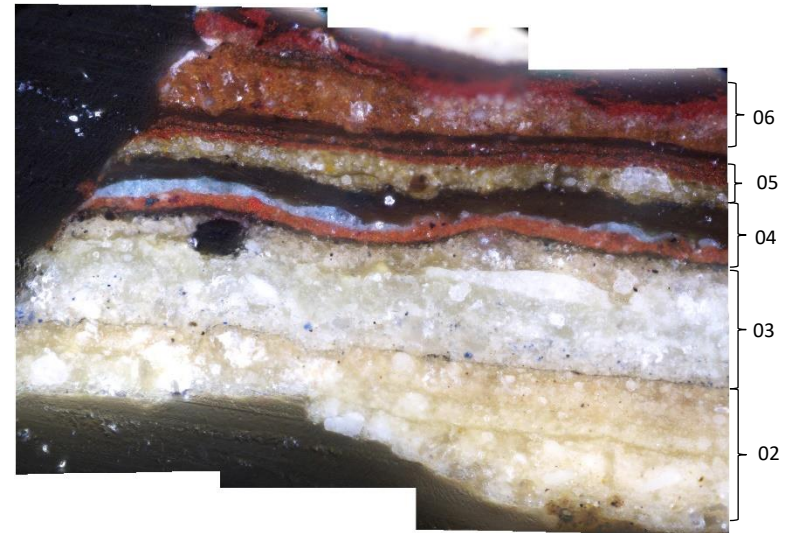
Scheme four has been applied with a dark red ground to samples 01, 02 and 03. The scheme then contains a variation with a thin, incomplete layer of either dark blue or light blue applied over it, the thickness of the film varies and has then been varnished prior to evidence of a broken thinly applied dark blue film seen over the varnish suggesting marbling. Sample three was examined at 500x magnification in brightfield mode and is shown in Figure 19 below.

*Figure 19: sample 03 (taken at 500x magnification, brightfield mode) showing the composition of layers in the earliest schemes of decoration.*

Under ultraviolet light the overlying varnish is well integrated with the light blue veining suggesting the varnish may have been applied before the veining had dried. The light blue pigments are also mixed with larger granular pigments of a transparent nature, there is evidence of dark blue pigments within the red ground.

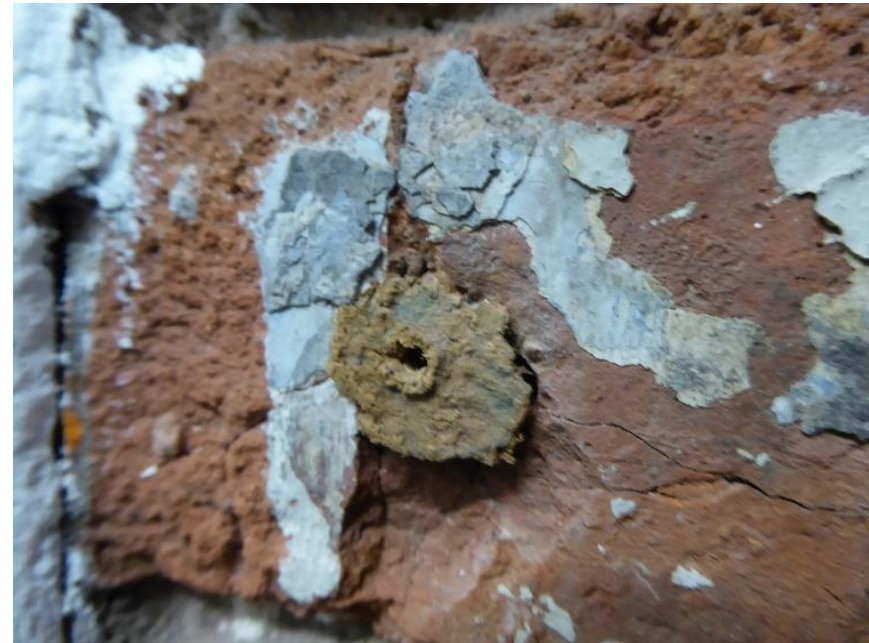
The earliest applied decoration to the brickwork was a blue tinted limewash/distemper. The use of blue varied depending on the desire to off-set the natural yellowness of the limewash or to tint the paint film. The amount of pigment seen in the paint layers indicates an intention to create a light blue colour to the staircase rather than a brightened white. At least three schemes of the light blue colour limewash/distemper was noted and has been overpainted at a later date by cream colour, followed by off-white and bright white paint films. These later schemes of decoration were applied after the second half of the twentieth century, noted due to the lack of dirt films between the schemes and the reaction to ultraviolet light. In contrast the earliest blue colour schemes do have a build up of dirt layers between the schemes and, given the proximity to the power station on Dickinson Street it is likely these schemes pre-date the twentieth century.

*Figure 20: evidence of historic blue-grey decoration surviving to the lower ground floor.*

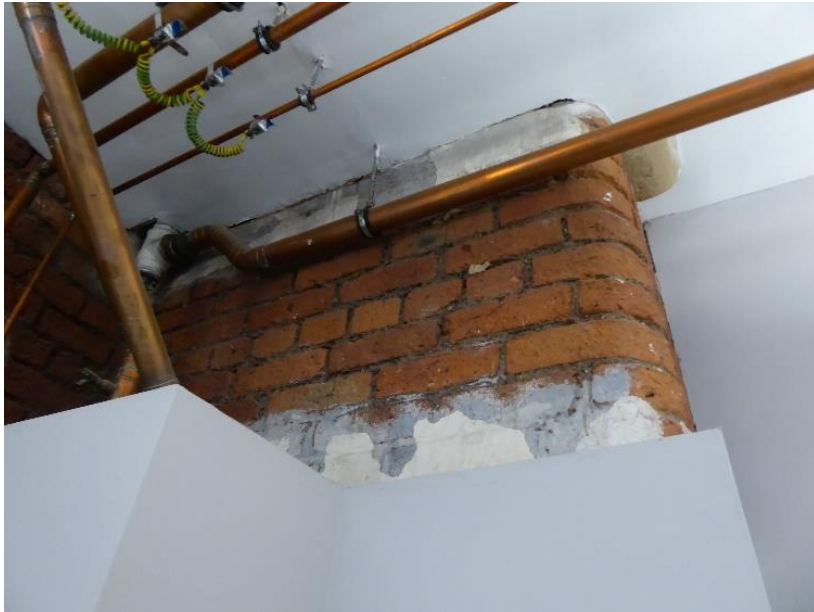
*Figure 21: Section of retained historic decoration to the lower ground floor office / exhibition space.*

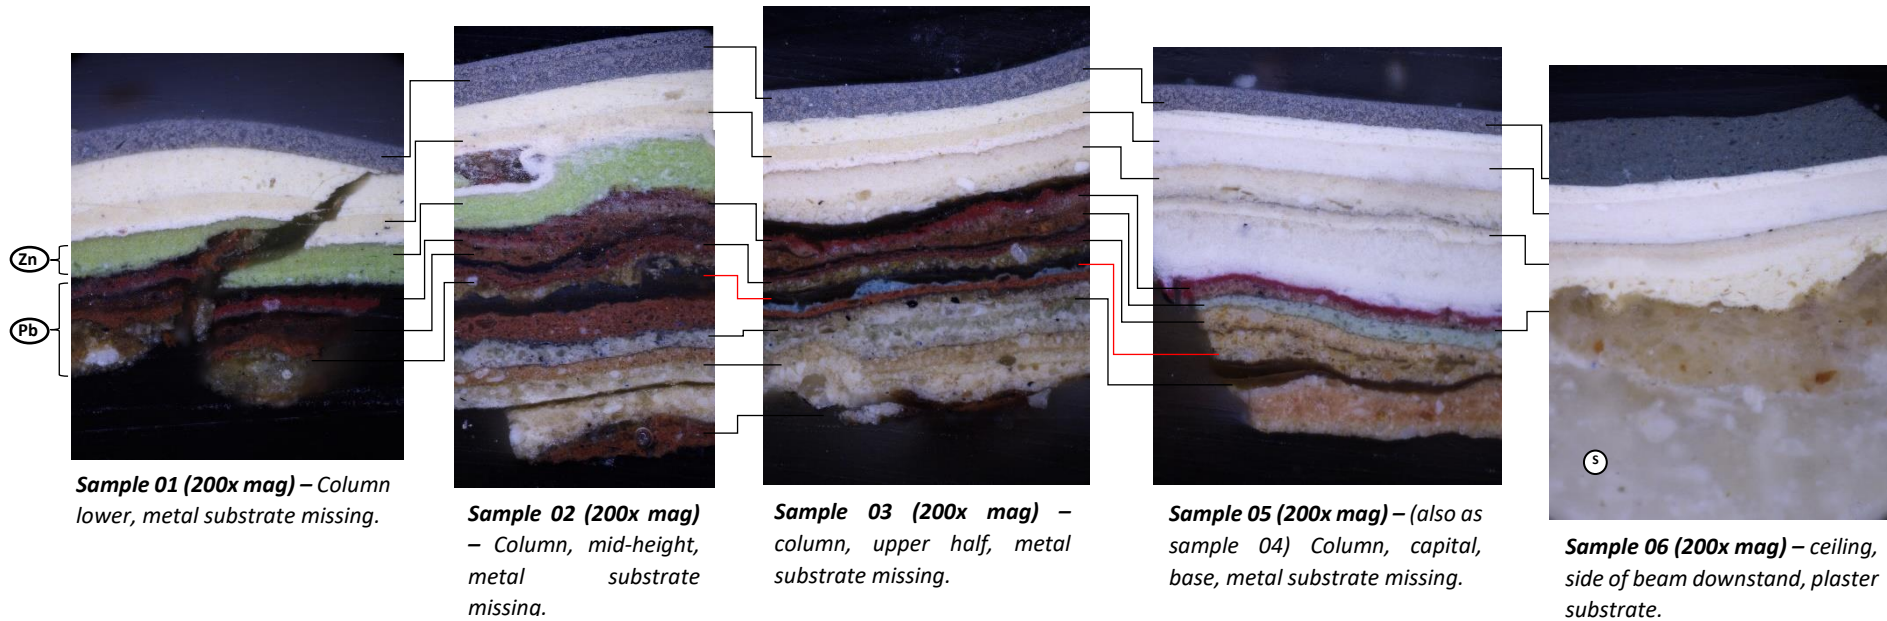
### 6.1.1. Column & ceiling

- Analysis of the samples taken from the column reveal a comparable treatment and number of schemes. The earliest schemes to sample 01 from the lower section are missing and there is some indication of a variation in the earliest schemes between sample 02 and 03 indicating the lower portion was treated slightly differently from the upper.
- Within the schemes to the column there is evidence of a special paint finish – this may be marbling, or similar finish and further investigation is required (scheme marked).
- Sample 06 taken from the beam show fewer schemes of decoration than the columns with a cream colour evident as the first scheme.
- The lack of paint archaeology suggests loss of applied decoration though this was noted across all samples taken from this area and further investigation of the ceiling may be required to ascertain presence of additional finishes.

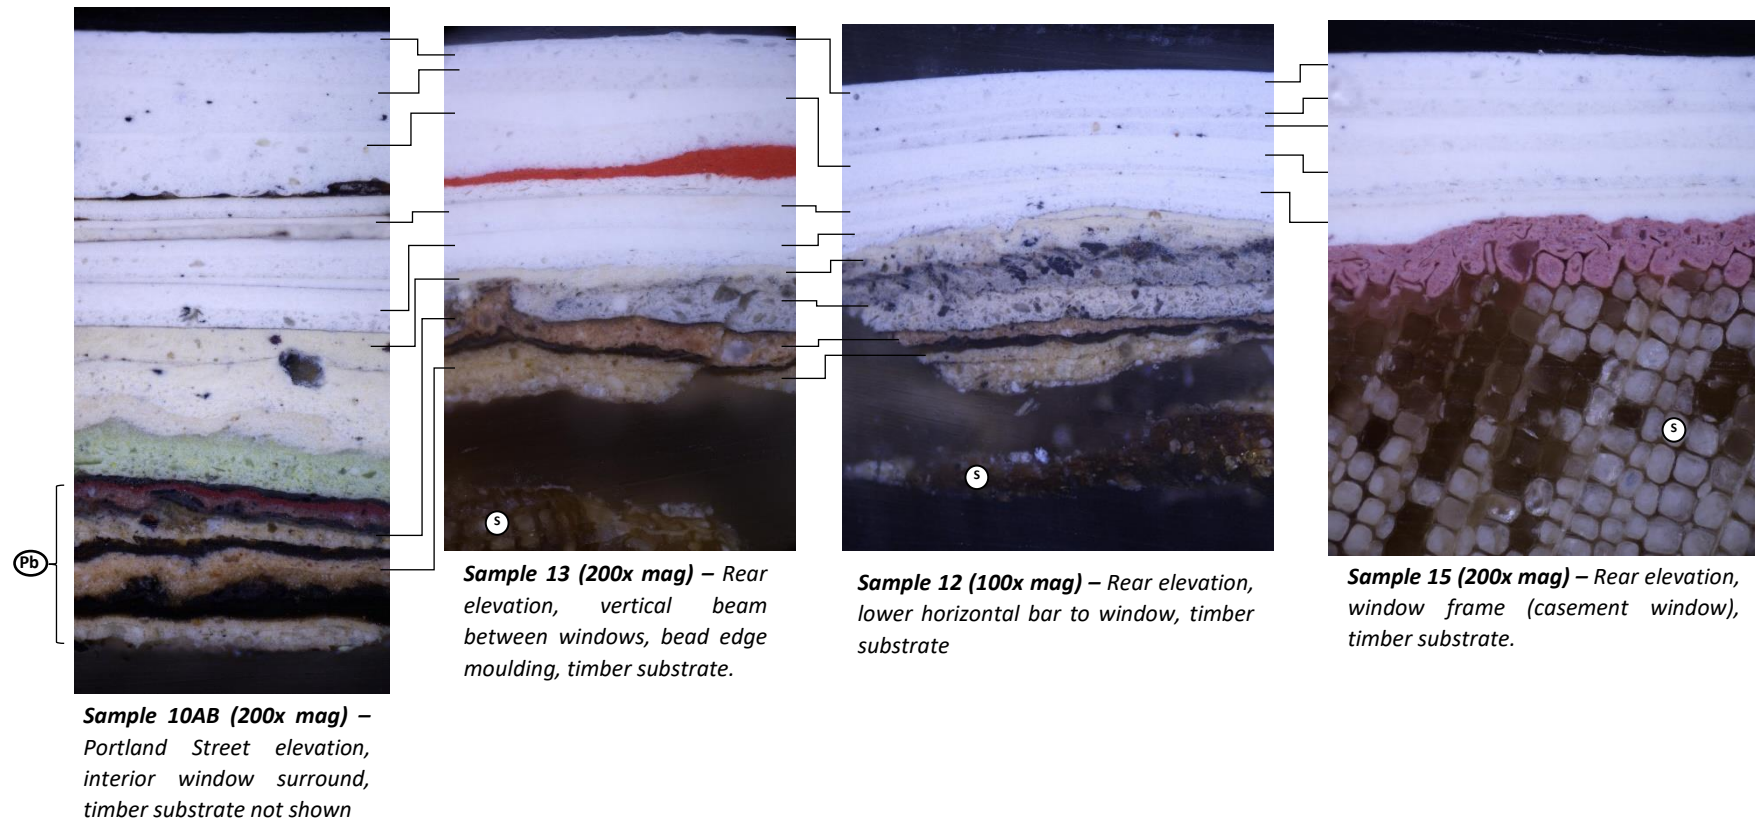
### 6.1.2. Windows

- Sample 10 taken from an interior facet to a Portland Street elevation window contains a significant number of paint films. The earliest schemes have been applied in lead-based oil paints and have varnish films over. These are followed by a number of schemes applied in oil alkyd and synthetic resin-based paints indicating this sample likely contains a full paint archaeology for this facet.
- Samples taken from the rear elevation window show comparable initial treatment but fewer schemes of decoration with sample 15 containing only later synthetic resin-based paint film indicating this facet may be a later replacement.

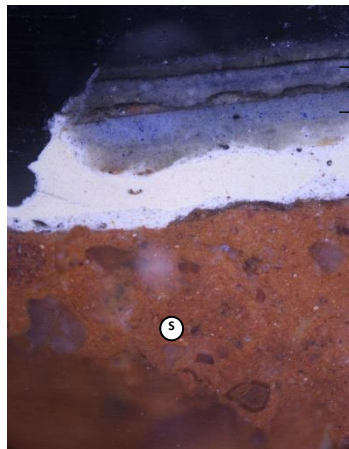
**Sample 20A (200x mag)** – Rear staircase, wall, brick substrate.

- Sample 20 has split into two sections (A & B shown above). Sample 20A shows what appears to be an initial white colour applied to the brickwork but is a bleed through of later paint layers into fractured earlier paint film – blue.

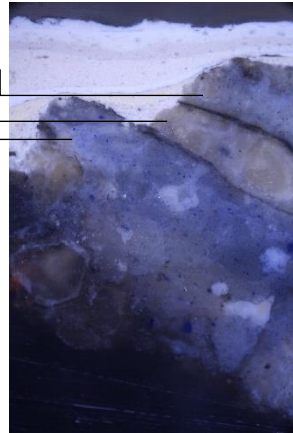
**Sample 20B (200x mag)** - Rear staircase, wall, brick substrate. .

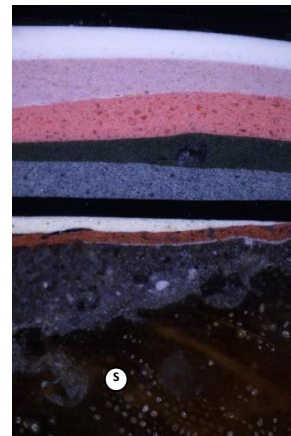
**Sample 17 (200x mag)** – Rear staircase, handrail, timber substrate.

- The earliest treatment of the joinery to the staircase suggests a dark grey to the handrail but varnish to the spindles (noted under UV light in sample 18). In a number of the subsequent schemes that followed this the use of dark red, black and dark green is noted.

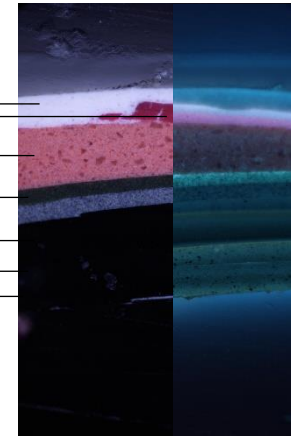
**Sample 18 (200x mag)** – Rear staircase, spindle, timber substrate not shown (inset UV image to RH side).
