## DESIGN AND ACCESS REPORT

### MIDLAND HOTEL - WEST ENTRANCE

| PROJECT REF. | 2045 |

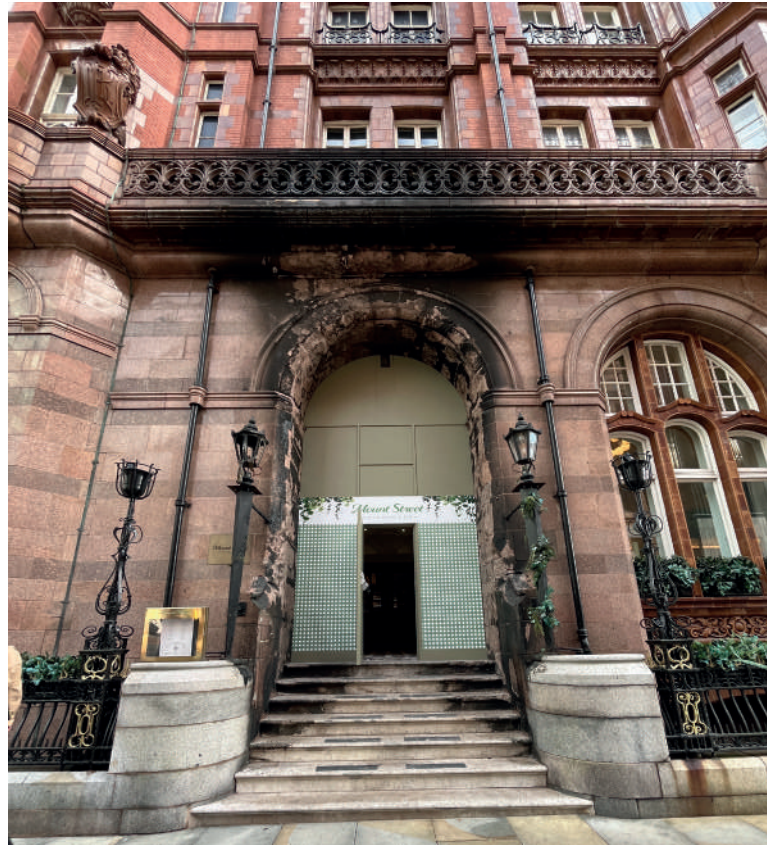
Fire damaged West Entrance - current condition

In January 2024 the West entrance was the subject of an arson attack. A significant amount of damage has been done to the stone in this area, along with wider soot/smoke staining.

The timber entrance door was damaged beyond use, however please note that we are advised there is an existing Listed Building Consent in place for a replacement door. Temporary hoarding is in place on site now.

The strategic brief given by the client, is to repair and reinstate stonework and associated ancillary materials which were damaged in the arson attack, January 2024.

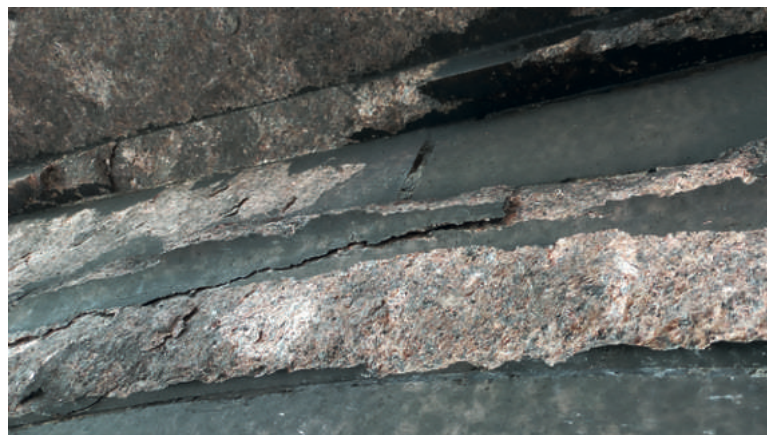
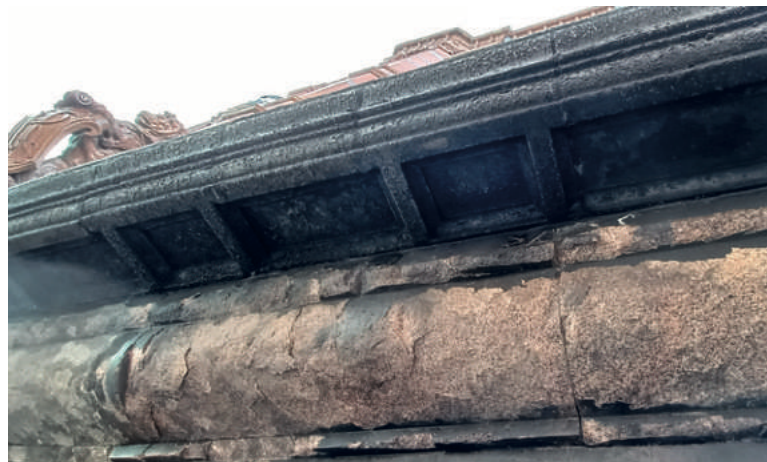
As part of the works, the stonemasons cleaned off any large loose pieces, and took samples of the stones and mortars. The core samples were then reinstated with a resin and lime mortar to suit their location.

- The granite blocks are full thickness. The stone varies in depth depending on the location. From nom. 390mm to upto 500mm. Behind the stone, is a brick structure. There is no gap, and the stones are mortared together. The structure is sound, and cracks beyond the surface were not observed at 3 no. core drill locations.
- The stone arch is load-bearing.
- The joints are nom. 3mm wide at the face, with the voussoir stones tapered in plan to form wider bedding joints.

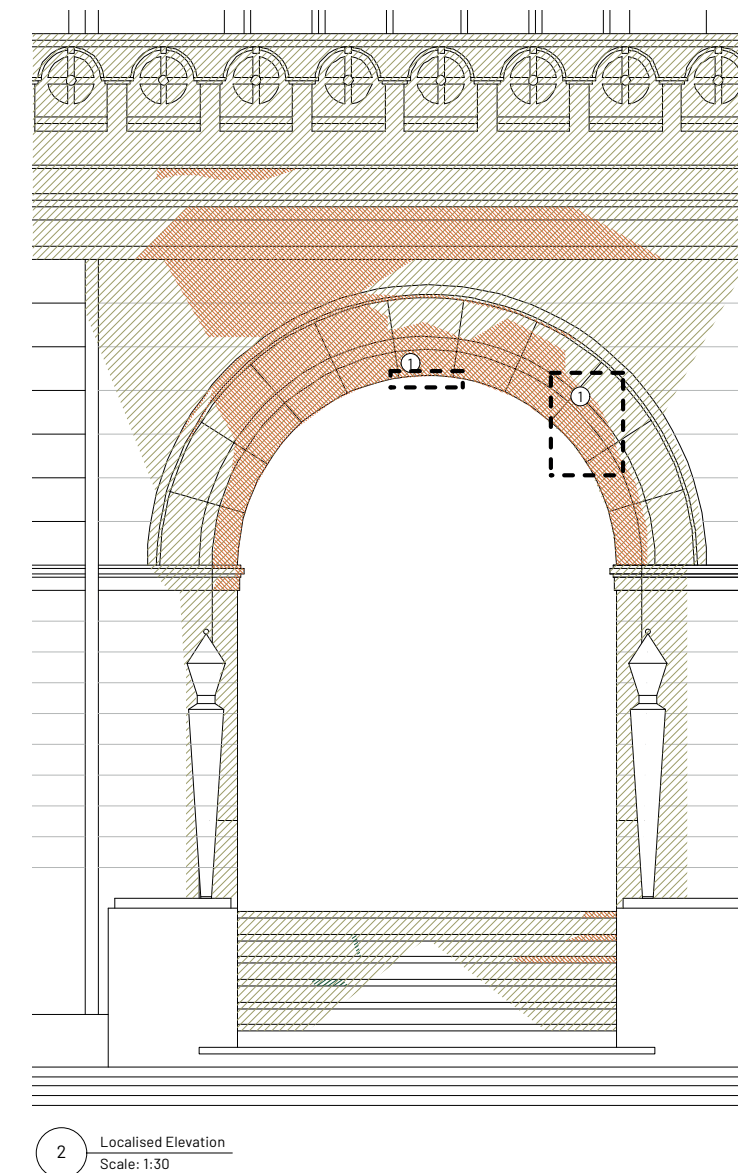
Areas for investigation highlighted on condition survey - Elevation

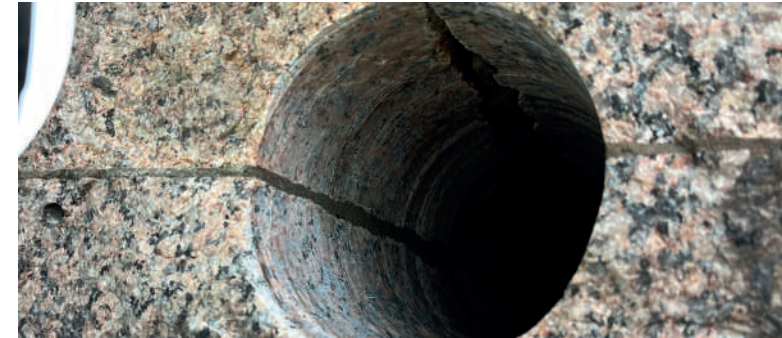
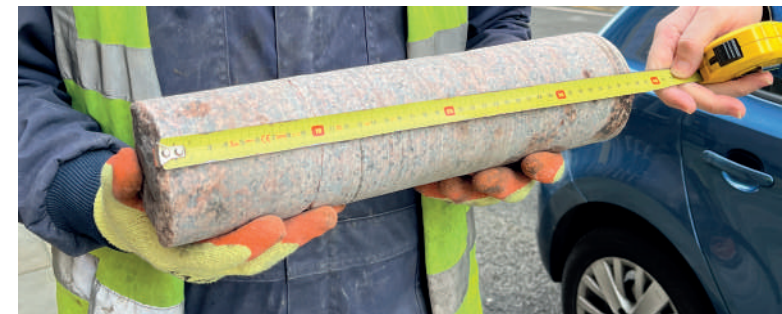
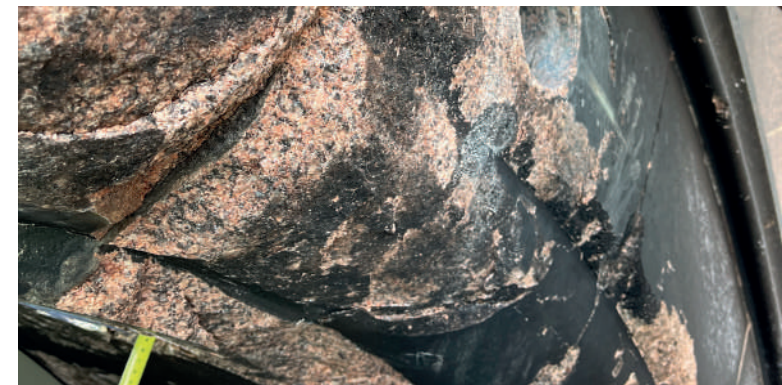
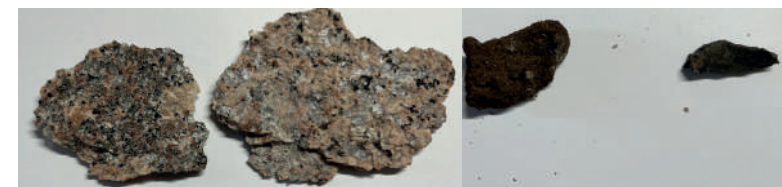
- There are 2 no. types of bedding mortar.
- a) bedding of the walls with a dark relatively crumbly sandy mix. Little textural variation.
- b) voussoir bedding darker and harder in nature. Possibly formed from cinder. Again, sandy with little texture variation.

Images from the site investigation

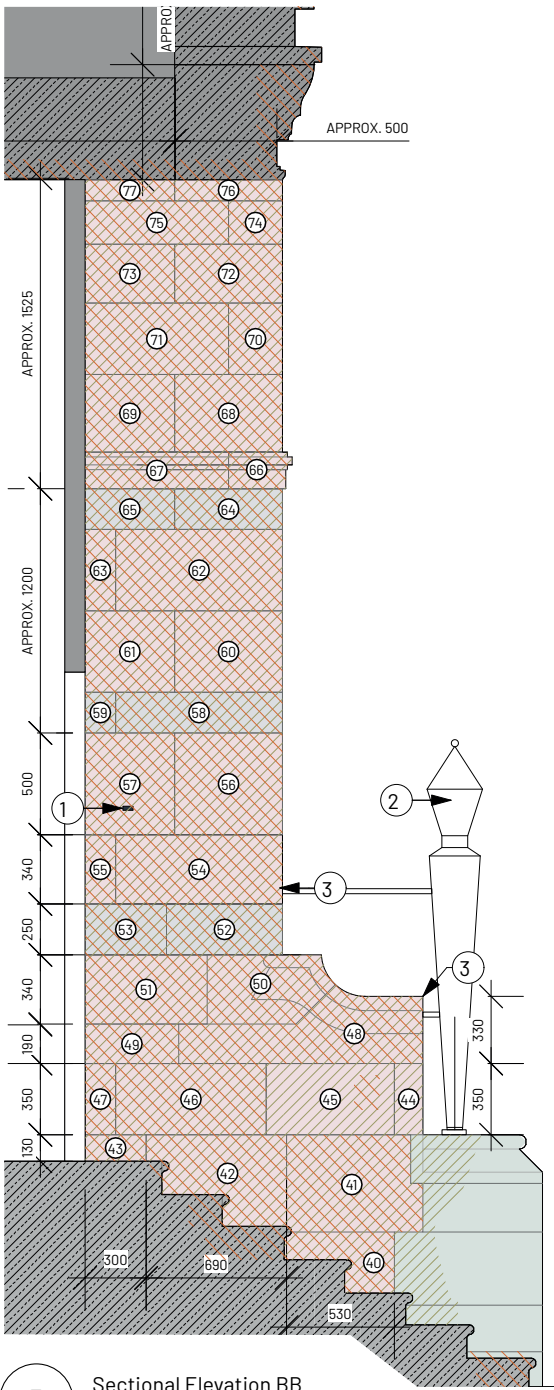
3 Sectional Elevation BB  
Scale: 1:30

Extract from proposed sectional elevation drawing

- The repair is to be carried out using face part 100mm deep indents. This will minimize the volume of old stone to cut out, new stone to buy and can be enacted without undermining the rest of the structure above.
- Chain drills the damaged stone to a depth of

nom. 100mm to take new stone faces which will be mortared, and resin dowelled in place.

- Core drill and grind out inner stones that are not bounded by damaged stones (i.e. those closest to the doorway) to take new stone faces which will be mortared, and resin dowelled in place.

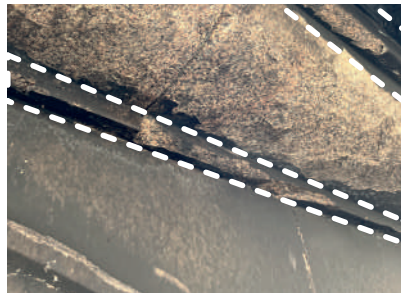
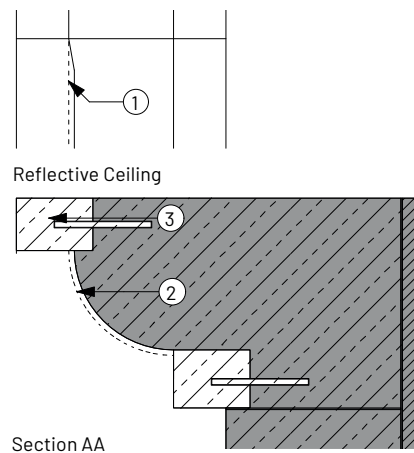
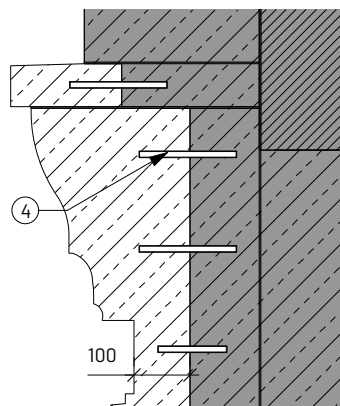
Extract from typical details drawing.

- Install a scaffold tower to the full area of damage/soiling. This will be designed to enable the entrance to continue to be used as a fire escape for most of the works.
- Install temporary arch formwork to support the structure during the works.

- Clean stonework and faience terracotta balcony with a soft abrasive - used at the lowest velocity required to prevent damage to non damaged surrounding surfaces. This will allow checking for any further cracked or otherwise damaged pieces currently hidden by the brittle damaged surface
- Once the repair work is complete, a high pressure steam clean will be used to remove the soot soiling to otherwise sound stone.

- Cantilevered stones beneath faience terracotta balcony. Redress damaged faces, with a sloped transition between the surrounding original profile and the new recessed face.
