# Historic Paint Analysis

## Timber, Ironwork and Masonry

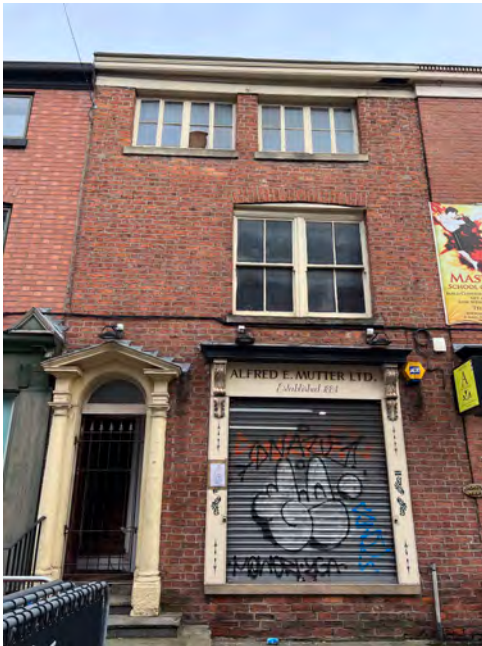
Internally the all the window frames have been painted black underneath only timber is visible (Fig.5 &6). Externally to the front the window frames are cream in colour (Fig.1), underneath lies a layer of gloss black and past that a bottle green colour (Fig. 8). Historical photos show them to be black (Fig. 26). External rear windows frames are black gloss (Fig. 4) with no other layers of historical paint.

Fig.1 Front Elevation windows and masonry

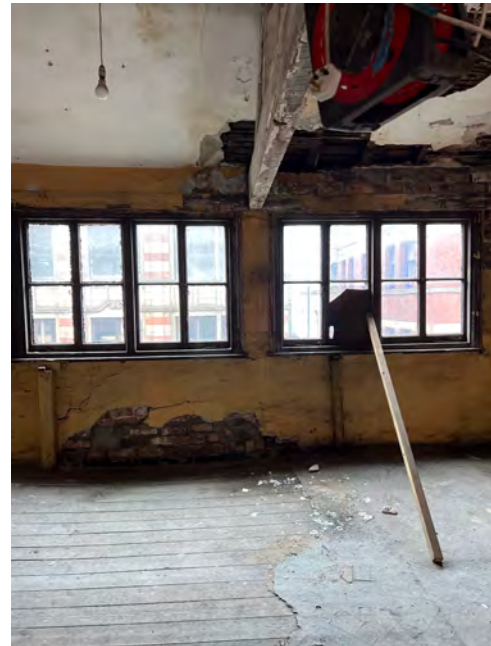
Fig 2. Internal windows to front of building.

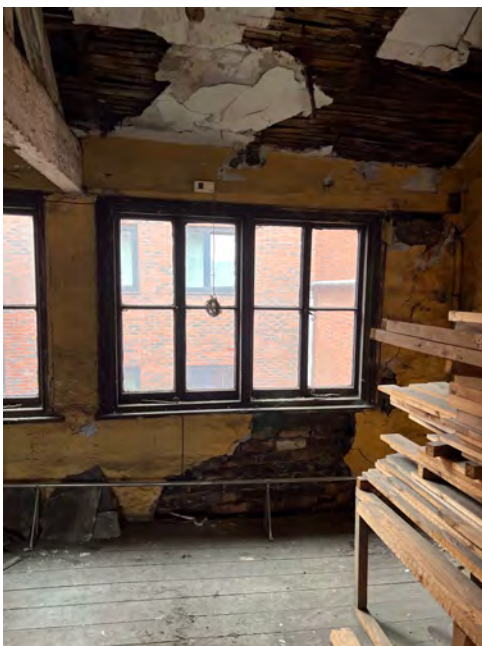
Fig. 3 Internal windows to rear.

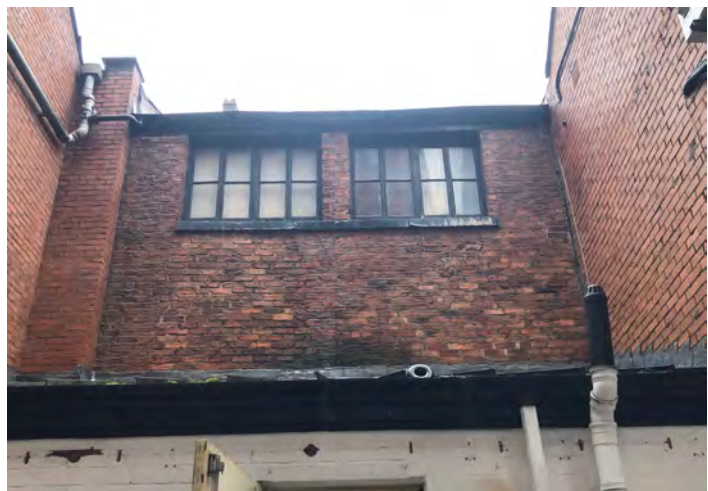
Fig. 4 Rear elevation windows and lintels.

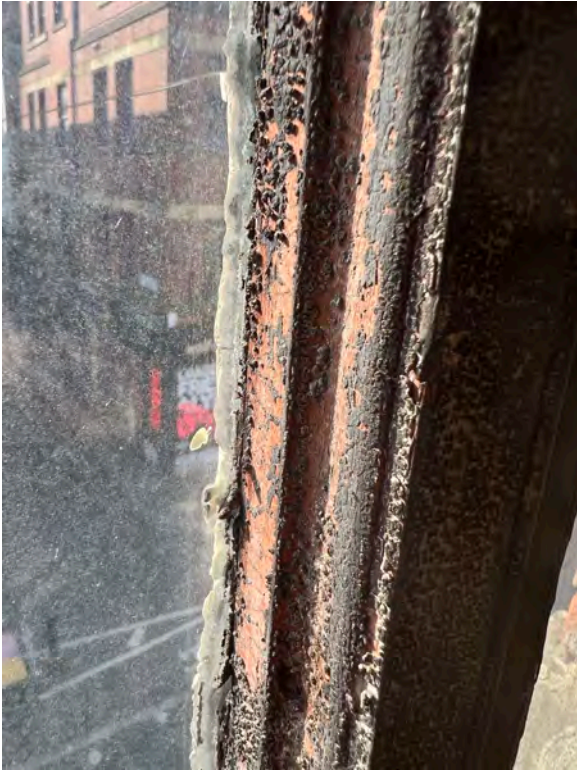
Fig. 5 Internal second floor front window. Single layer of black paint on existing timber frame.

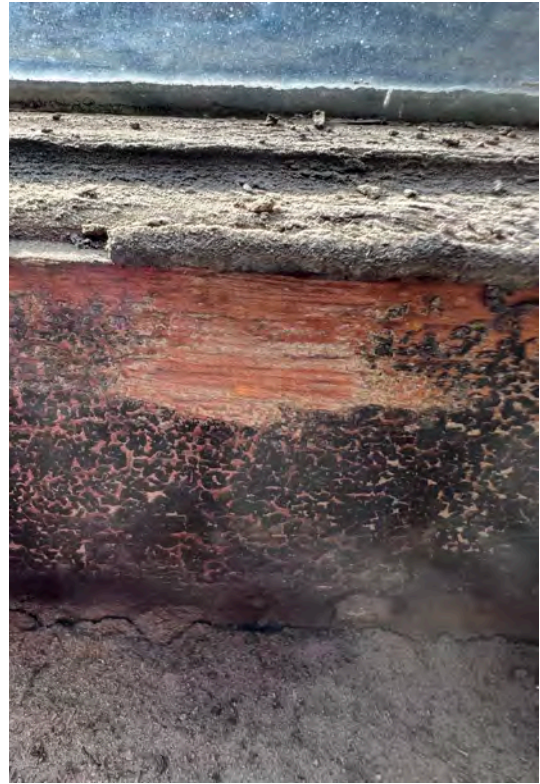
Fig. 6 Internal second floor rear window. Single layer of Black paint on top of timber.

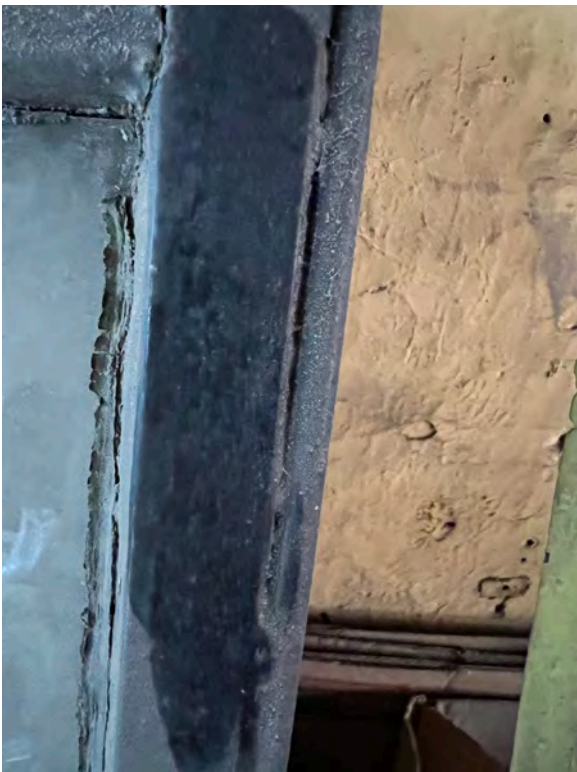
Fig.7 External side of second floor front window, top layer of black gloss paint

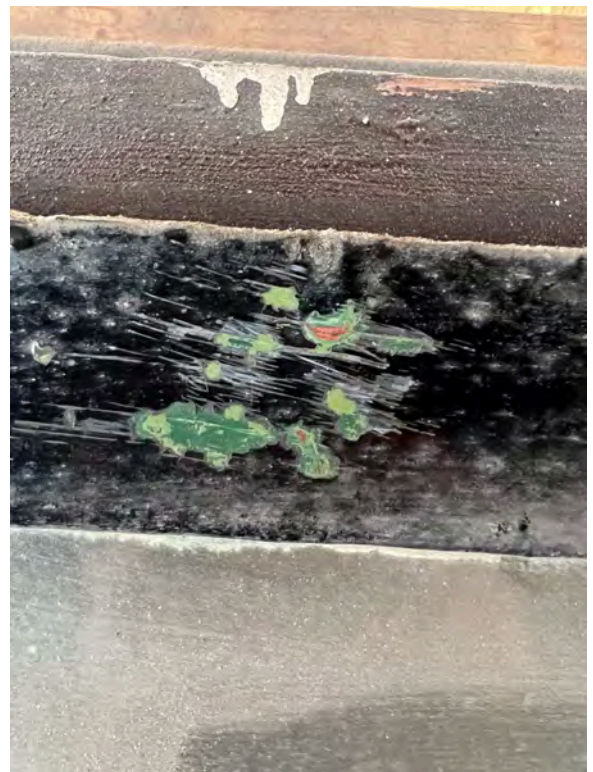
Fig. 8 External side of second floor window removal of top layer reveals a bottle green paint colour below and timber beyond.

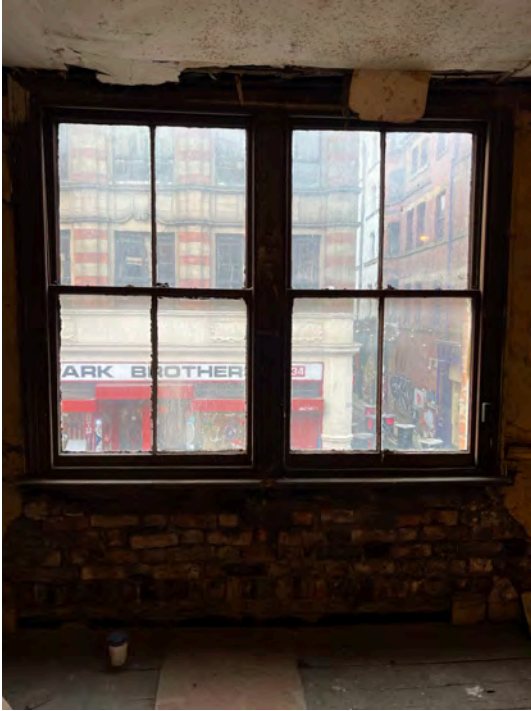
Fig.9 First Floor front window

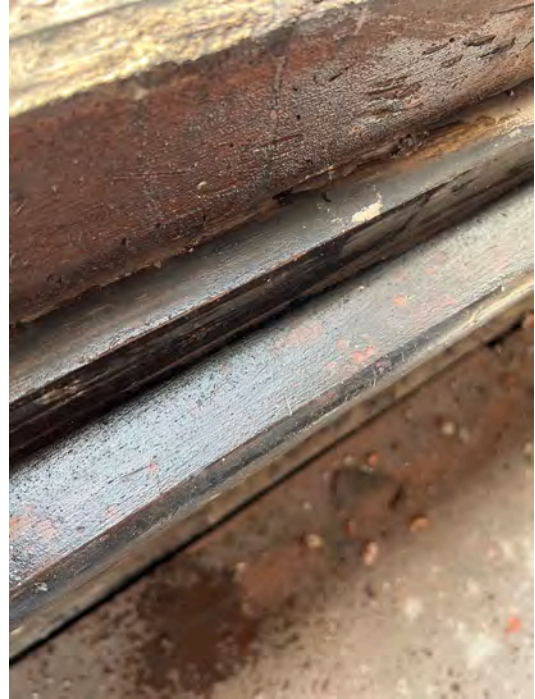
First floor front window sill is a coat of black paint on the timber (Fig.10), the window mullion appears to be a layer of brown varnish (Fig.11), underneath the timber is still visible. The rear widow of a later design which has been bricked up (Fig. 12) shows a light green paint to the surface and a darker bottle green underneath. The bottle green colour and brown varnish are visible on what would be the external part of the frame (Fig.14 & 15).

Fig.10 Cill shows single layer of black paint on timber.

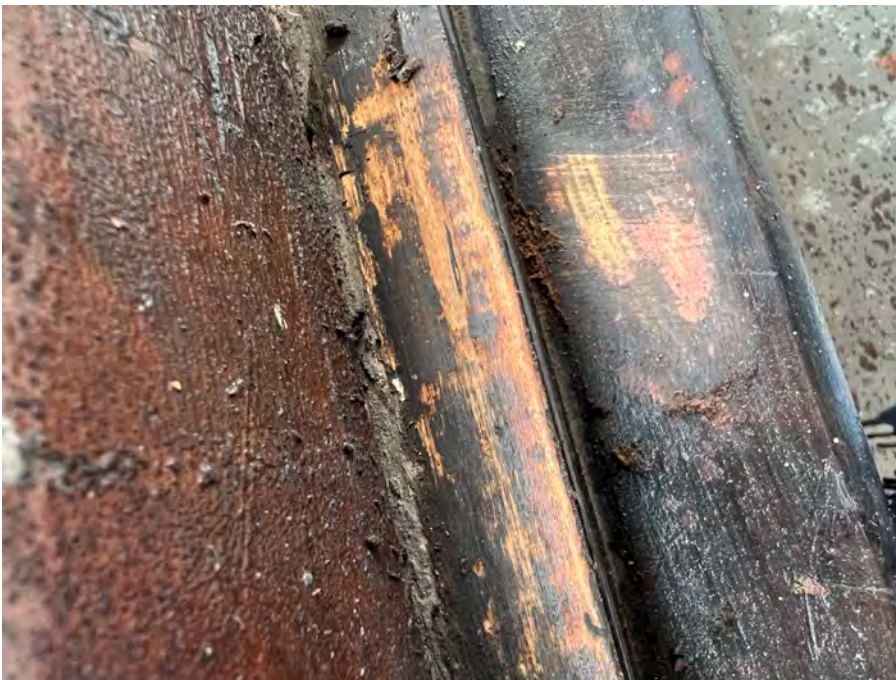
Fig.11 Visible is single layer of black paint on cill and brown varnish on mullion.

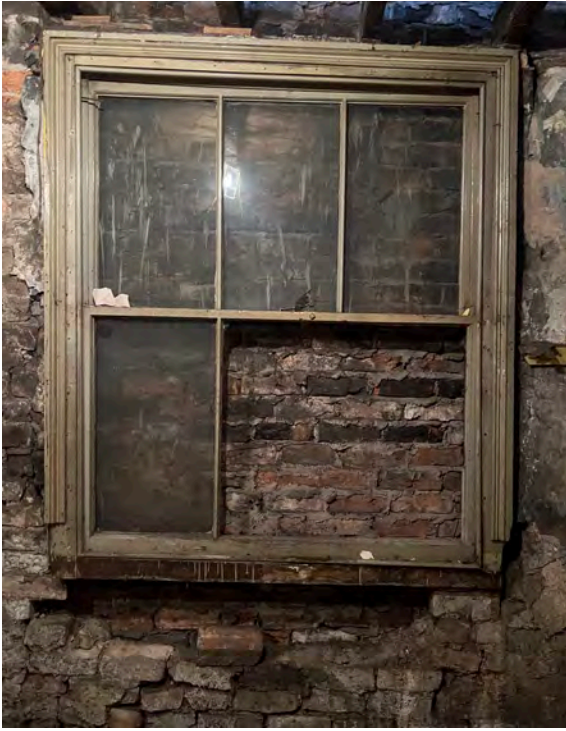
Fig. 12 First floor rear window that has been bricked up.

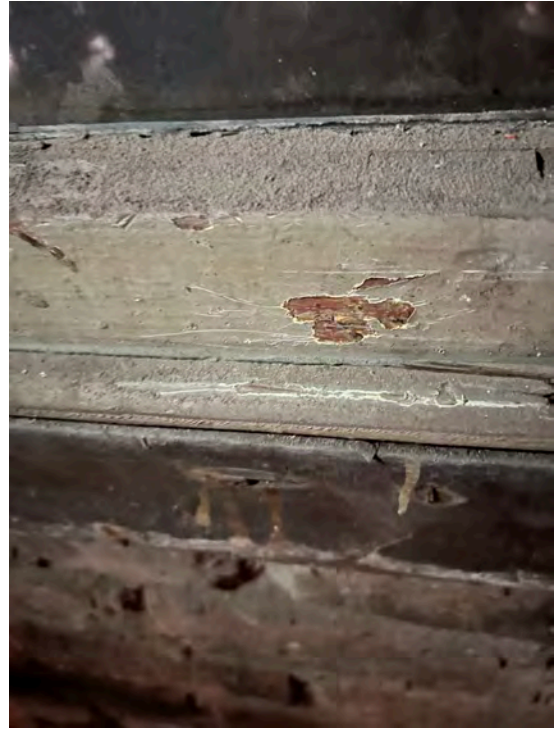
Fig. 13 Close up of rear window showing the light green colour to the surface.

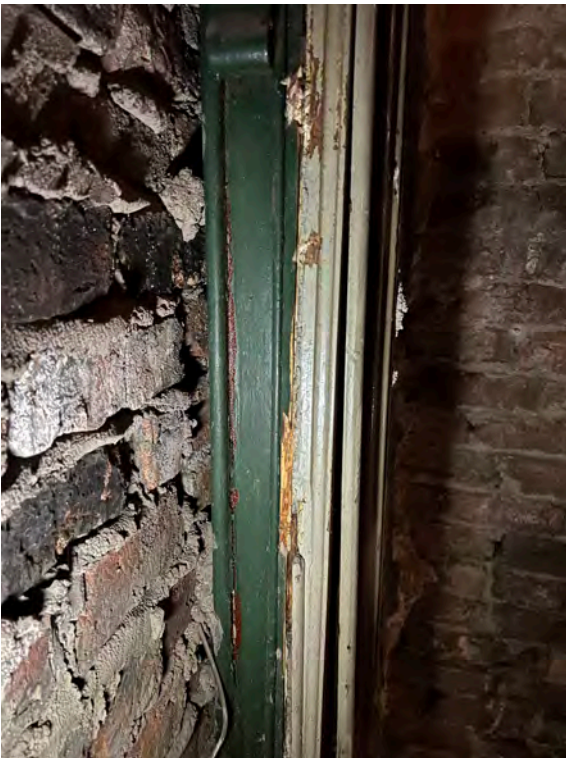
Fig. 14 Showing the bottle green paint that would have been on the exterior of the window before it was bricked up.

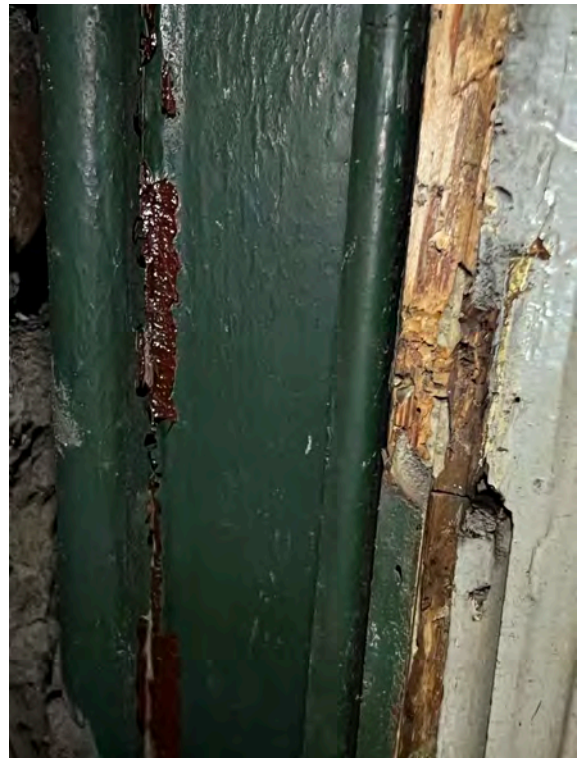
Fig. 15 Detail of the exterior window frame showing the brown varnish under the dark bottle green paint layer.

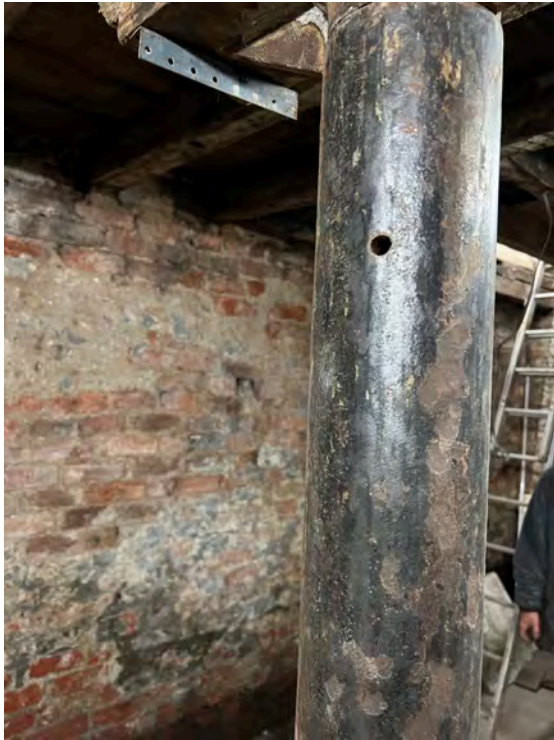
In the basement there are three iron columns. Column 1 (Fig.16) the largest in diameter and can be seen to have large amounts of black paint remaining on the surface (Fig.17). Column 2 (Fig.18) largely covered in rust (Fig.19), it can't be determined as to what colour it originally was. Column 3 (Fig.20) has one flat edge to it, again the majority of it covered in rust but some small areas have black paint still visible (Fig. 21).

Fig. 16 Column 1 the largest in diameter.

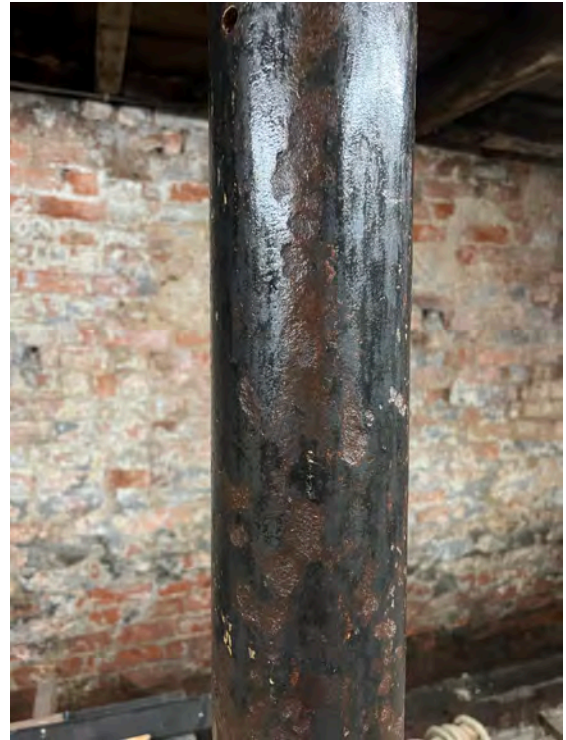
Fig. 17 Column 1 showing visible black paint.

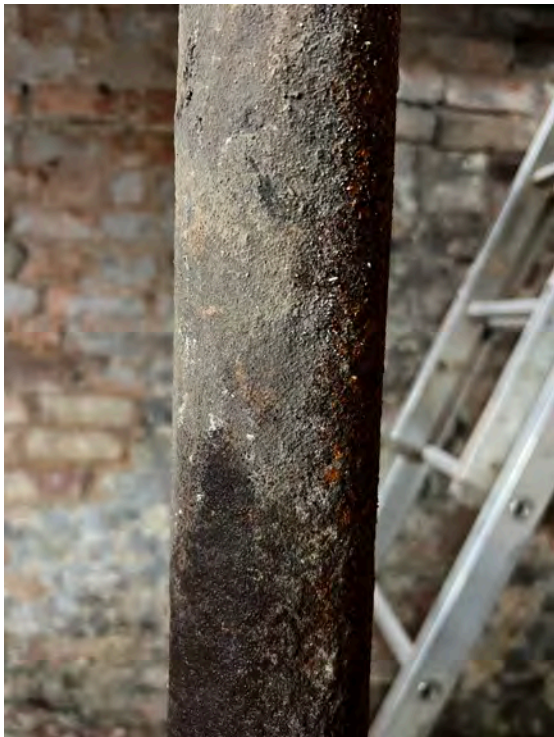
Fig.18 column 2, dirt and rust present.

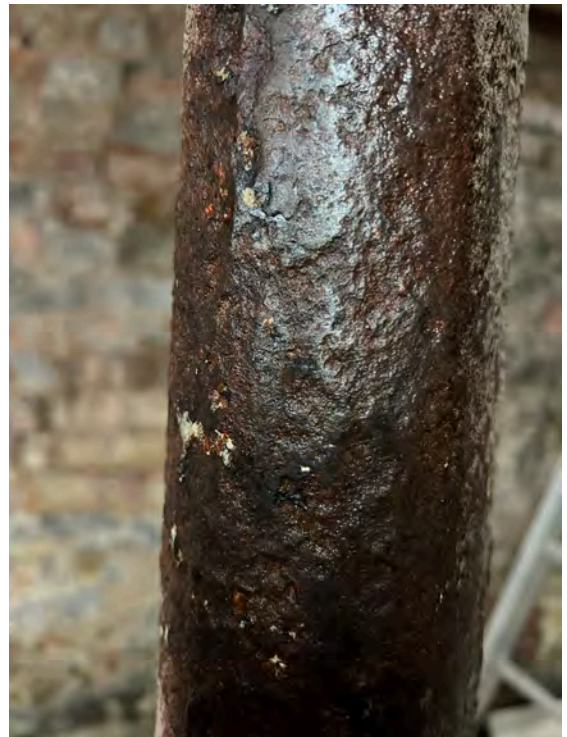
Fig.19 wiping down column 2 reveals rust and no paint.

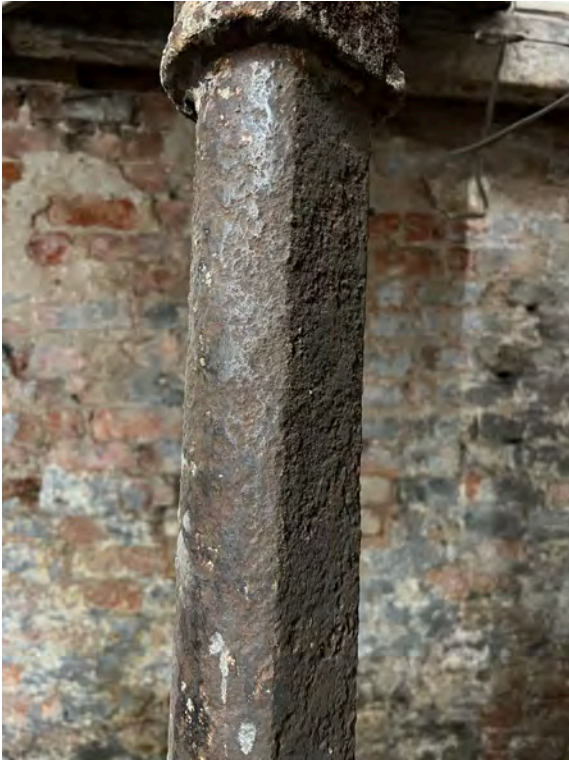
Fig. 20 Column 3 has a flat edge.

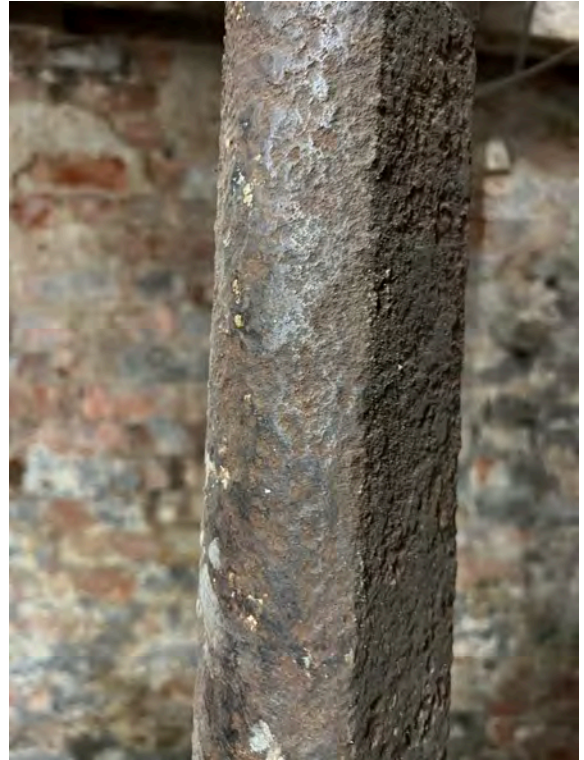
Fig. 21 column 3 is majority rust covered but there are small areas of black paint.

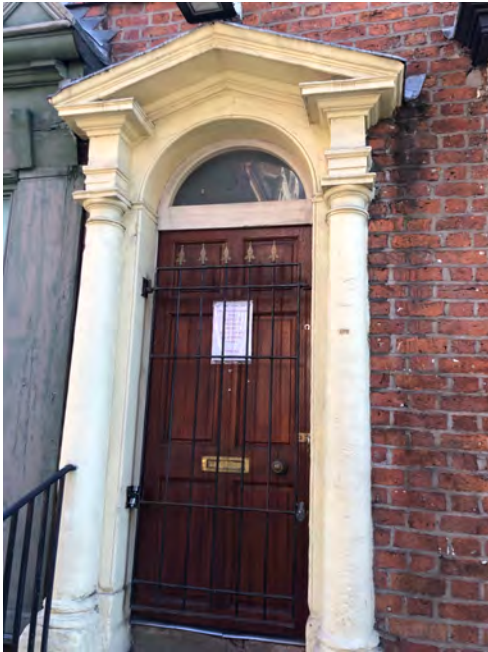
The front of the building has masonry around the entrance and the window cill. The columns and portico have been painted a light yellowy cream (Fig.22) without any sign of other paint beneath (Fig.23). Although historical photos show they had been black (Fig.27) The cill (Fig. 24) is currently without paint although again from historical photos it was black (Fig.26).

Fig. 22 Columns and portico to entrance.

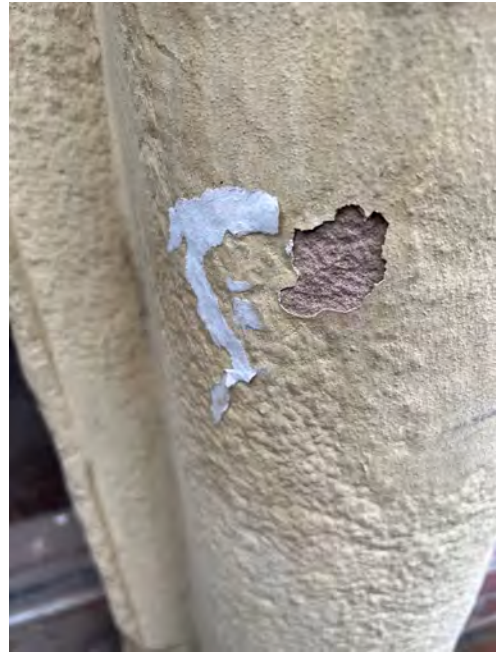
Fig. 23 Removal of single layer of paint revealed original masonry beneath

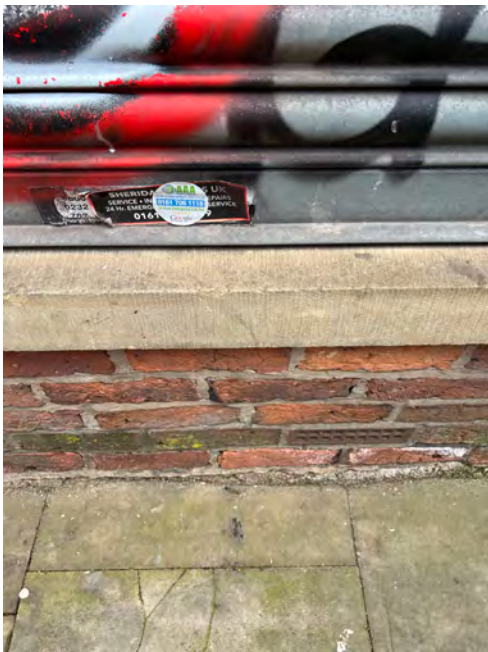
Fig. 24 Cill to shop front.

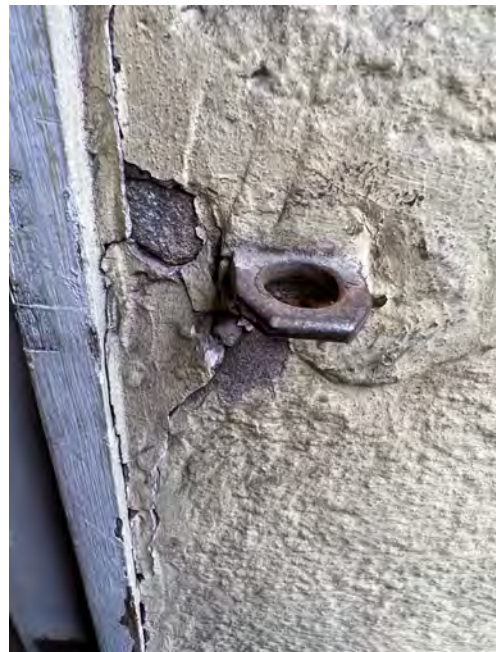
Fig.25 Loose paint shows stone beneath

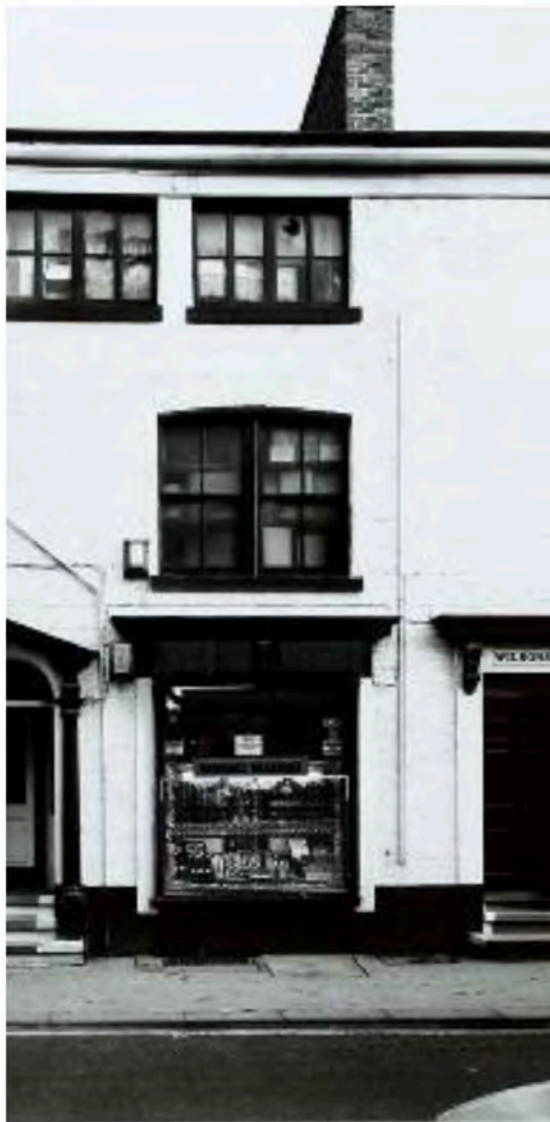
Fig. 26 Photo from Heritage Statement showing all cills, window frames and columns painted black.

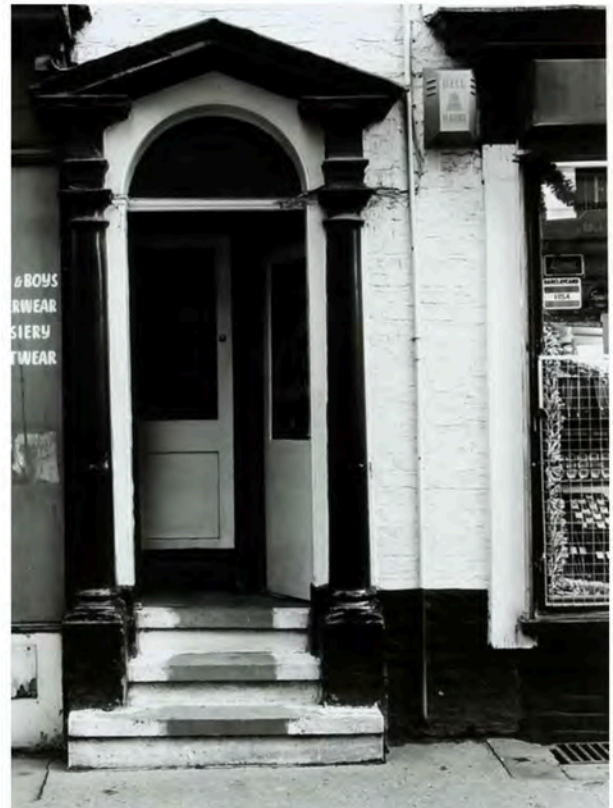
Fig. 27. Photo from Heritage Statement, closer look at the entrance columns and portico painted black.
