**Highway Dilapidation Survey**  
**Longhurst Road, Blackley**

Location: Longhurst Road, Blackley, M9 8NS

A road condition survey was carried out on Longhurst Road, located outside the former day nursery site and neighbouring residential properties. The purpose of the inspection is to provide a report on the current condition of the highway prior to construction work commencing on the adjacent land.

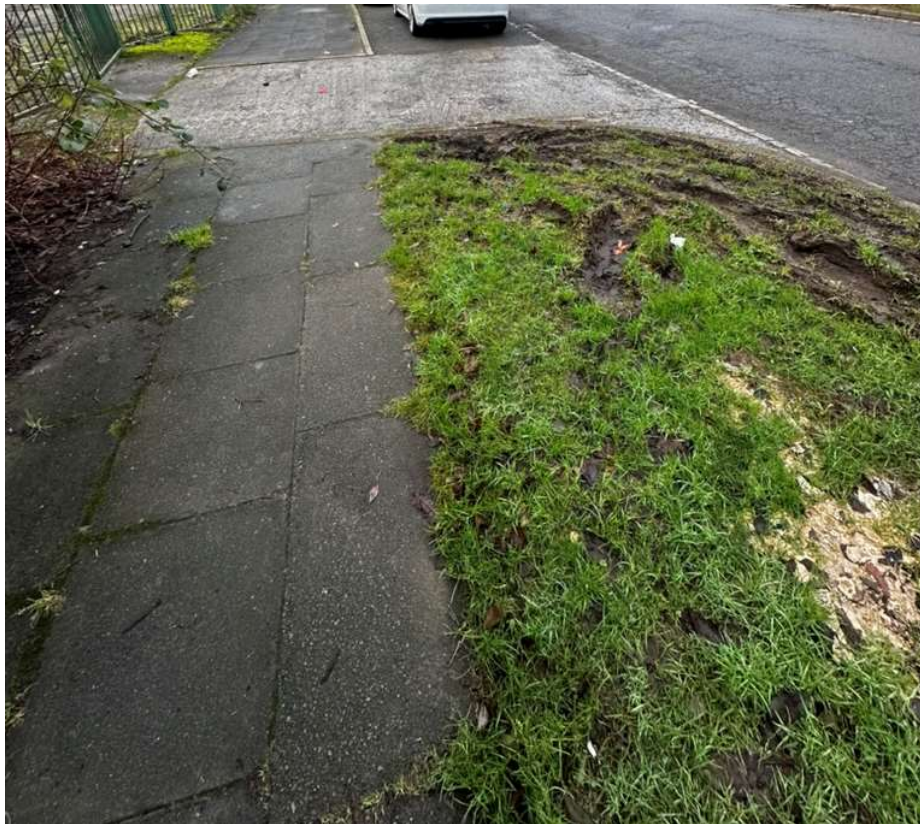
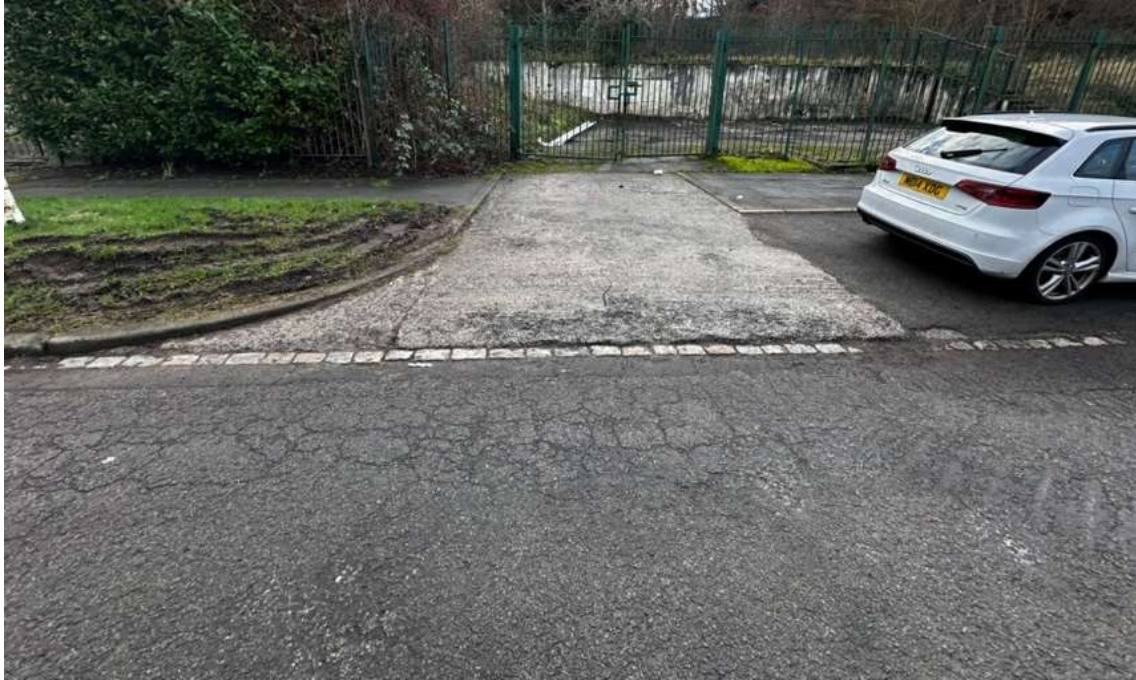
## **1.0 - Existing Site Entrance**

Slight cracking on the surface of the road tarmac directly outside of the existing site entrance. Mixture of paving stones and concrete footpath in poor state of repair. Multiple cracks on all surfaces and generally uneven. Kerb worn but generally in reasonable repair. Visible damage to the grass verge caused by vehicles running over the tangent point when using the layby.

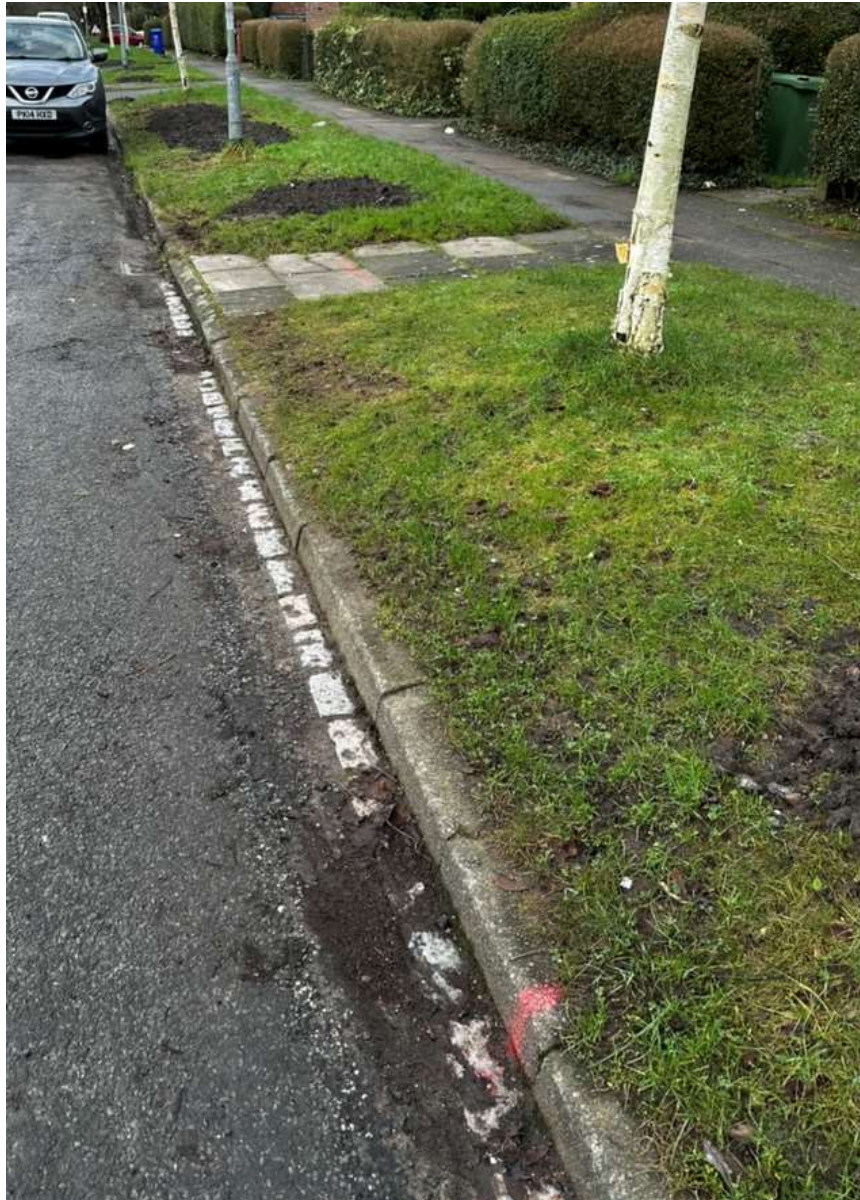
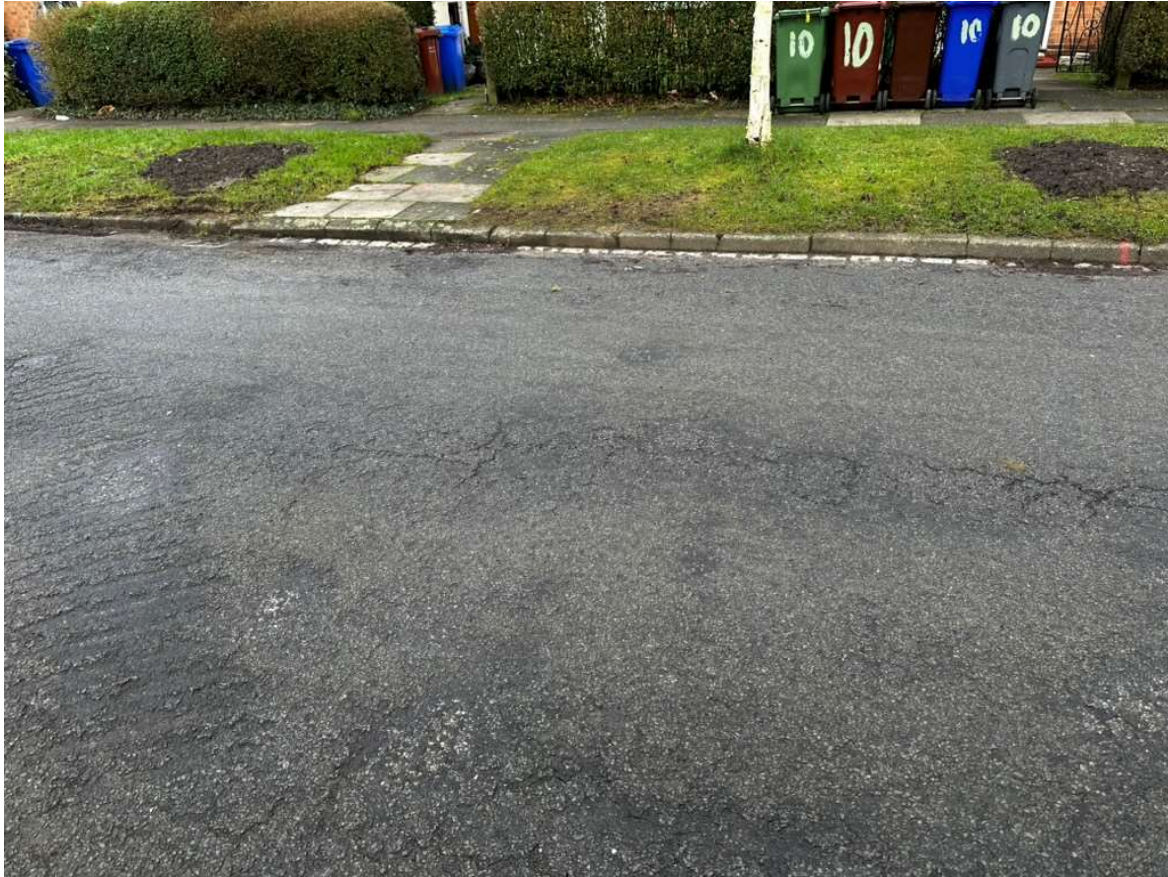
### **1.1 - Adjacent Site Entrance**

Kerbs generally in good repair although worn. Noticeable cracking in surface tarmac on road. No patch repairs on the road. Flagged footpath in good condition however minor vegetation growth between joints.

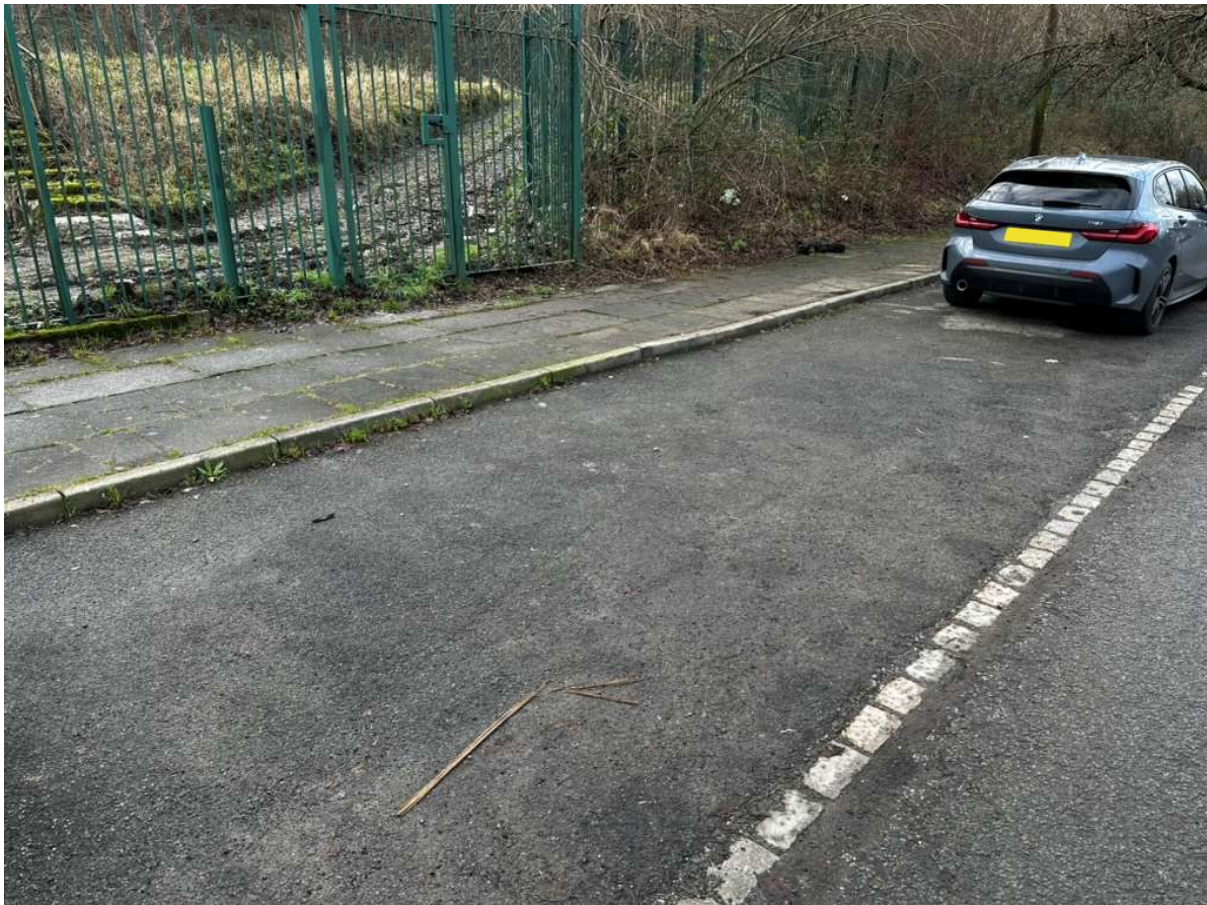
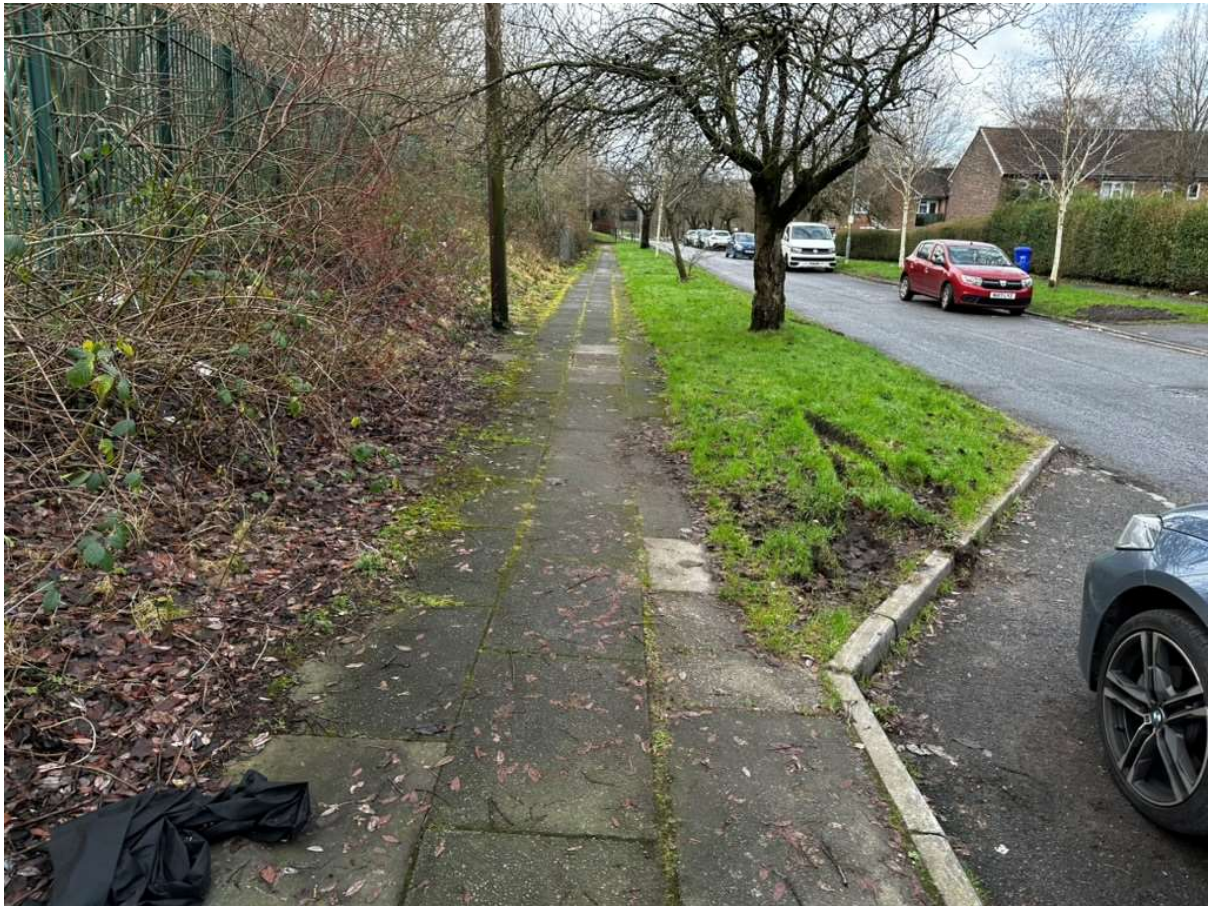
## **2.0 - Proposed New Apartment Entrance**

Layby surfacing showing signs of wear and tear, no patching but generally in reasonable condition. Flagged surface uneven throughout with vegetation growing in various areas along the cracks. Parking bay condition shows signs of deterioration from use, however generally in good condition. Damage to grass verge from vehicles mounting kerb. Kerbs generally in good repair, however excess vegetation growth along joints.

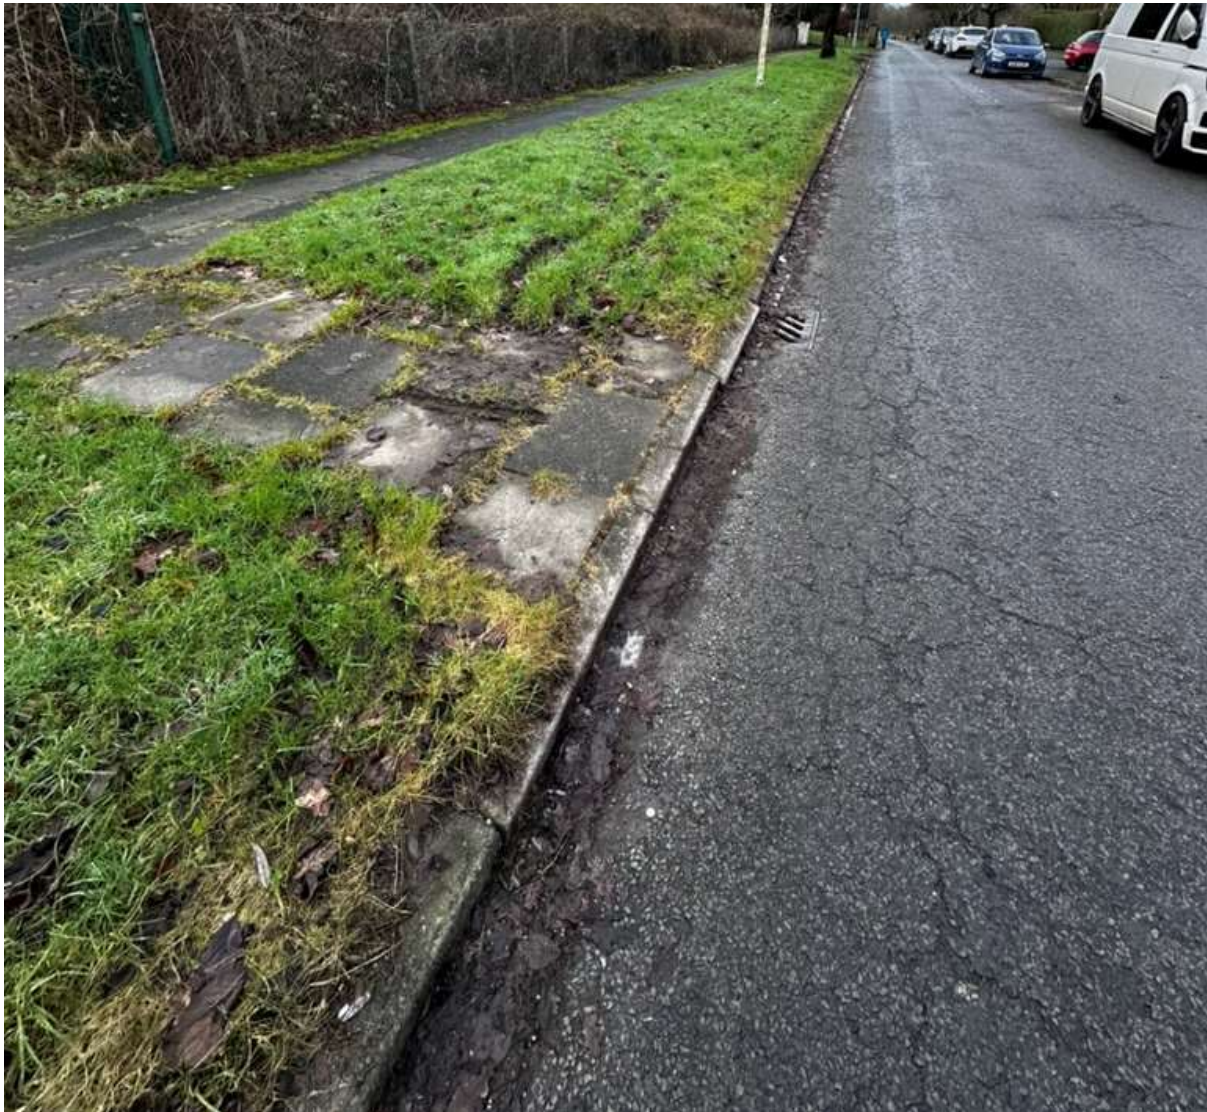
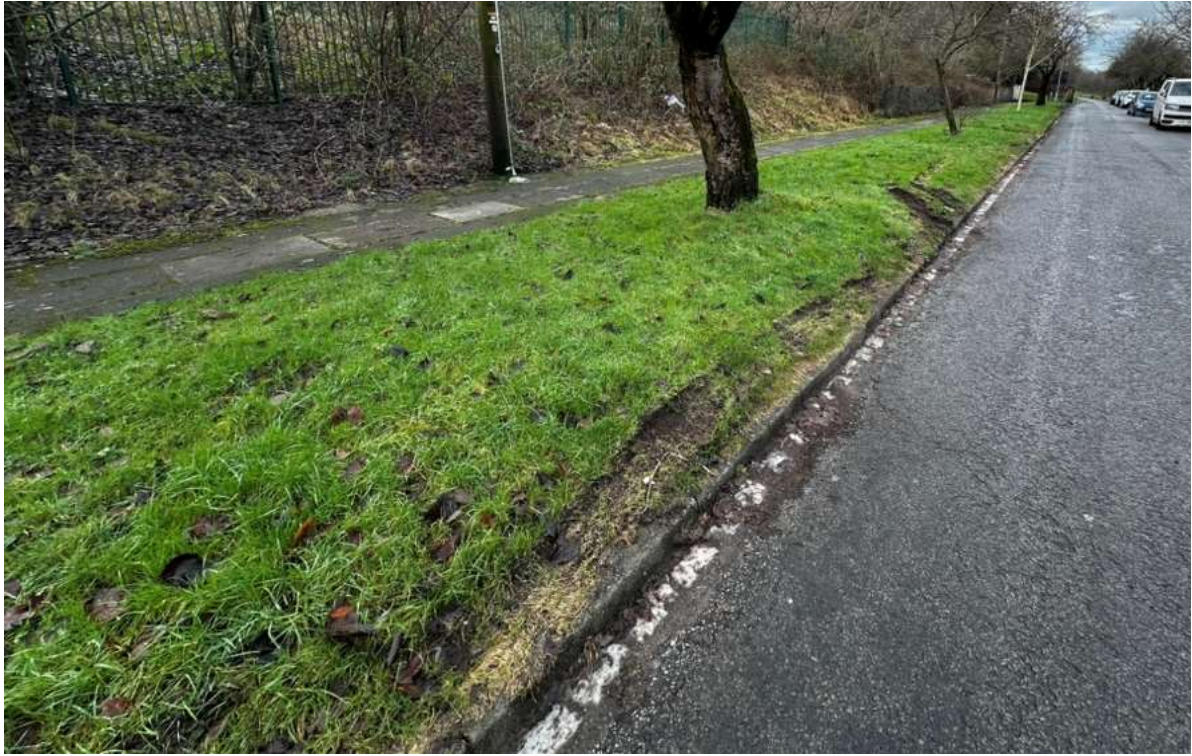
### **3.0 – Proposed Plot Access Area**

Footpath flagging in poor condition with vegetation growing between cracks. Kerbs general wear and tear. Road surface wear and tear with noticeable surface cracking. No patch repairs. Damage to grass verge from vehicles tracking.

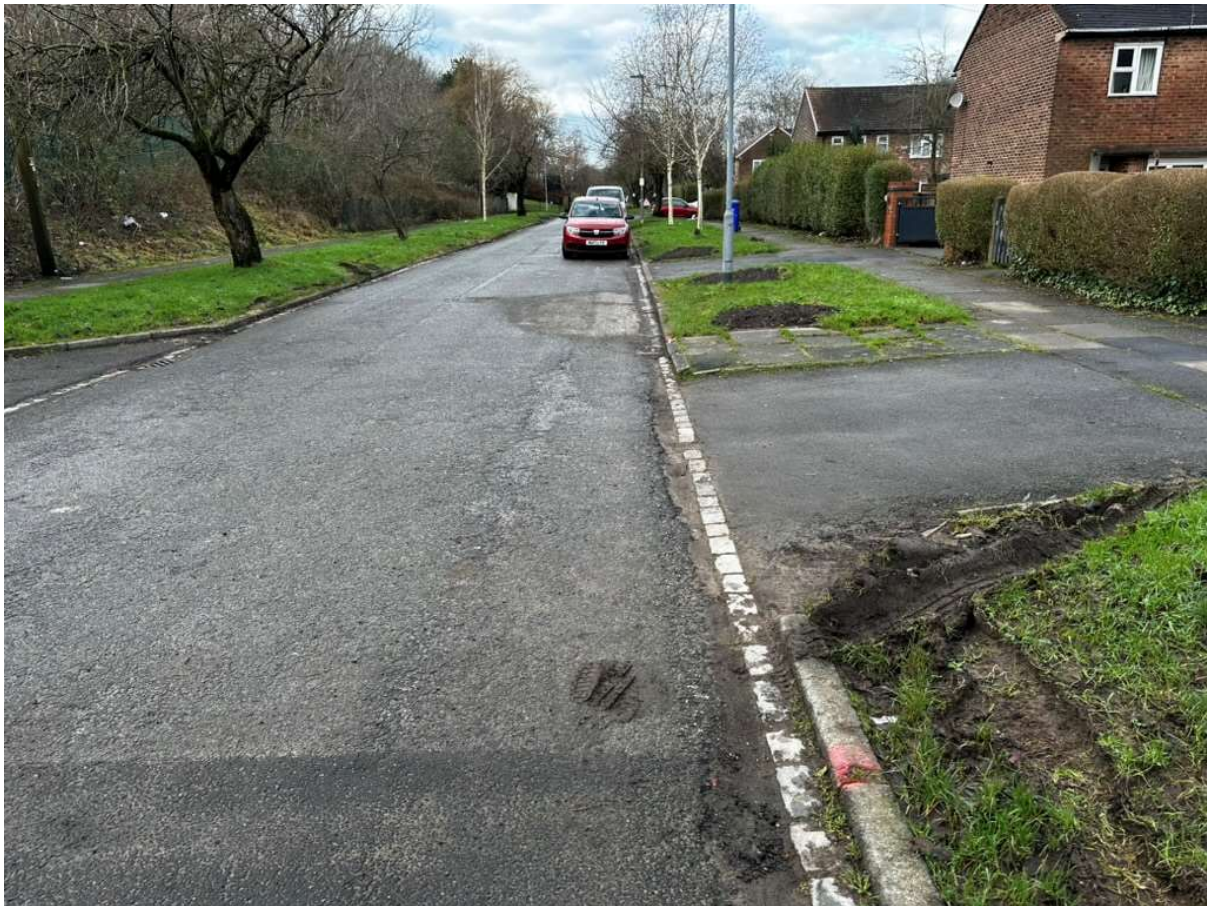
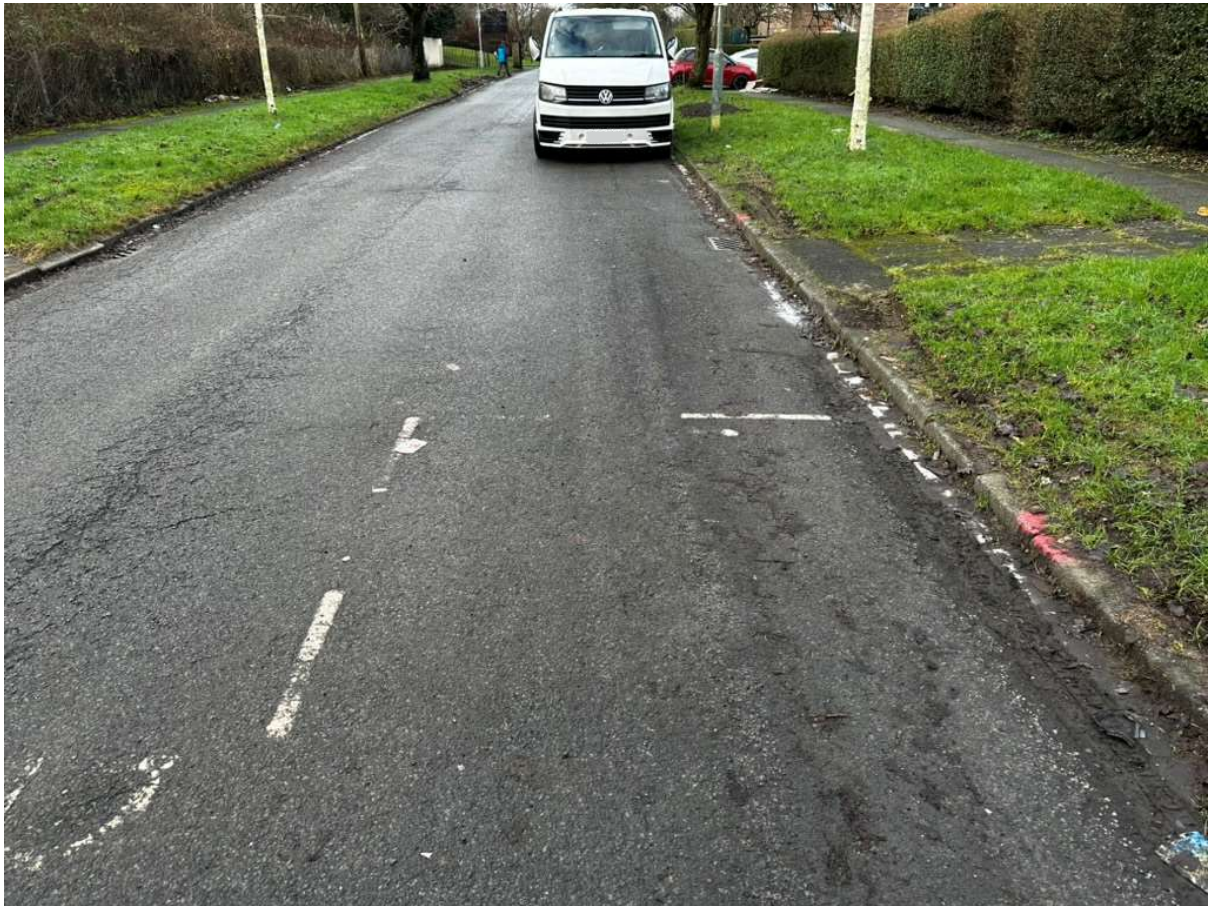
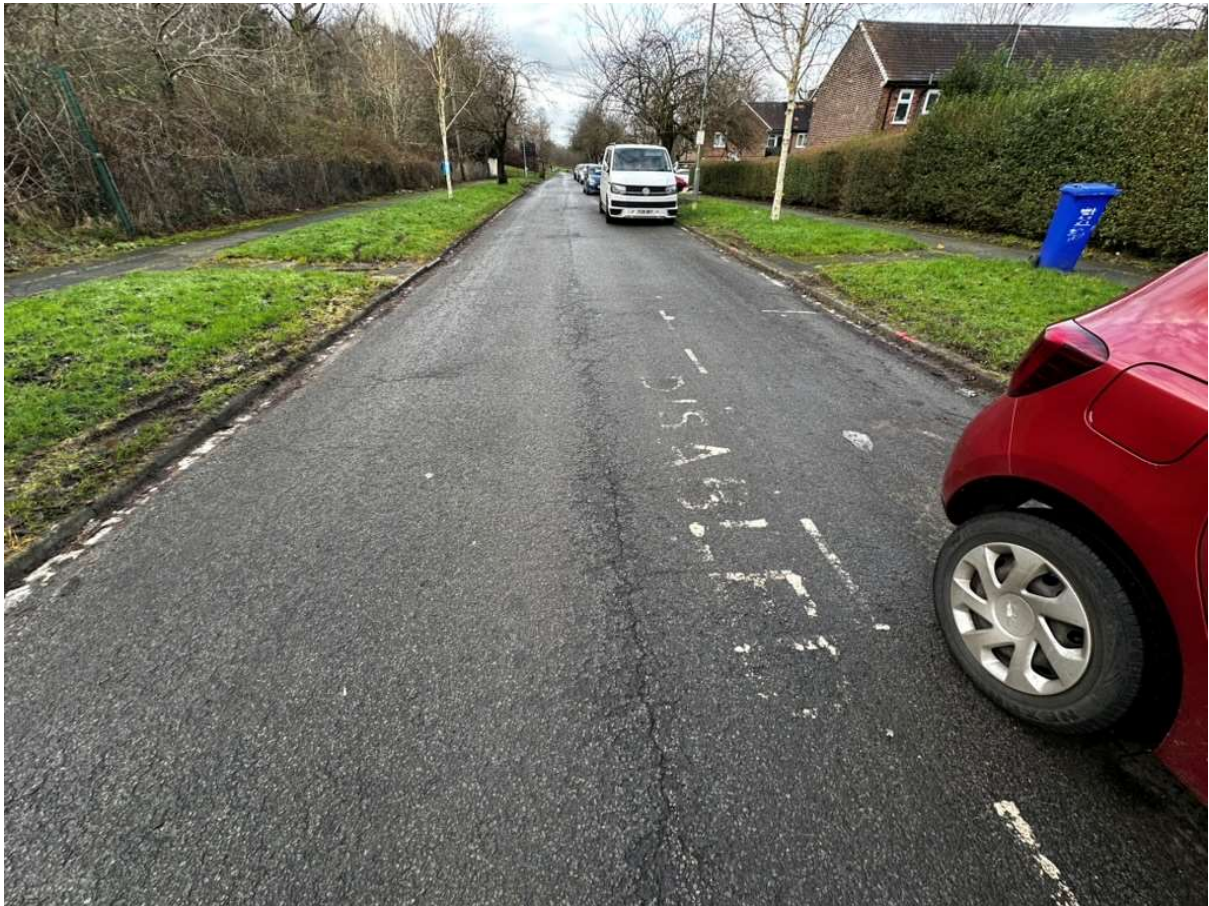
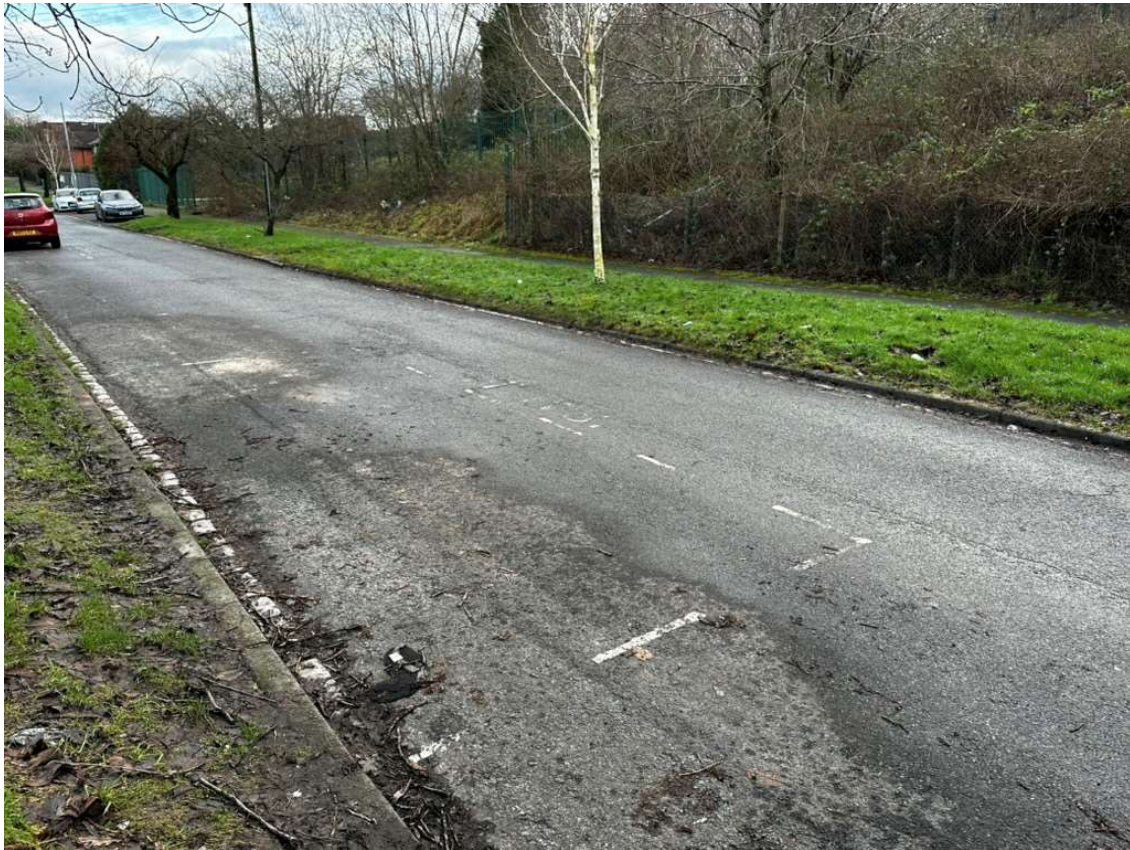
### **3.1 - Footpath and Road Opposite Proposed Plot Access**

Footpath paving uneven and in poor state of repair, visible openings with vegetation. Road tarmac in poor condition with patch damage to surface. Kerbs general wear and tear with vegetation covering some areas. Disabled bay road markings faded and generally in poor condition. Road surface noticeable surface wear and tear, with slight cracking at apex of road. Patching to channel line breaking up.

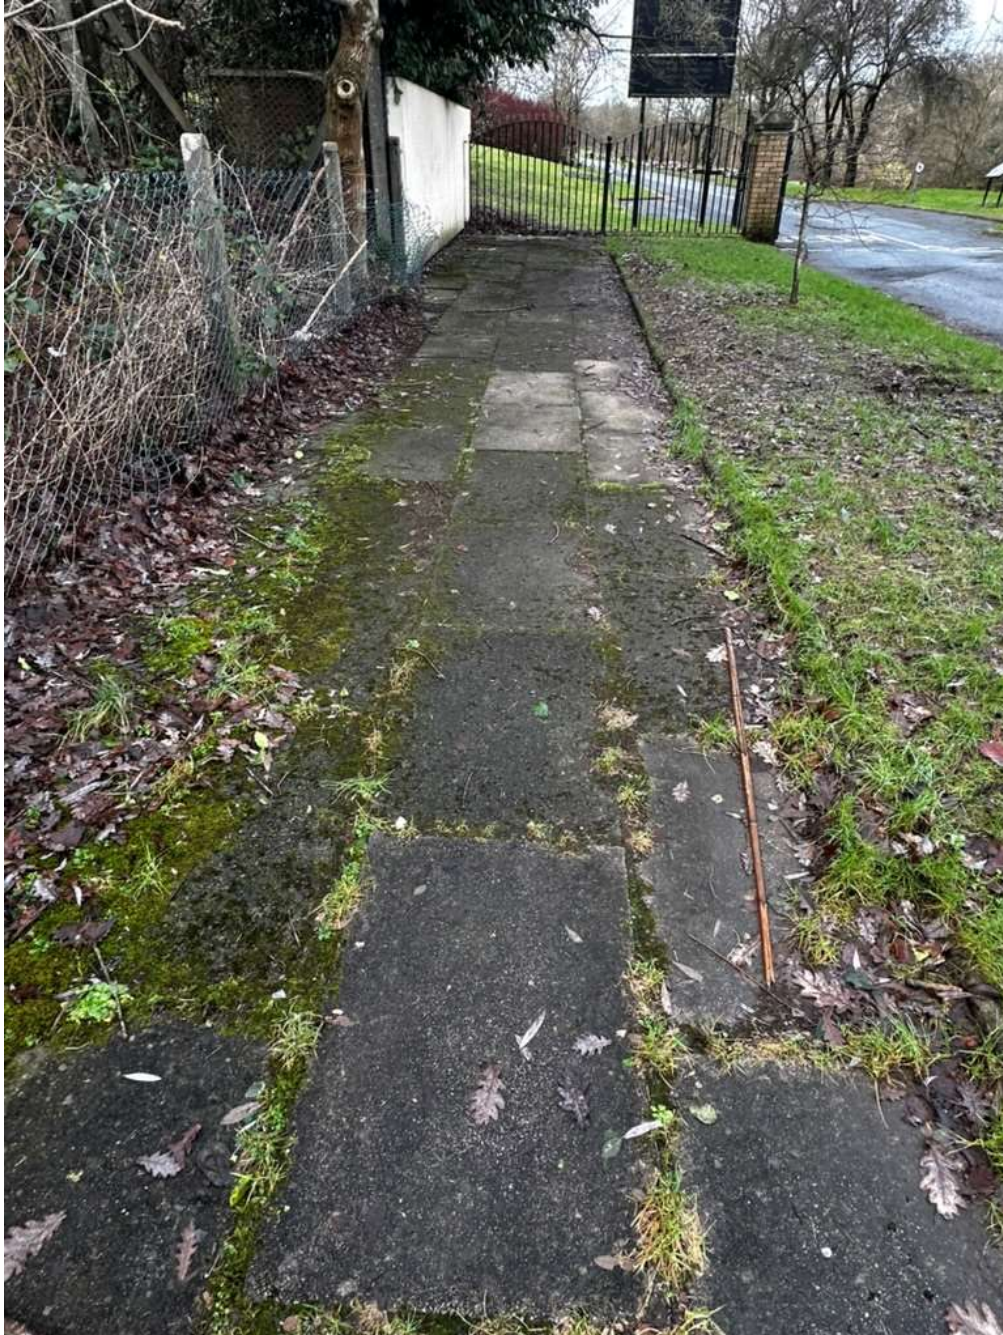
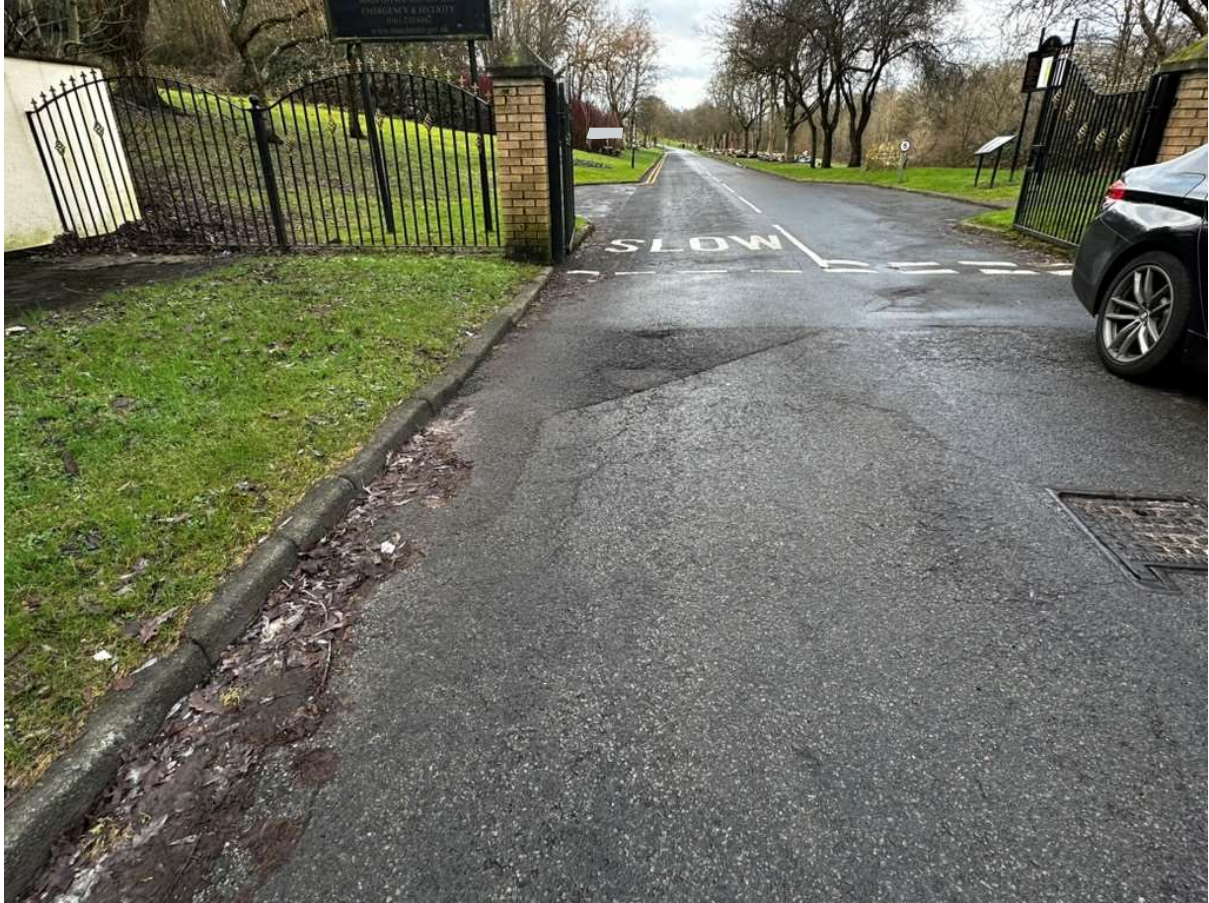
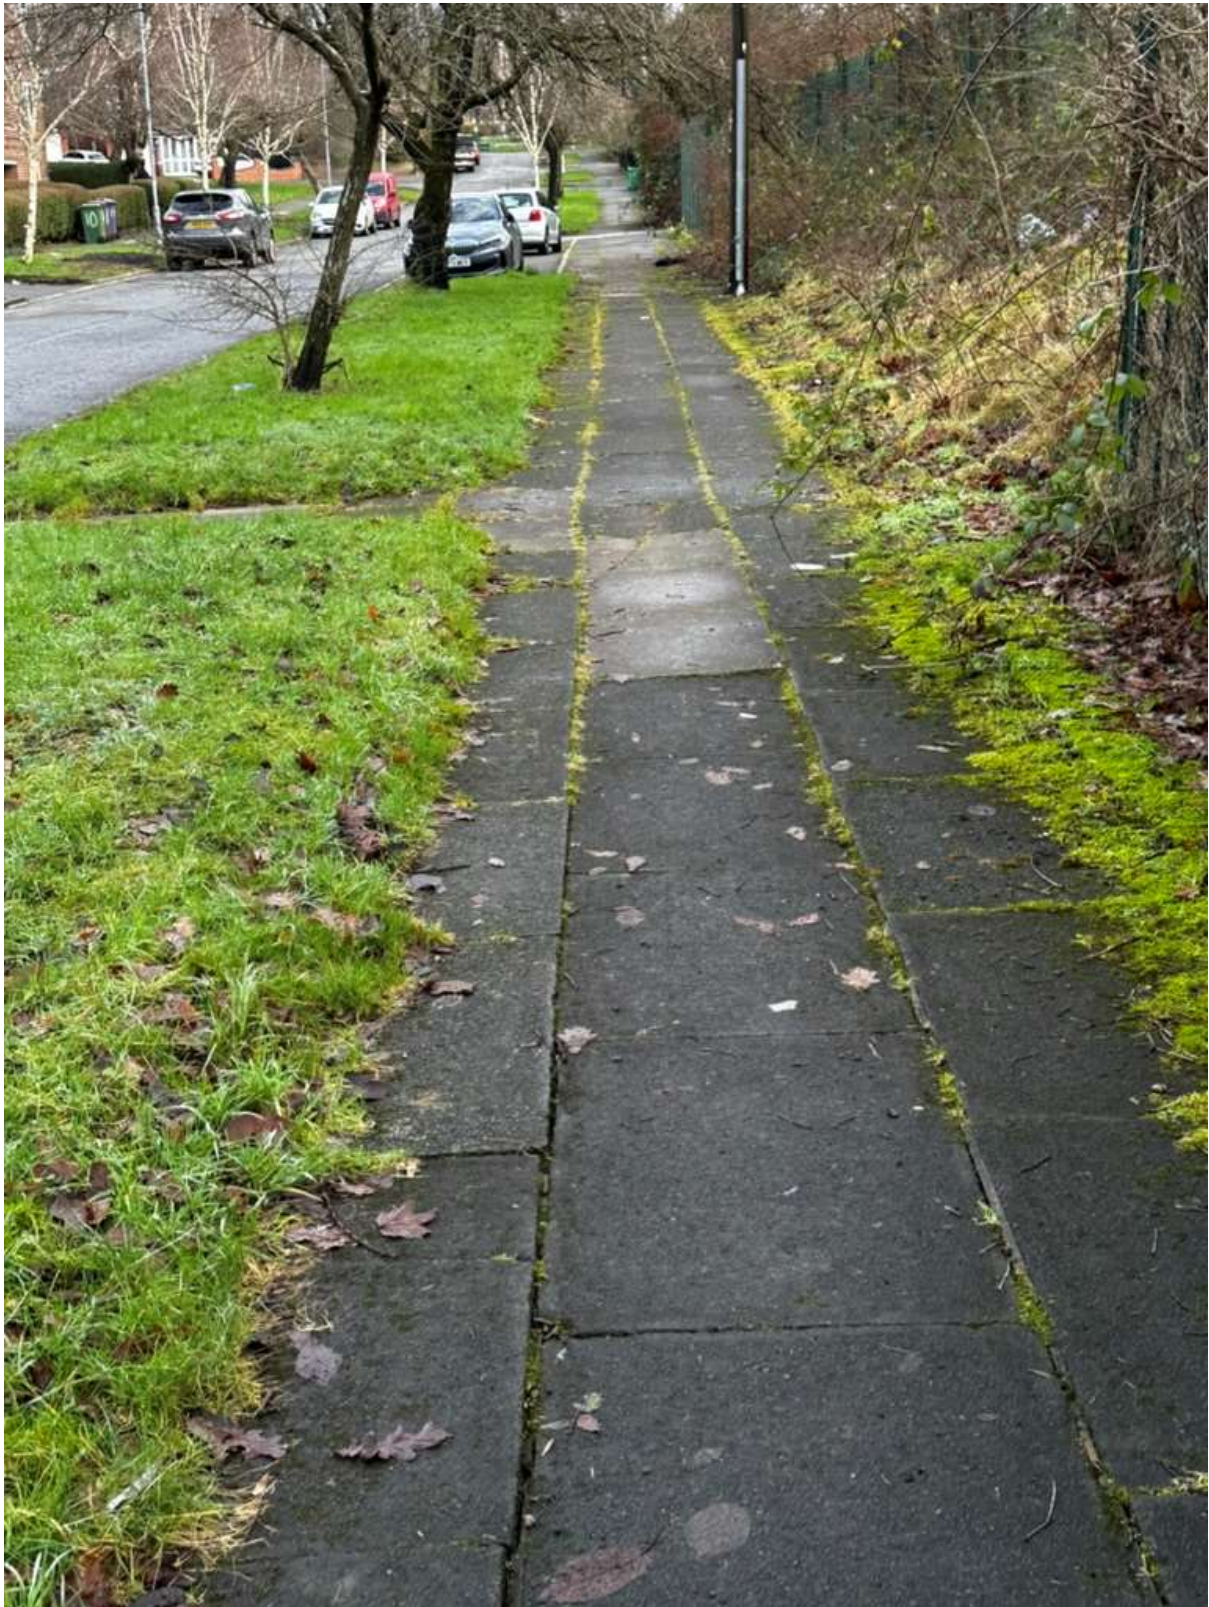
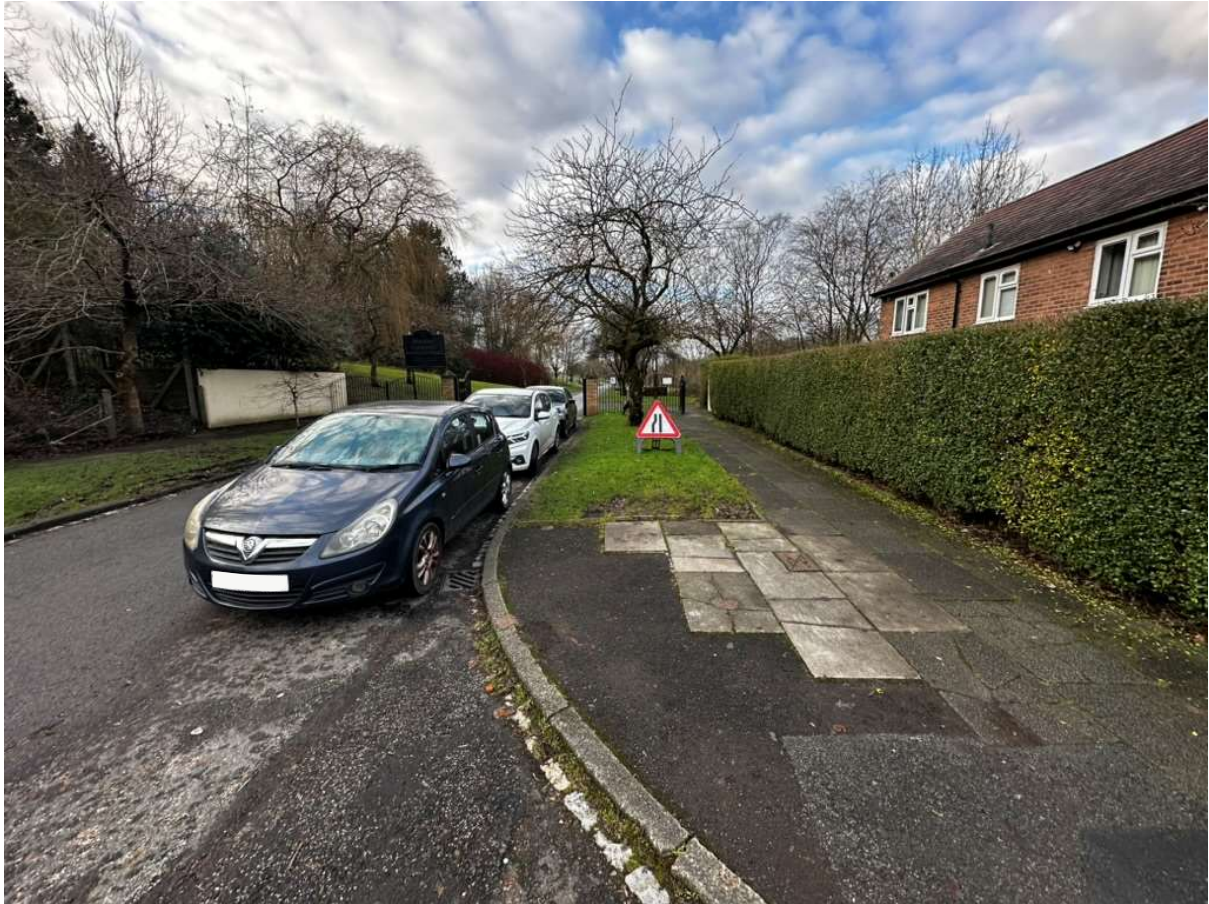
#### **4.0 - Footpath and Road Outside Cemetery Entrance**

Footpath paving uneven and in poor state of repair, visible cracks on both footpaths with vegetation. Grass verge encroaching onto footpath. Visible patch repairs to footpath tarmac. Kerbs general wear and tear with vegetation bordering some areas. Road surface general wear is visible with patch repairs outside of cemetery entrance. No visible surface cracking around road manhole.
